Annual Monitoring Report

Monitoring Year 5 of 7

Pee Dee Stream Restoration Project

NCDMS Project No.: 95350

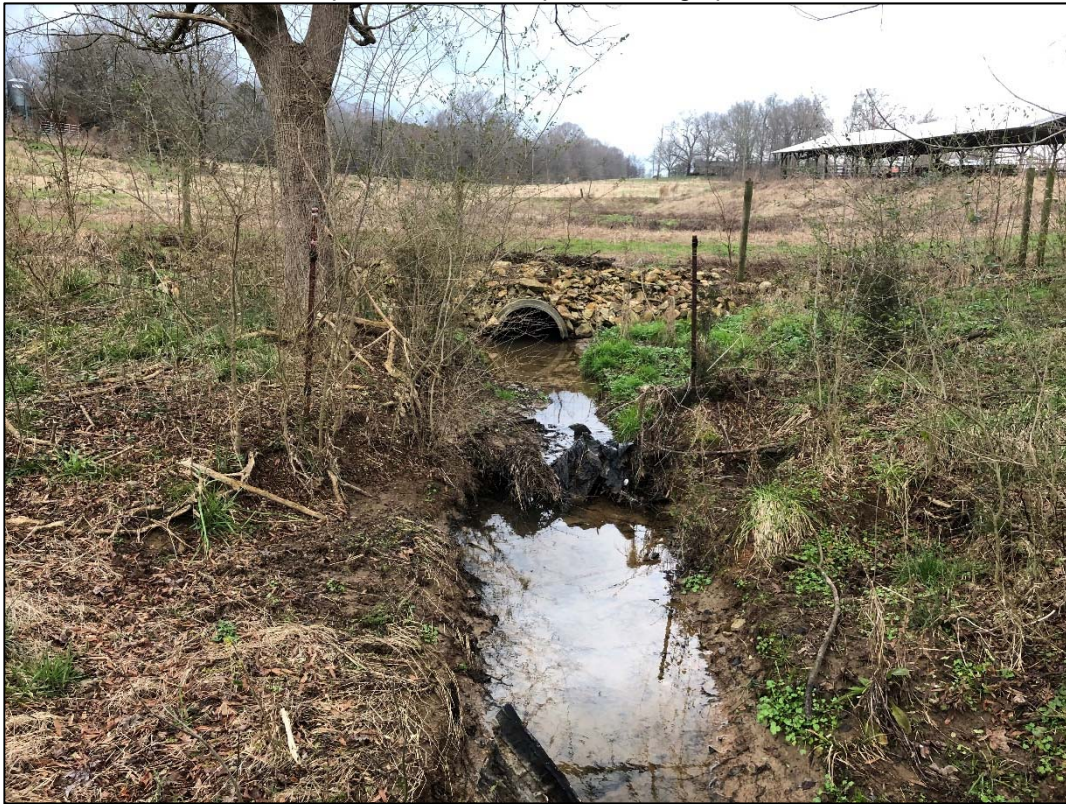
Thompson 1 above old pond looking upstream
