Annual Monitoring Report

Monitoring Year 6 of 7

Pee Dee Stream Restoration Project
NCDMS Contract No.: 004644
NCDMS Project No.: 95350
USACE Action ID: SAW-2012-01077
DWR #: 13-1140

Montgomery County, NC
Data Collected: November 2020
Date Submitted: January 2021

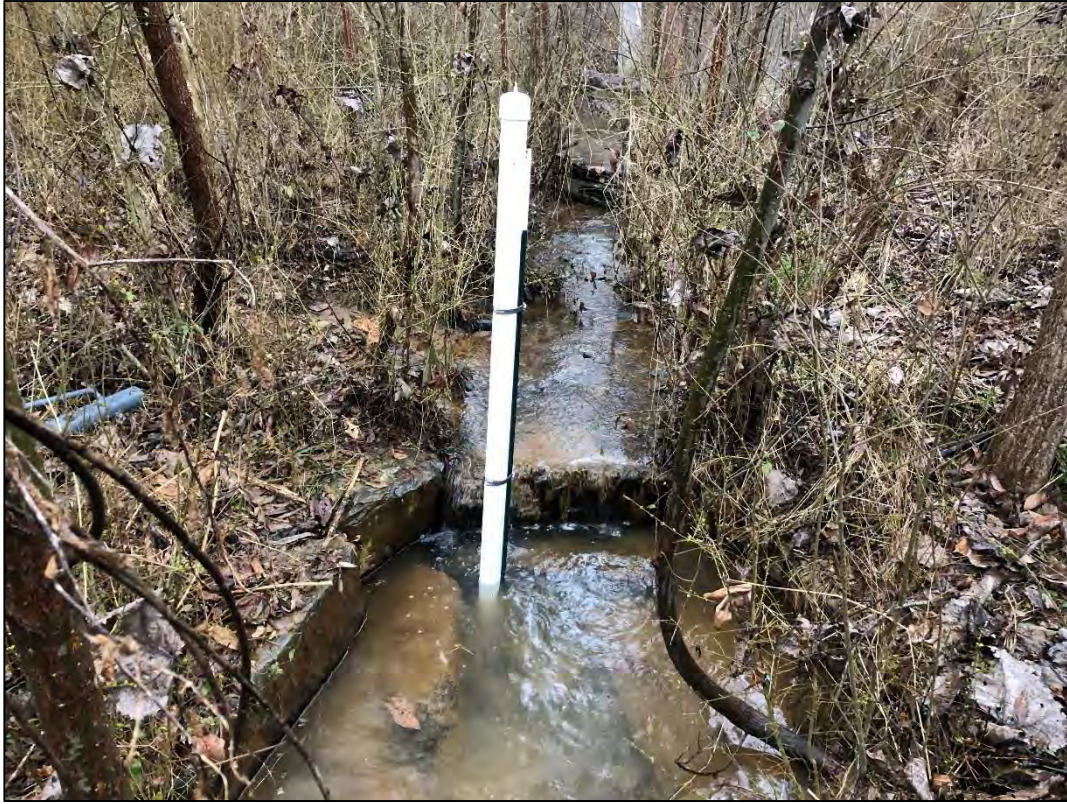
Thompson 1 looking upstream at Pee Dee Road

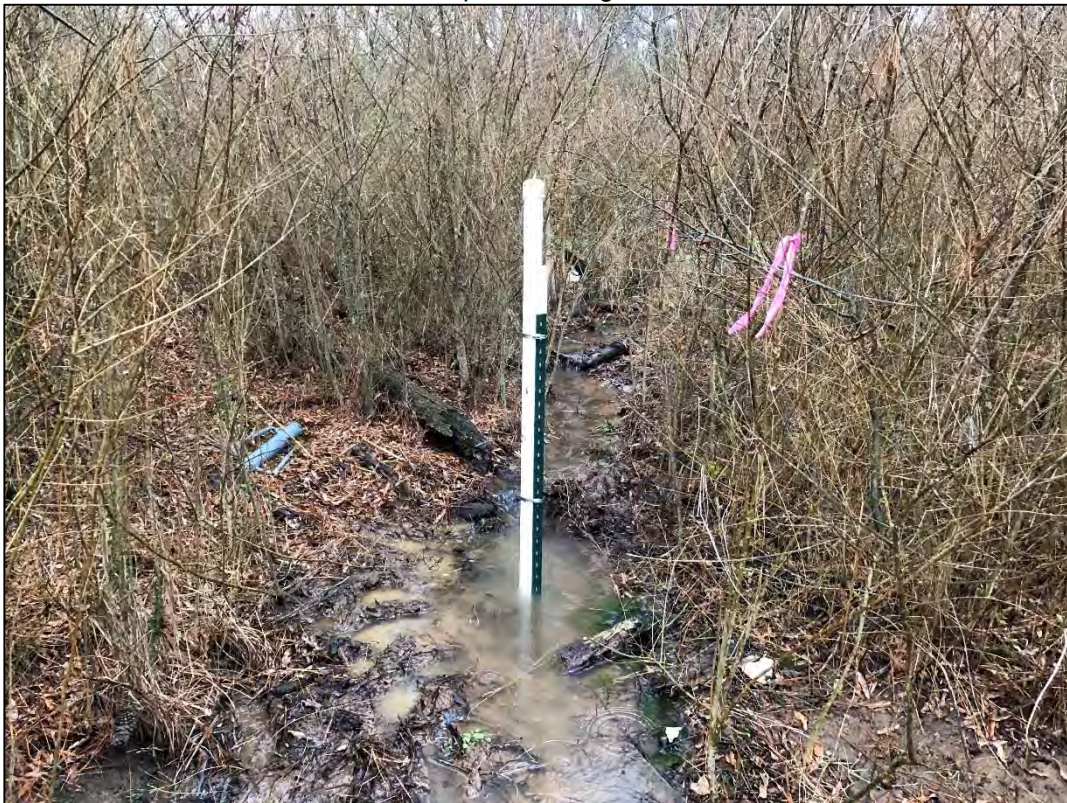
- Despite the hand work RES performed on the channel through the wetland area on Dale 1, the area resembled more of a braided system. DWR recommended using valley length for all of Dale 1. Valley length for Dale 1 would reduce the credits from 250 SMUs to 240 SMUs.

Dale 1 in old pond looking downstream
