Monitoring Report- Year 5  
FINAL VERSION  
Pen Dell Mitigation Project  
Calendar Year of Data Collection: 2022

NCDEQ DMS Project Identification # 97079  
NCDEQ DMS Contract # 6824  
Neuse River Basin (Cataloging Unit 03020201)  
USACE Action ID Number: SAW-2016-00885  
NCDEQ DWR Project # 2016-0403 V2  
Johnston County, NC  
Contracted Under RFP # 16-006477  
Data Collection Period: March and September 2022  
Submission Date: November 30<sup>th</sup>, 2022

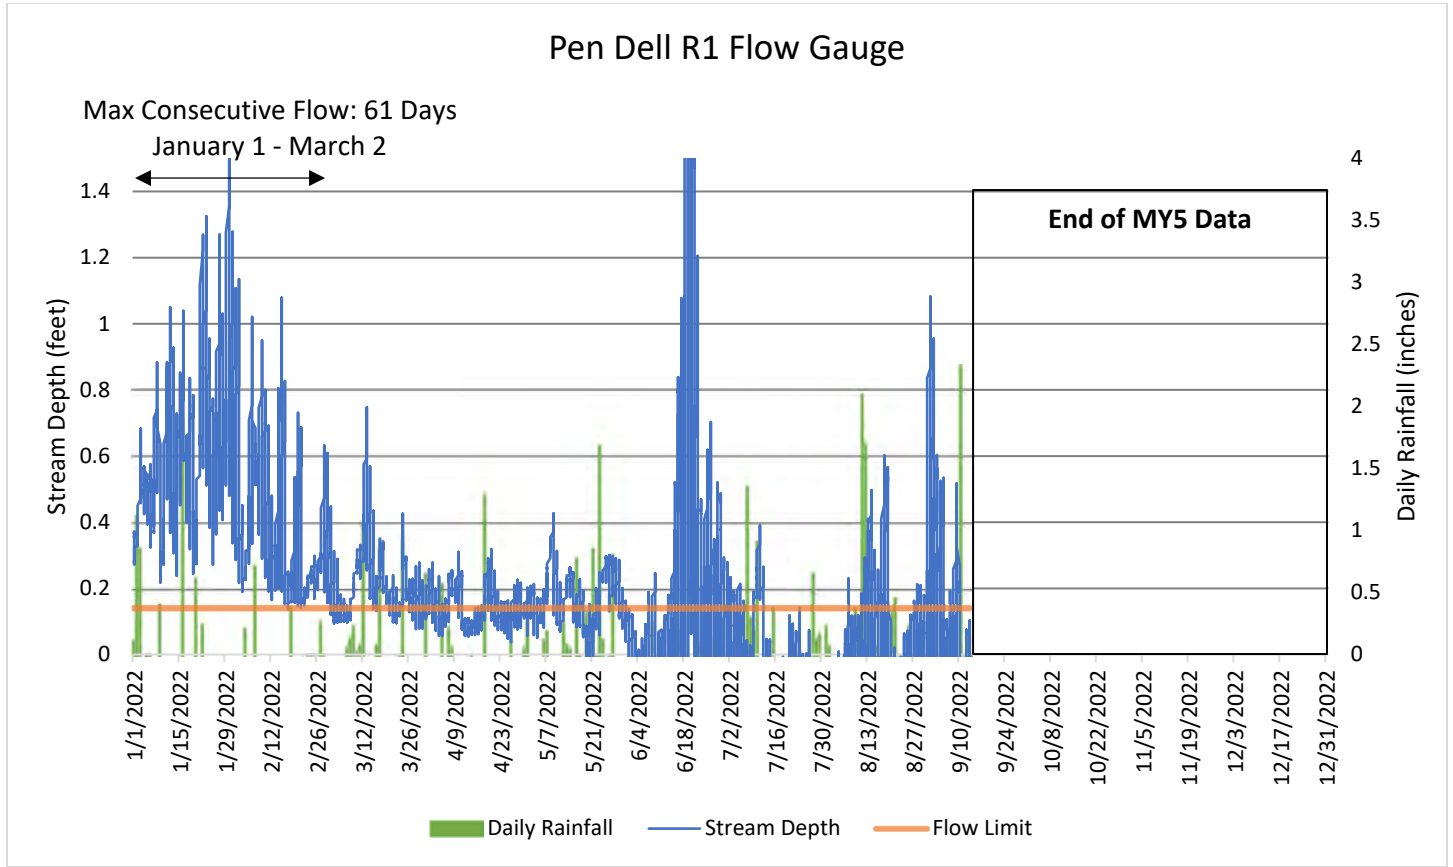
Figure 3a:

Jurisdictional stream flow documentation and monitoring of restored intermittent reaches is achieved using a flow gauge (pressure transducer) within the thalweg of the channel towards the middle portion of enhanced Reach R1 (Figure 1). Additionally, to determine if rainfall amounts are normal for the given year, precipitation data was obtained from CLAY Central Crops Research Station in Johnston County, approximately nine miles southwest of the site. The flow gauge documented that the stream exhibited surface flow for 61 consecutive days from January 1<sup>st</sup> to March 2<sup>nd</sup>, 2022 (see Figure 3).

\*Longest consecutive days of flow: 61 days, January 1, 2022 – May 2, 2022.
