Monitoring Report- Year 6  
FINAL VERSION  
Pen Dell Mitigation Project  
Calendar Year of Data Collection: 2023

NCDEQ DMS Project Identification # 97079  
NCDEQ DMS Contract # 6824  
Neuse River Basin (Cataloging Unit 03020201)  
USACE Action ID Number: SAW-2016-00885  
NCDEQ DWR Project # 2016-0403 V2  
Johnston County, NC  
Contracted Under RFP # 16-006477  
Data Collection Period: March and October  
2023 Submission Date: December 29, 2023

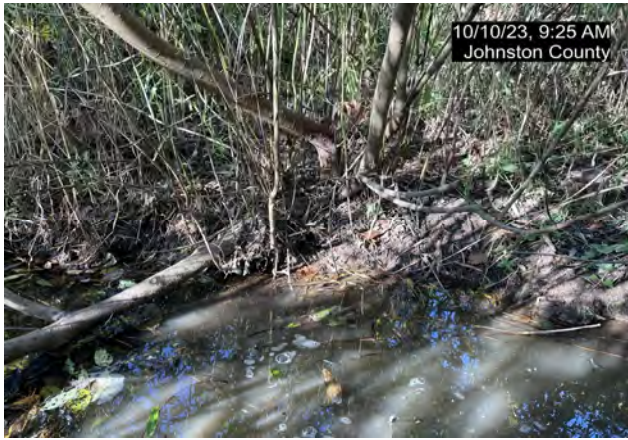
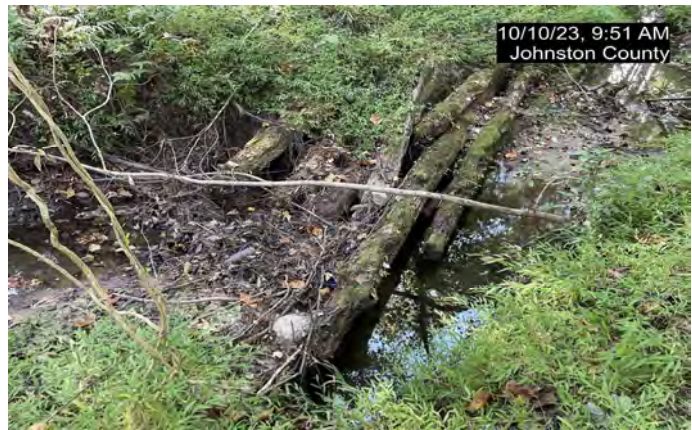
Table 8. Verification of Flow Events						
Monitoring Year	Date of Data Collection	Date of Occurrence	Method	Greater than Bankfull (Bkf) or Qgs ( $Q2^{*0.66} = 36.64$ CFS) Stage?	Photo/ Notes	Measurement above bankfull
MY1	9/17/2018	9/16-9/17/2018	Observed indicators of stage (wrack lines) after storm event	Bkf	Photos	NA
	11/21/2018	9/16-9/17/2018	Crest Gauge	Bkf	Photos	
MY2	7/26/2019	7/24/2019	Crest Gauge	Bkf	Photos	0.11 ft
MY3	2/7/2020	Unknown	Crest Gauge	Bkf & Qgs	Photos	0.85 ft
	10/13/2020	Unknown	Crest Gauge	Bkf	Photos	0.13 ft
MY4	1/13/2021	Unknown	Crest Gauge	Bkf	Photos	1.35 ft
	7/13/2021	Unknown	Crest Gauge	Bkf	Photos	1.03 ft
MY5	3/30/2022	Unknown	Crest Gauge and observed recent alluvial deposits	Bkf	Photos	0.80 ft
MY6	10/10/2023	Unknown	Observed wrack line indicators	Bkf	Photos	NA
