MONITORING YEAR 2 ANNUAL REPORT FINAL

PERRY HILL MITIGATION SITE

Orange County, NC
Neuse River Basin
HUC 03020201

DMS Project No. 100093
DMS Contract No. 7744
DMS RFP No. 16-007576
USACE Action ID No. 2019-00125
DWR Project No. 2019-0157

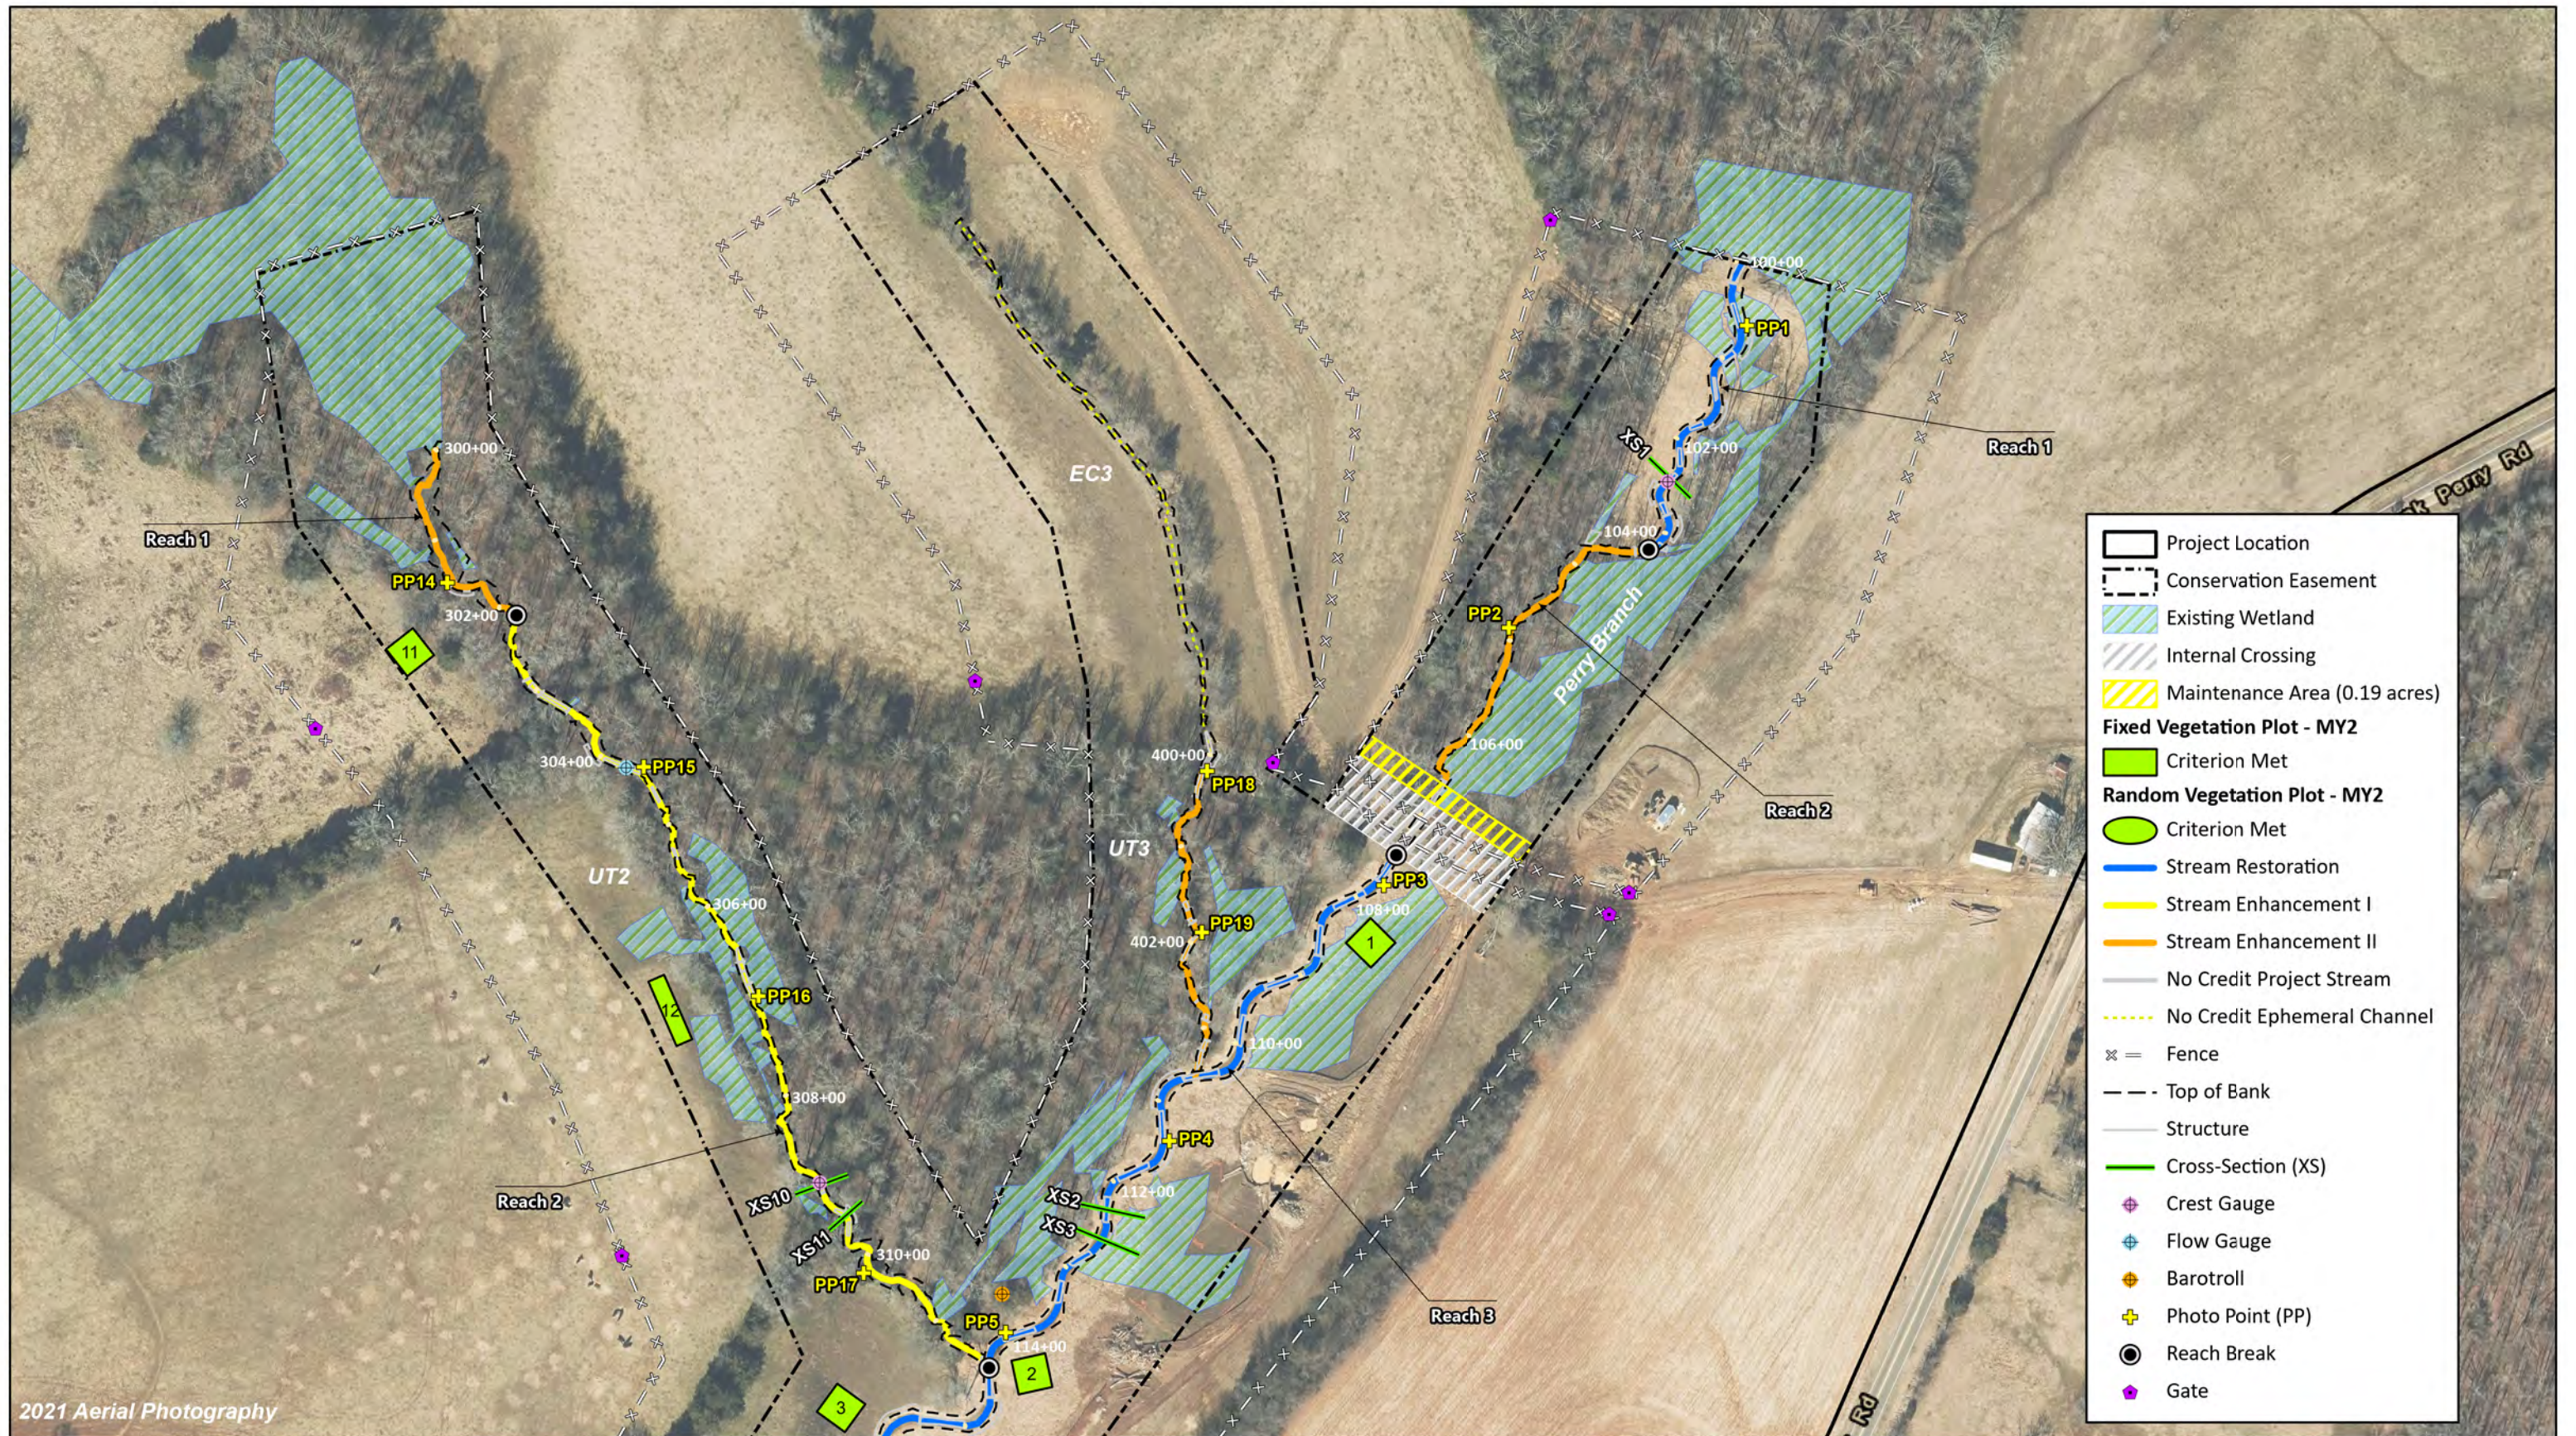
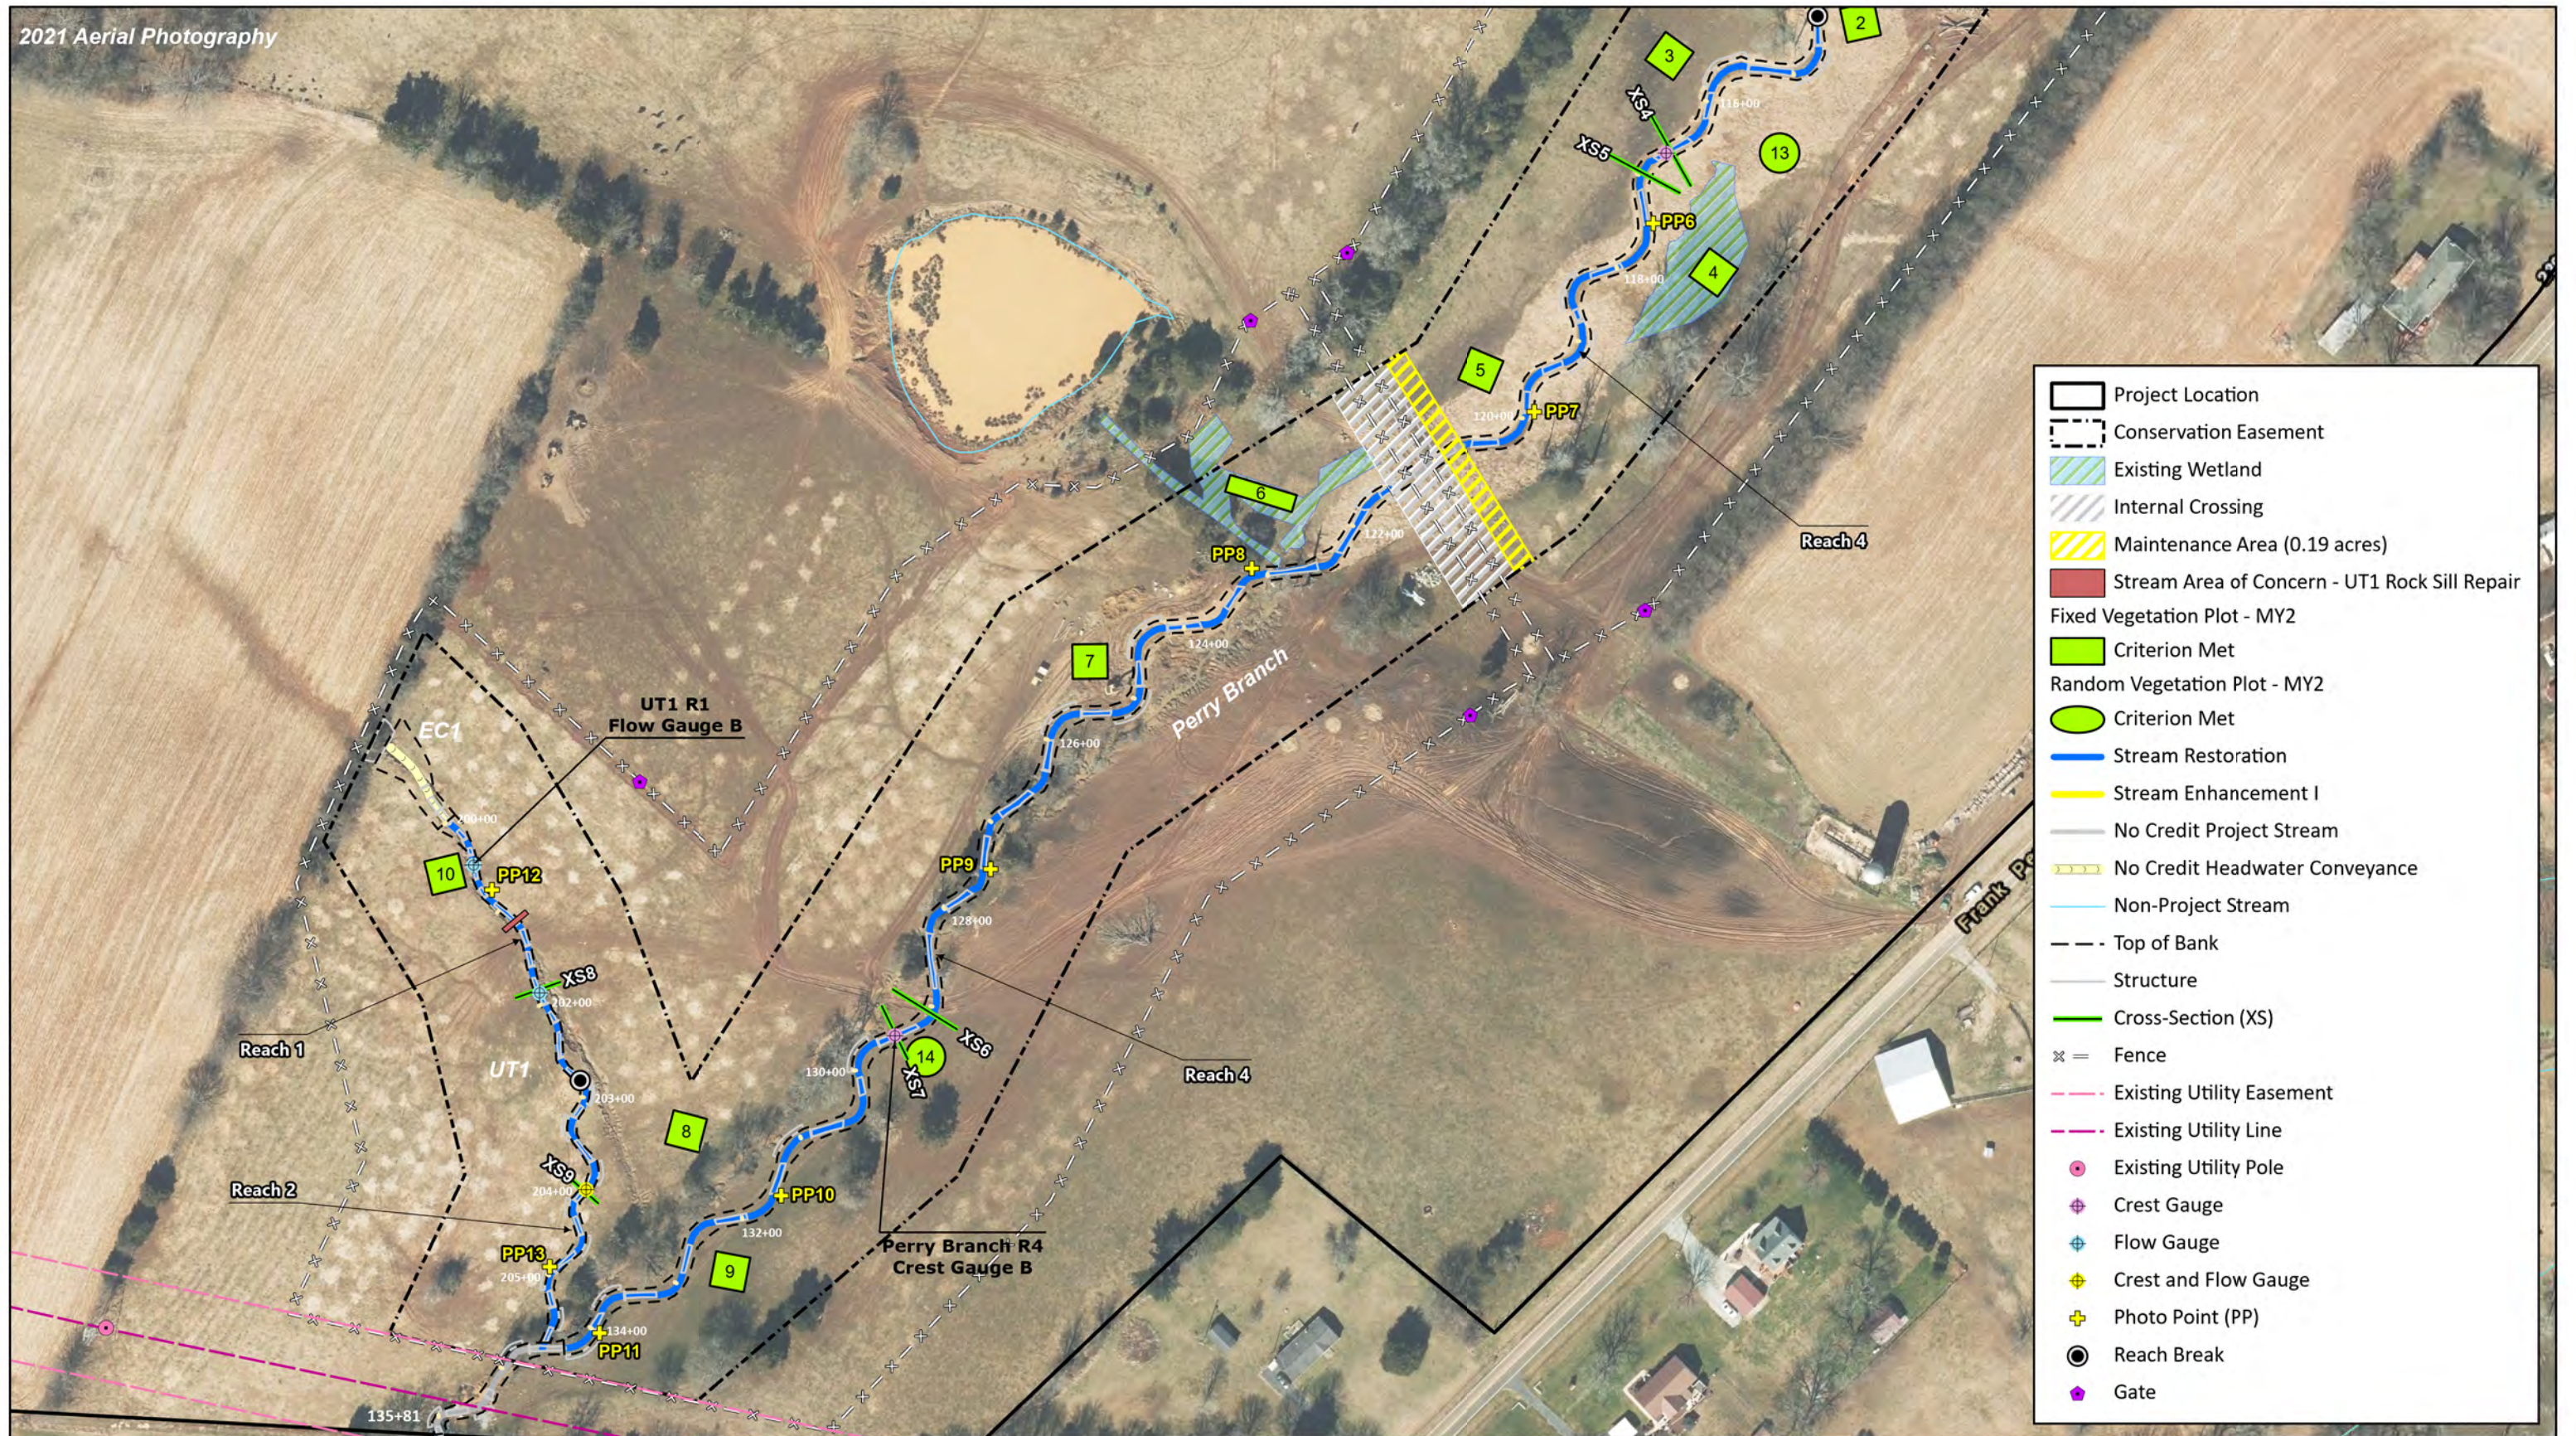
Figure 1. Current Condition Plan View
 Perry Hill Mitigation Site
 DMS Project No. 100093
 Monitoring Year 2 - 2022

Wildlands continued to observe the lack of flow in the short stretch of UT1 Reach 1 through the winter and spring of 2022. When gauge data and observations did not show an increase in flow throughout the wettest part of the year (see Section 2.5 Hydrology Assessment Section below), it was decided that repairs were necessary. In September 2022, a rock sill was repaired by reinstalling filter fabric and backfill material on the upstream face. The original fabric and backfill material are believed to have failed to seal this structure, resulting in stream flow going subsurface. The repair was completed to return the structure to the original design condition. This does not leave much to see on the surface, however pictures with a red arrow pointing to the area of disturbance in the channel are included in Appendix A – Stream Area of Concern Repair Photographs. Approximately five linear feet of channel were impacted (see Figure 1b for location). Wildlands will continue to monitor flow in MY3.

UT1 Reach 1 flow gauge B (Figure 1b) was installed upstream of the original flow gauge (in cross-section 8 in Figure 1b) in December 2021 to learn the extent of the low flow stretch on UT1 Reach 1. Twenty consecutive days and 92 total days of flow were recorded in MY2. While this is below the 30 consecutive day minimum, all gauges are taking a measurement every 30 minutes. If one reading during a 24-hour period falls below thalweg, the entire day does not count toward the consecutive days of flow. The UT1 Reach 1 flow gauge B flow events plot shows that most of the readings in January and half of February are above the thalweg (see the Recorded In-stream Flow Events Plots in Appendix D). Refer to Appendix D for Hydrology Summary Data.
