# MY1 (2022) MONITORING REPORT

## PHANTOM MILL

DMS Project No. 100057

Data Collection: January 2022-October 2022

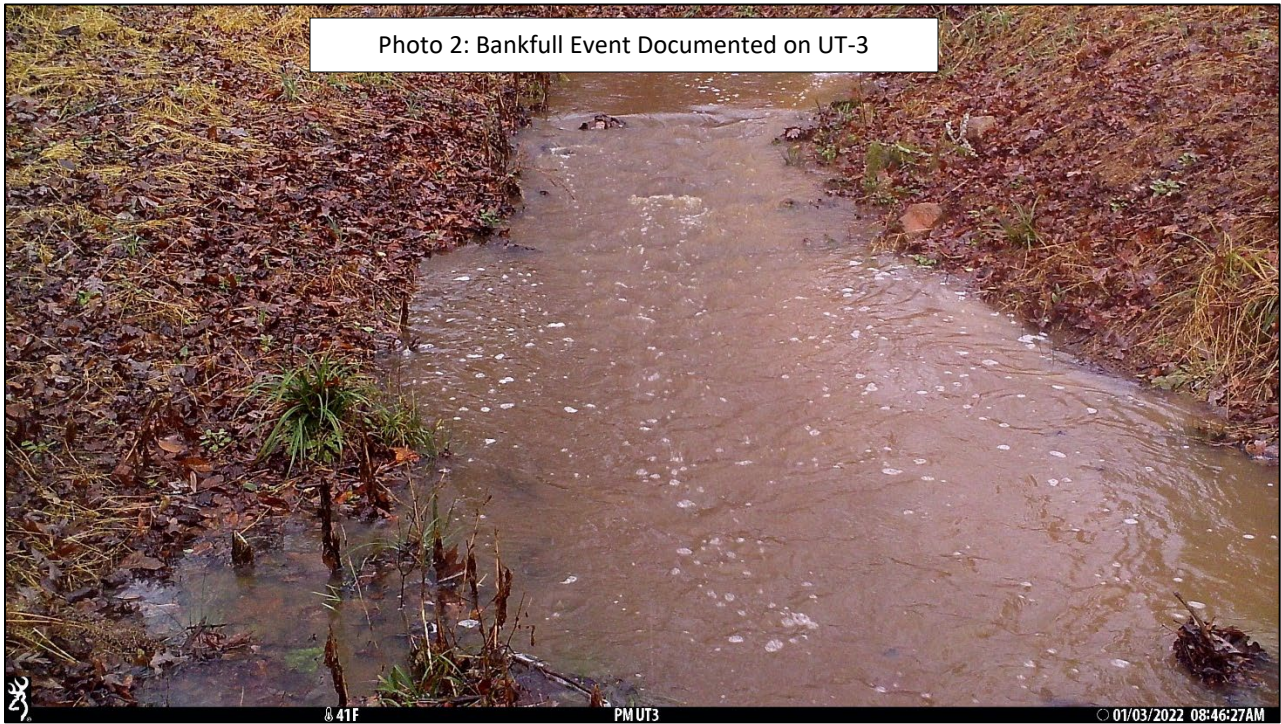
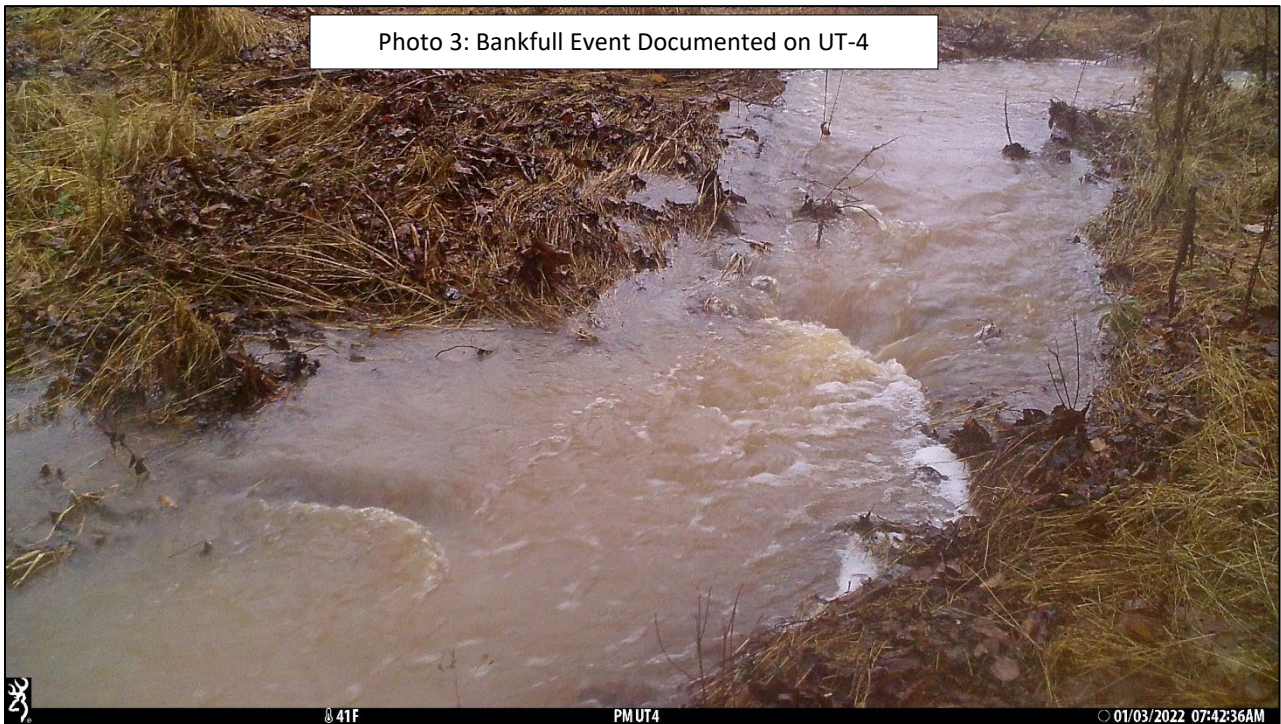
Photo 4: Bankfull Event Documented on UT-4

Date of Data Collection	Date of Occurrence	Method	Photo (if available)
January 3, 2022	January 3, 2022	A bankfull event was documented on Cane Creek, UT-3, and UT-4 by trail camera and stream gauge evidence after 1.79 inches of rain were captured at an onsite rain gauge.	1, 2, 3
March 12, 2022	March 12, 2022	A bankfull event was documented on the UT-4 trail camera and UT-2, UT-3, and UT-4 stream gauges after 1.17 inches of rain were captured at an onsite rain gauge.	4
April 18, 2022	April 18, 2022	A bankfull event was documented on the UT-4 trail camera and UT-2, UT-3, and UT-4 stream gauges after 1.11 inches of rain were captured at an onsite rain gauge.	5
October 5, 2022	July 27, 2022	UT-2, UT-3, and UT-4 stream gauges documented a bankfull event after 2.75 inches of rain were captured at an onsite rain gauge.	--
