MONITORING YEAR 3 REPORT

PHILLIPS–WILLIS SITE MIDDLE FORK CREEK

Madison County, North Carolina

EEP Project Number: 92703
Contract Number: D06082; Task Order: 07MON1-11

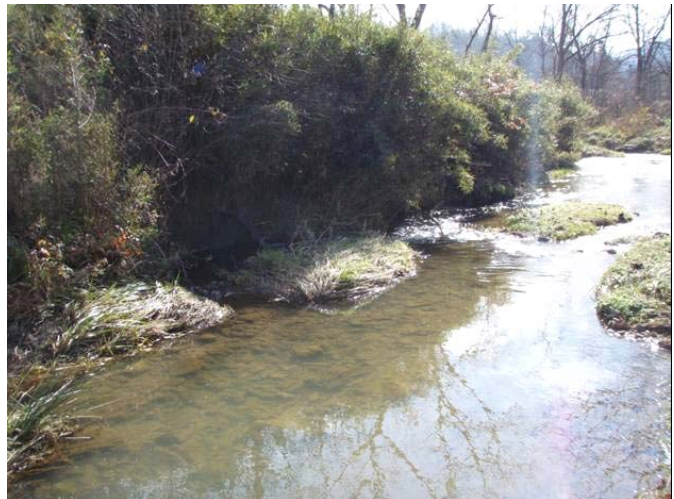
The few problem areas that were observed and photo documented were confined to the MFC channel (Appendix Table B.1.1). Problem areas such as bank sloughing or scour were typically <25 ft in length. Three locations with mid-channel bars were noted along the MFC reach. Bank sloughing, likely caused by a field drain, appears to have resulted in the formation of one mid-channel bar. The others appear to be the result of a combination of past beaver dam construction and heavy bed load being transported downstream from off-project areas. Beaver dam removal and animal eradication have occurred at the project site on three separate occasions; once the beaver dams were removed, the channel cut through the sediments deposited when the dams were ponding stream flows. Beaver dams also created two observed over-wide areas in the channel. These over-wide points along the channel have resulted in bank scour and bar formation problem areas. The most recent beaver dam was constructed on WB near its confluence with MFC. This channel obstruction was noted during the MY3 survey

Stream problem area 1, MFC bank sloughing, 25 Nov 2009.

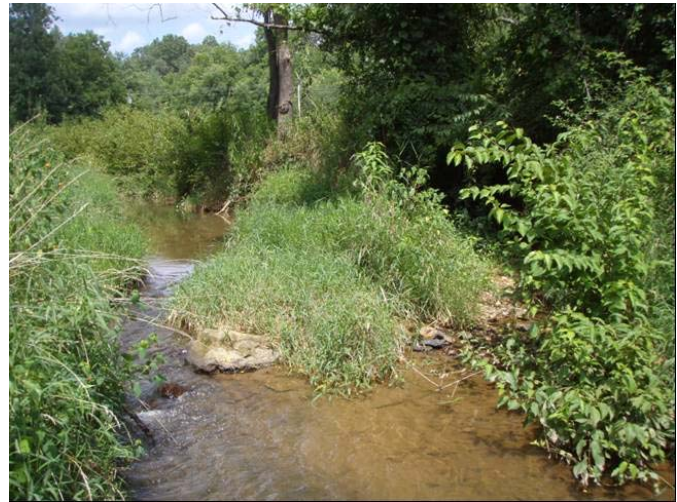
Stream problem area 3, MFC mid channel bar, 25 Nov 2009.

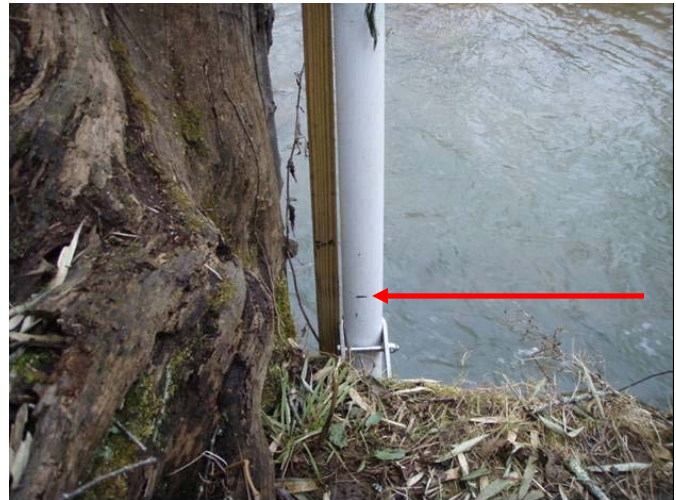
Bankfull elevation on crest gage noted with red arrow

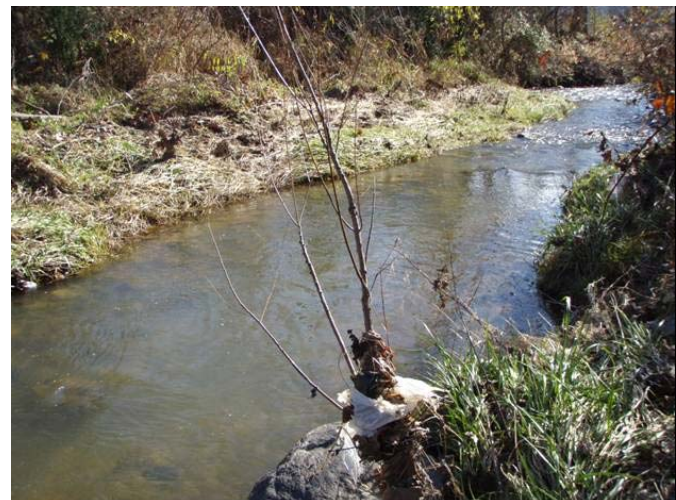
Phillips-Willis Site, MFC (EEP project number 92703)			
Date of Data Collection	Date of Occurrence	Method	Photo Number (if available)
17 May 2009	7 May 2009	Crest gauge	1
29 January 2010	25 January 2010	Crest gage, Wrack line	1, 2

Photo 2, wrack line resulting from 25 Jan 10 bankfull event.
