# PINCH GUT CREEK STREAM RESTORATION PROJECT

## ANNUAL MONITORING REPORT FOR 2010 (YEAR 3)

Contract Number D06043-A

**Prepared by:** Michael Baker Engineering, Inc.

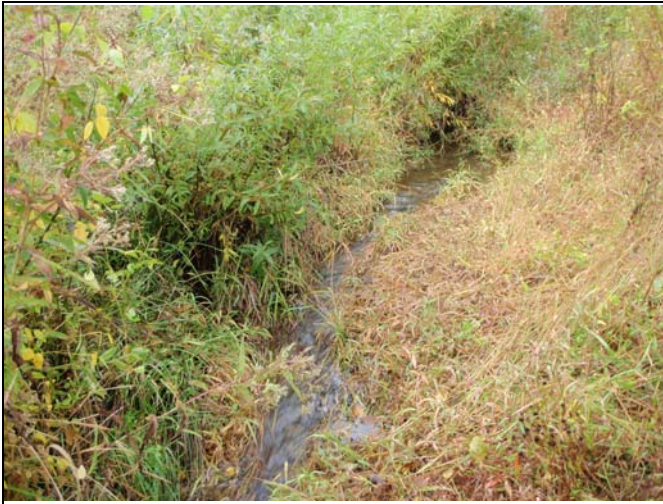
Constructed Riffle, Downstream of Culvert, UT1  
Reach 4 End

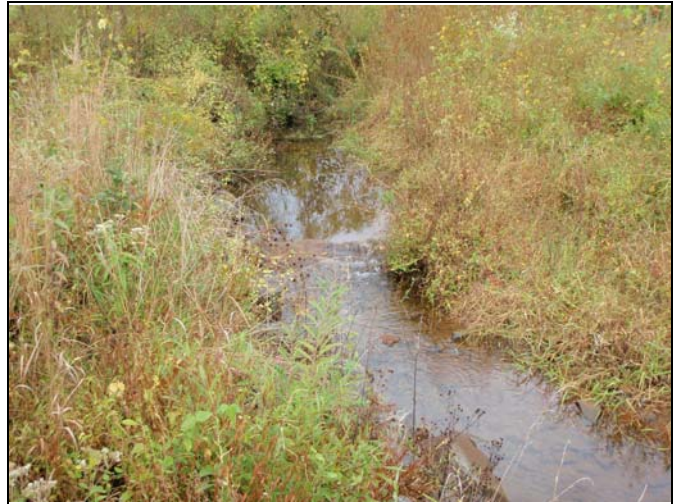
Photo Point 1 – Constructed Riffle, UT1 Reach 4

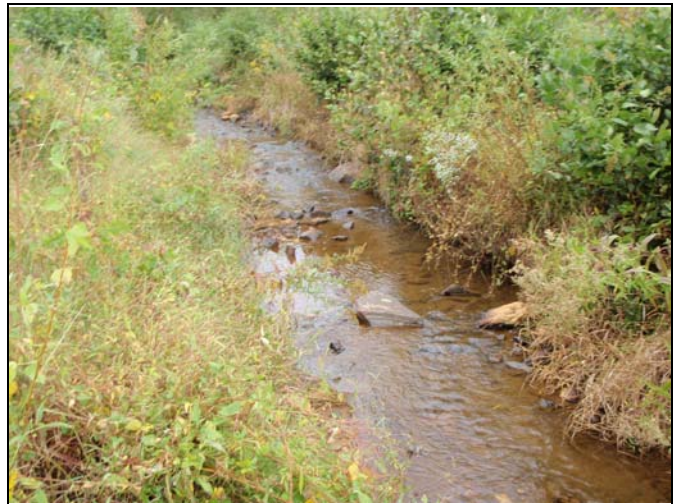
Photo Point 3 – Constructed Riffle, UT1 Reach 4

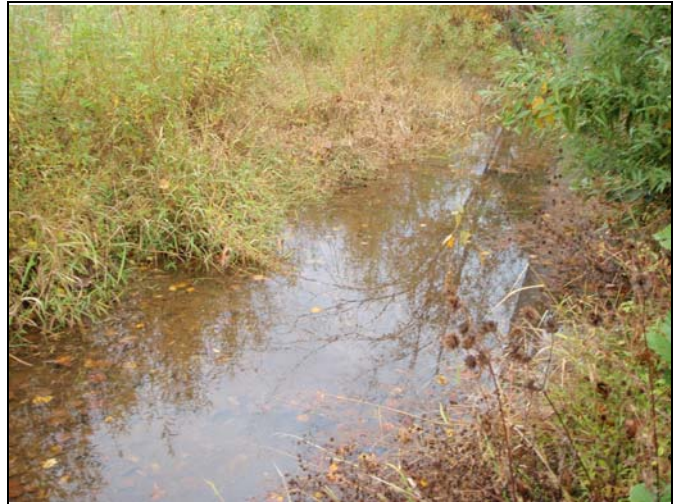
Photo Point 7 – Constructed Riffle, UT1 Reach 4

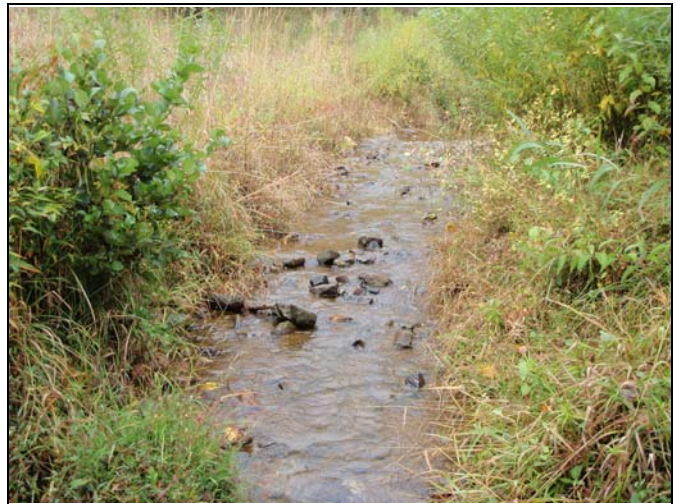
Photo Point 9 – Constructed Riffle, UT1 Reach 4

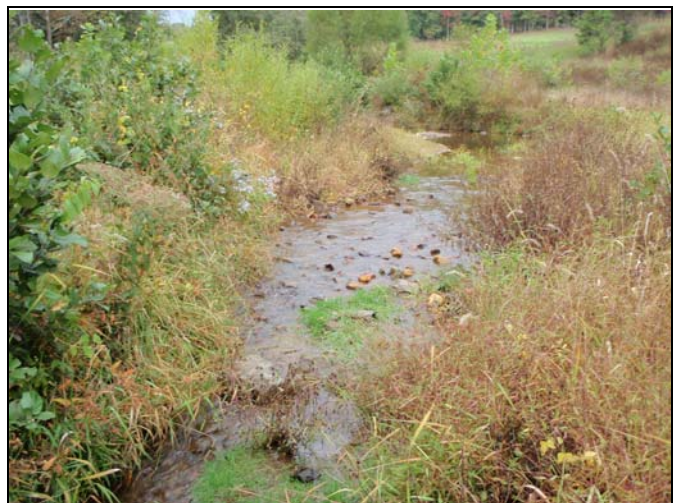
Photo Point 11 – Constructed Riffle, UT1 Reach 4

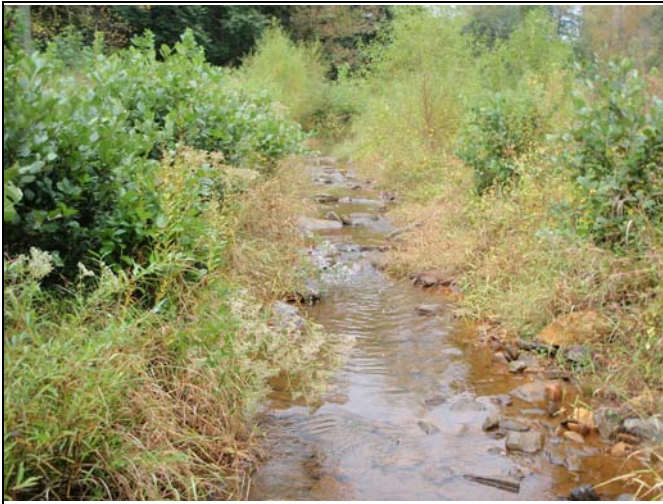
Photo Point 12 – Constructed Riffle, UT1 Reach 4

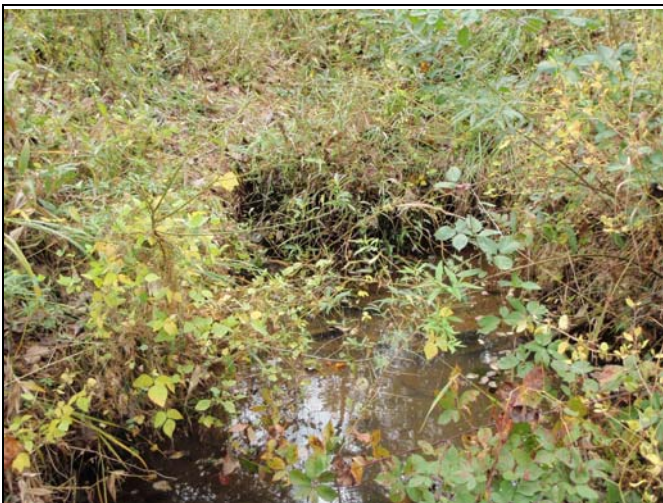
Photo Point 140 – Constructed Riffle, UT6
