PINCH GUT CREEK STREAM RESTORATION PROJECT

ANNUAL MONITORING REPORT FOR 2011 (YEAR 4)

Contract Number D06043-A

Prepared by: Michael Baker Engineering, Inc.

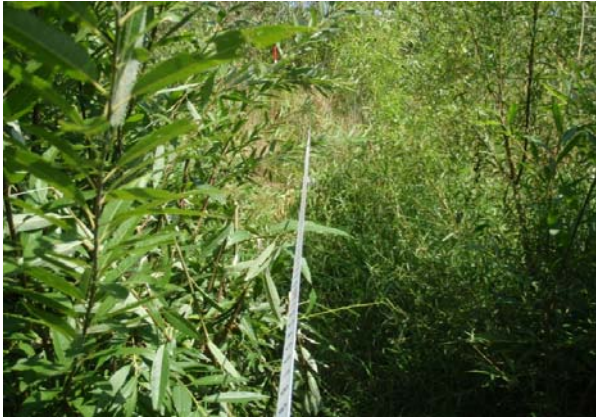
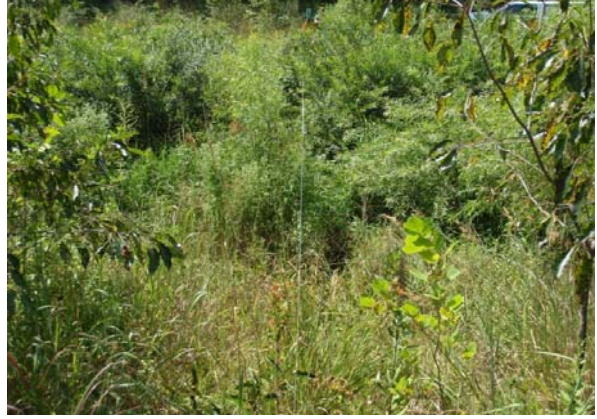
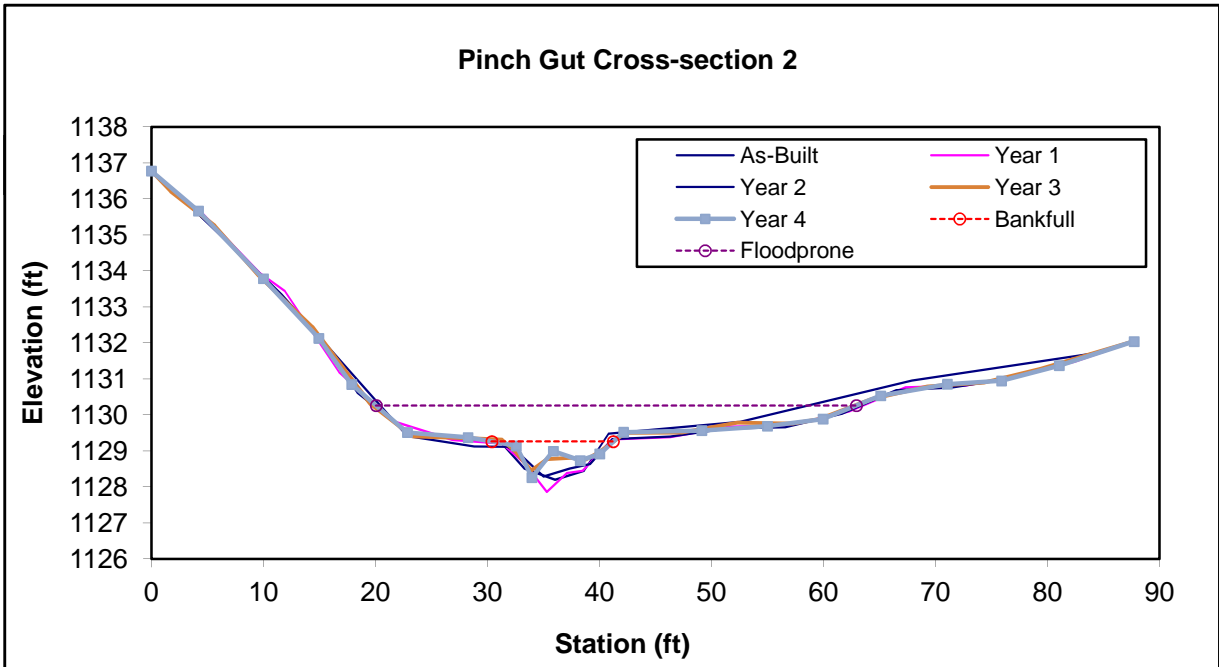
Permanent Cross-section 2, Station 21+26
 (Year 4 Data - Collected November 2011)

Feature	Stream Type	BKF Area	BKF Width	BKF Depth	Max BKF Depth	W/D	BH Ratio	ER	BKF Elev	TOB Elev
Riffle	Cc	4	10.84	0.37	1	29.14	1.3	4	1129.26	1129.52

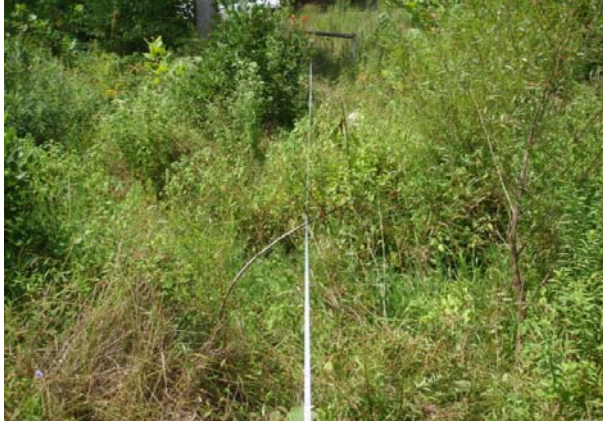
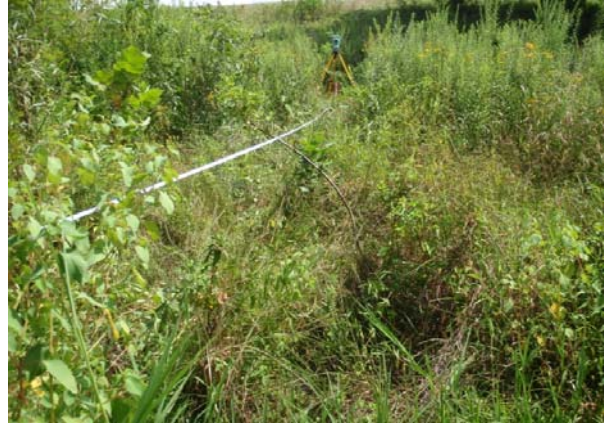
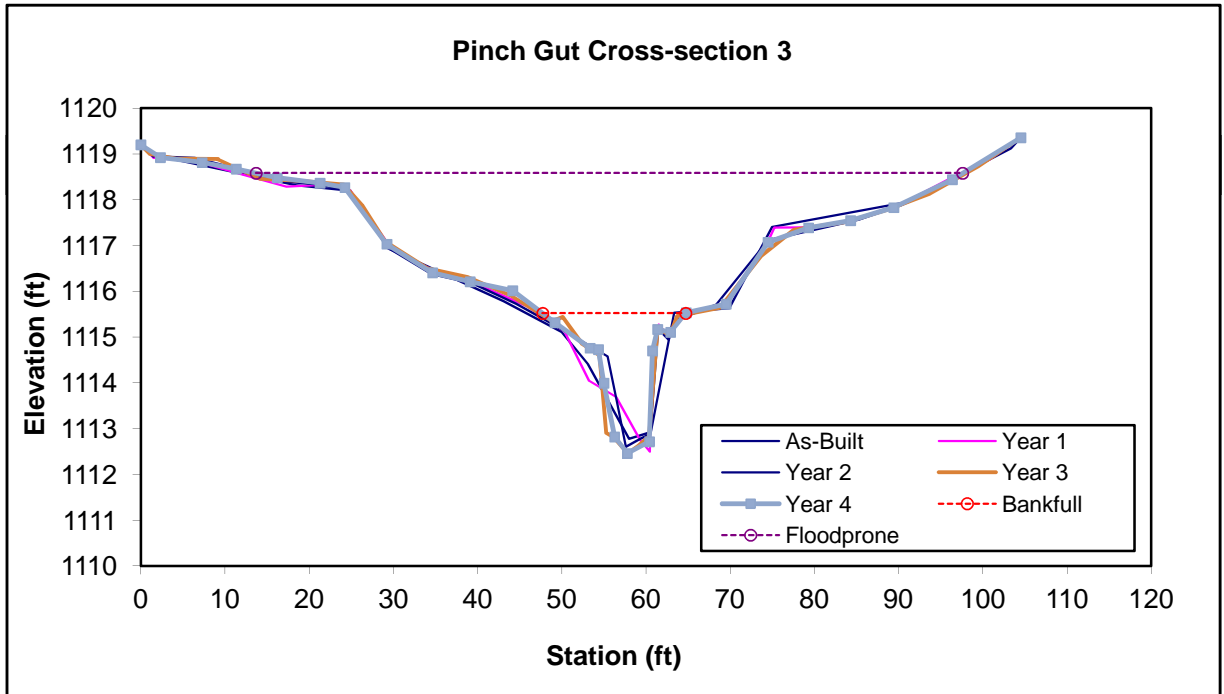
Permanent Cross-section 3, Station 28+99
 (Year 4 Data - Collected November 2011)

Feature	Stream Type	BKF Area	BKF Width	BKF Depth	Max BKF Depth	W/D	BH Ratio	ER	BKF Elev	TOB Elev
Pool		20.4	16.99	1.2	3.06	14.17	1	4.9	1115.52	1115.53

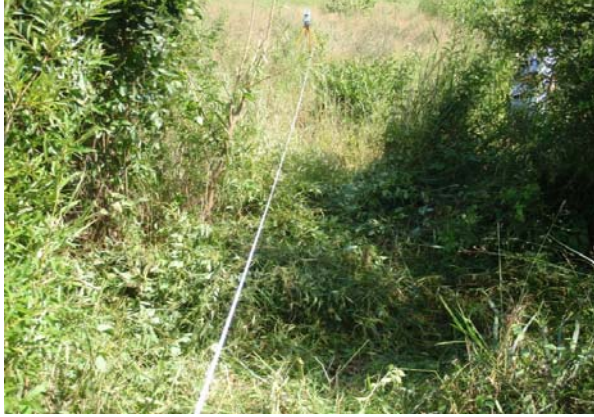
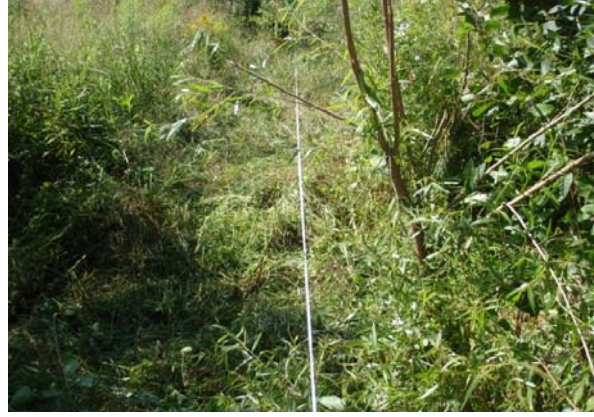
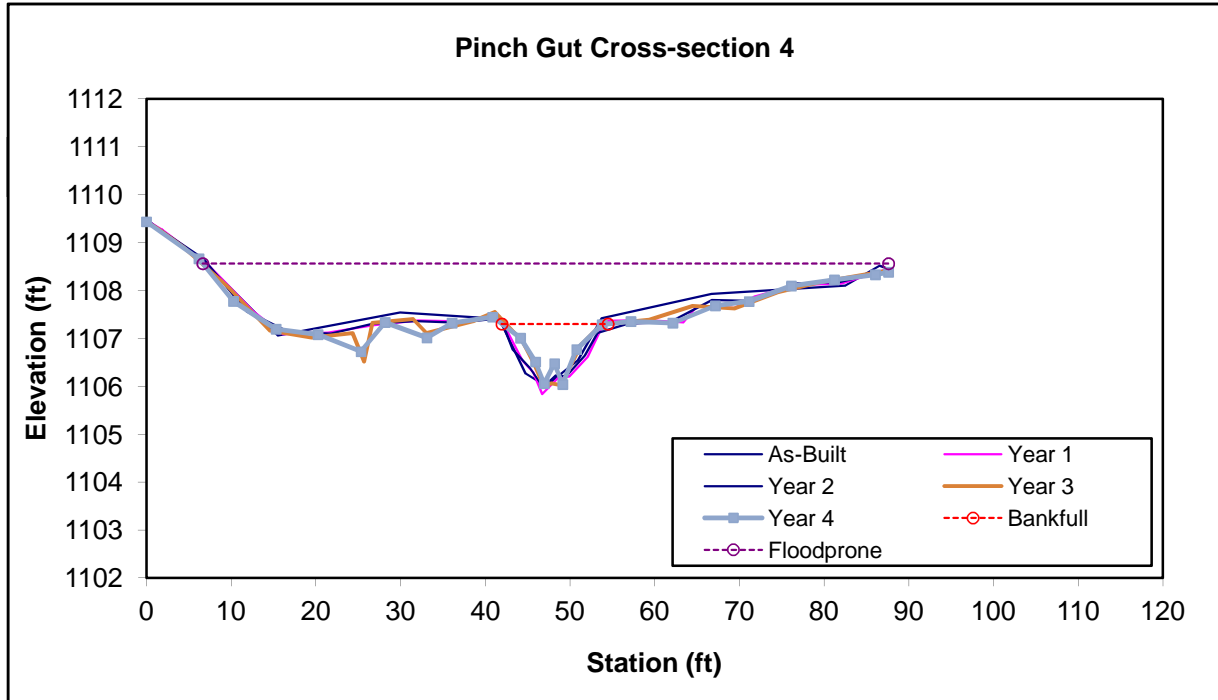
Permanent Cross-section 4, Station 31+34
 (Year 4 Data - Collected November 2011)

Feature	Stream Type	BKF Area	BKF Width	BKF Depth	Max BKF Depth	W/D	BH Ratio	ER	BKF Elev	TOB Elev
Riffle	C	6.9	12.52	0.55	1.26	22.78	1	6.5	1107.3	1107.29

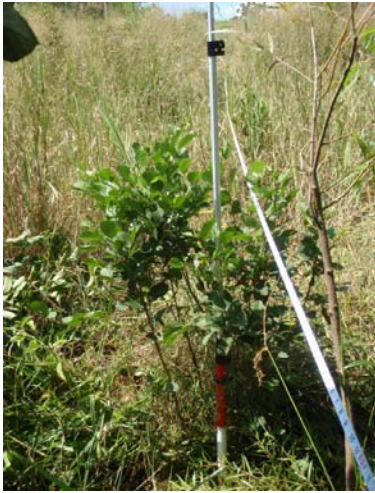
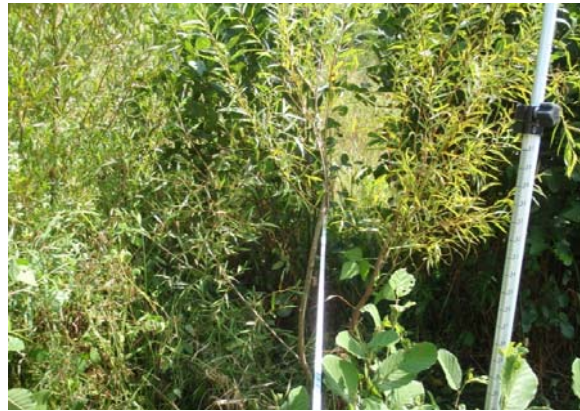
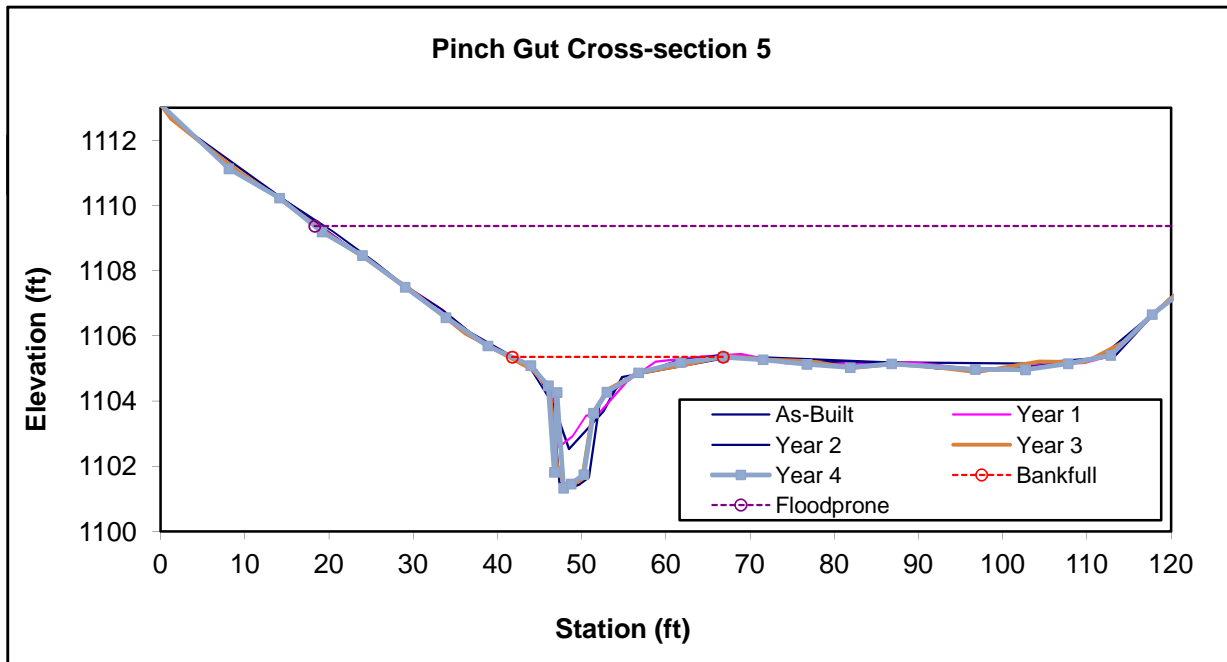
Permanent Cross-section 5, Station 35+97
 (Year 4 Data - Collected November 2011)

Feature	Stream Type	BKF Area	BKF Width	BKF Depth	Max BKF Depth	W/D	BH Ratio	ER	BKF Elev	TOB Elev
Pool		25.2	25.03	1.01	4.02	24.9	1	4.4	1105.35	1105.35

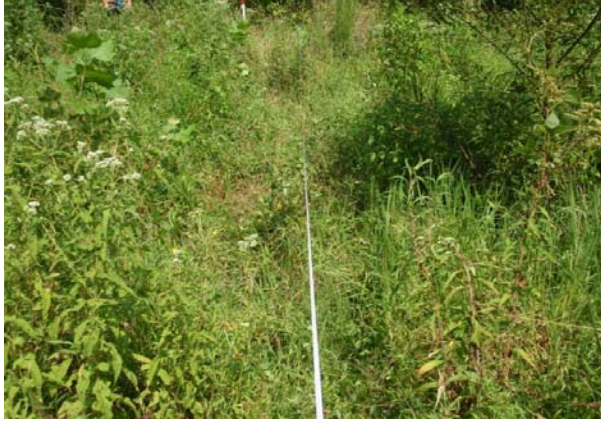
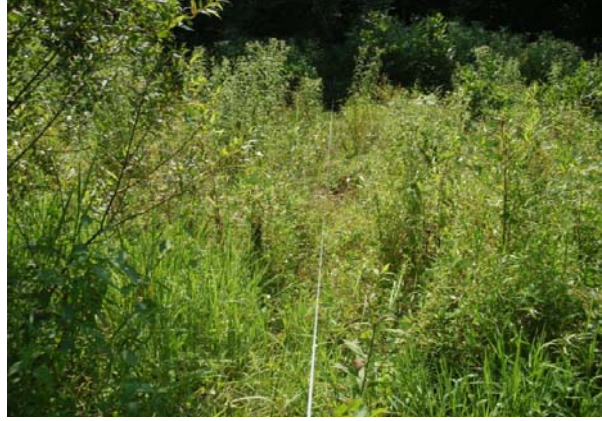
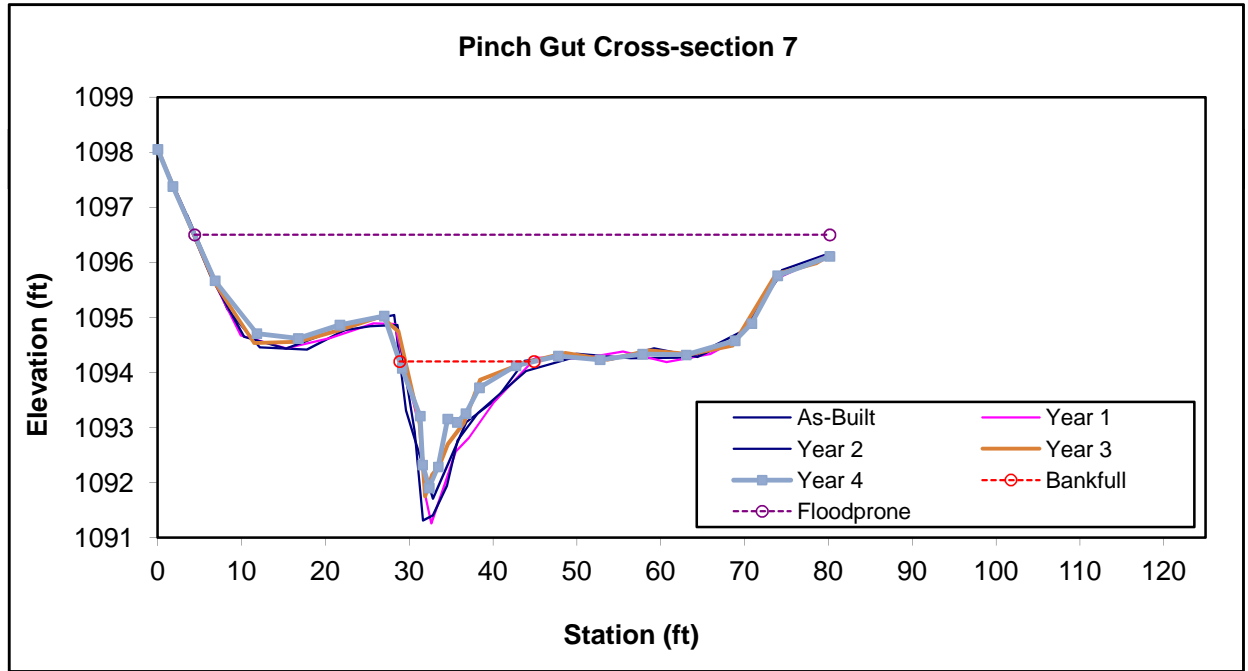
Permanent Cross-section 7, Station 45+44
 (Year 4 Data - Collected November 2011)

Feature	Stream Type	BKF Area	BKF Width	BKF Depth	Max BKF Depth	W/D	BH Ratio	ER	BKF Elev	TOB Elev
Pool		11.9	16.02	0.74	2.3	21.52	1	4.7	1094.2	1094.3

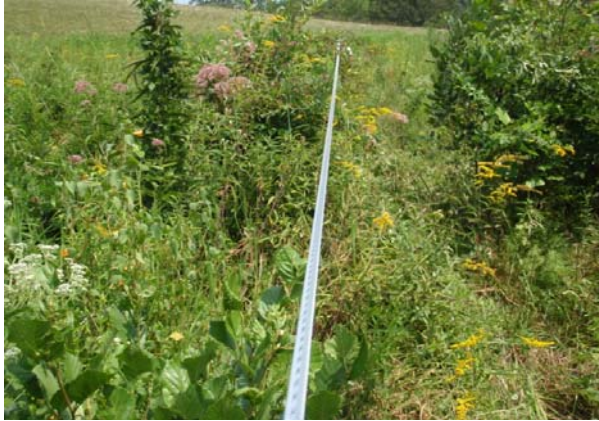
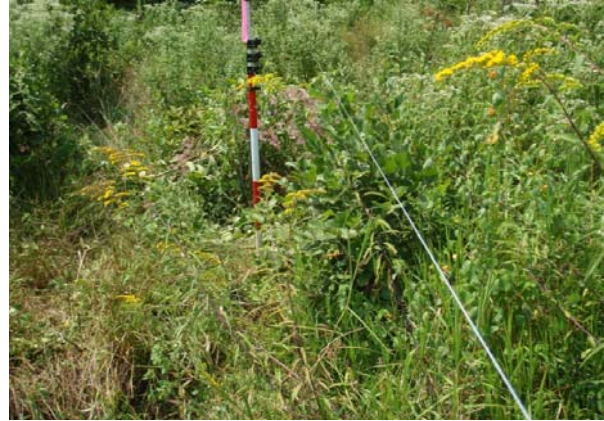
Permanent Cross-section 8, Station 53+47
 (Year 4 Data - Collected November 2011)

Feature	Stream Type	BKF Area	BKF Width	BKF Depth	Max BKF Depth	W/D	BH Ratio	ER	BKF Elev	TOB Elev
Riffle	Cc	10.6	11.94	0.89	1.91	13.41	1	10.2	1081.18	1081.18

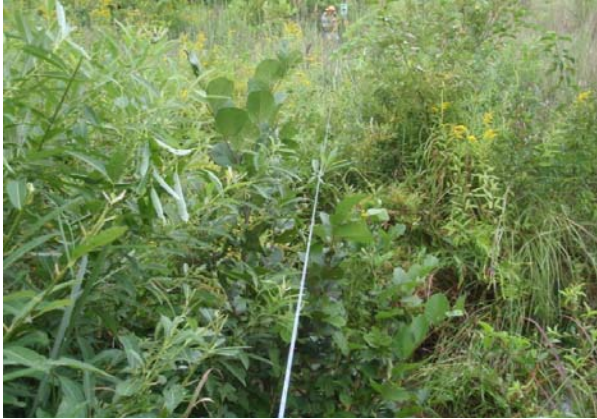
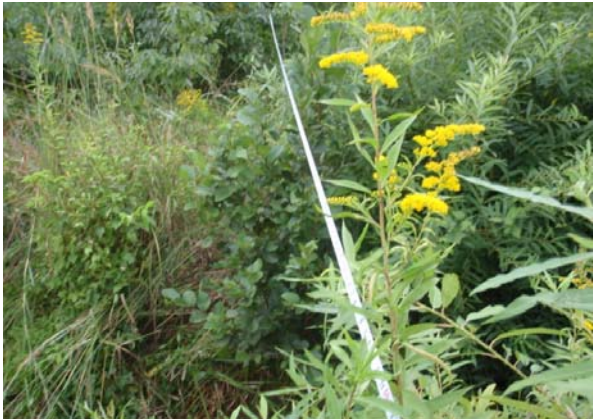
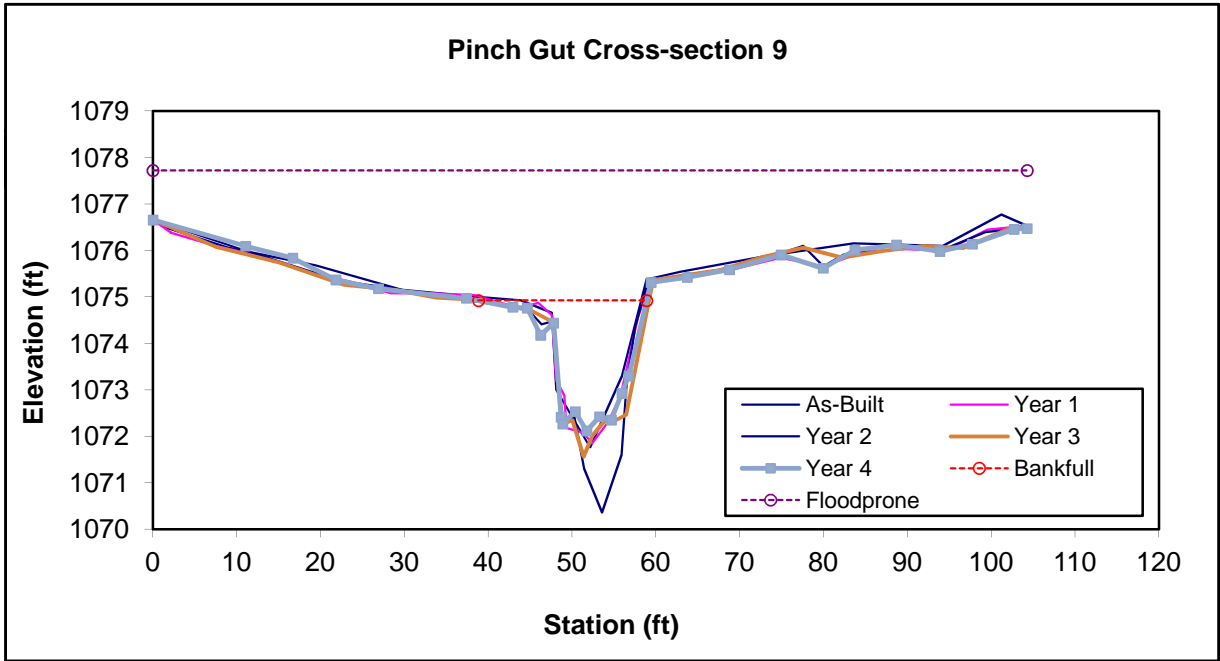
Permanent Cross-section 9, Station 56+39
 (Year 4 Data - Collected November 2011)

Feature	Stream Type	BKF Area	BKF Width	BKF Depth	Max BKF Depth	W/D	BH Ratio	ER	BKF Elev	TOB Elev
Pool		25.1	20.07	1.25	2.8	16.04	1	5.2	1074.92	1074.97

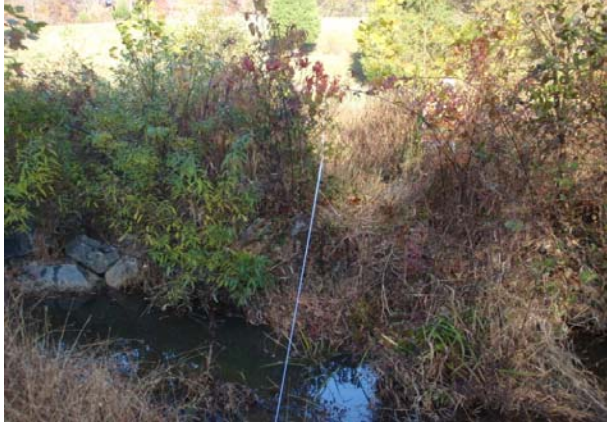
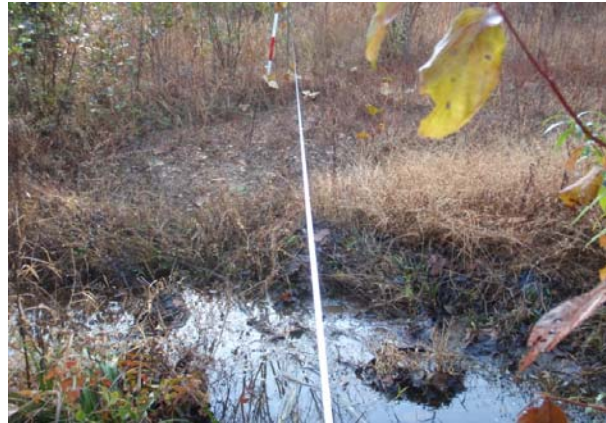
Permanent Cross-section 11, Station 73+68
 (Year 4 Data - Collected November 2011)

Feature	Stream Type	BKF Area	BKF Width	BKF Depth	Max BKF Depth	W/D	BH Ratio	ER	BKF Elev	TOB Elev
Pool		65.8	41.97	1.57	4.96	26.76	1	3.2	1053.63	1053.39

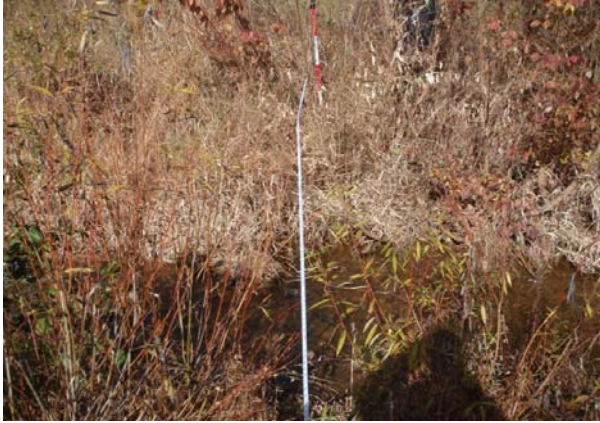
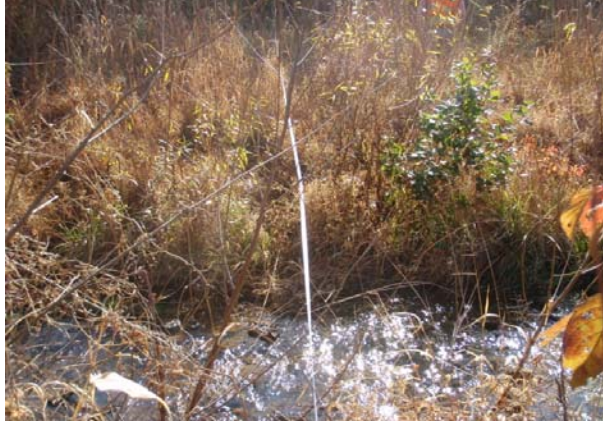
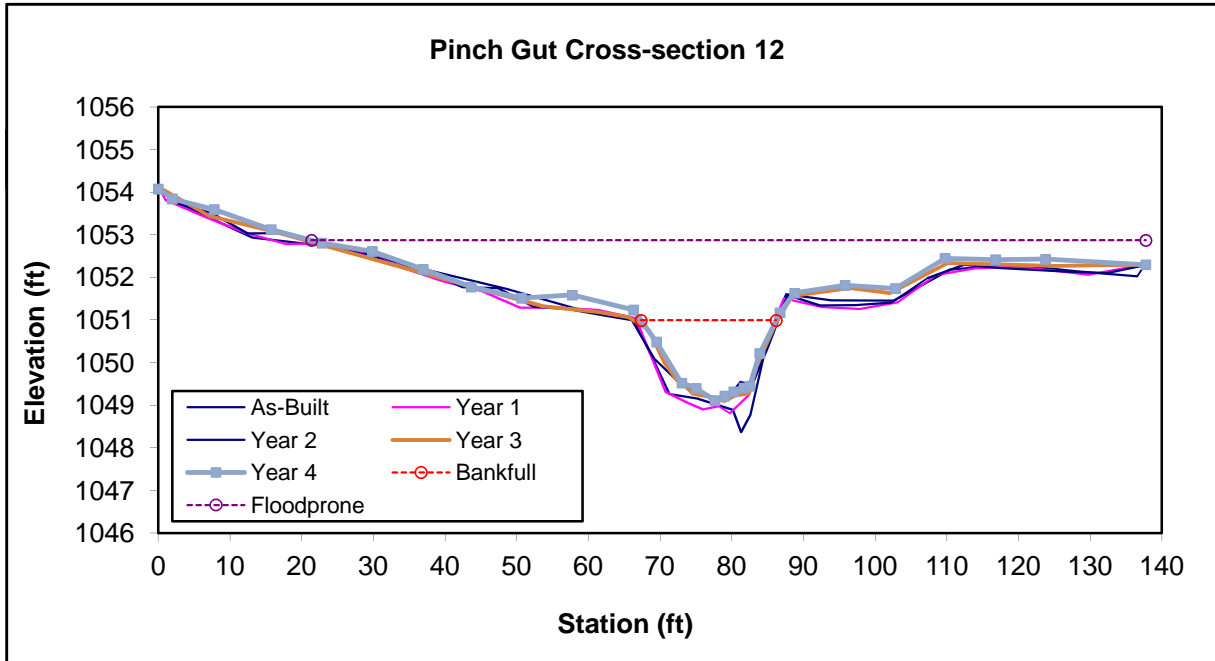
Permanent Cross-section 12, Station 75+37
 (Year 4 Data - Collected November 2011)

Feature	Stream Type	BKF Area	BKF Width	BKF Depth	Max BKF Depth	W/D	BH Ratio	ER	BKF Elev	TOB Elev
Riffle	C	22.4	18.83	1.19	1.88	15.84	1.1	6.2	1050.99	1051.24
