Pinch Gut Creek Tributary Site
EEP ID (IMS) # 92518
FDP CONTRACT NUMBER # D06043-A
USACE ACTION ID # 2007-02849-285
DWQ 401 # 07-1420

CLOSEOUT REPORT

Stream

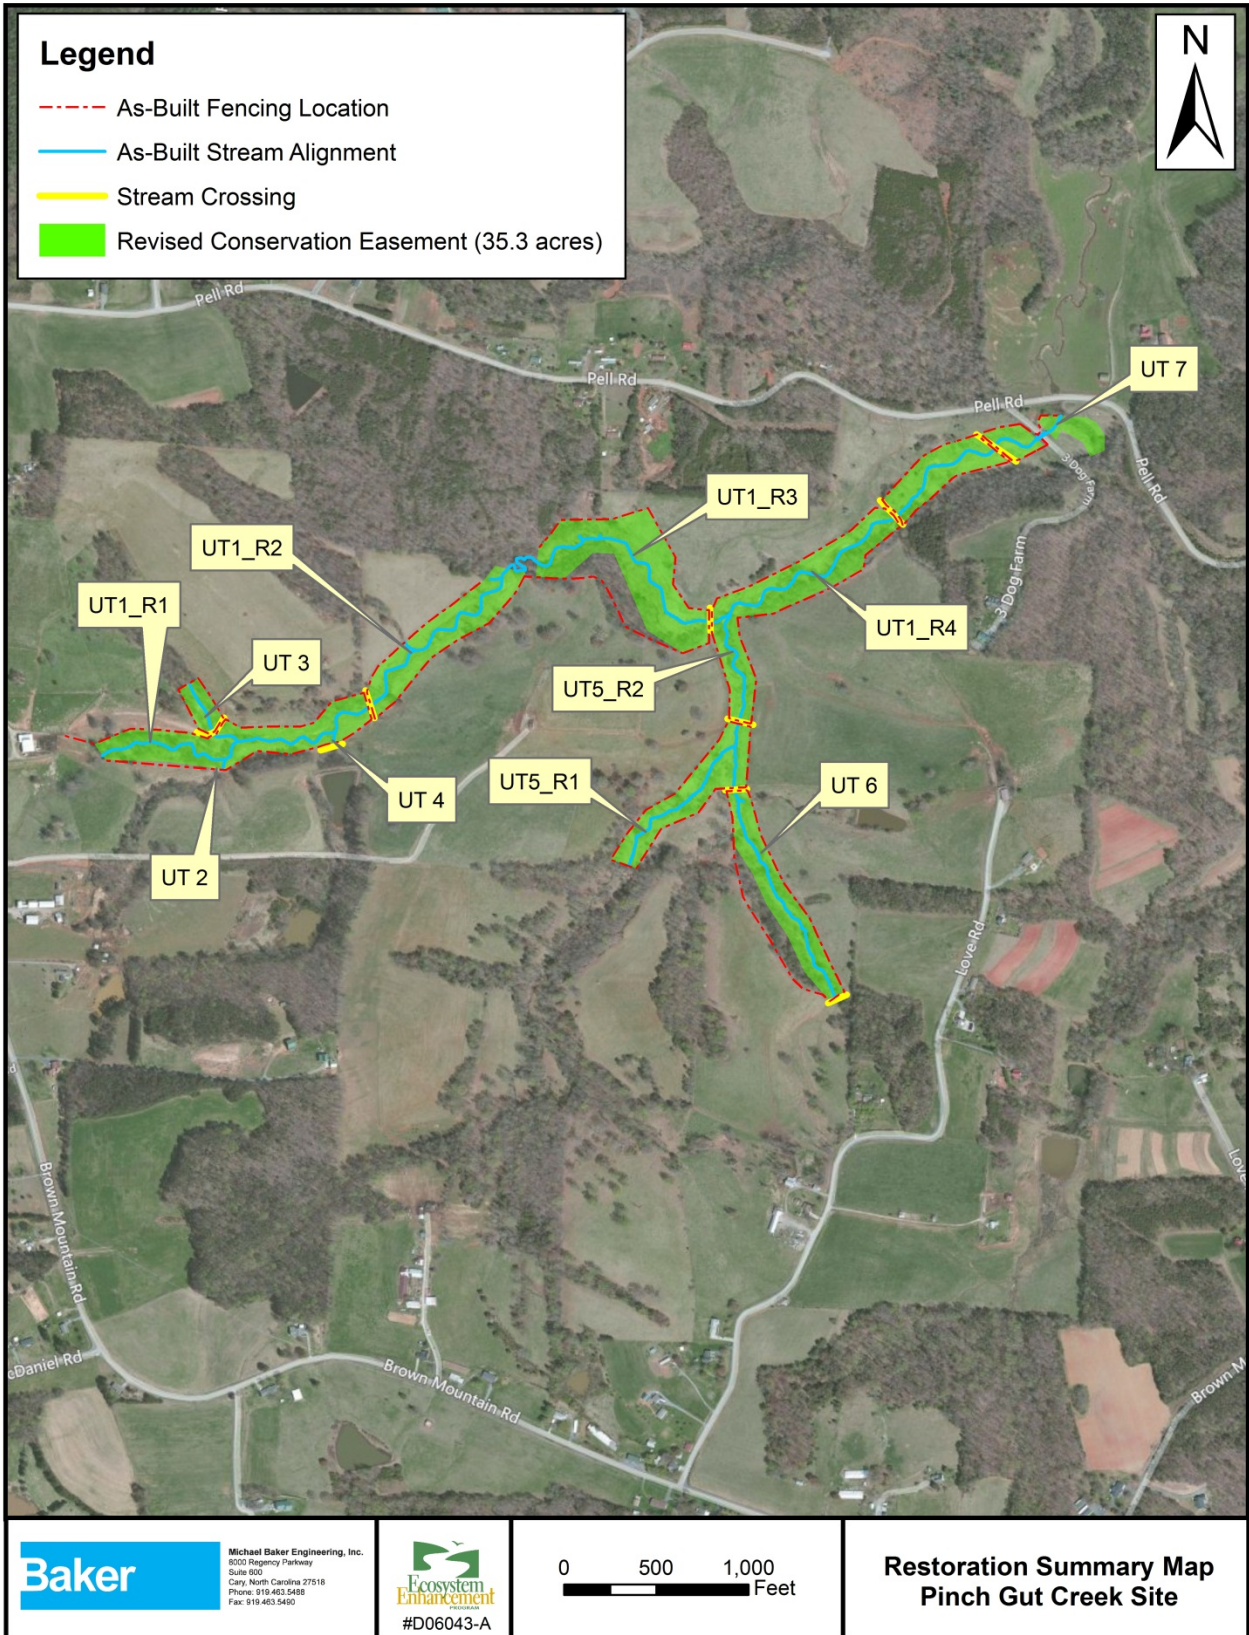
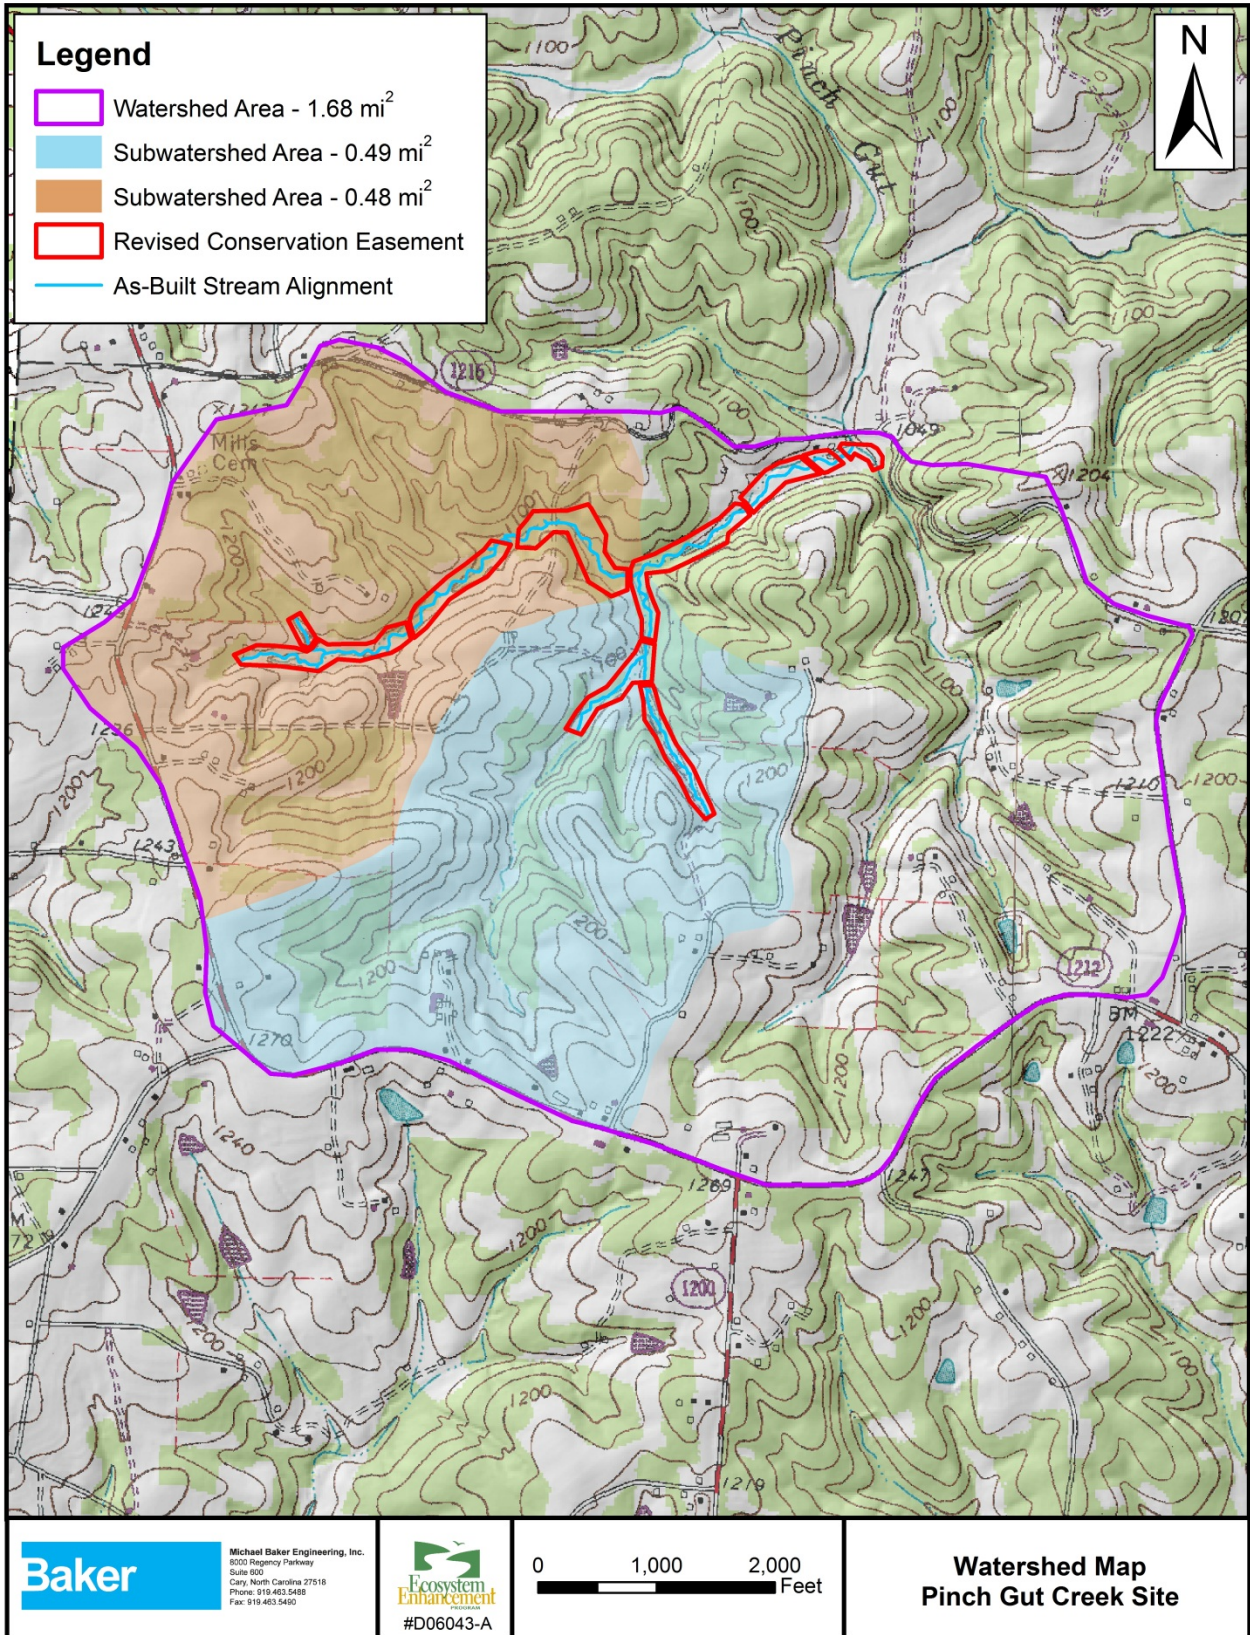
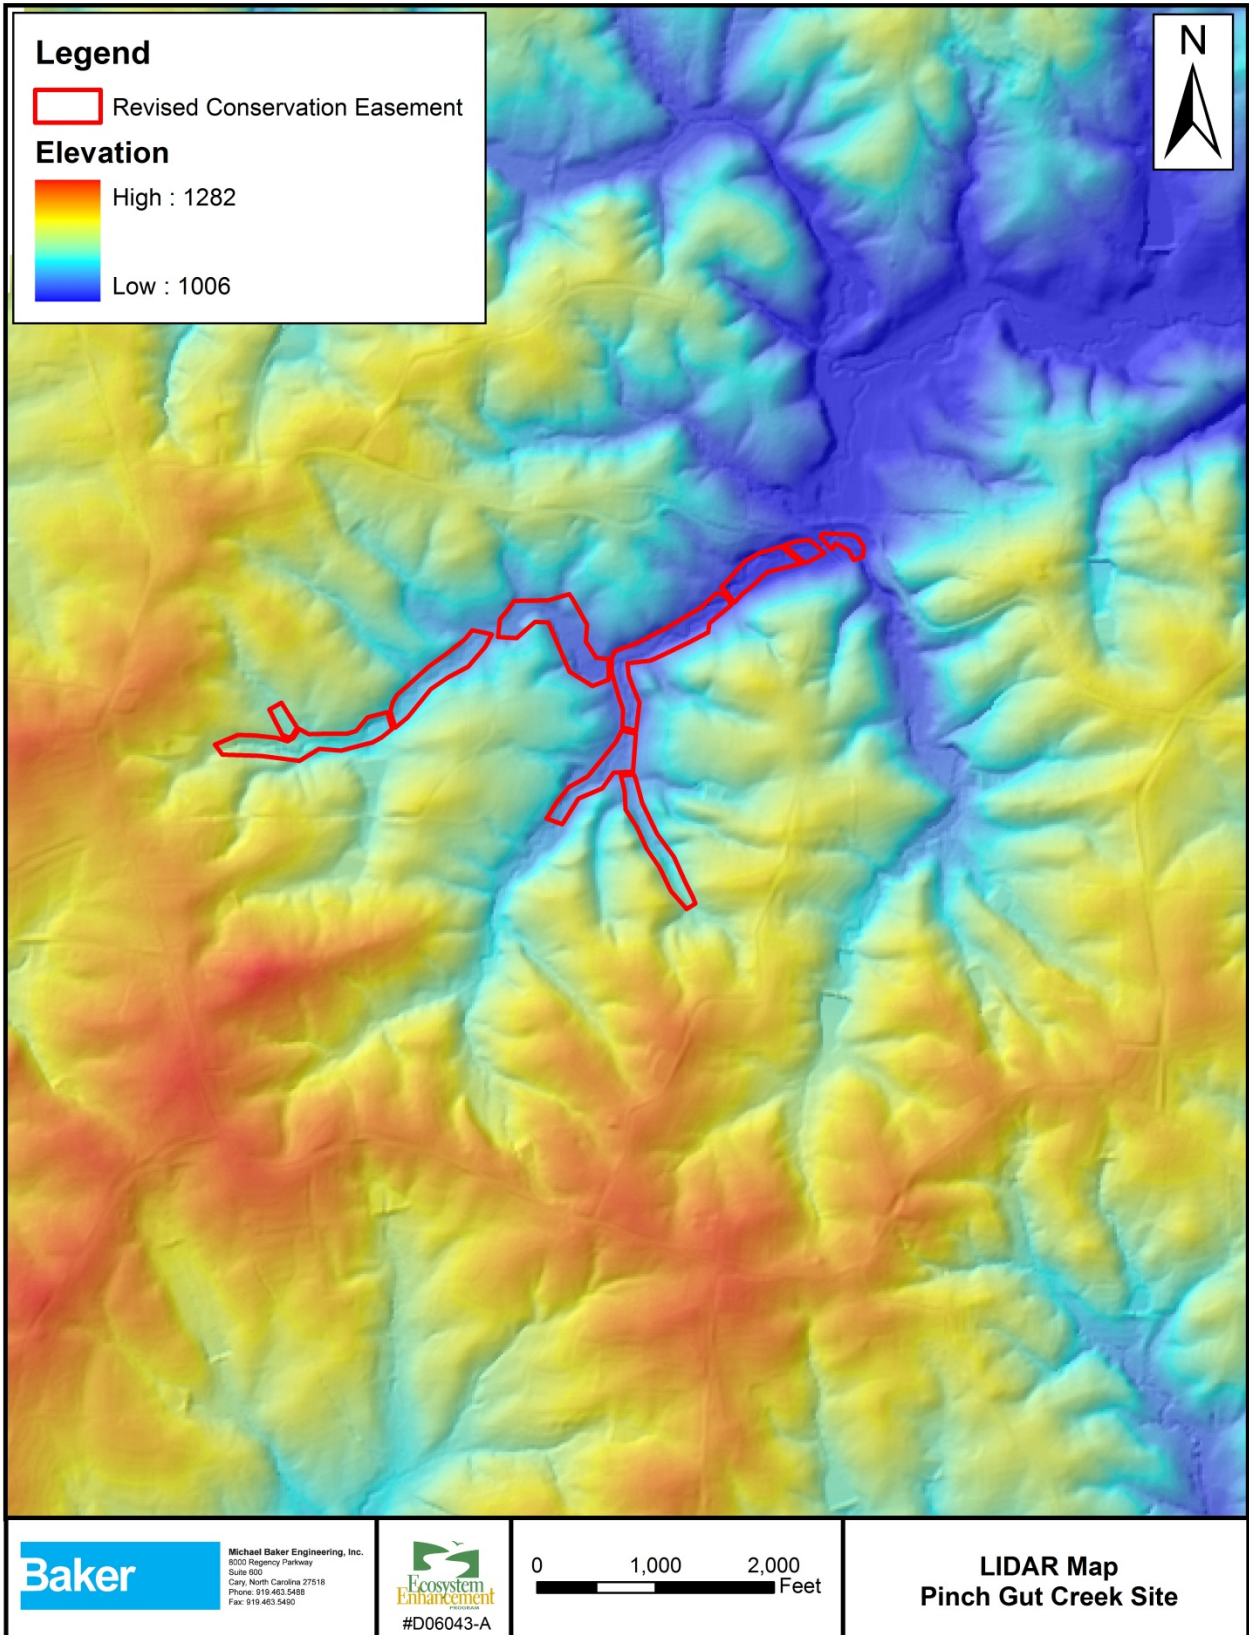
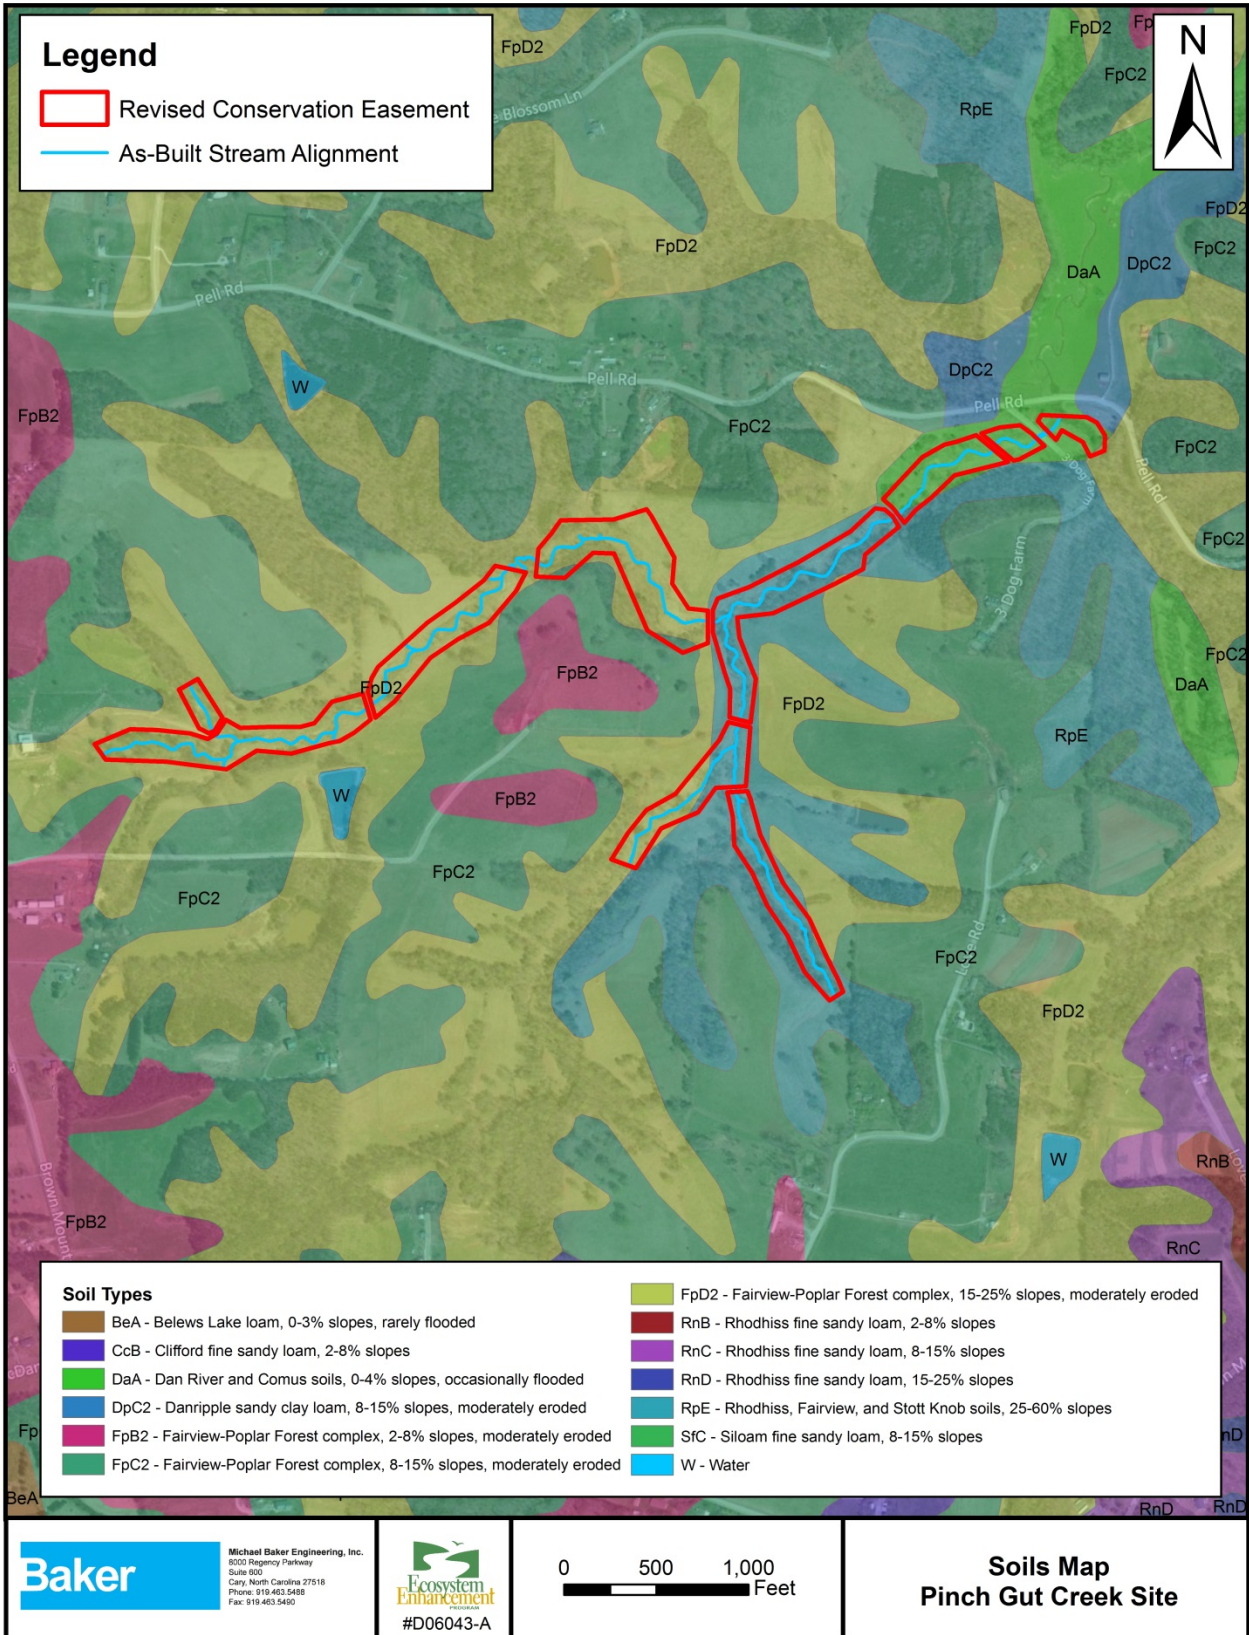
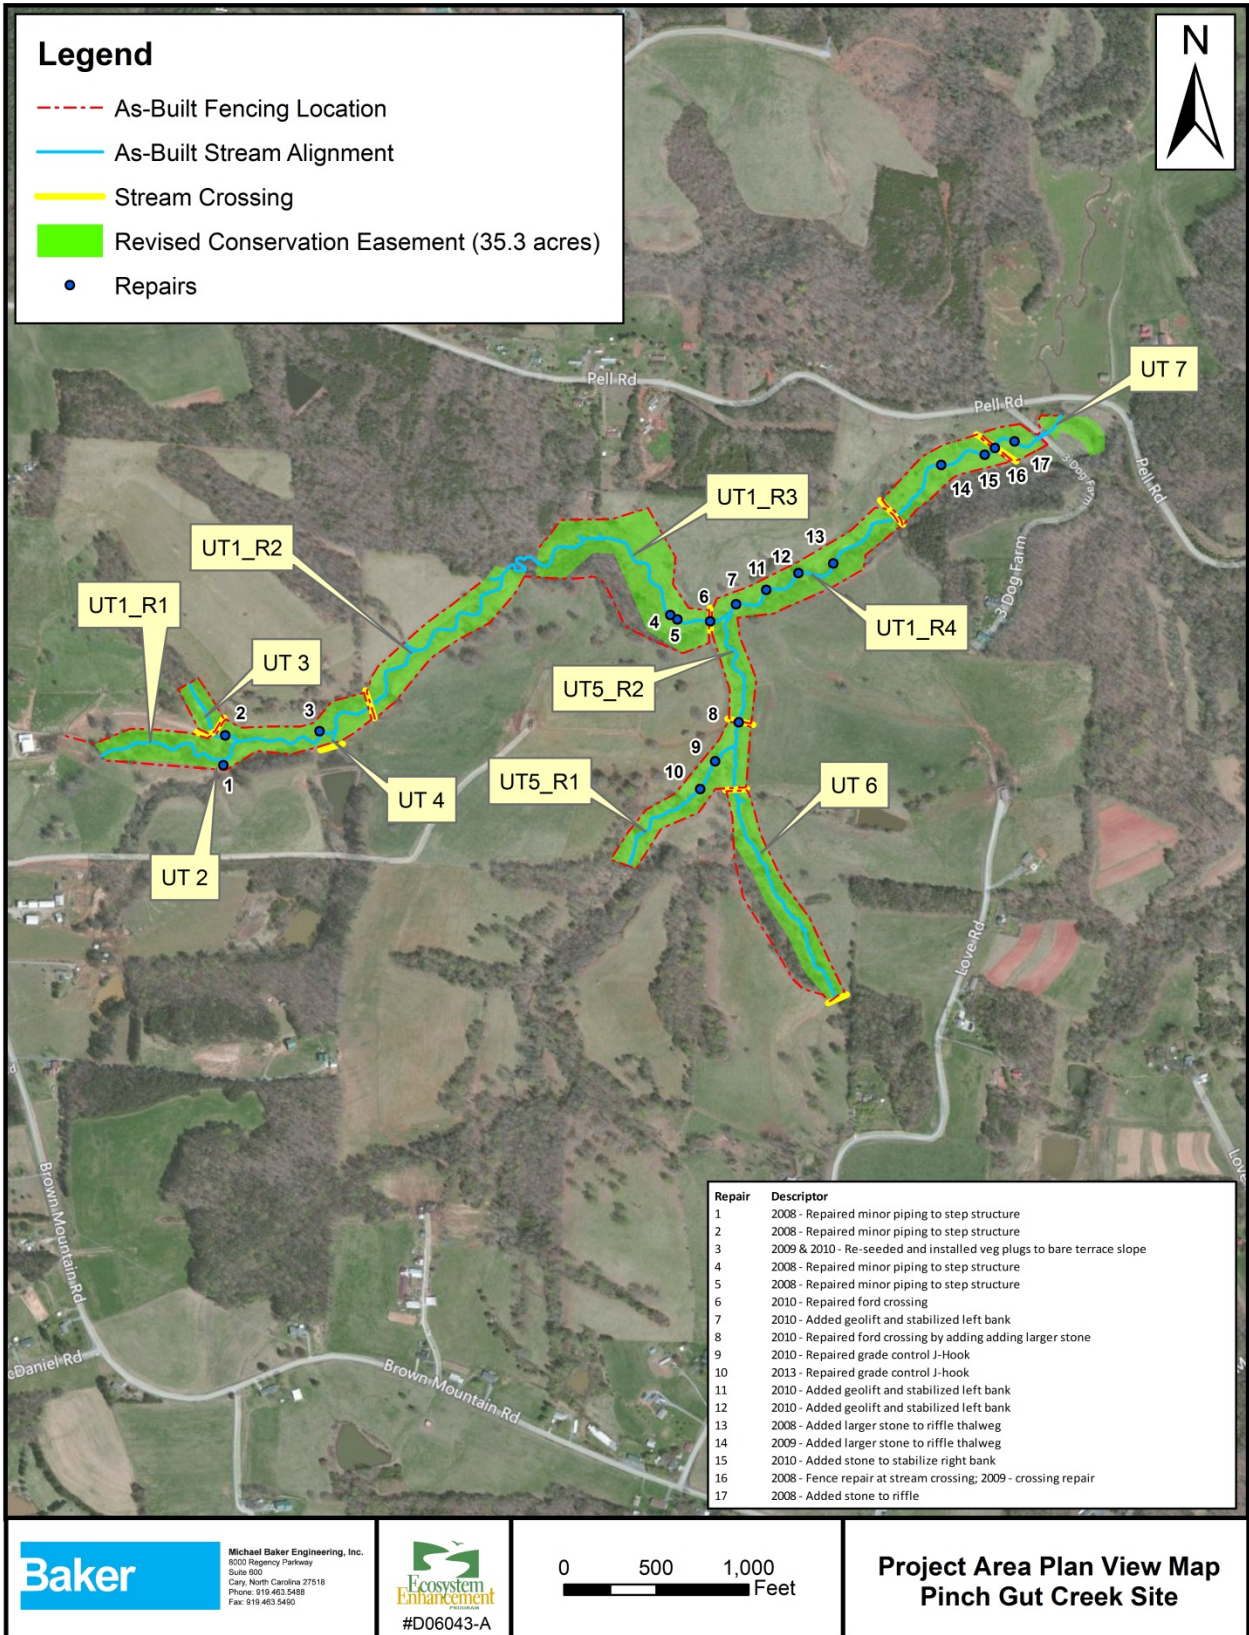
**Project Area Plan View Map
 Pinch Gut Creek Site**

Repair	Descriptor
1	2008 - Repaired minor piping to step structure
2	2008 - Repaired minor piping to step structure
3	2009 & 2010 - Re-seeded and installed veg plugs to bare terrace slope
4	2008 - Repaired minor piping to step structure
5	2008 - Repaired minor piping to step structure
6	2010 - Repaired ford crossing
7	2010 - Added geolift and stabilized left bank
8	2010 - Repaired ford crossing by adding larger stone
9	2010 - Repaired grade control J-hook
10	2013 - Repaired grade control J-hook
11	2010 - Added geolift and stabilized left bank
12	2010 - Added geolift and stabilized left bank
13	2008 - Added larger stone to riffle thalweg
14	2009 - Added larger stone to riffle thalweg
15	2010 - Added stone to stabilize right bank
16	2008 - Fence repair at stream crossing; 2009 - crossing repair
17	2008 - Added stone to riffle
