MONITORING YEAR 3 AND YEAR 4 REPORT
PLEMMONS/KIRKPATRICK MITIGATION SITE
SPRING CREEK

Madison County, North Carolina

EEP Project Number: 92607
Contract Number: D06082; Task Order: 06FB05-1

Period Covered: January 2009 – December 2010

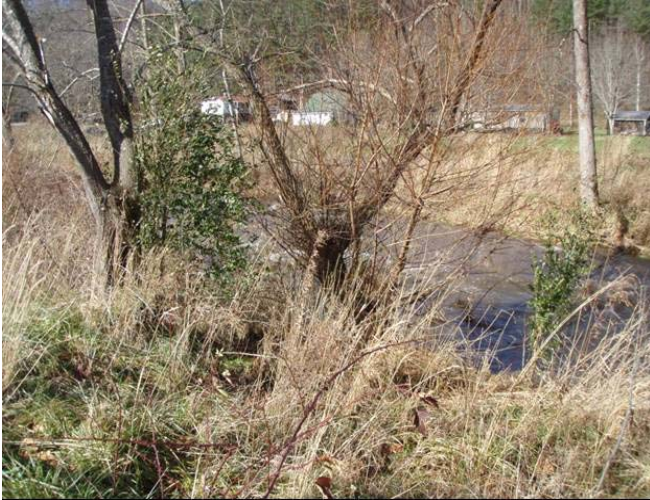
Vegetation problem area photo 3, 9 Dec 2009.

The non-native vegetation observed at the site remains at a relatively low density overall with the most concentrated portion of invasive vegetation located on the right bank at the lower end of the project site. The locations Vegetation problem areas or invasive species occurrences were noted on the MY3-MY4 plan view (Figure 3).
