MONITORING YEAR 5 REPORT

PLEMMONS/KIRKPATRICK MITIGATION SITE SPRING CREEK

Madison County, North Carolina

EEP Project Number: 92607
Contract Number: D06082; Task Order: 06FB05-1

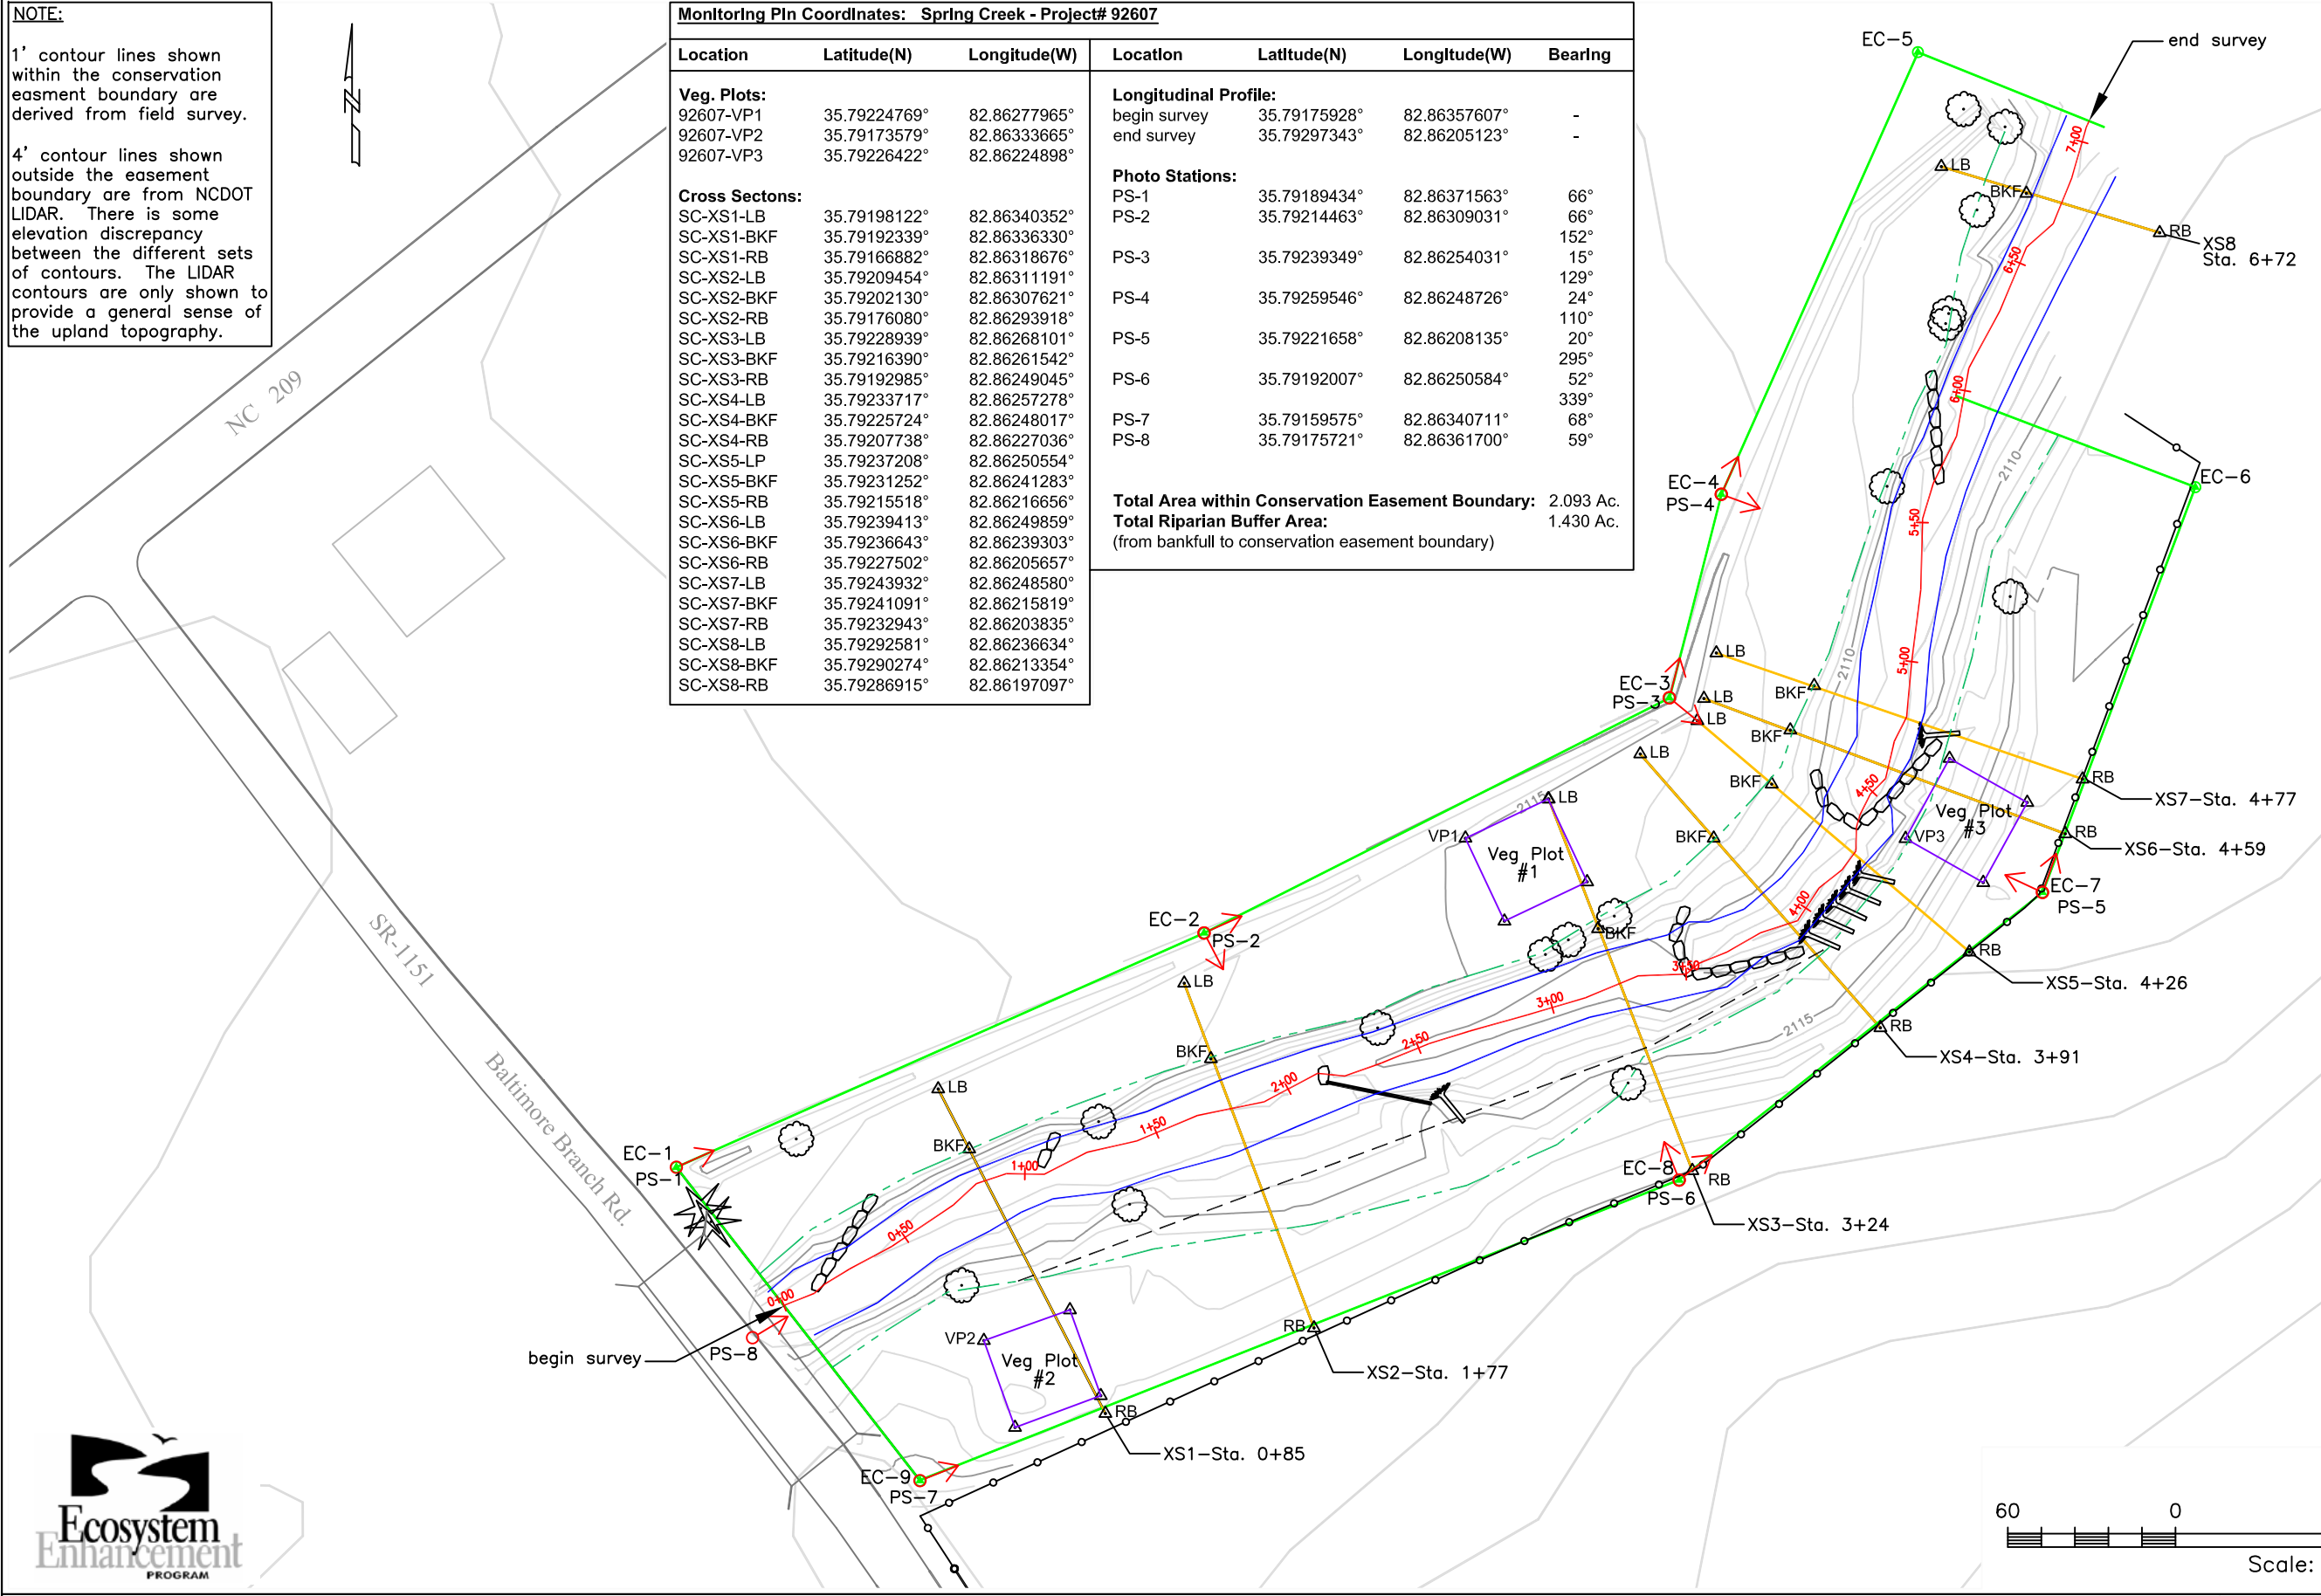
FIGURE 3. - Plemmons/Kirkpatrick Mitigation Site, Spring Creek, French Broad River Drainage, Madison County, NC. EEP Project #92607, MY5 Plan View.

Channel cross-sectional dimensions, pattern, and longitudinal profile were surveyed in December 2011 to document morphological characteristics of the active channel for MY5 (Figure 3). In addition, the locations of all constructed stream features (i.e., rock vanes, log vane, and J-hook vanes) were assessed for stability and structural integrity. Moreover, no deviation has occurred between established survey stations nor has any channel instability been observed between MY1 and MY5.

Profile.—The entire length (680 ft) of the longitudinal profile was surveyed during MY0-MY5 (Figure 3; Appendix B.7). Feature lengths, slopes, depths, and spacing were calculated following each monitoring survey (Table 8). From post-construction through MY5, riffle lengths have ranged from 14 to 77 ft, which approximate the design values (25 to 75 ft) for riffle length. Riffle slopes have ranged from 0.002 ft/ft to 0.024 ft/ft over the course of all monitoring surveys. With the exception of three riffle slope calculations (MY0 = 0.002 ft; MY1 = 0.005 ft; MY2 = 0.024 ft), all riffle slopes have been maintained within the design range of values (0.008 to 0.023 ft/ft). Pool lengths have closely approximated design values across in each of the monitoring years, ranging from 16 to 68 ft. Pool-to-pool spacing decreased following construction and has ranged from 61 to 195 ft over all monitoring years. Construction of five in-stream structures (J-hooks, rock vanes, log vane) increased the number pool features within the project reach and is the reason pool-to-pool spacing is lower than pre-existing, reference, or design values. The thalweg alignment and edge of water survey points that define the location of the active channel indicate only minimal changes (thalweg movement) over the 5 years post-construction.
