# **Annual Monitoring Report**

Monitoring Year 1 of 7

Poplin Ridge Stream Restoration Project

NCDMS Project No.: 95359

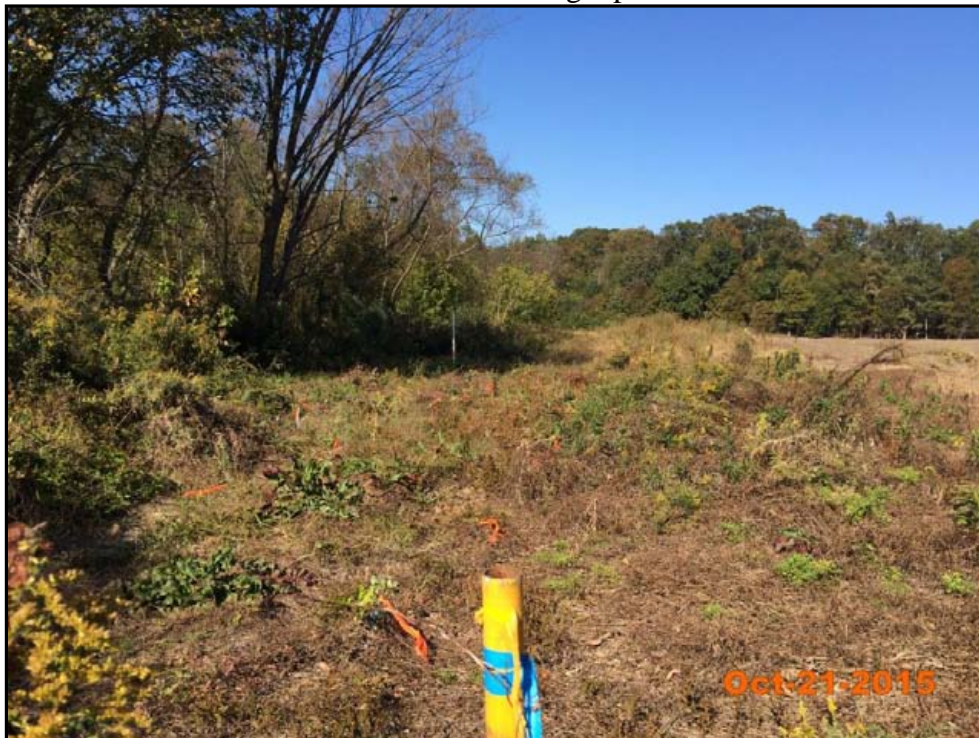
Project Reach UT2-1 – Permanent Photo Station 10  
Station 4+50 – Looking Upstream

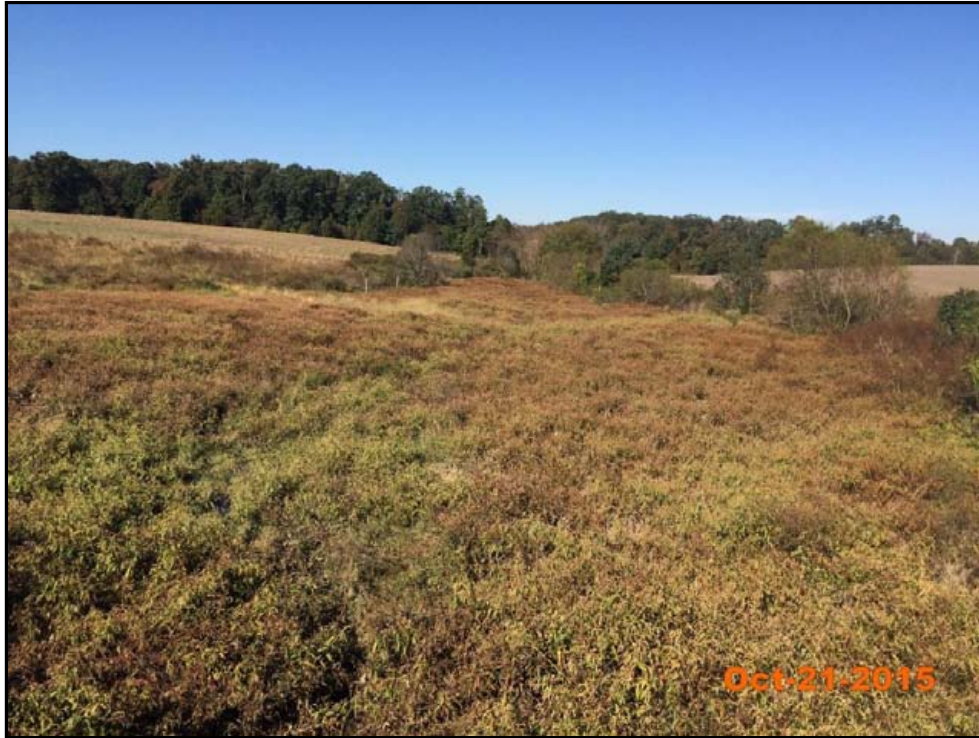
Project Reach UT2-2– Permanent Photo Station 11  
Station 11+00 – Looking Upstream at Pond Bottom

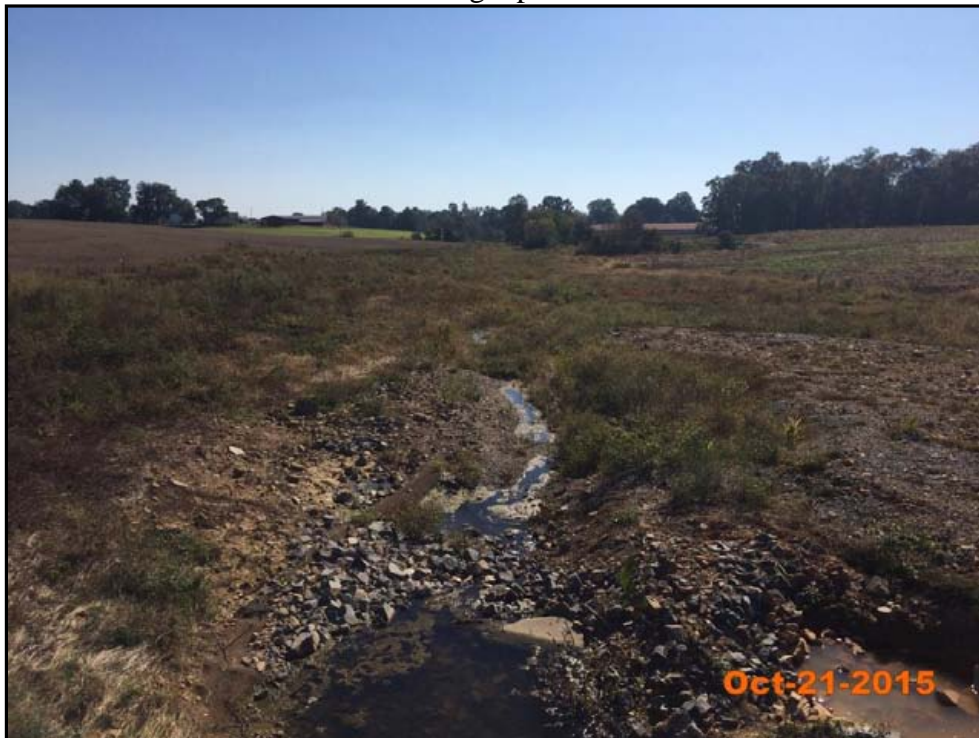
Project Reach UT2-2 – Permanent Photo Station 12  
Station 11+00 – Looking Downstream

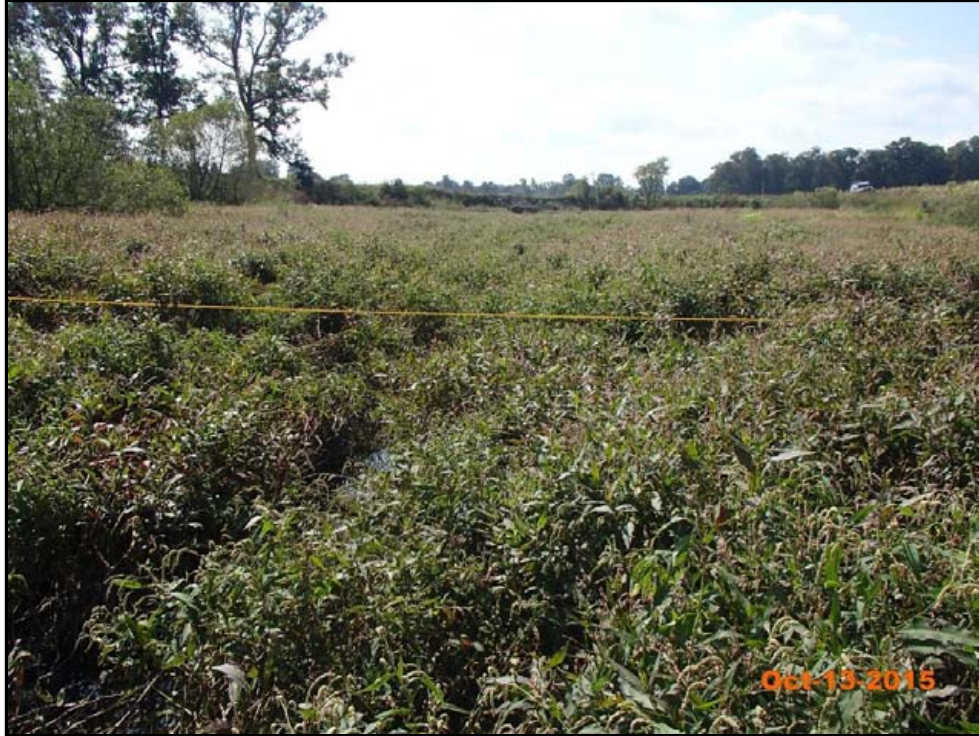
Project Reach UT2-2 – Permanent Photo Station 13  
Station 7+59 – Looking Downstream

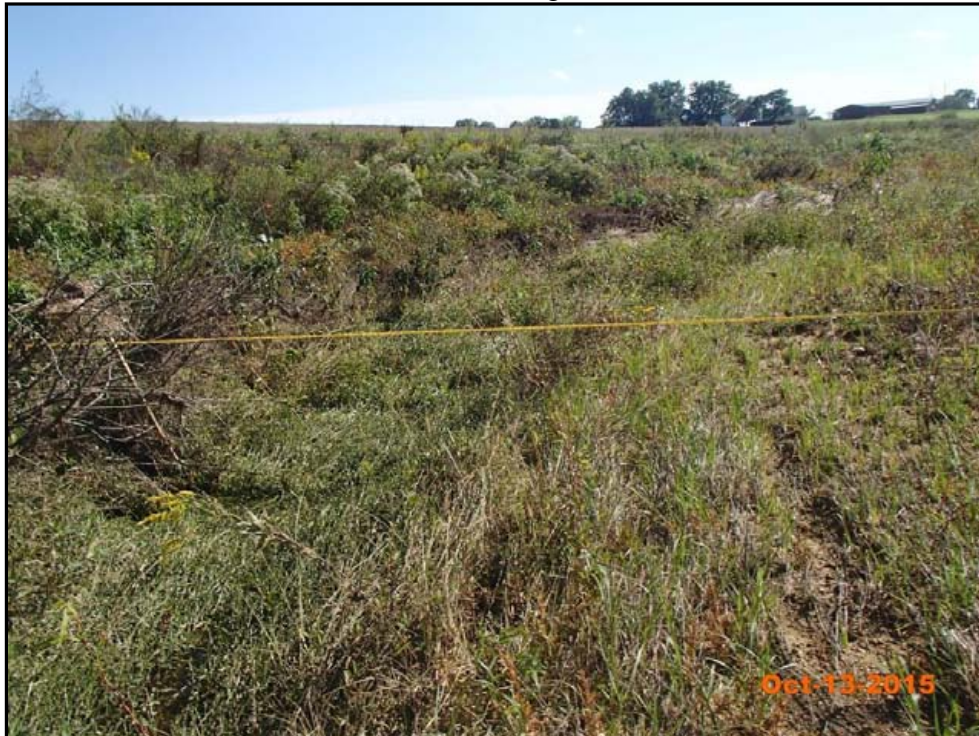
Project Reach UT2-3 – Permanent Photo Station 14  
Station 13+83 – Looking Downstream

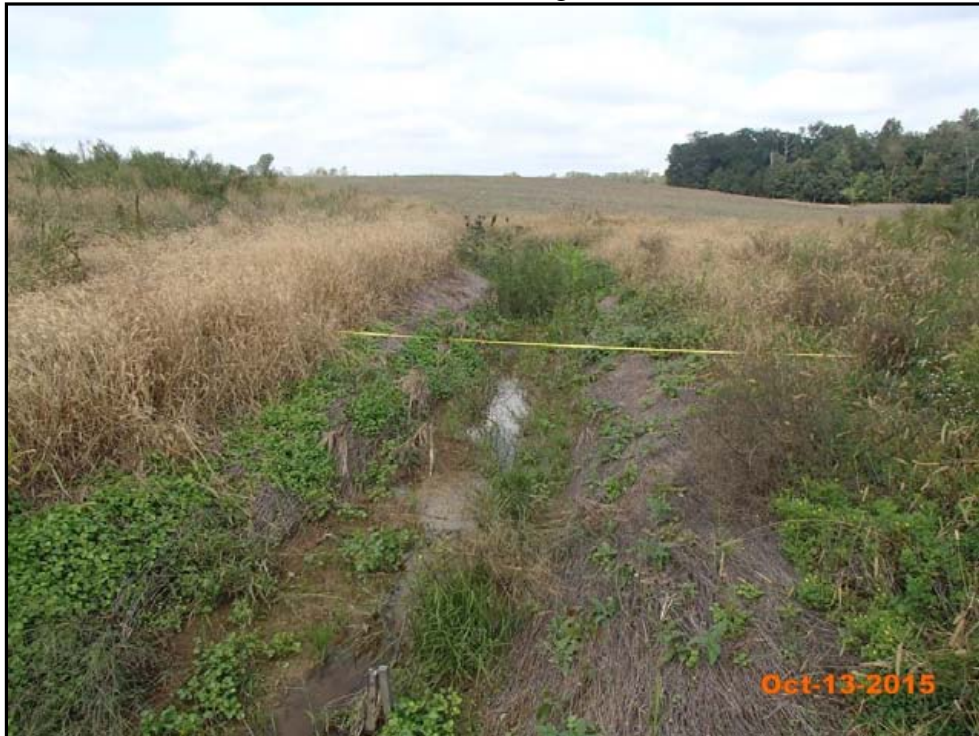
Project Reach UT2-A – Permanent Photo Station 16  
Station 1+22 – Looking Upstream
