Annual Monitoring Report

Monitoring Year 2 of 7

Poplin Ridge Stream Restoration Project

NCDMS Project No.: 95359

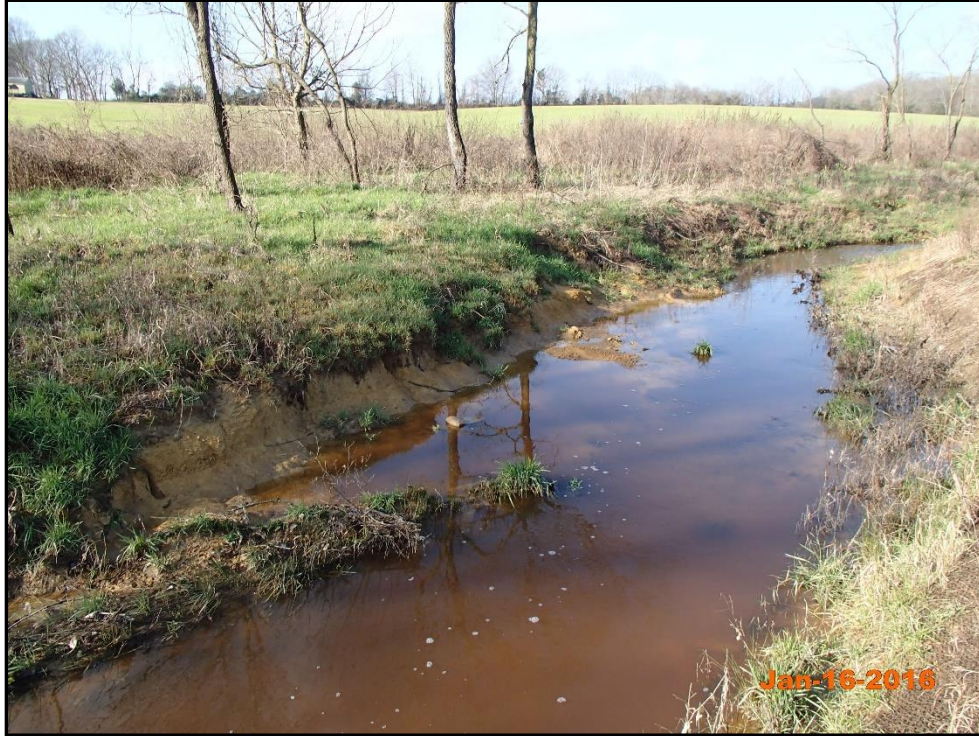
Project Reach UT1-2 – Bank Erosion 19+00 Right Descending Bank

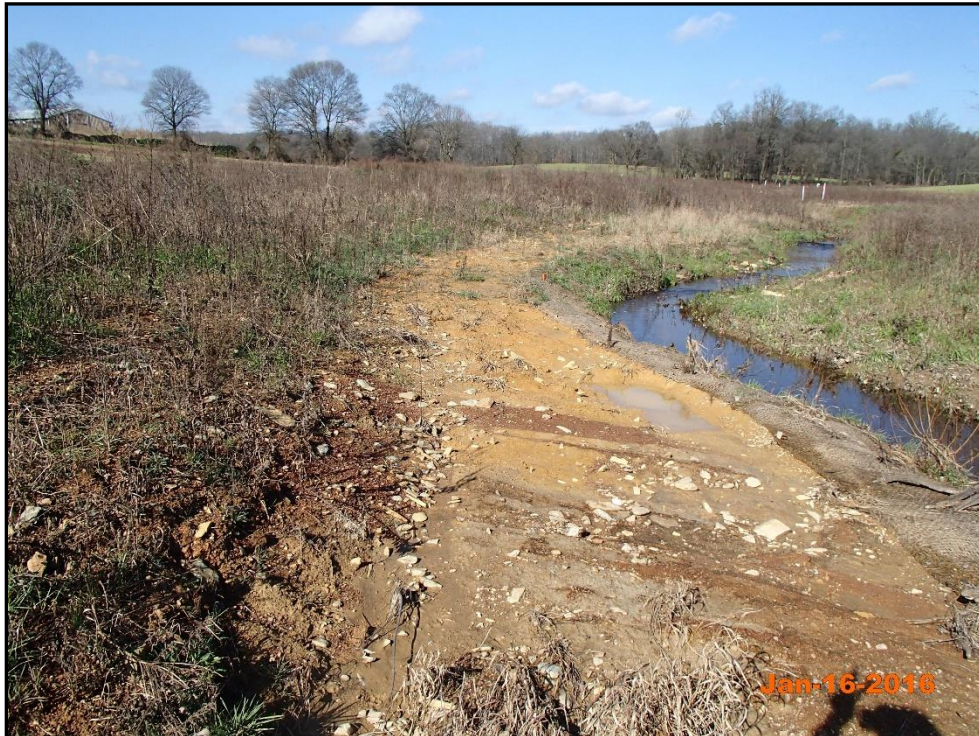
Project Reach UT1-3 – Bare Area 29+00 Right Descending Bank

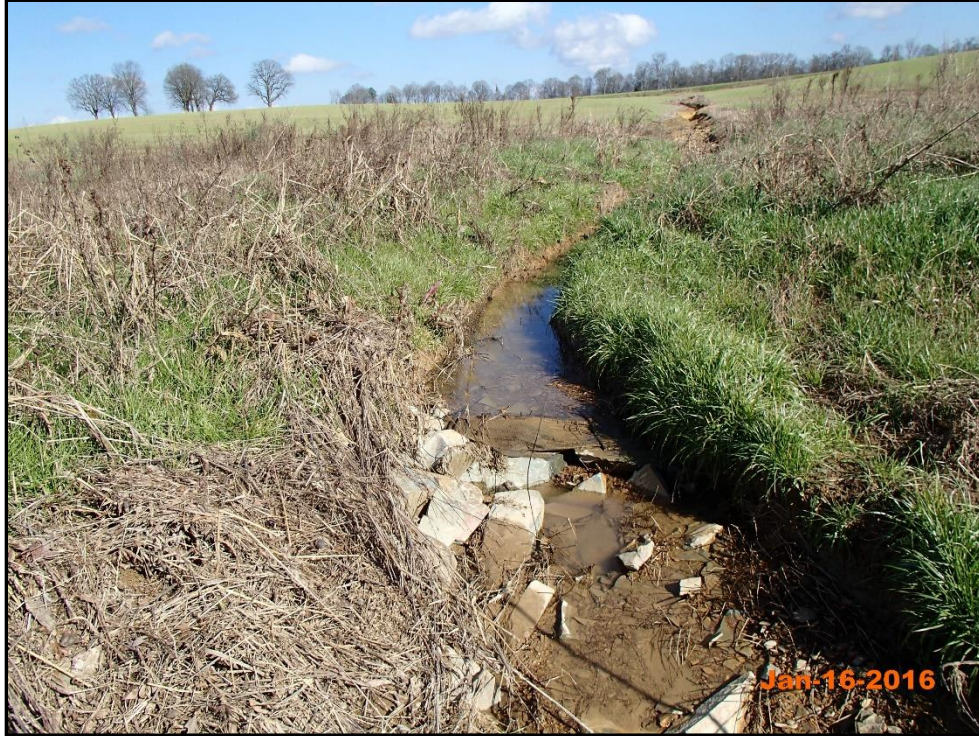
Project Reach UT1-4 – Stressed BMP Structure Left Descending Bank 42+25

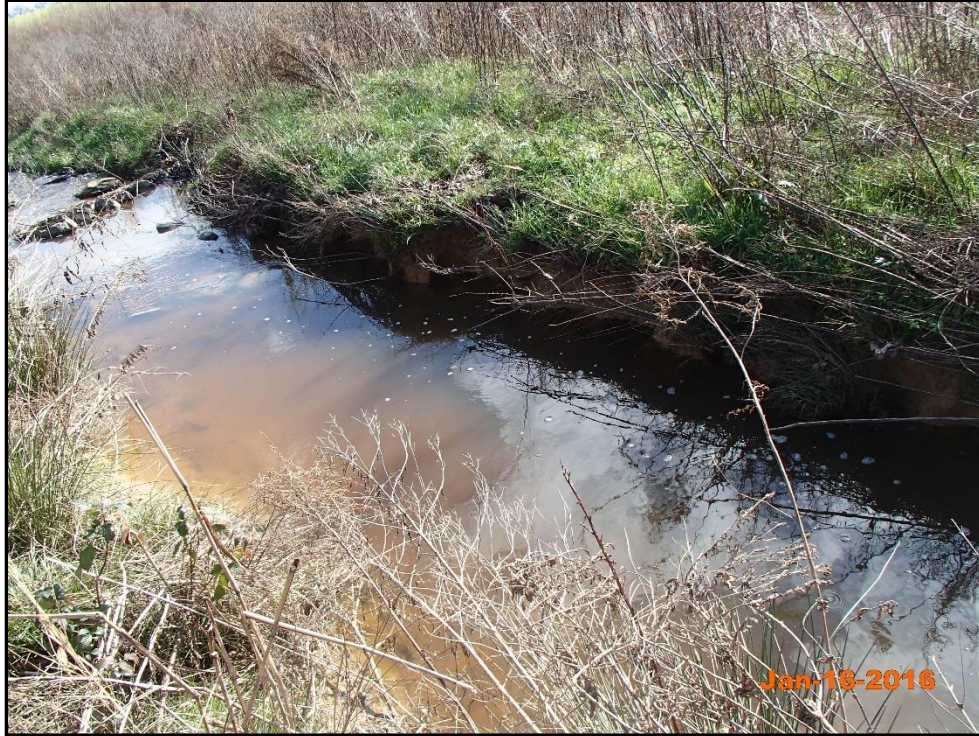
Project Reach UT1-C – Bank Scour 4+00 Right Descending Bank

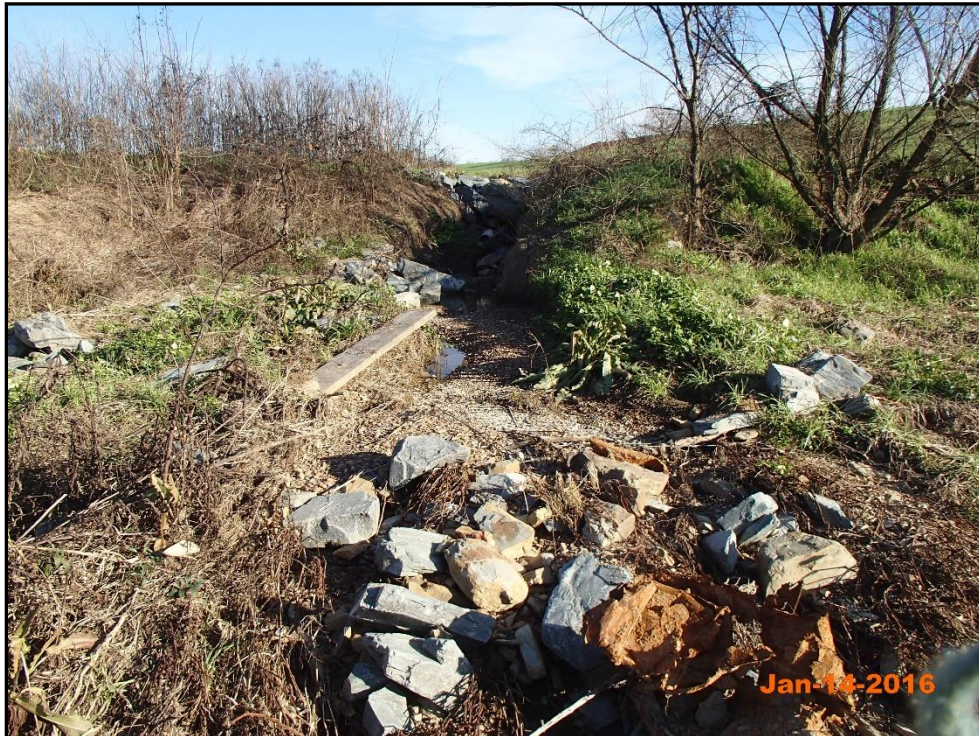
Project Reach UT2-2 – Stressed BMP 8+75

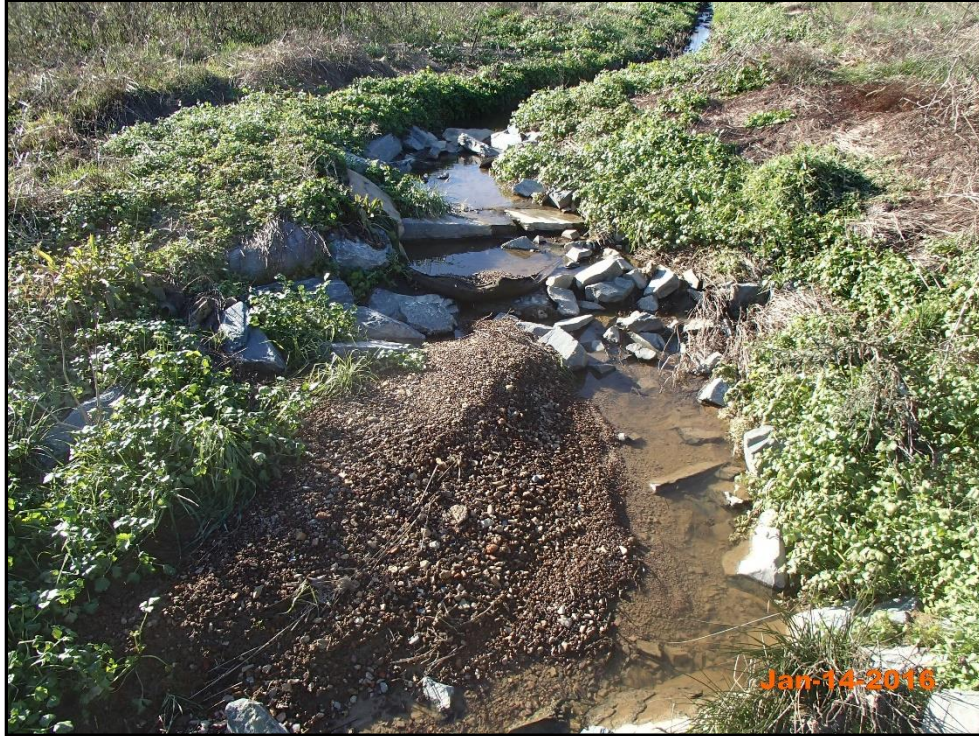
Project Reach UT2-A – Stressed Structure 3+75 Left Descending Bank
