Annual Monitoring Report

Monitoring Year 3 of 7

Poplin Ridge Stream Restoration Project

NCDMS Contract No.: 004672

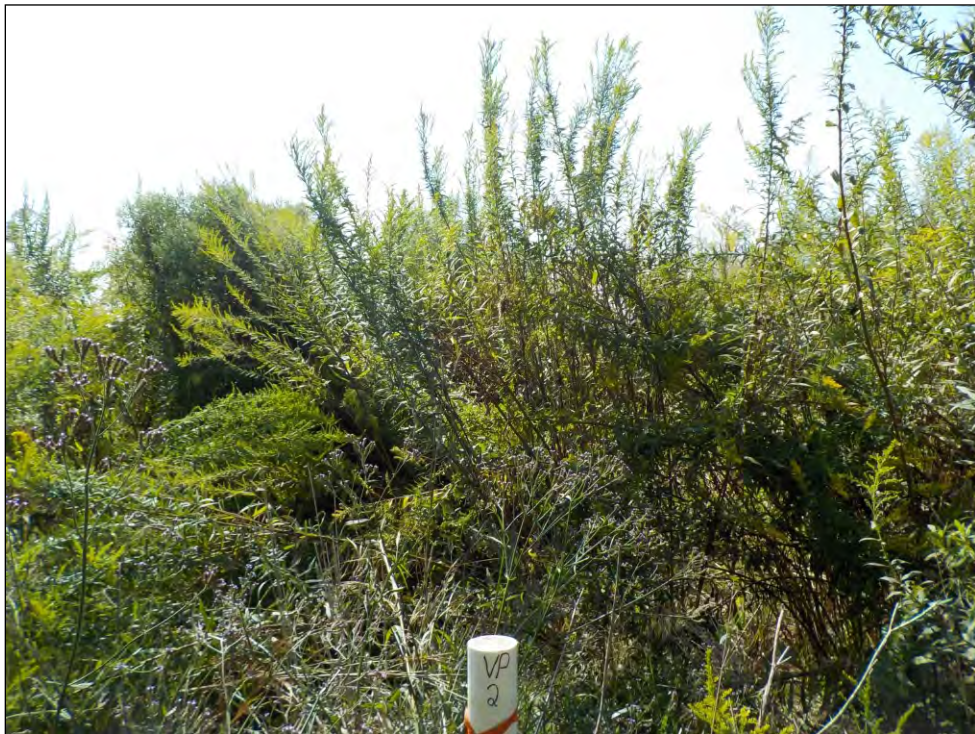
Poplin Ridge - Vegetation Monitoring Plot 2
September 19, 2017

Monitoring of 13 permanent vegetation plots was completed during September 2017. Summary tables and photographs associated with MY3 monitoring can be found in Appendix C. With the exception of Plots 2, 8, 9, and 10, MY3 monitoring data indicates that all vegetation monitoring plots met the MY3 interim success criteria of 320 planted stems per acre. Planted stem densities among the plots ranged from 81 to 1,093 planted stems per acre with a mean of 595 stems per acre across all plots. When volunteer stems are included, densities ranged between 121 and 6,475 total stems per acre with a mean of 1,090 stems per acre across all plots. A total of 18 plant species were documented within the monitoring plots. The estimated average planted stem height was 201 cm (6.6 ft). Low stem densities in plots 2, 8, 9, and 10 are likely attributed to a combination of dry conditions and shallow, rocky soil.

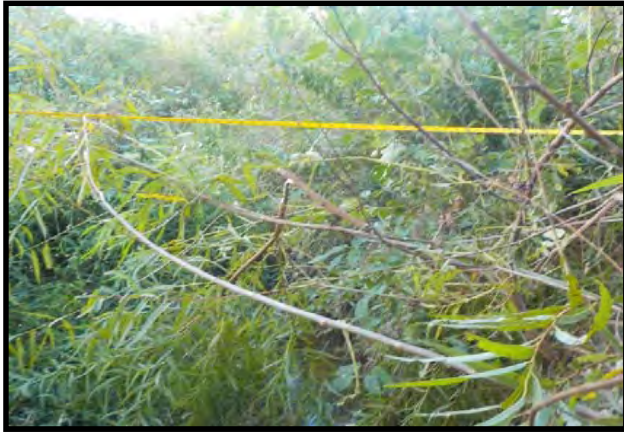
Upstream

Cross Section 27 (Riffle)						
Based on fixed baseline bankfull elevation	Base	MY1	MY2	MY3	MY5	MY7	MY+
Record elevation (datum) used	582.2	582.2	582.2	582.2			
Bankfull Width (ft)	16.5	15.9	15.6	15.4			
Floodprone Width (ft)	>50.0	>50.0	>50.0	>50.0			
Bankfull Mean Depth (ft)	1.3	1.2	1.1	1.0			
Bankfull Max Depth (ft)	2.1	1.9	1.9	1.8			
Bankfull Cross Sectional Area (ft ²)	21.5	18.3	17.8	15.6			
Bankfull Width/Depth Ratio	12.7	13.8	13.6	15.1			
Bankfull Entrenchment Ratio	>2.2	>3.1	>3.2	>3.3			
Bankfull Bank Height Ratio	1.0	1.0	1.0	1.1

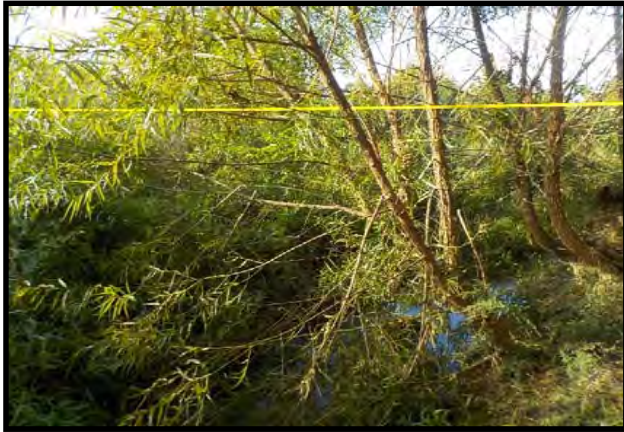
Upstream

Cross Section 28 (Riffle)						
Based on fixed baseline bankfull elevation	Base	MY1	MY2	MY3	MY5	MY7	MY+
Record elevation (datum) used	579.7	579.7	579.7	579.7			
Bankfull Width (ft)	15.9	15.4	15.3	15.0			
Floodprone Width (ft)	>50.0	>50.0	>50.0	>50.0			
Bankfull Mean Depth (ft)	1.5	1.4	1.4	1.3			
Bankfull Max Depth (ft)	2.6	2.5	2.5	2.5			
Bankfull Cross Sectional Area (ft ²)	24.2	21.7	21.9	20.0			
Bankfull Width/Depth Ratio	10.4	10.9	10.8	11.2			
Bankfull Entrenchment Ratio	>2.2	>3.3	>3.3	>3.3			
Bankfull Bank Height Ratio	1.0	1.0	1.0	1.1

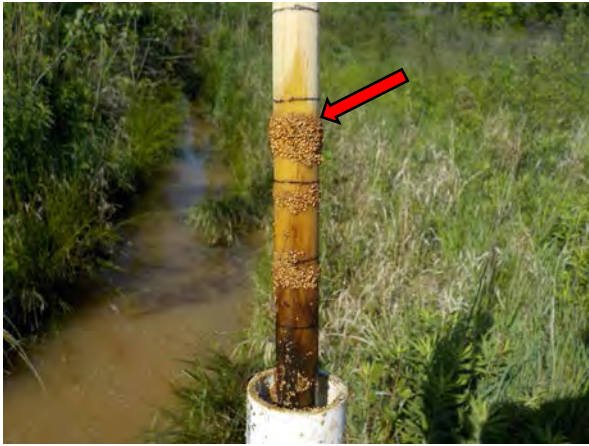
Crest Gauge @ UT1-2 – 0.49 ft.

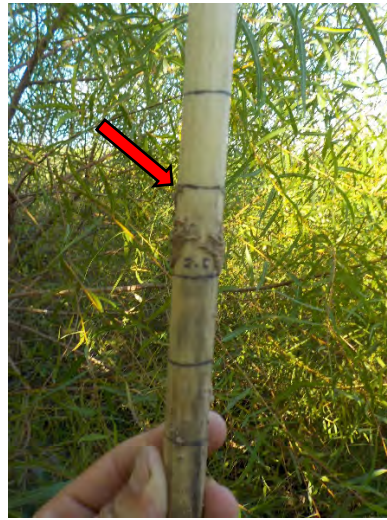
Crest Gauge @ UT1-4 – 2.6 ft.

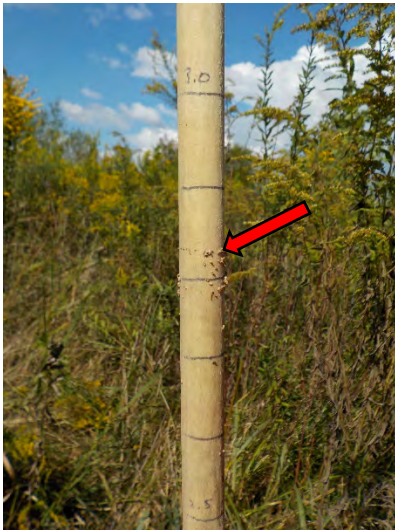
Crest Gauge @ UT2-3 – 2.83 ft.
