Annual Monitoring Report

Monitoring Year 5 of 7

Poplin Ridge Stream Restoration Project

NCDMS Project No.: 95359

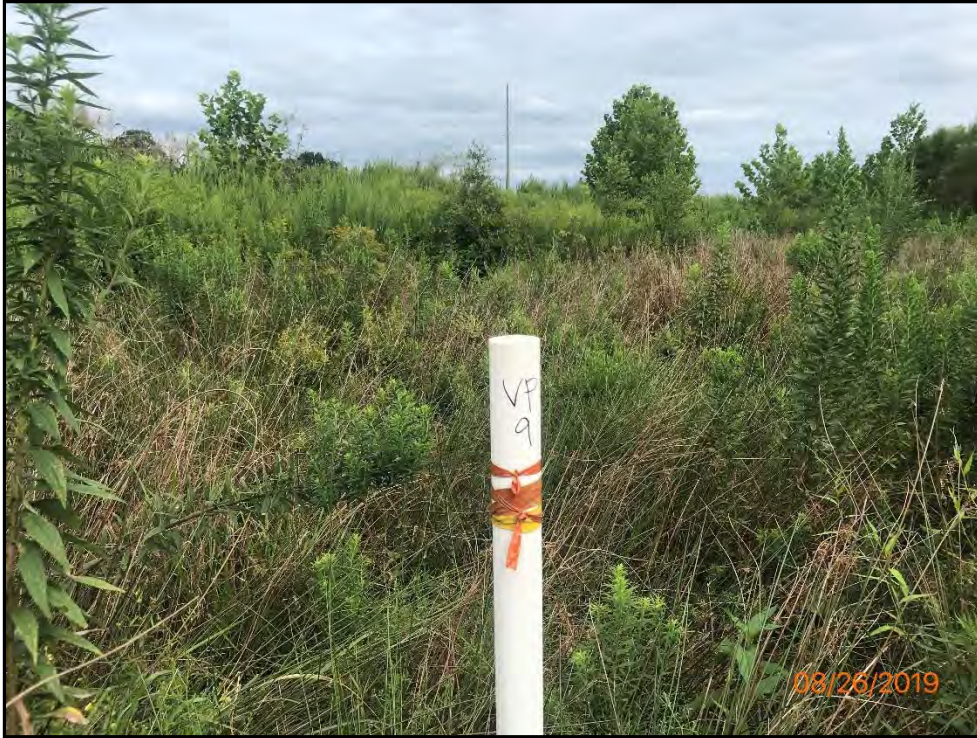
Monitoring of 13 permanent vegetation plots was completed in late August 2019. Summary tables and photographs associated with MY5 monitoring can be found in **Appendix C**. With the exception of Plots 9 and 10, MY5 monitoring data indicates that all vegetation monitoring plots met the MY5 interim success criteria of 260 planted stems per acre. Planted stem densities among the plots ranged from 40 to 931 planted stems per acre with a mean of 576 stems per acre across all plots. When volunteer stems are included, densities ranged between 40 and 1,578 total stems per acre with a mean of 669 stems per acre across all plots. A total of 19 plant species were documented within the monitoring plots. The average planted stem height in plots was 9.3 feet. Low stem densities in plots 9 and 10 are likely attributed to a combination of dry conditions and shallow, rocky soil. The areas in and around these plots were replanted in early 2018 but the replanted stems did not survive.

Low Stem Density Area (VP9)

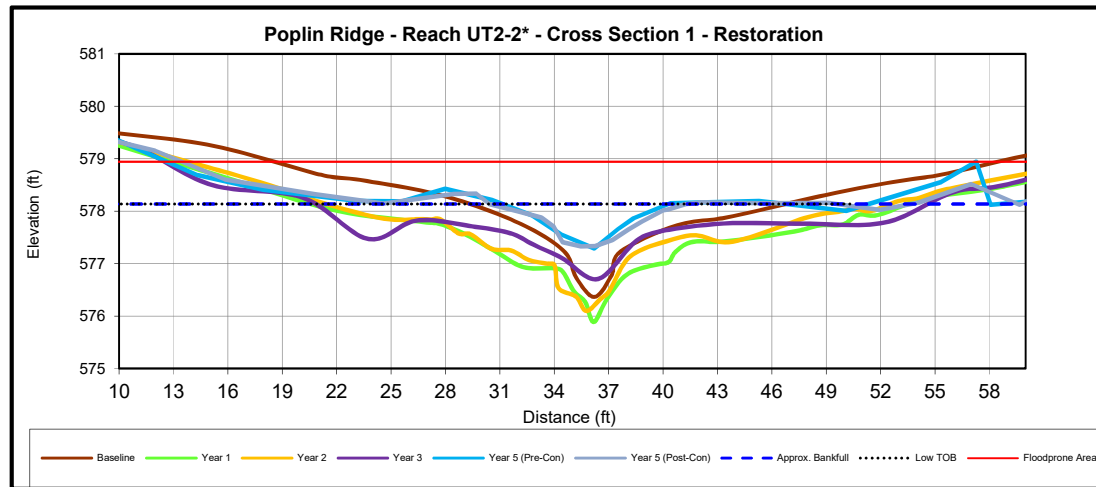
Dimension	Cross Section 1						
	Base	MY1	MY2	MY3	MY5	MY7	MY+
Bankfull Elevation (ft) - Based on AB-XSA ¹	577.24	577.24	577.24	577.24	578.14		
Bankfull Width (ft) ¹	3.2	5.5	5.2	4.3	10.8		
Floodprone Width (ft) ¹	>17.2	>17.2	>17.2	26.2	52.4		
Bankfull Mean Depth (ft)	0.5	0.7	0.6	0.3	---		
Bankfull Max Depth (ft) ²	0.9	1.4	1.1	0.5	0.8		
Low Bank Elevation (ft)	-	-	-	-	578.14		
Bankfull Cross Sectional Area (ft ²) ²	0.6	3.7	3.3	1.1	4.2		
Bankfull Width/Depth Ratio	6.4	8.2	8.1	16.7	---		
Bankfull Entrenchment Ratio ¹	>2.2	>3.1	>3.3	6.0	4.8		
Bankfull Bank Height Ratio ¹	1.0	1.0	1.0	1.3	1.0

*Reach UT2-2 was reconstructed in September 2019

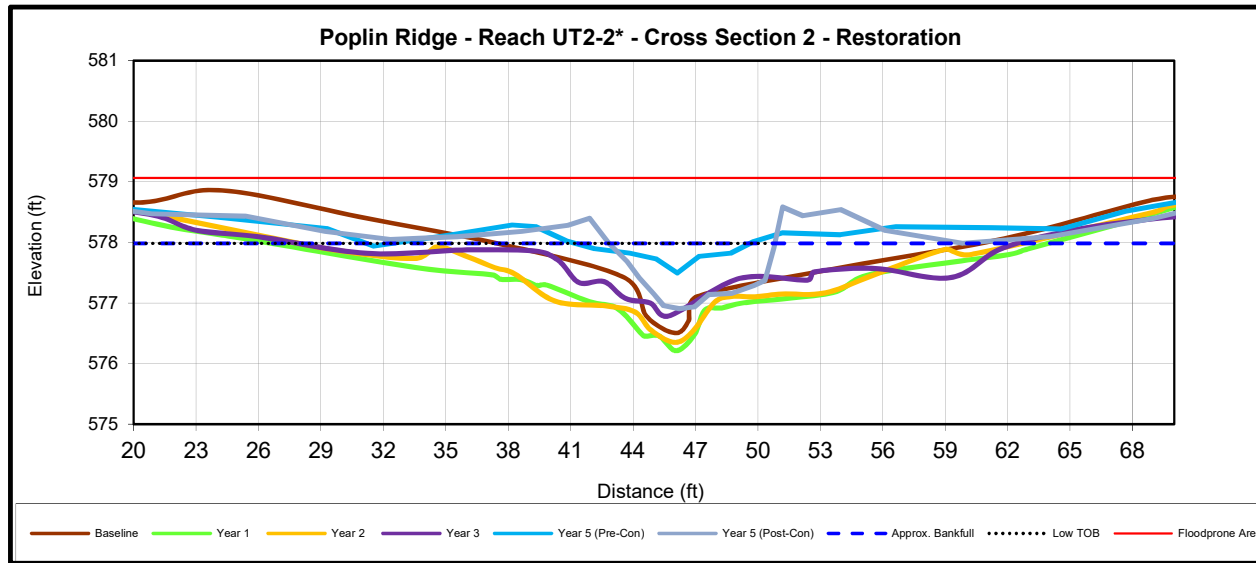
Dimension	Cross Section 2						
	Base	MY1	MY2	MY3	MY5	MY7	MY+
Bankfull Elevation (ft) - Based on AB-XSA ¹	577.10	577.10	577.10	577.10	577.99		
Bankfull Width (ft) ¹	3.0	5.6	5.3	3.9	8.0		
Floodprone Width (ft) ¹	>15.2	>15.2	>15.2	11.2	66.2		
Bankfull Mean Depth (ft)	0.4	0.5	0.4	0.1	---		
Bankfull Max Depth (ft) ²	0.6	1.3	0.8	0.3	1.1		
Low Bank Elevation (ft)	-	-	-	-	577.99		
Bankfull Cross Sectional Area (ft ²) ²	1.1	2.7	2.2	0.5	5.8		
Bankfull Width/Depth Ratio	7.9	11.5	12.5	28.8	---		
Bankfull Entrenchment Ratio ¹	>2.2	>2.7	>2.9	2.9	8.3		
Bankfull Bank Height Ratio ¹	1.0	1.0	1.0	2.0	1.0

*Reach UT2-2 was reconstructed in September 2019

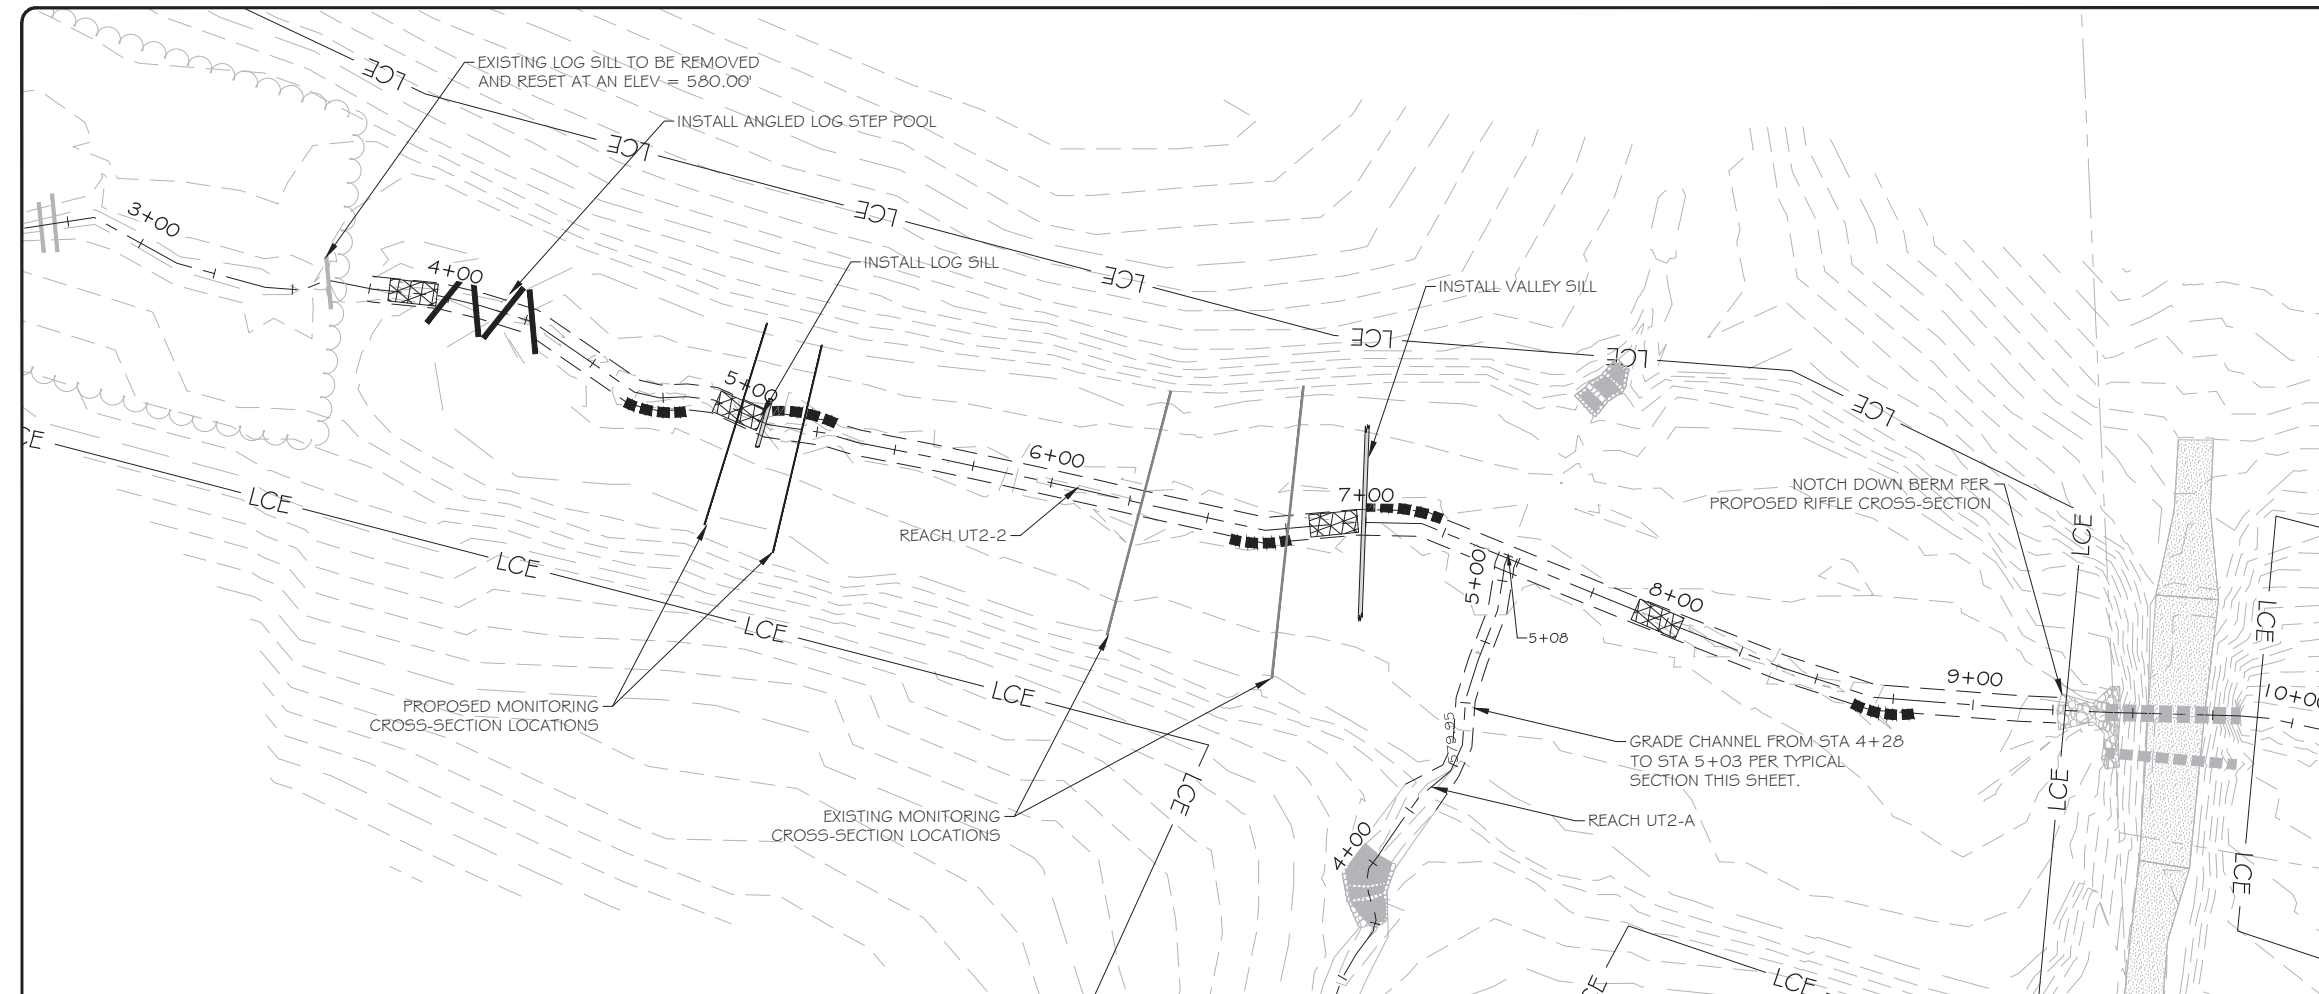
REACH UT2 STA 3+70 TO STA 9+20

Issue: The log sill at the start of UT2-2 (Sta: 3+61.97) is set too high and is blocking flow during low flow conditions.

Treatment: RES will repair and stabilize these headcuts by installing several grade control/drop structures as shown on the attached Sheet 2.
