Annual Monitoring Report

Monitoring Year 6 of 7

Poplin Ridge Stream Restoration Project

NCDMS Contract No.: 004672

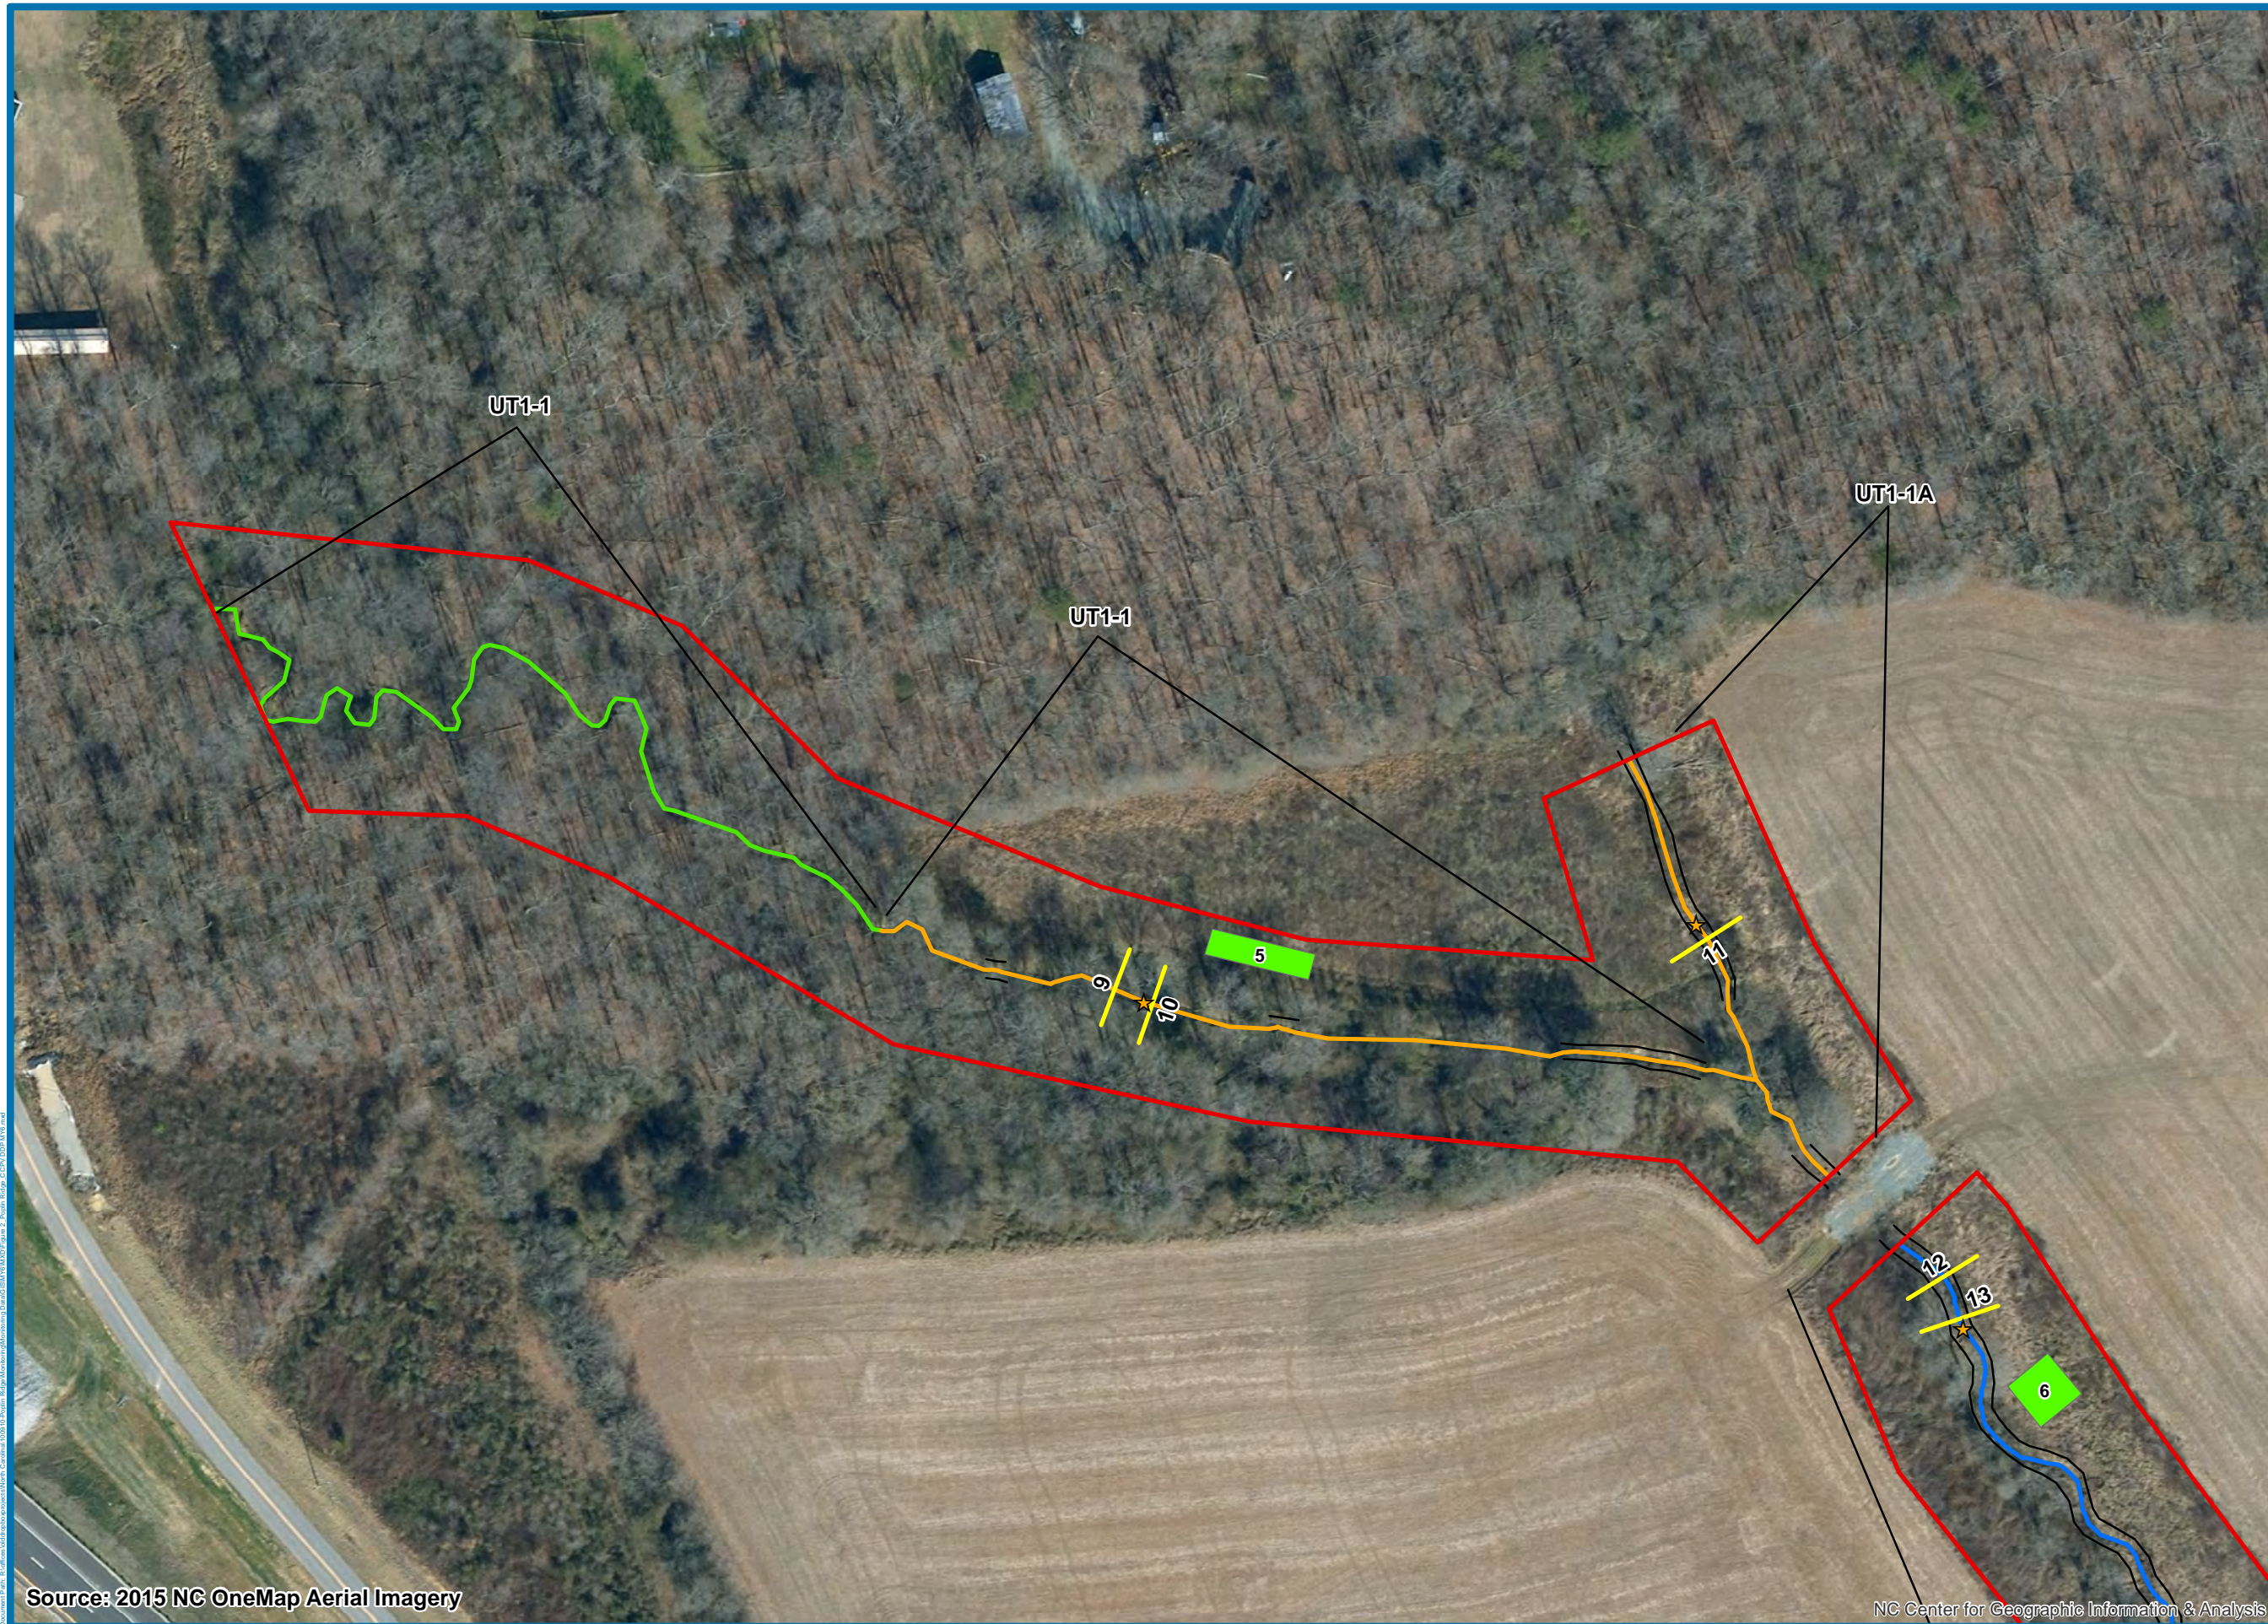
Figure 2
1
Poplin Ridge Stream Restoration Project
MY6 2020
Current Conditions
Plan View

Visual assessment of the stream channel was performed in order to document signs of instability, such as eroding banks, structural instability, or excessive sedimentation. Small areas of bank scour, bed aggradation, and bed degradation were reported as problem areas in previous years but are no longer problem areas MY6. RES will continue to monitor these areas during future visits to assess the stability of the channel and the need for any repair.
