Pott Creek II Stream Restoration Project Year 4 Monitoring Report - 2008

**November 2008
Prepared By:**

**Mid - Atlantic
Mitigation, LLC**

1.0 EXECUTIVE SUMMARY/PROJECT ABSTRACT

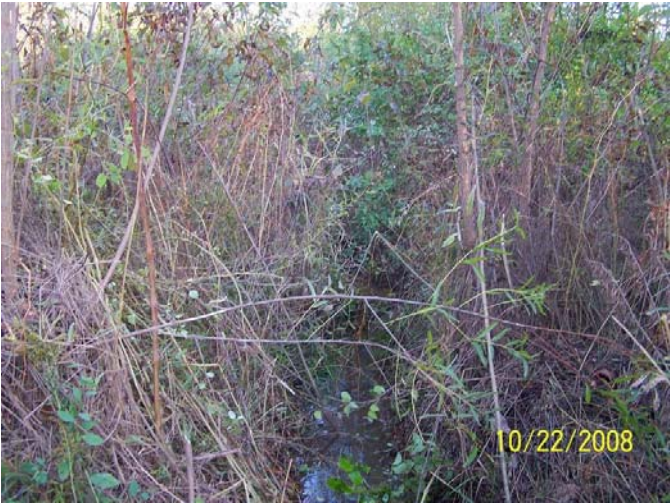
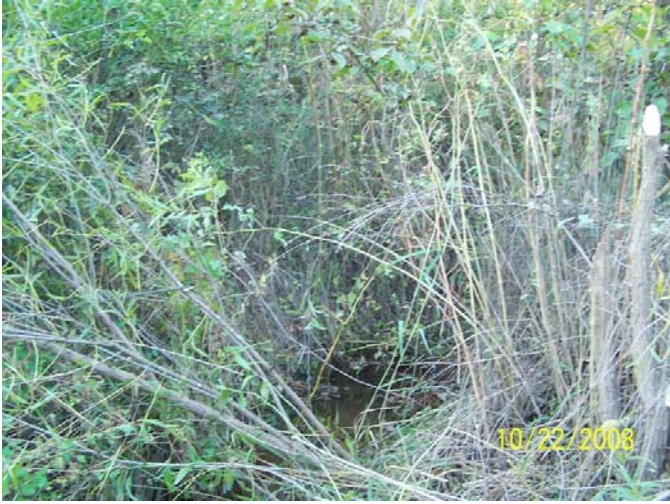
UT1 Cross Section – facing downstream

The thalweg of UT1 trends towards being left of center, and photos show this area as being well vegetated and stable. It appears that some silt deposition and/or deposition of organic material from vegetation growth have caused the cross section to become more shallow. UT 1 is the largest of the UT's and shows a trend of shallowing and deepening from year to year which will adjust with future storm events that may wash out the silt and/or organic material from this cross section.
