**Powell Property Wetland and Stream Mitigation Project
Bertie County, NC**

**2009 Annual Monitoring Report
Year 1**

**NCEEP Project Number D06065-B
Chowan River Basin
USGS Catalog Unit 03010203**

Date: March, 2010

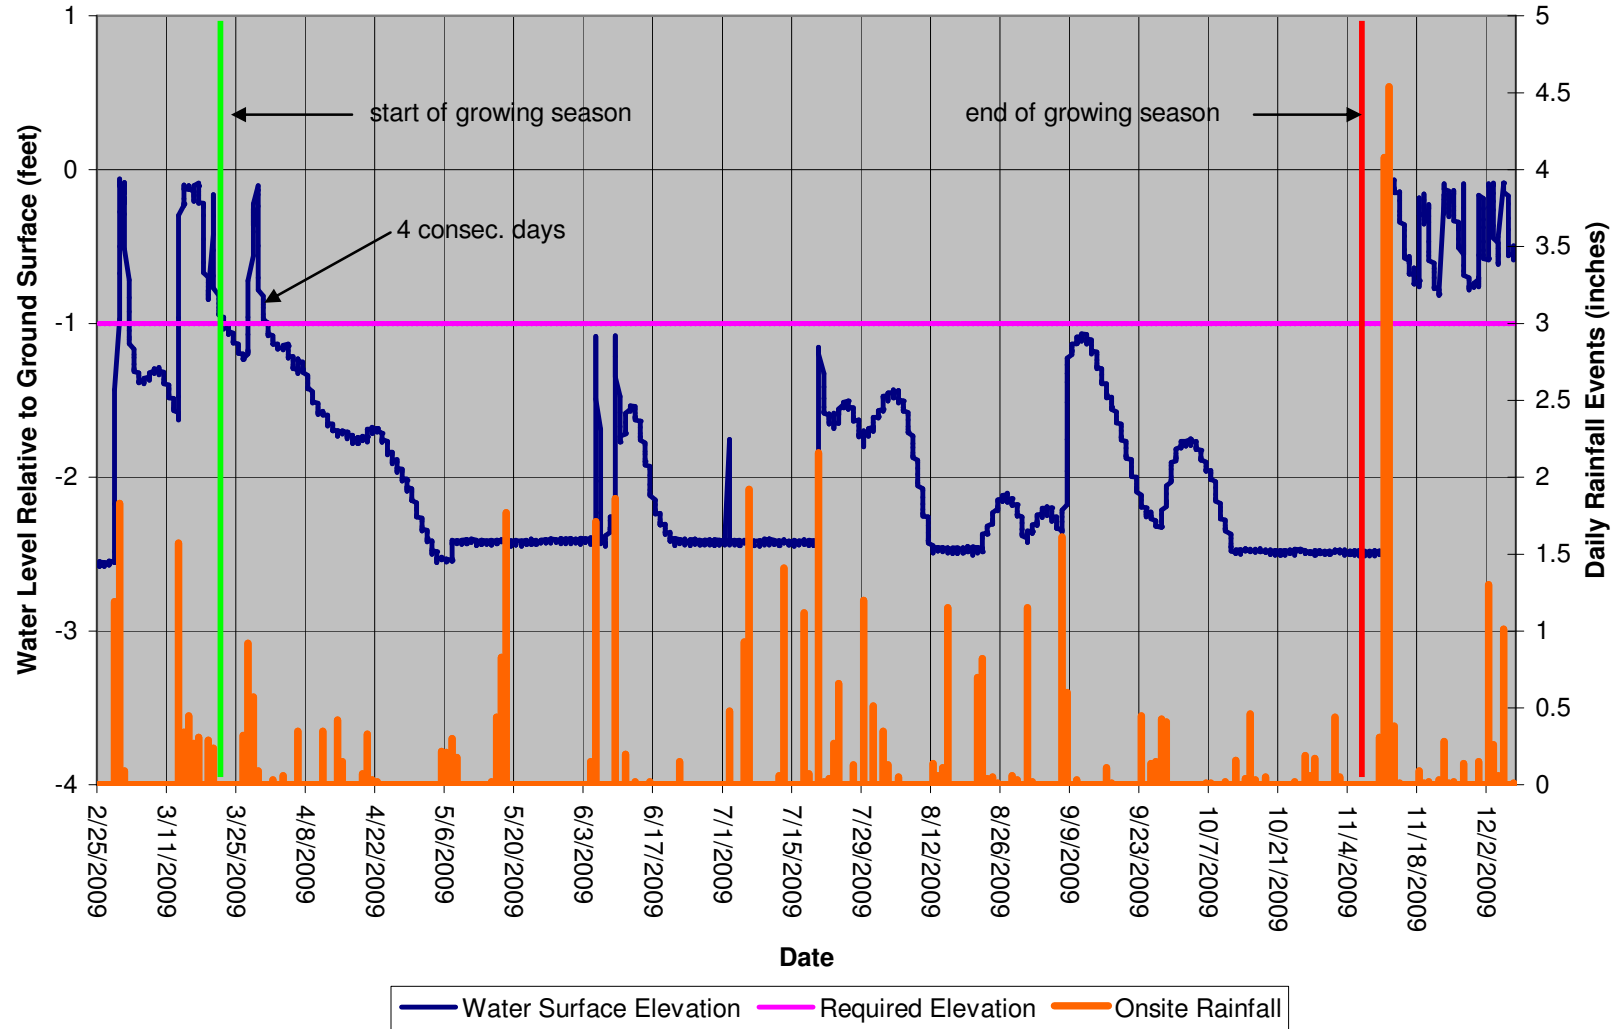
Powell Monitoring Gauge #4 (2238366)

Feature/Issue	Gauge	Probable Cause
Inadequate Hydrology	4, 6 and 7	Under Investigation
