**Prestonwood Golf Course
(Hatchet's Grove)
Stream Restoration Monitoring Report
EEP Project # 289
Monitoring Year – 02
2006**

January 2007

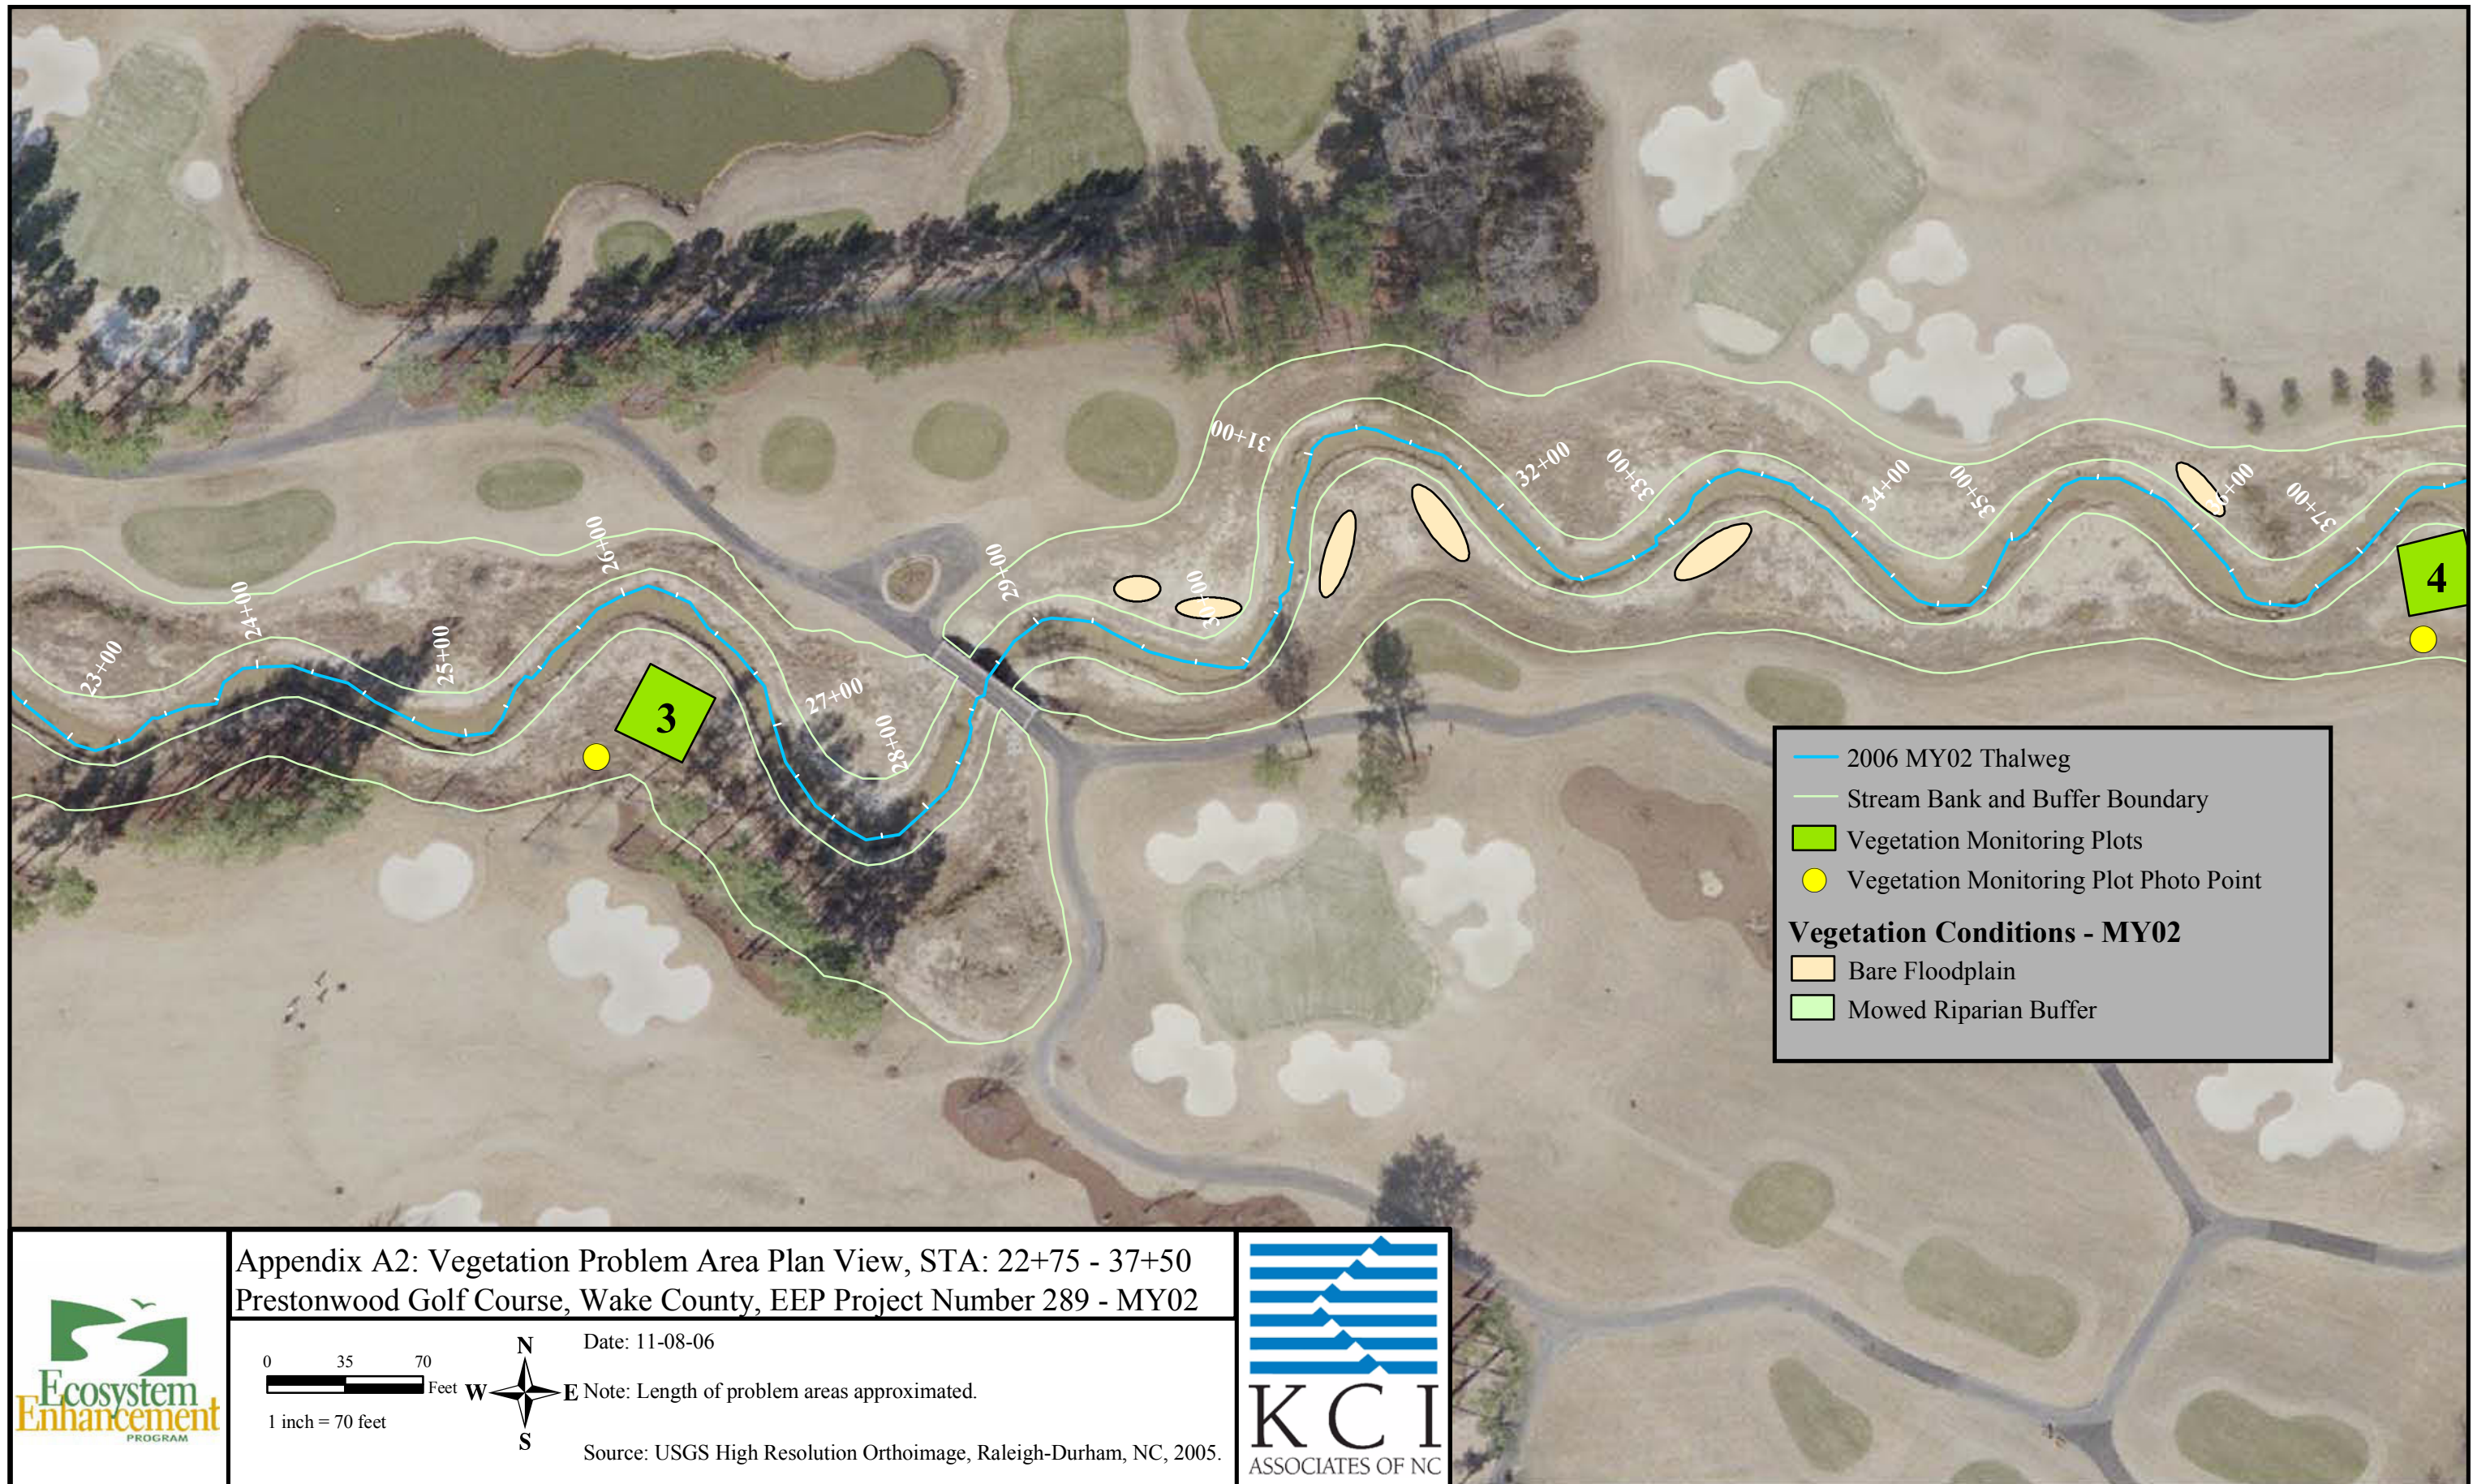
Appendix A2: Vegetation Problem Area Plan View, STA: 22+75 - 37+50
 Prestonwood Golf Course, Wake County, EEP Project Number 289 - MY02

Table A6a. Vegetative Problem Areas			
Project Number and Name: 289 – Prestonwood Golf Course (Hatchet’s Grove)			
Segment/Reach: Hatchet’s Grove (3,828 ft.)			
Feature/Issue	Station # / Range	Probable Cause	Photo #
Bare Floodplain	29+25 – 29+50	Floodplain erosion	VP1
	29+70 – 30+20	Floodplain erosion	
	30+30 – 30+80	Floodplain erosion	
	31+60 – 32+15	Floodplain erosion	
	32+85 – 33+25	Floodplain erosion	
	35+75 – 36+05	Floodplain erosion	
	37+60 – 38+10	Floodplain erosion	
Mowed Riparian Buffer	12+95 – 13+70	Golf course maintenance	VP2

It should be noted that the areas called out in App B2, the Stream Problem Area Table, as bank scour are raw banks and therefore devoid of vegetation. This can be seen in the representative photos for those problem areas.

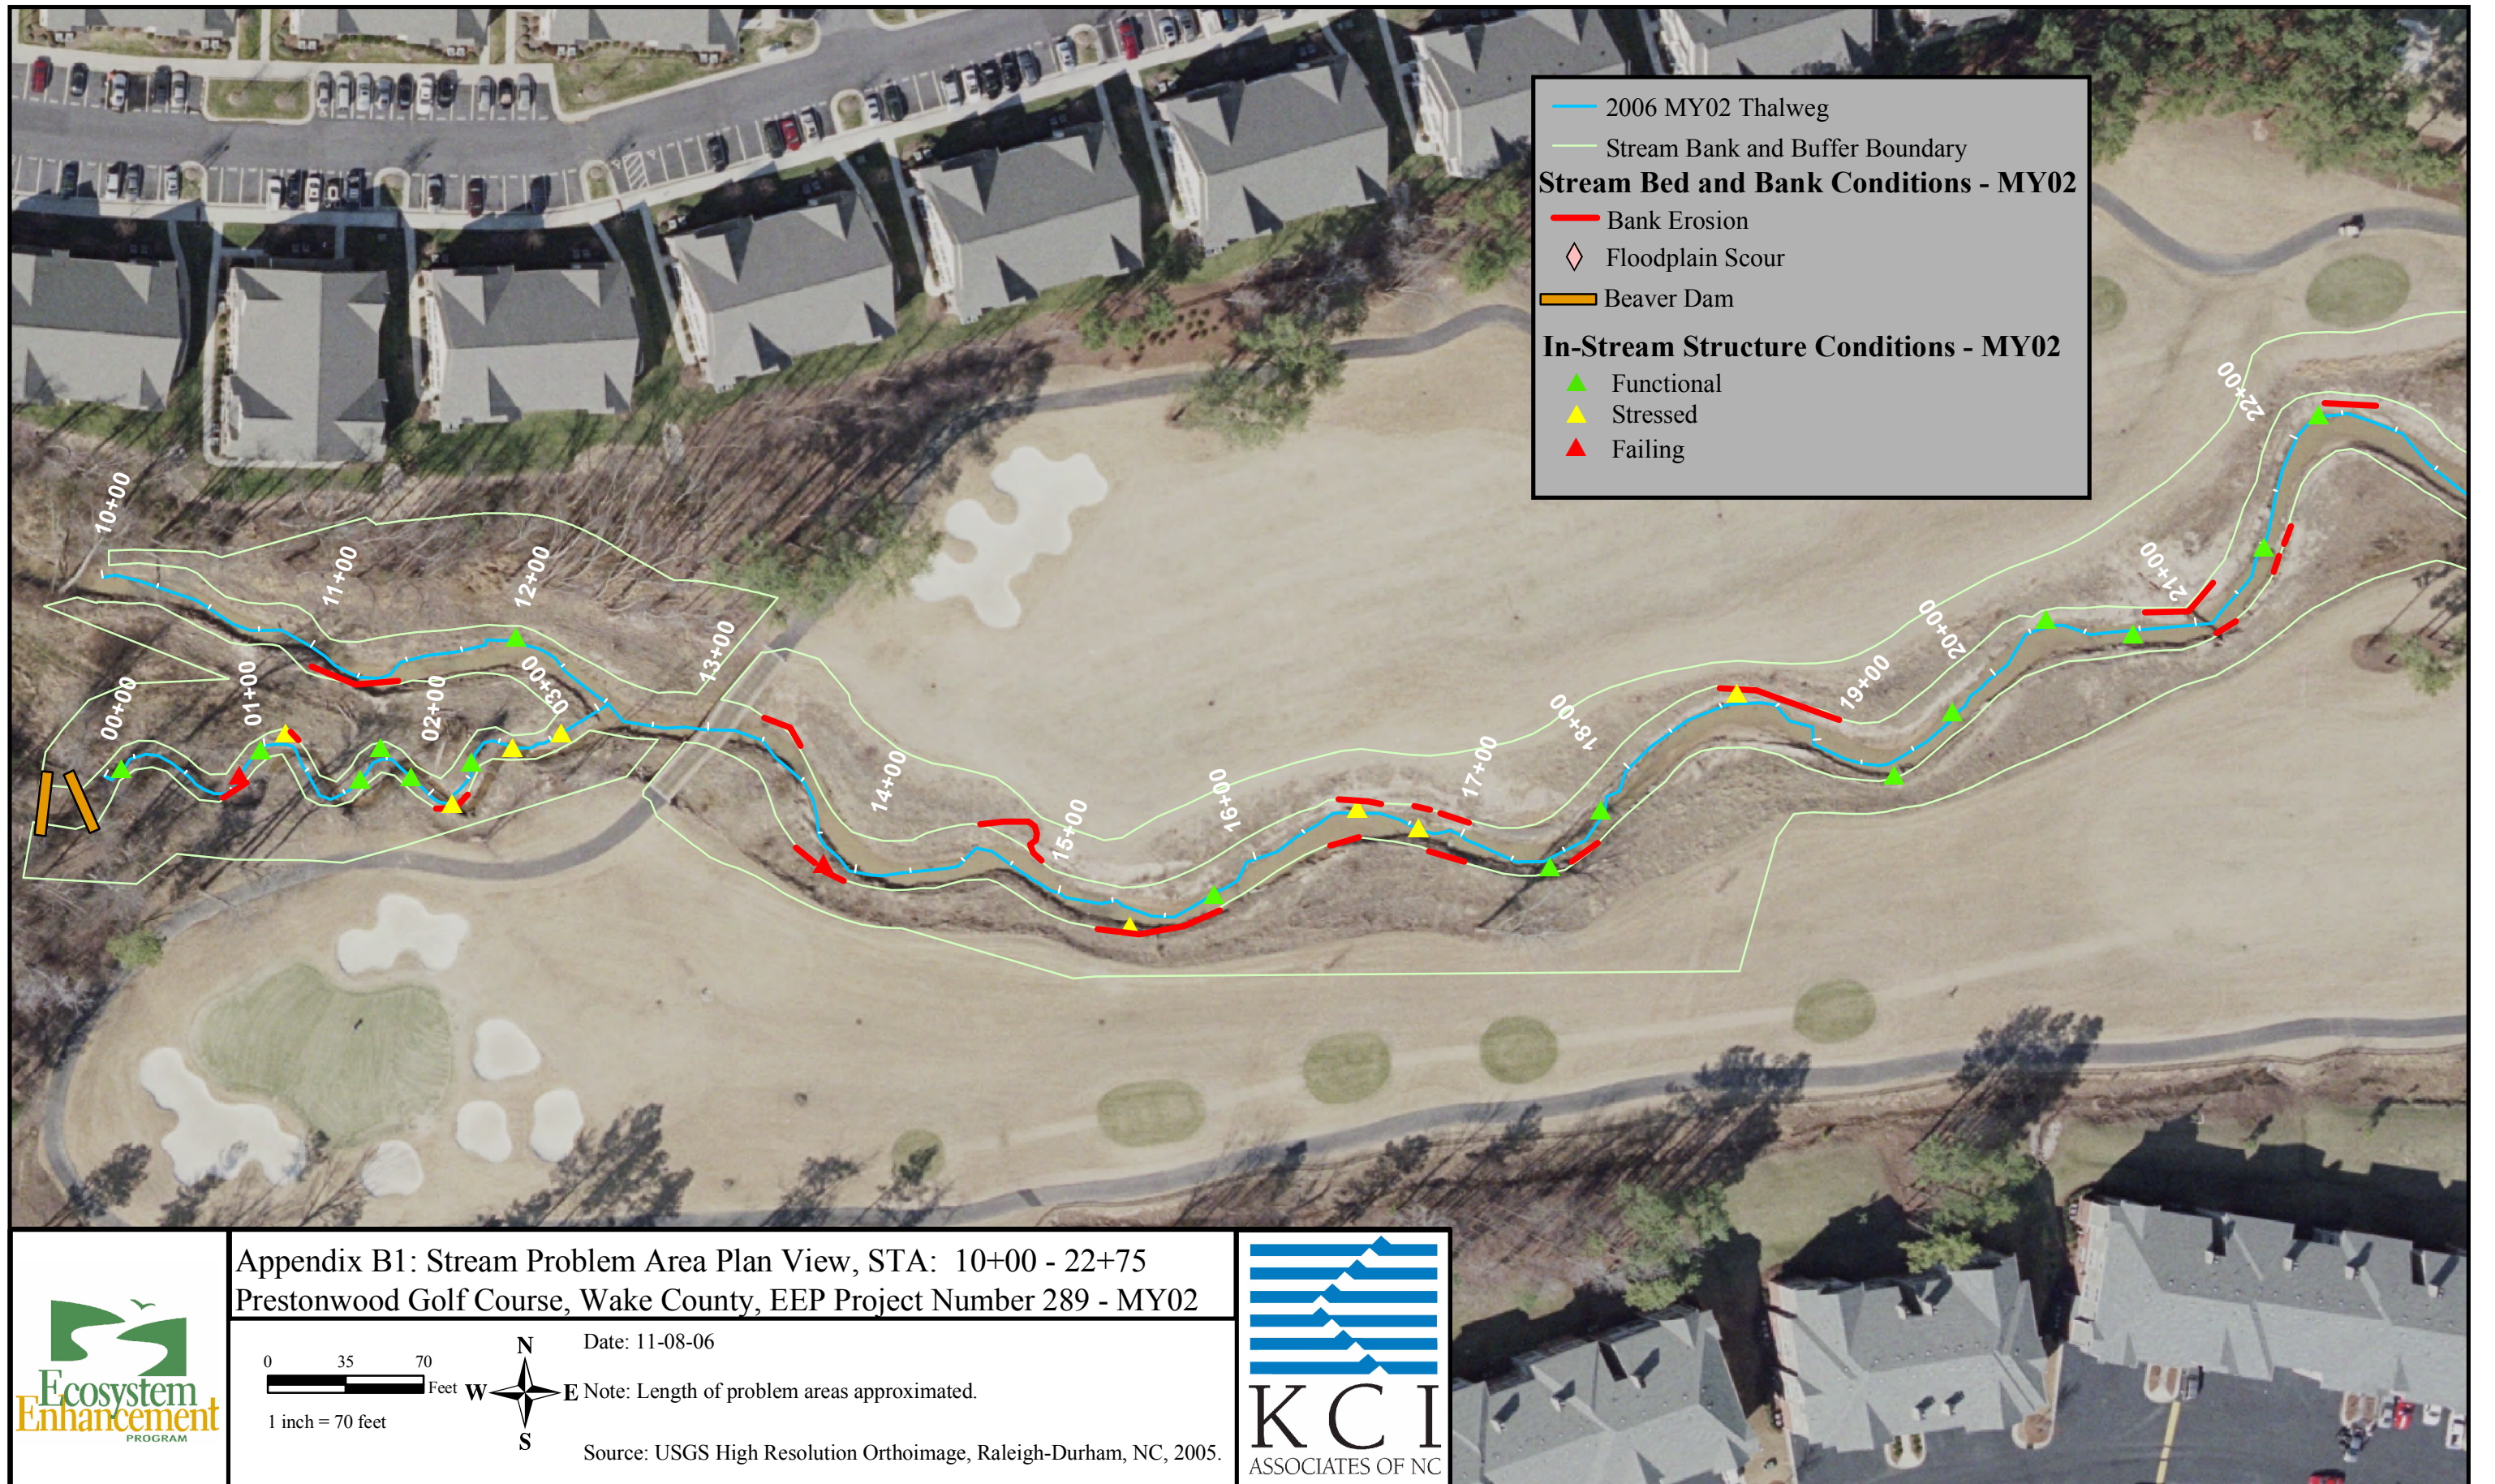
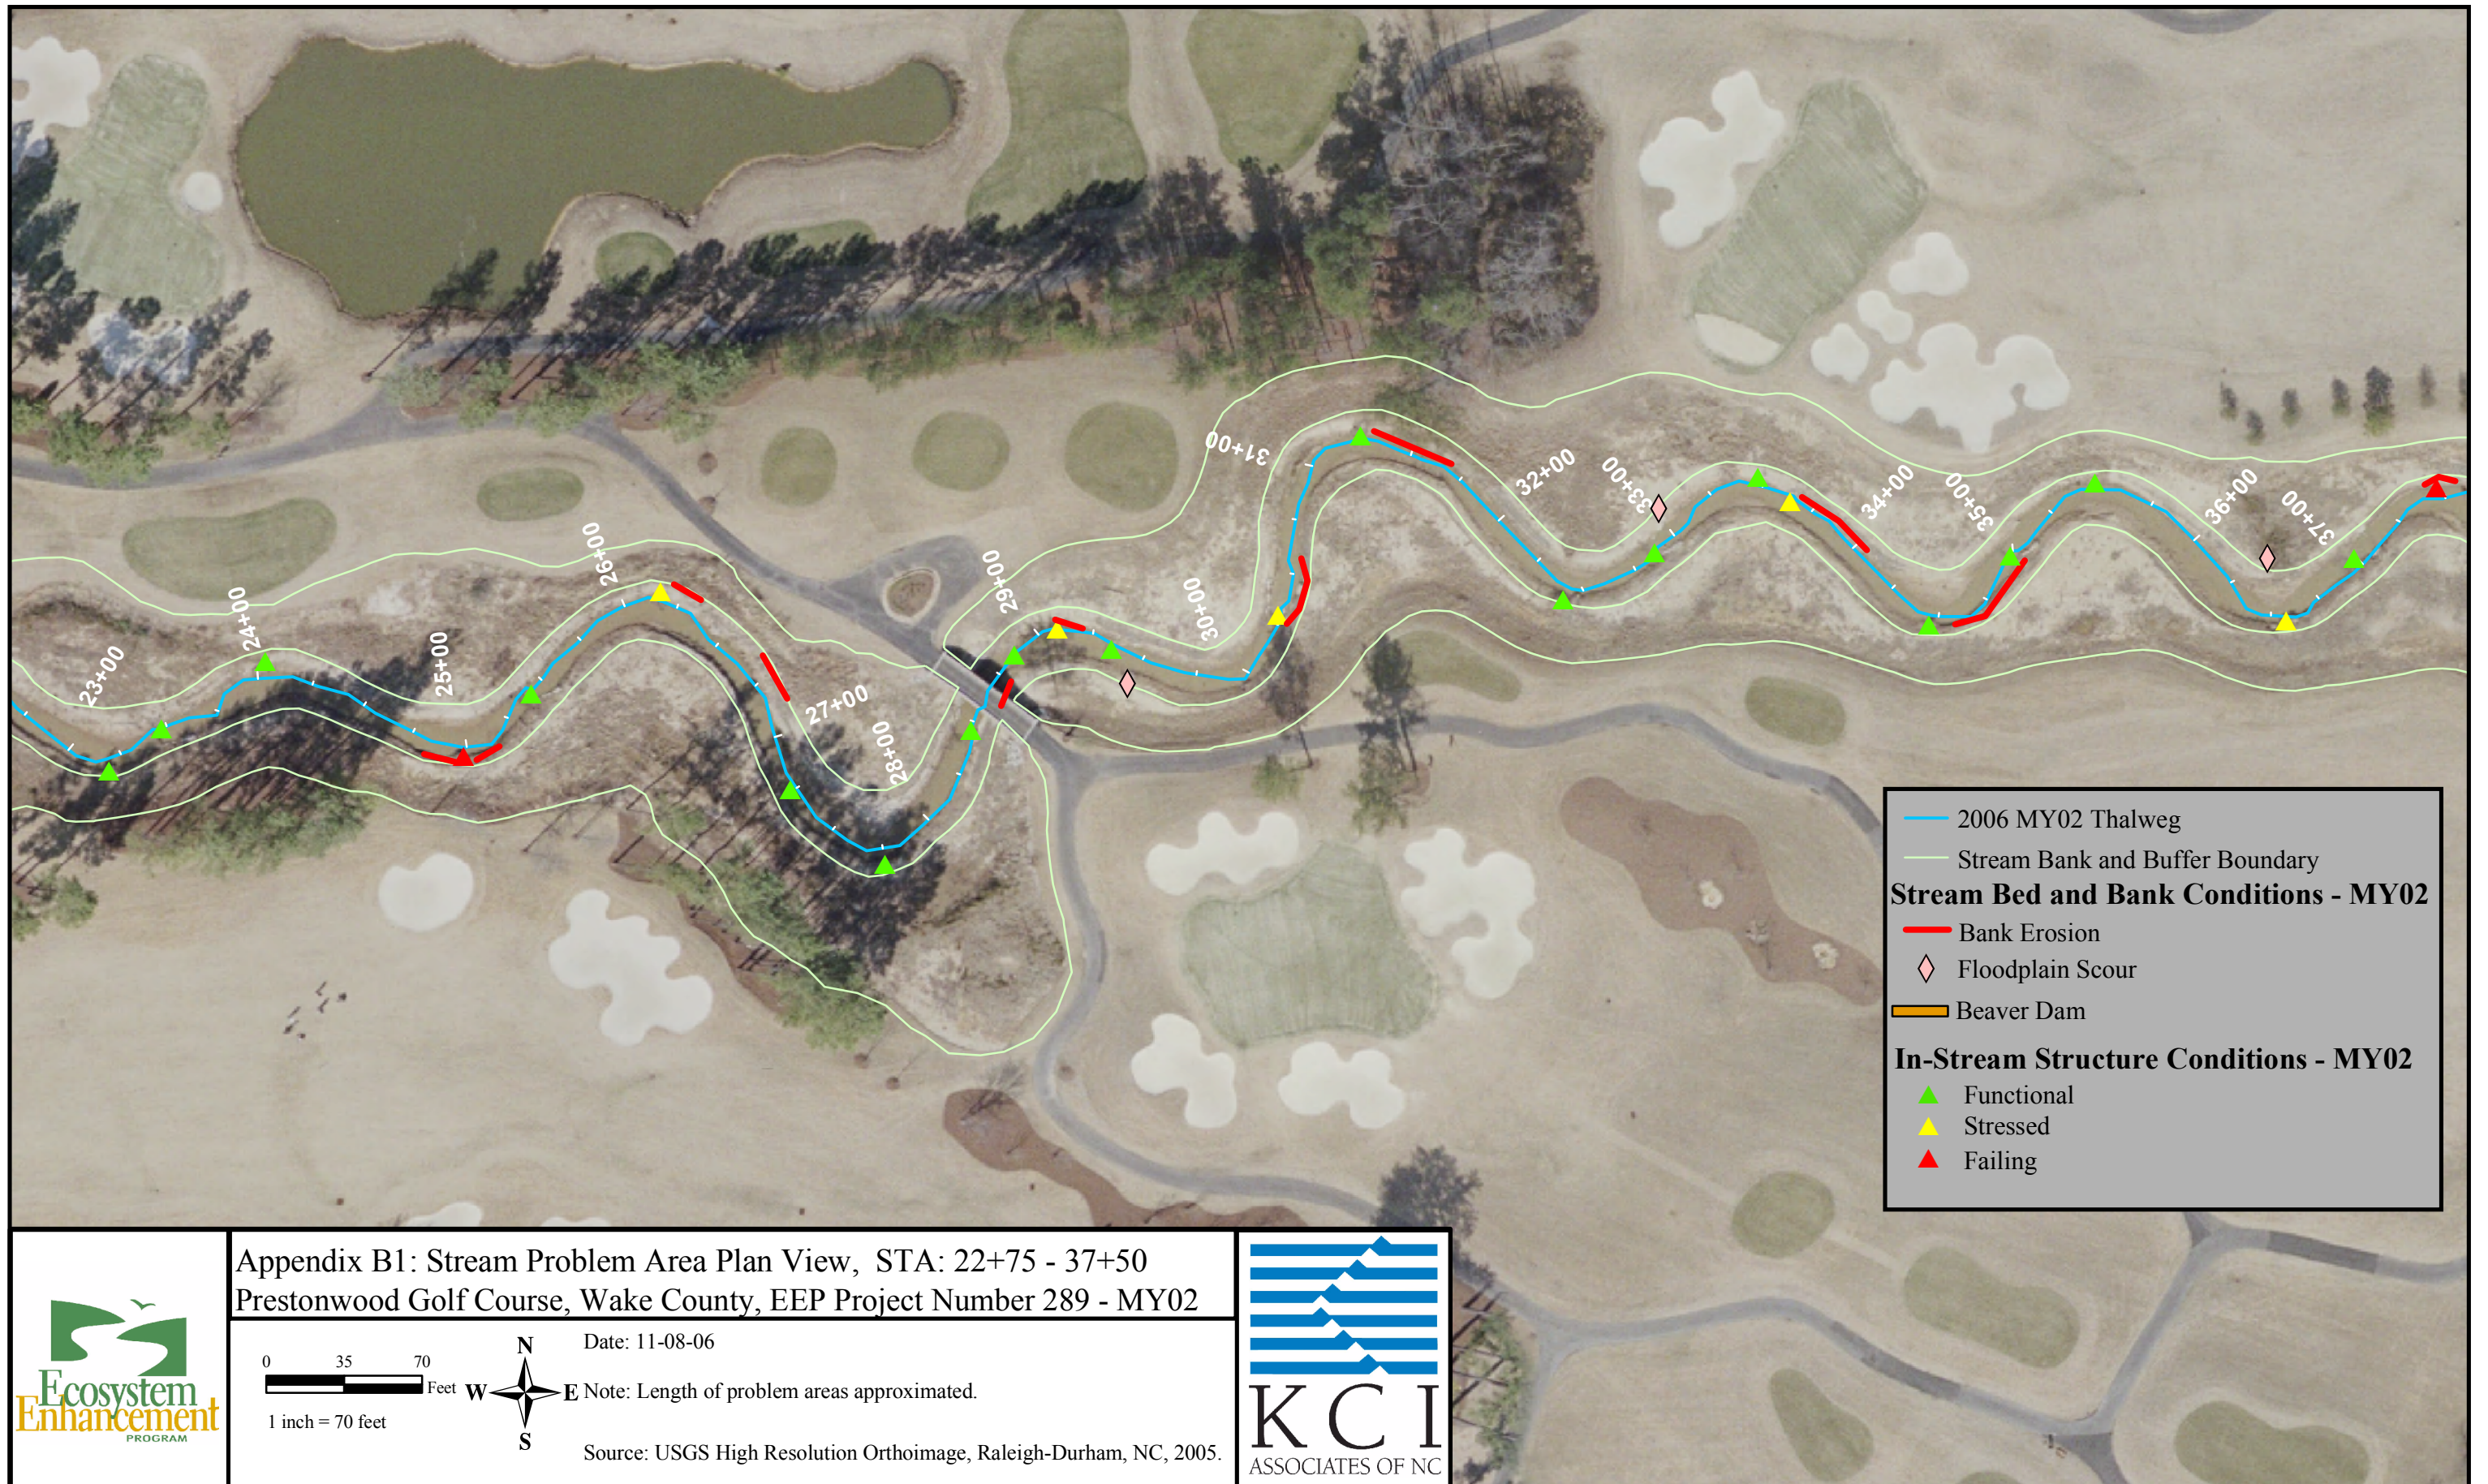
Appendix B1: Stream Problem Area Plan View, STA: 22+75 - 37+50
 Prestonwood Golf Course, Wake County, EEP Project Number 289 - MY02

Table B1a. Stream Problem Areas			
Project Number and Name: 289 – Prestonwood Golf Course (Hatchet's Grove)			
Segment/Reach: Hatchet's Grove (3,828 ft.)			
Feature Issue	Station numbers	Suspected Cause	Photo #
Bank Erosion	11+05 – 11+45	unknown	SP1
	13+20 – 13+40	unknown	
	13+70 – 14+00	unknown	
	14+50 – 14+90	unknown	SP2
	15+25 – 15+75	unknown	SP1
	16+40 – 16+65	unknown	
	16+75 – 17+05	unknown	
	17+50 – 17+70	unknown	
	18+50 – 19+00	unknown	
	20+75 – 21+25	unknown	
	21+40 – 21+60	unknown	
	22+20 – 22+40	unknown	
	24+75 – 25+15	unknown	
	26+20 – 26+35	unknown	
	26+60 – 26+90	unknown	
	28+60 – 28+75	unknown	
	29+05 – 29+20	unknown	
	30+25 – 30+60	unknown	
	31+25 – 31+70	unknown	
	33+70 – 34+05	unknown	
	34+60 – 35+00	unknown	
	37+40 – 37+55	unknown	
	39+30 – 39+70	unknown	
	40+45 – 40+65	unknown	
41+30 – 41+70	unknown		
42+50 – 43+05	unknown		
43+25 – 43+60	unknown		
44+00 – 44+25	unknown		
45+80 – 46+00	unknown		
47+15 – 47+35	unknown

The primary problem facing the Hatchet's Grove stream are extended areas of severe bank erosion. While the specific cause of the bank erosion is unknown, the radius of curvature applied to many of the meanders appears to be too small for this suburban watershed, causing instability throughout the meanders. These eroded banks should be closely monitored to determine if corrective actions are warranted. Floodplain conditions along the stream varied in terms of erosion and deposition. Between stations 10+00 and 28+00 the floodplain shows signs of aggradation as sand has been deposited on the floodplain during high flow events, see SP5. From station 28+00 to 39+00, the floodplain has eroded creating the bare areas shown in Appendix A2 and areas of floodplain scour as listed above. Most of the floodplain scour appears to have occurred immediately following construction, before vegetation stabilized the floodplain surface. These areas were reevaluated during the second year monitoring and they appear to be stabilizing as vegetation cover becomes more prominent. The lower third of the stream appears to have a stable floodplain. No significant aggradation or degradation was noted during the second monitoring year.
