**Prestonwood Golf Course  
(Hatchet's Grove)  
Stream Restoration Monitoring Report  
EEP Project # 289  
Monitoring Year – 03  
2007**

**February 2008**

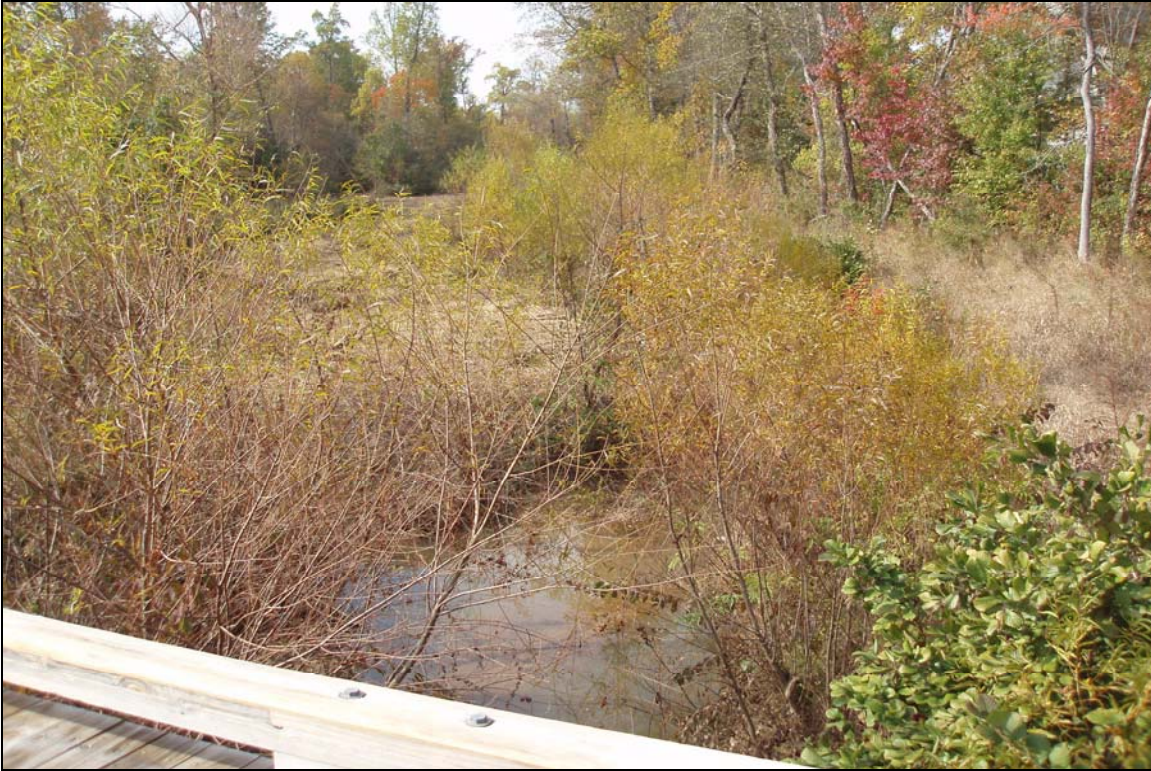
Photo Point 1 – Taken looking upstream from golf cart bridge at the upper 300 feet of the Hatchet’s Grove.  
11/13/07 - MY 03

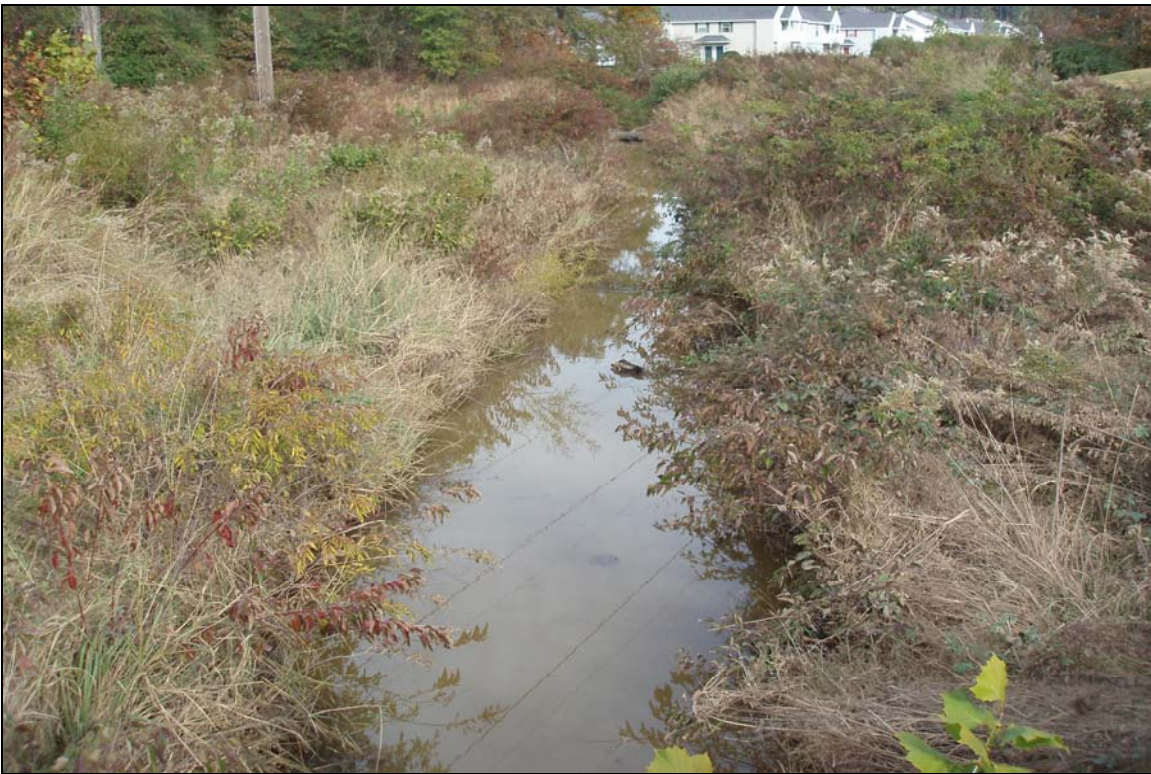
Photo Point 2 – Taken looking downstream from golf cart bridge at the lower 300 feet of the Hatchet’s Grove.  
11/13/07 - MY 03

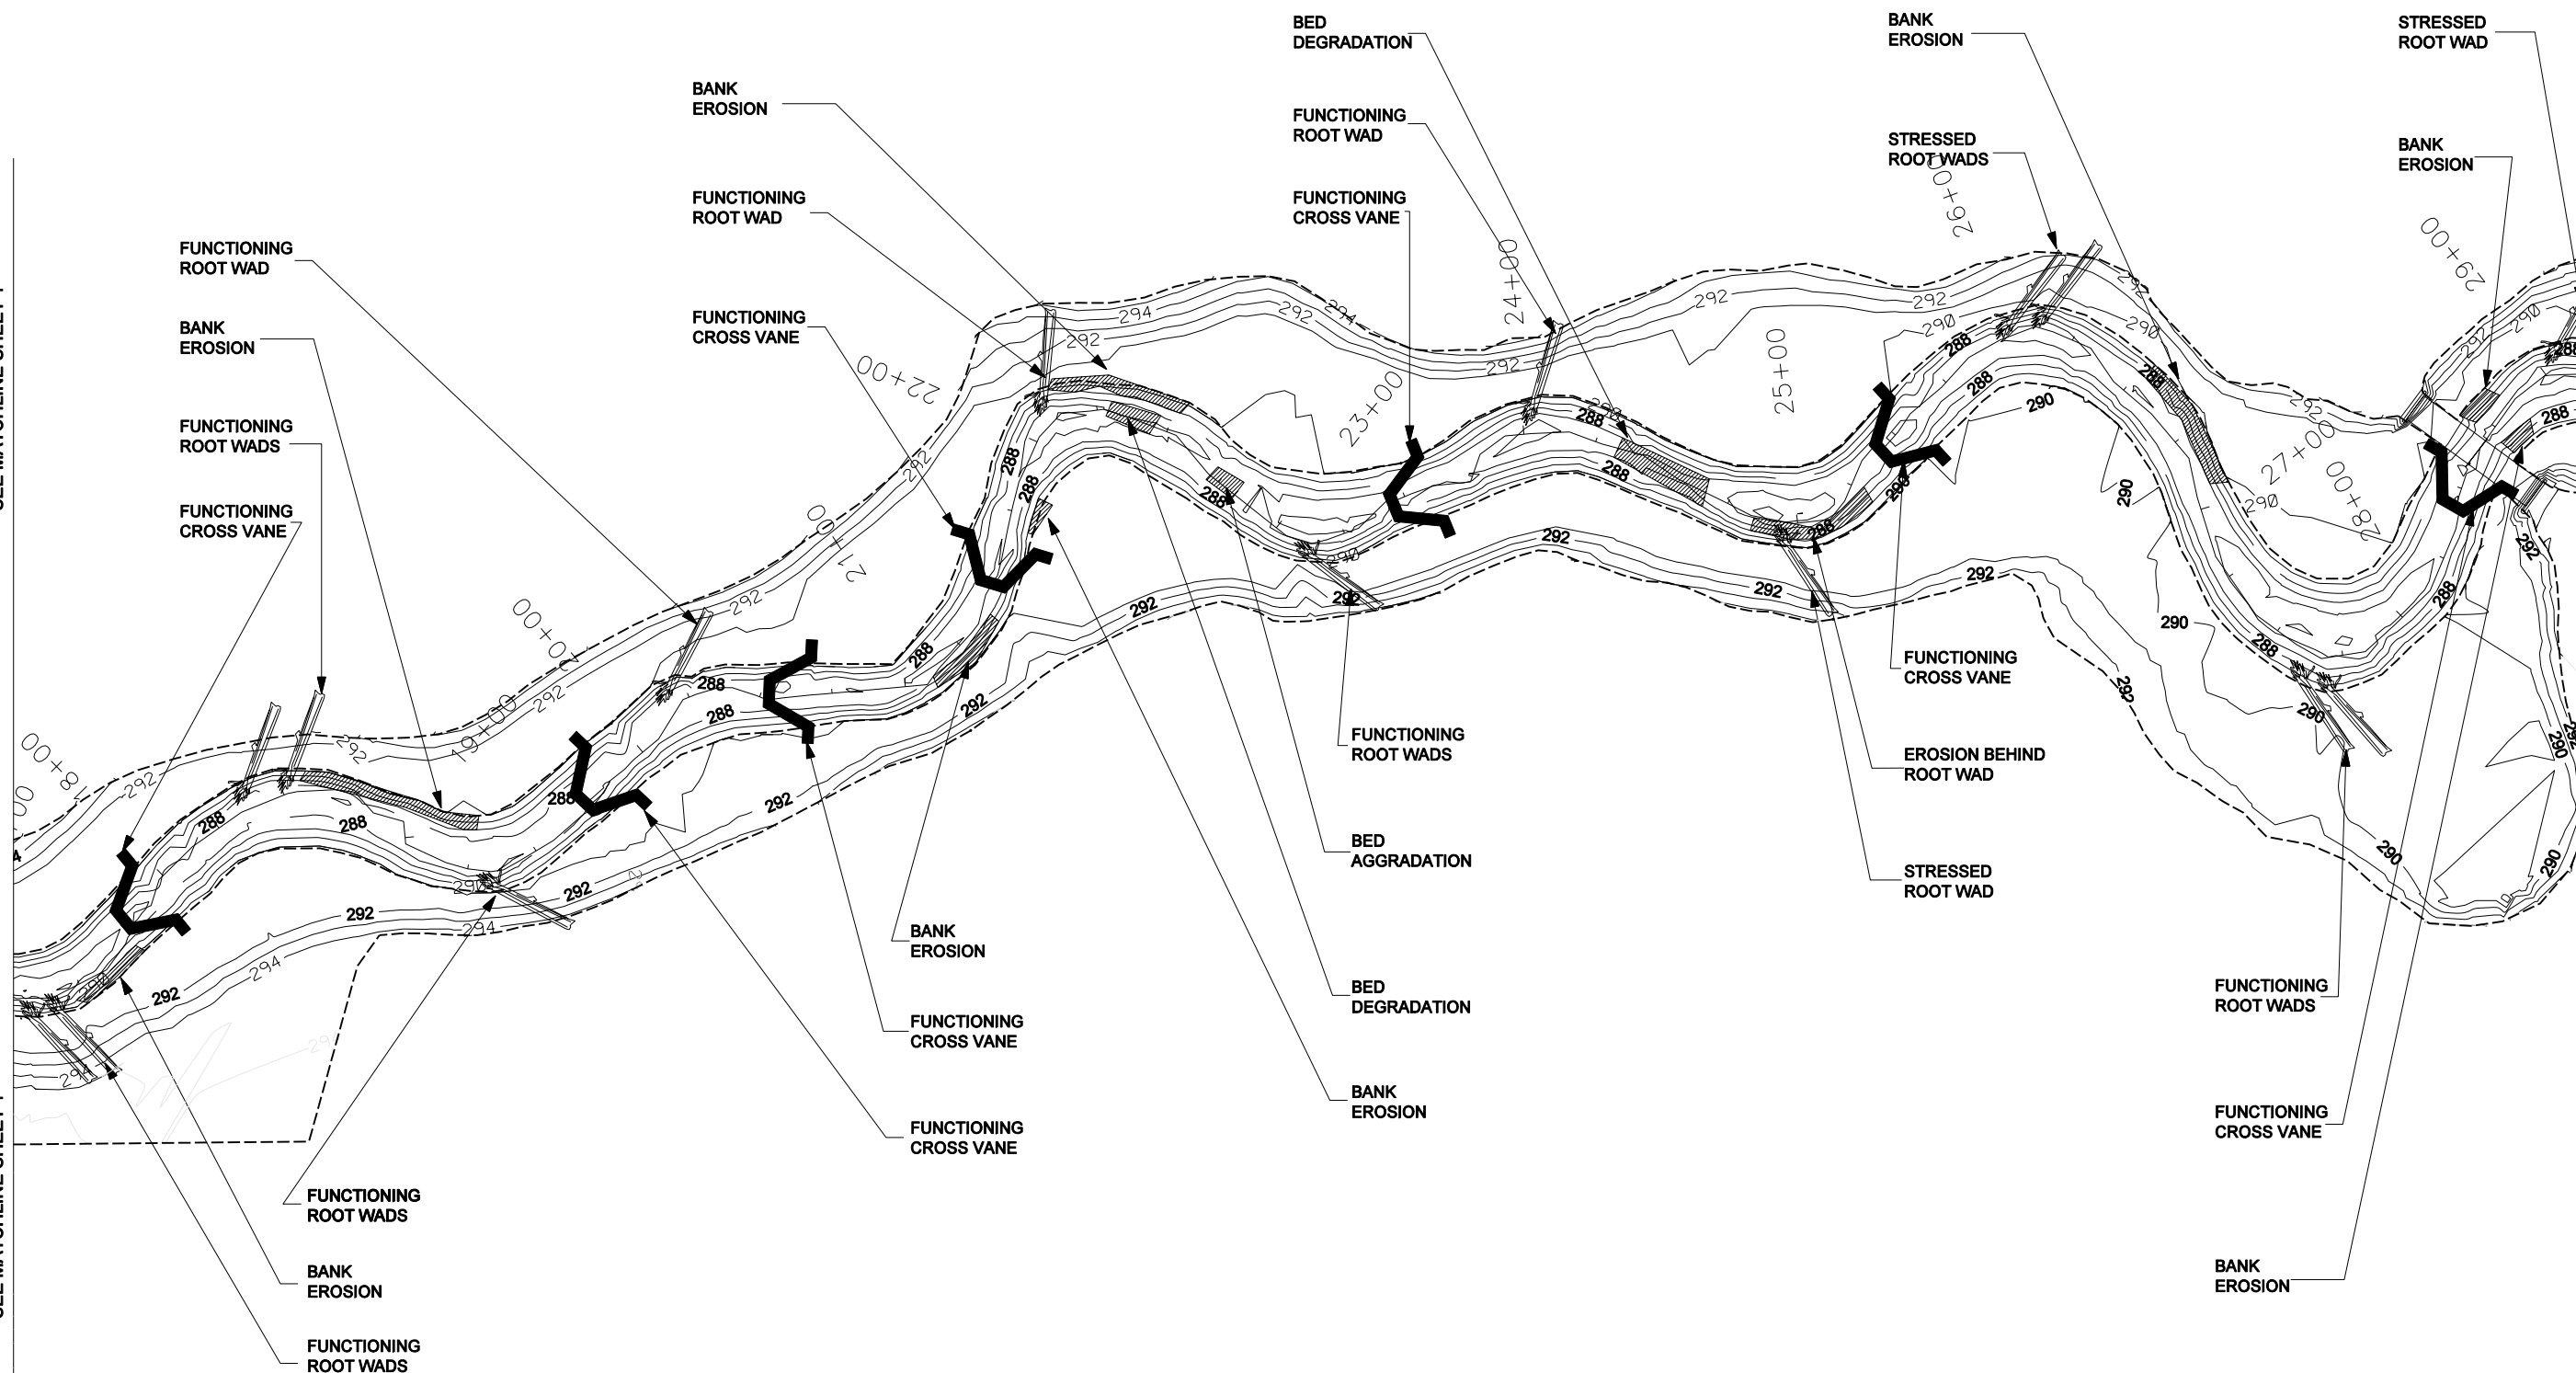
DATE: NOVEMBER 2007  
 SCALE: SEE SHEET  
**CURRENT CONDITIONS PLAN VIEW**  
 SHEET 2 OF 4

BANK  
 EROSION  
 FAILING  
 WOOD SILL  
 FUNCTIONING  
 WOOD SILL  
 FUNCTIONING  
 ROOT WAD

BED  
 DEGRADATION  
 STRESSED  
 WOOD SILL  
 BED  
 DEGRADATION  
 FUNCTIONING  
 WOOD SILL  
 BANK  
 EROSION

BED  
 DEGRADATION  
 BANK  
 EROSION  
 FUNCTIONING  
 ROOT WADS
