**Prestonwood Golf Course
(Hatchet's Grove)
Stream Restoration Monitoring Report
EEP Project # 289
Monitoring Year – 04
2008**

March 2009

In 2004, the North Carolina Ecosystem Enhancement Program (EEP) conducted restoration of Hatchet's Grove Tributary and a tributary to Hatchet's Grove (Meadow Creek). Soil and Environmental Consultants, PA (S&EC) designed the restoration. The watershed of approximately 3.7 square miles is located within the USGS 14-digit HUC 03020201080010 and the NCDWQ Sub-basin 03-04-02 of the Neuse River Basin. The project restored approximately 4,123 linear feet of channel, 3,828 feet on Hatchet's Grove and 295 feet on Meadow Creek through the Prestonwood Golf Course in Cary, North Carolina. The restoration was designed to correct problems within the existing stream corridor from channelization and poor vegetation maintenance practices. Construction was completed in 2004, and the first through third years of monitoring took place from 2005 through 2007. This report describes the findings of the fourth year of monitoring that took place in 2008.

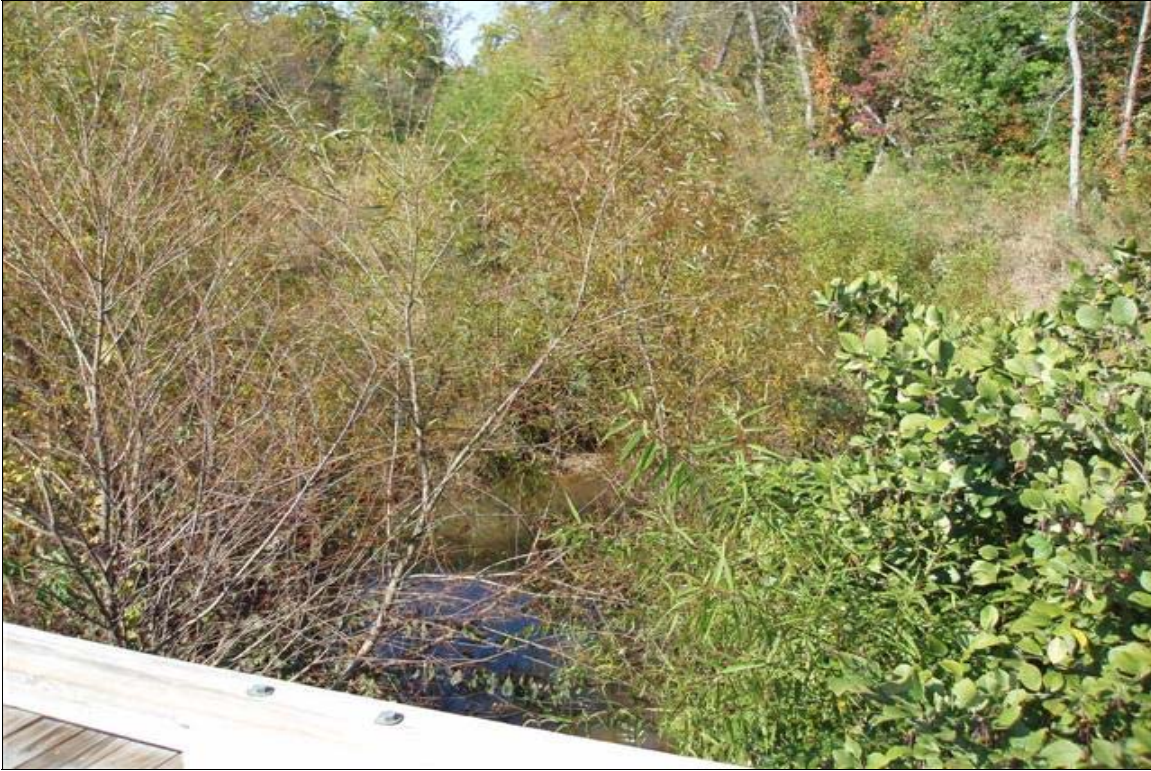
Photo Point 1 – Taken looking upstream from golf cart bridge at the upper 300 feet of the Hatchet’s Grove.
10/27/08 - MY 04.

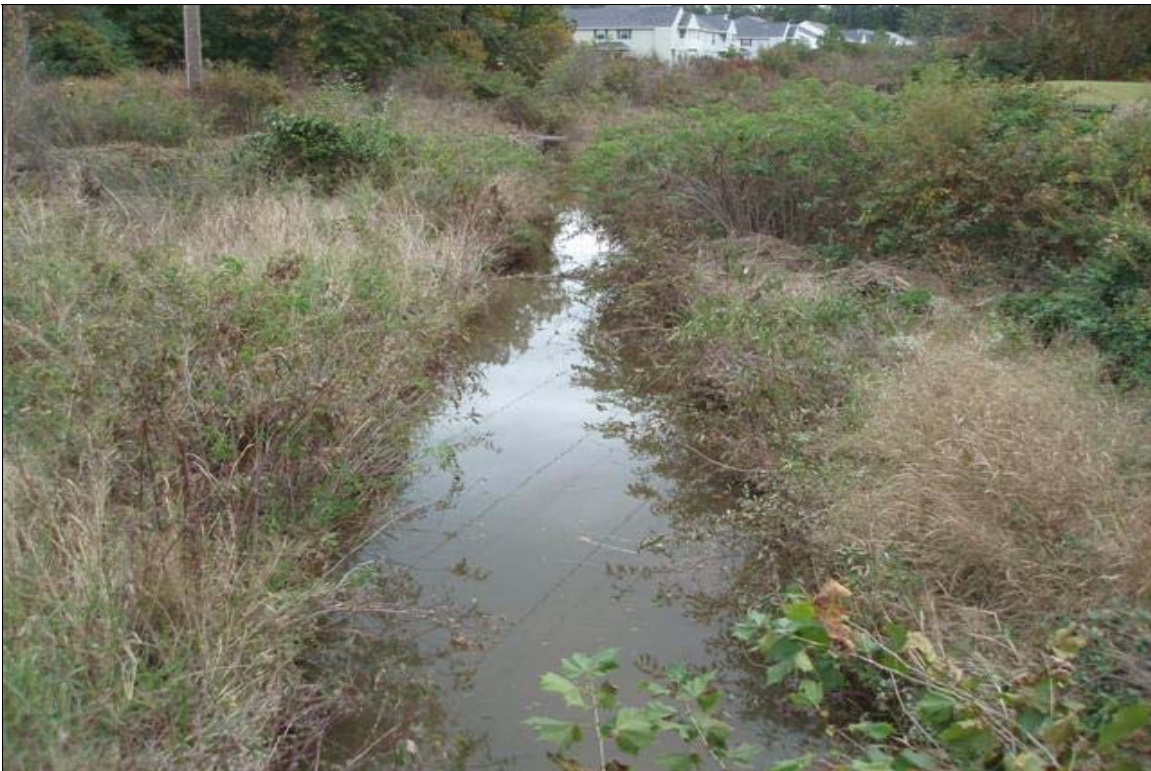
Photo Point 2 – Taken looking downstream from golf cart bridge at the lower 300 feet of the Hatchet’s Grove.
10/27/08 - MY 04.

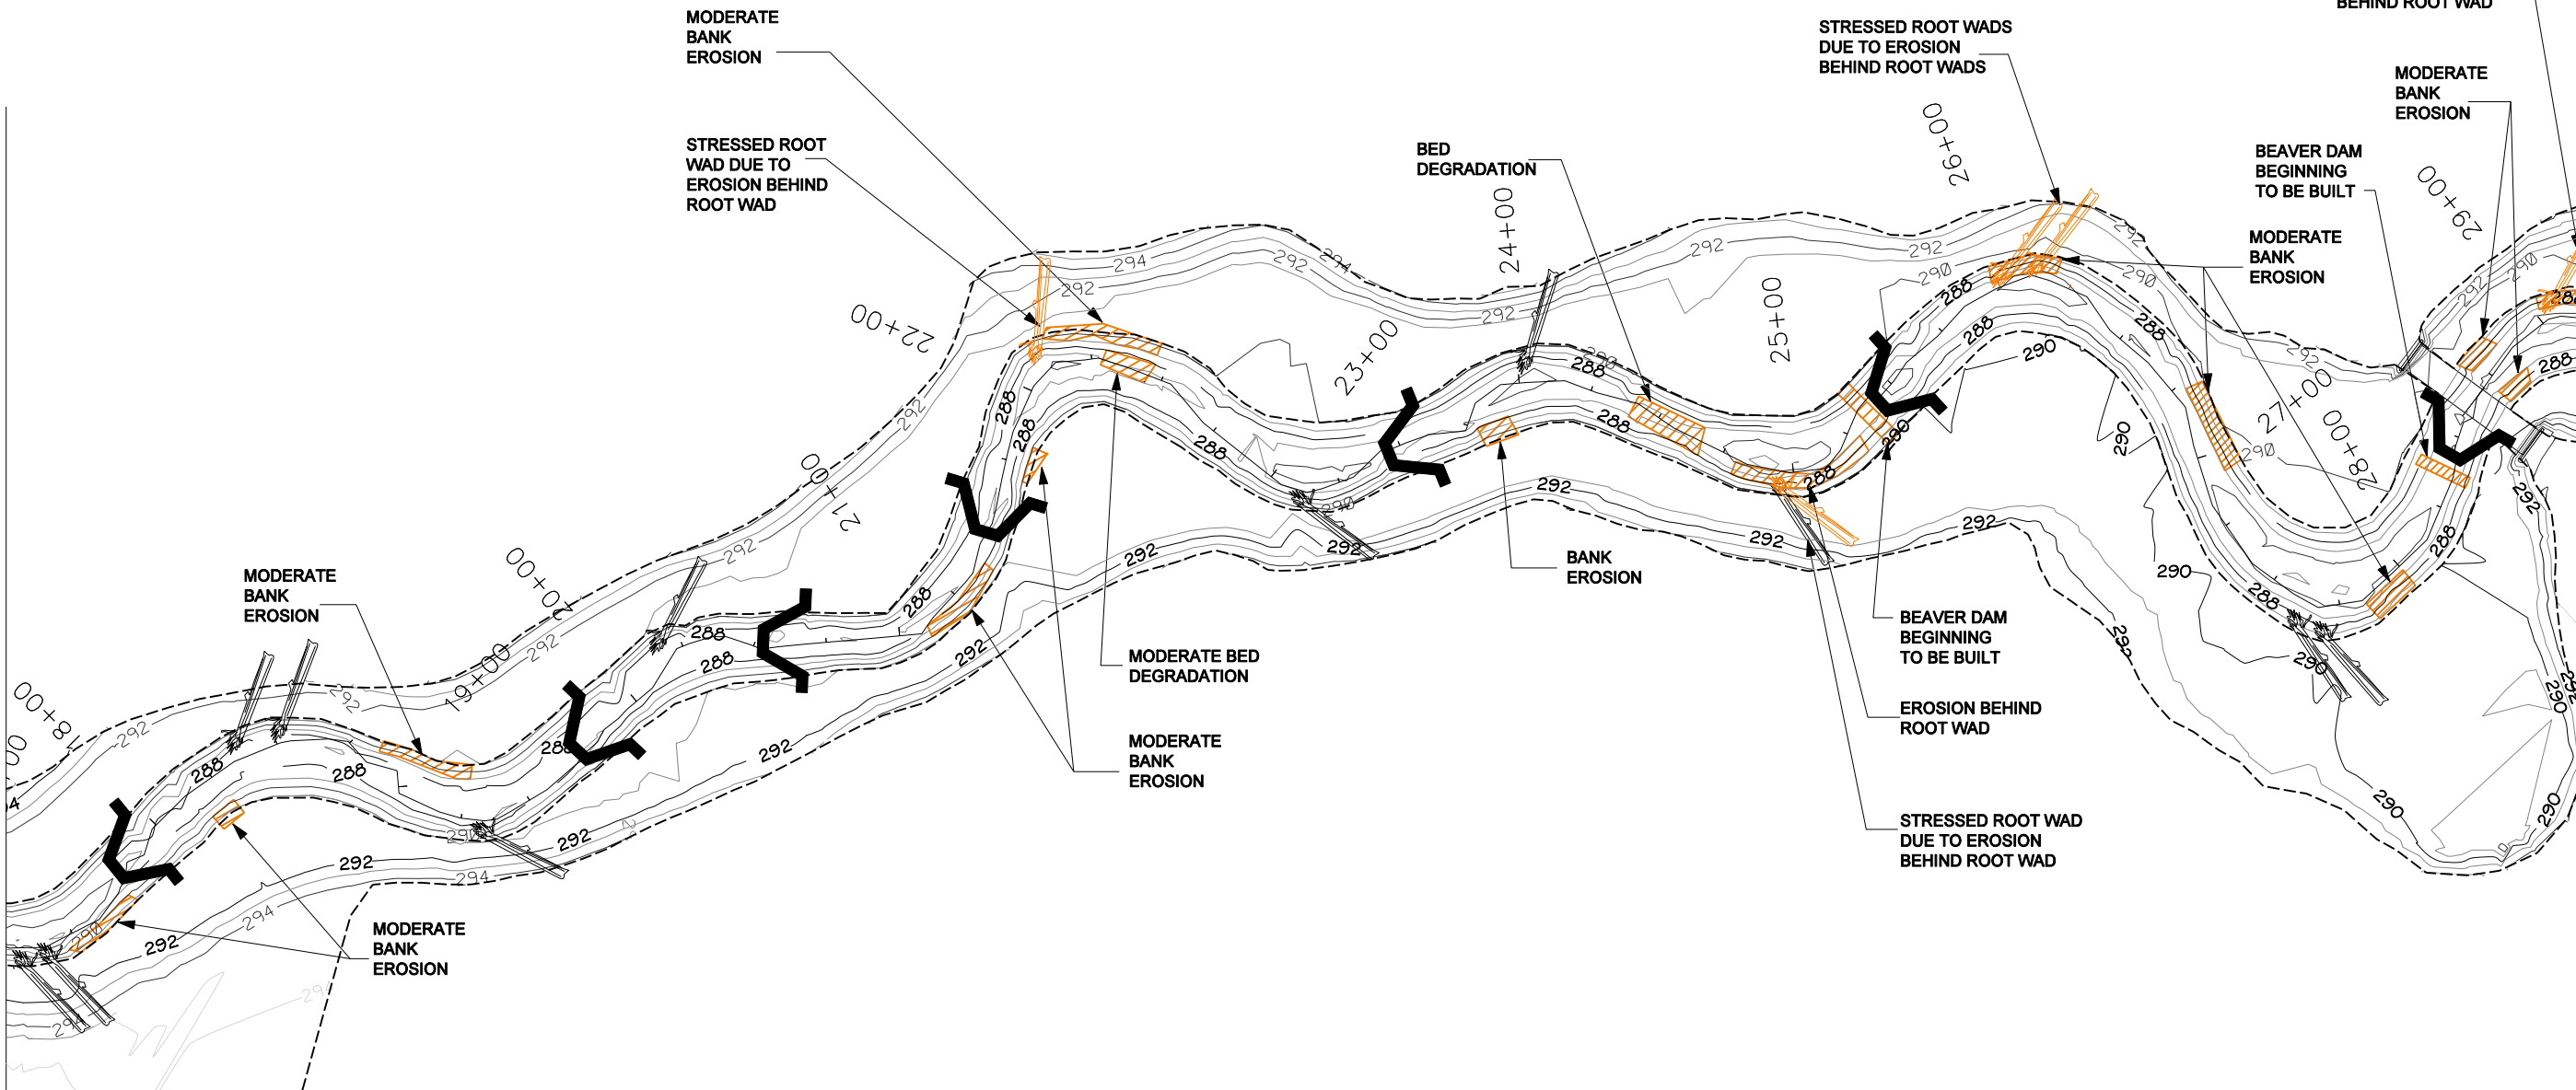
CURRENT CONDITIONS PLAN VIEW

STRESSED STONE SILL DUE TO BED DEGRADATION UP AND DOWNSTREAM OF SILL

MODERATE BED DEGRADATION

FAILED WOOD SILL DUE TO UNDERCUT BED

FAILED ROOT WAD DUE TO EROSION BEHIND ROOT WAD

STRESSED ROCK SILL DUE TO BED DEGRADATION UP AND DOWNSTREAM

FAILED ROOT WADS DUE TO EROSION BEHIND ROOT WADS
