# **YEAR ONE MONITORING REPORT**

## **Jefferson Pilot Stream Restoration Guilford County, North Carolina**

**N.C. Wetlands Restoration Program**  
\_\_\_\_\_NCDENR\_DWQ

**January 2003**

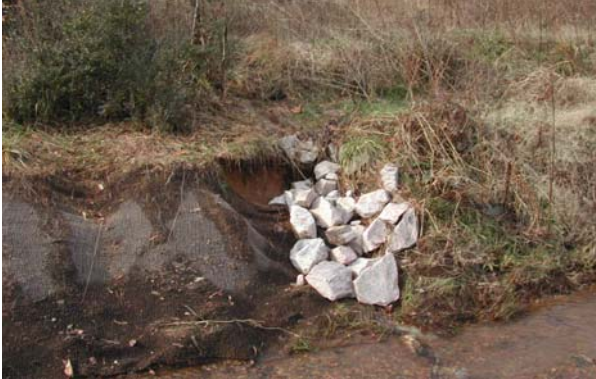
Problem: (Station 7+50-Left Bank) Erosion from overland flow and deer crossing

- a. Remove the existing blanket.
- b. Re-grade the area.
- c. Hydro seed with seed, fertilizer and mulch.
- d. Place Erosion Control Blanket rated for steeper slopes and medium to high flow.
- e. Increase the woody and herbaceous vegetation both upslope and on the banks to promote stability through vegetation.

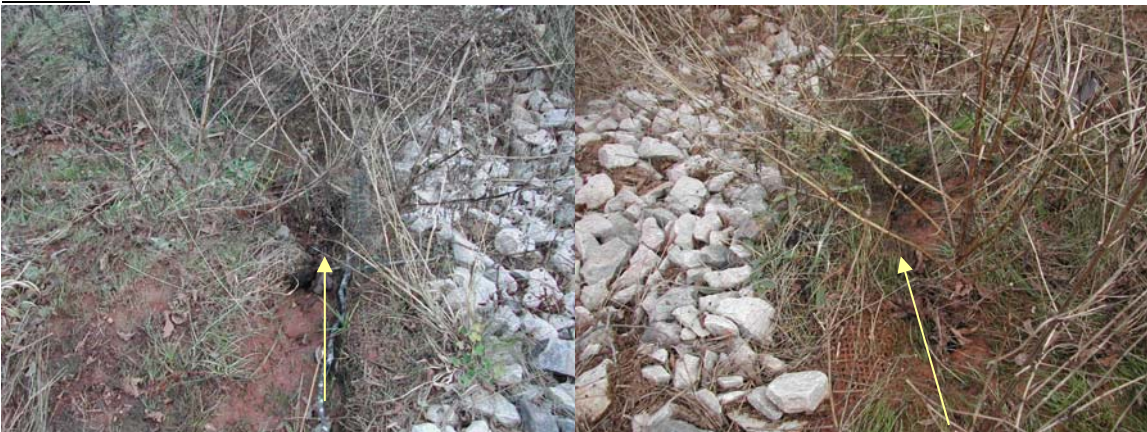
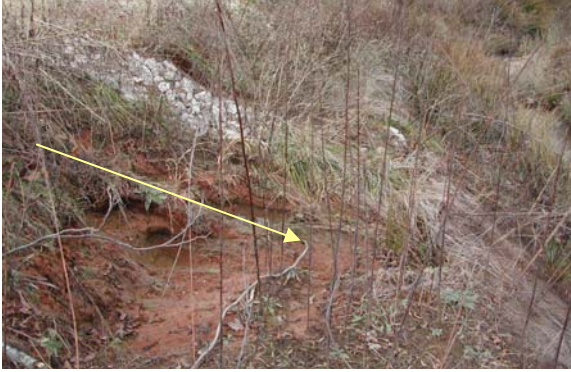
Problem: (Station 13+80-Right Bank) Erosion from overland flow

- a. Remove the existing blanket.
- b. Re-grade the area.
- c. Hydro seed with seed, fertilizer and mulch.
- d. Place Erosion Control Blanket rated for steeper slopes and medium to high flow.
- e. Increase the woody and herbaceous vegetation both upslope and on the banks to promote stability through vegetation.

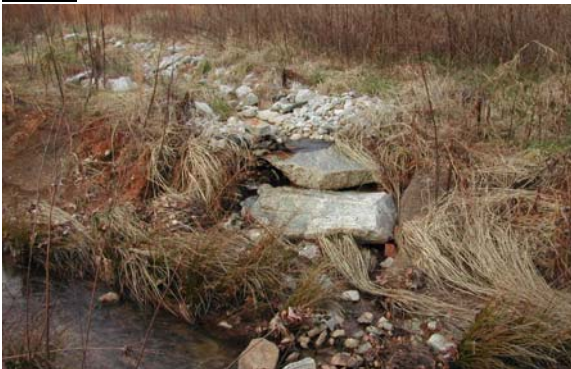
Problem: (Station 14+40-Right Bank) Overland flow has eroded behind rootwad rock and coir.

- a. Remove the boulder and existing blanket.
- b. Re-grade the area.
- c. Hydro seed with seed, fertilizer and mulch.
- d. Place Erosion Control Blanket rated for steeper slopes and medium to high flow.
- e. Increase the woody and herbaceous vegetation both upslope and on the banks to promote stability through vegetation.
- f. Replace the boulder on top of the Erosion Control Blanket.

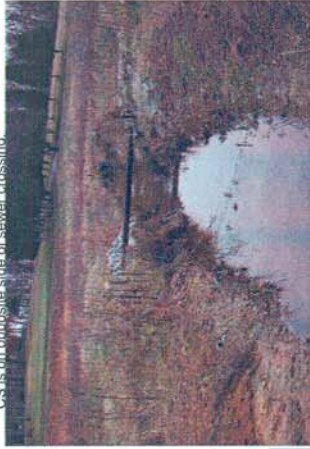
Riffle (CS#4) looking in the upstream direction. CS is on opposite side of sewer crossing.

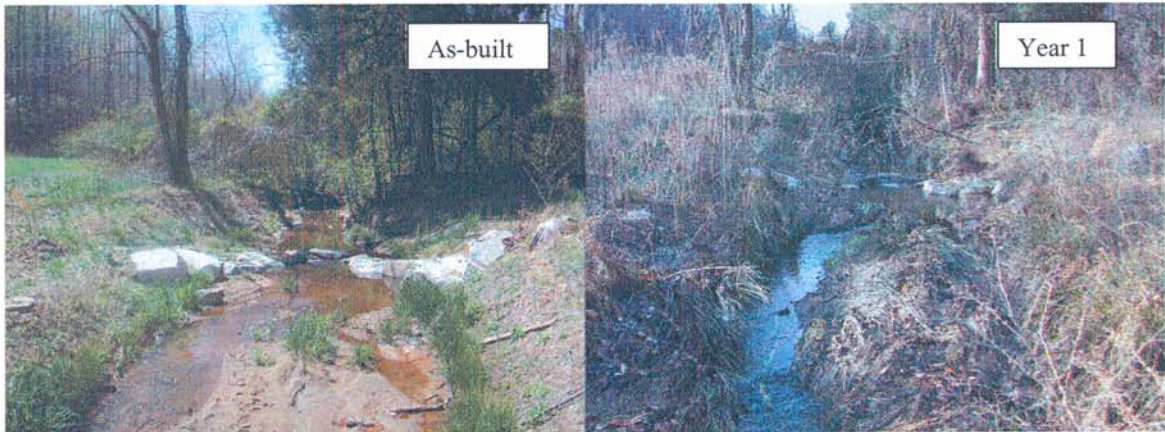
M1-US: Meander 1, looking in the upstream direction. Fenceline represents the beginning of the project and longitudinal profile. Note bar formation and vegetation establishment in this region.

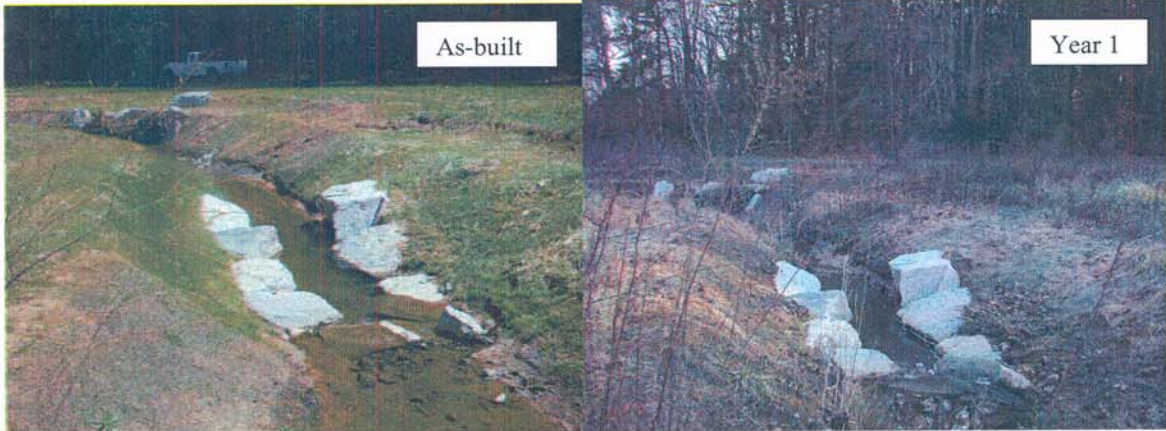
M3-DS: View from Meander 3 looking downstream towards a cross vane that was installed after the main construction period due to concerns with the grade downstream.

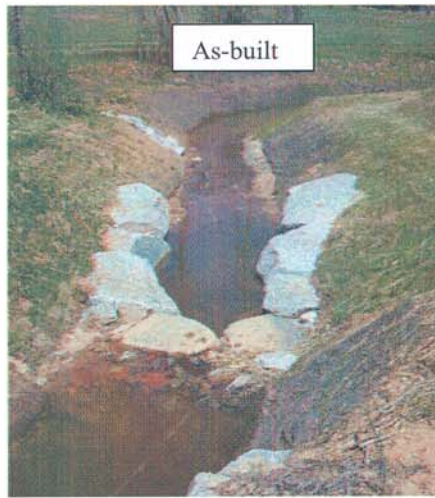
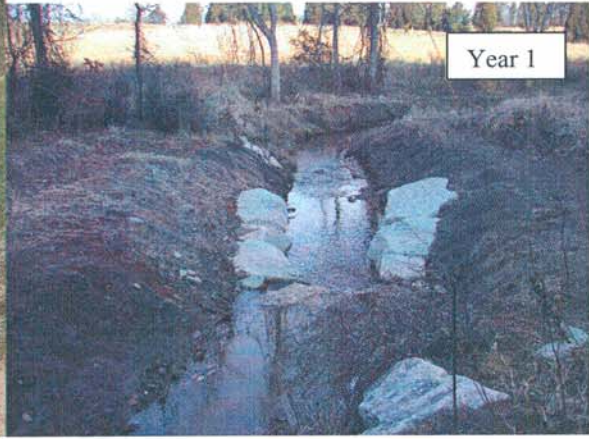
M6-DS: View from Meander 6 looking downstream.

M6-DS: View from Meander 6 looking downstream. Note newly constructed cross-vane due to upstream degradation since the initial construction. Water is short cutting between the cross boulders on the right side.

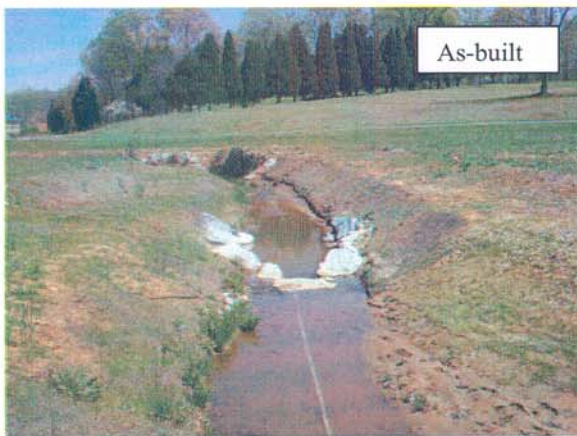
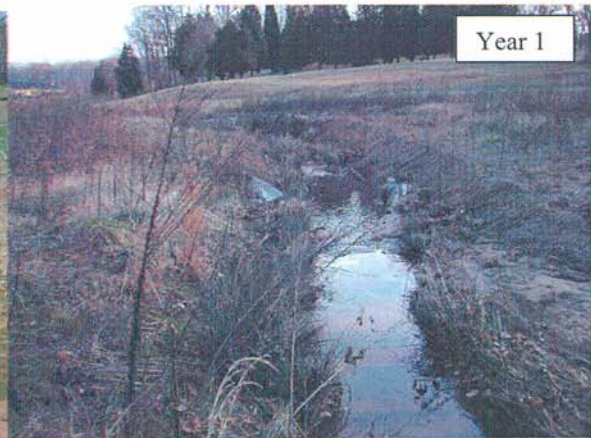
M9-DS: View from Meander 9 looking downstream. Note the point bar formation in the lower right corner of picture.

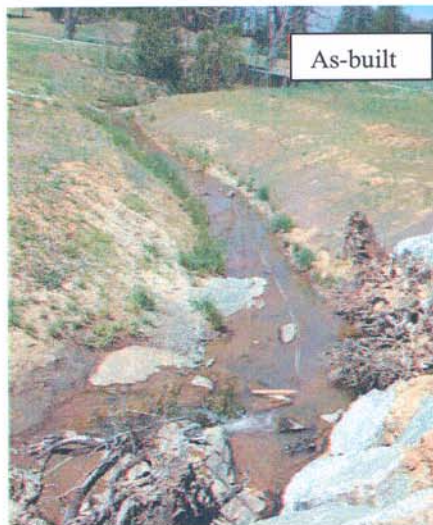
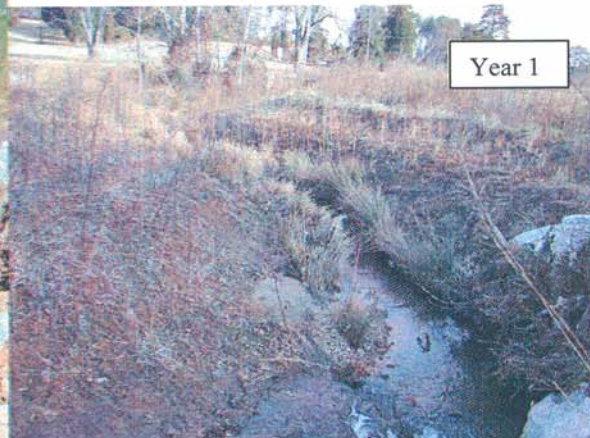
M10-DS: View from Meander 10 looking downstream. Note the bedrock in the bed of the channel exposed during construction.

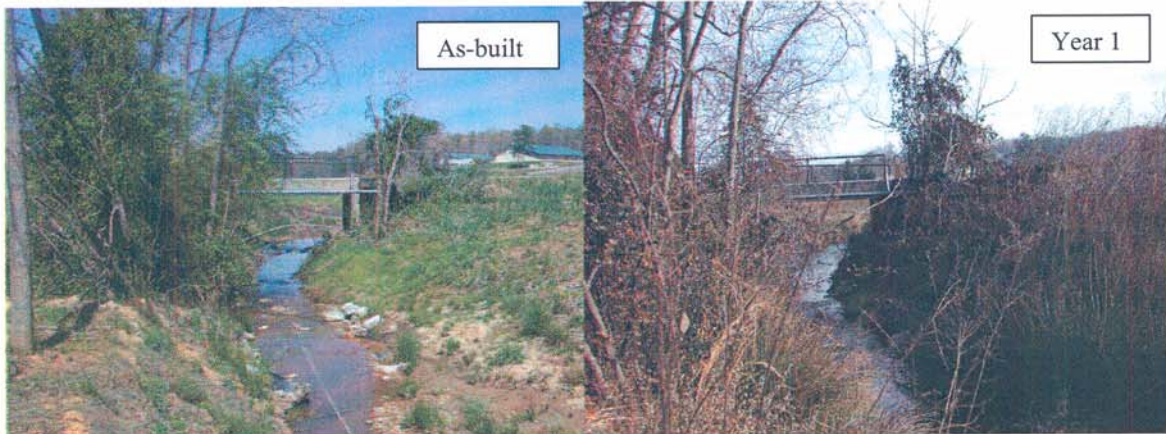
M11-DS: View from Meander 11 looking downstream. Jefferson Club Road crosses the stream via this 14' x 7.5 box culvert.

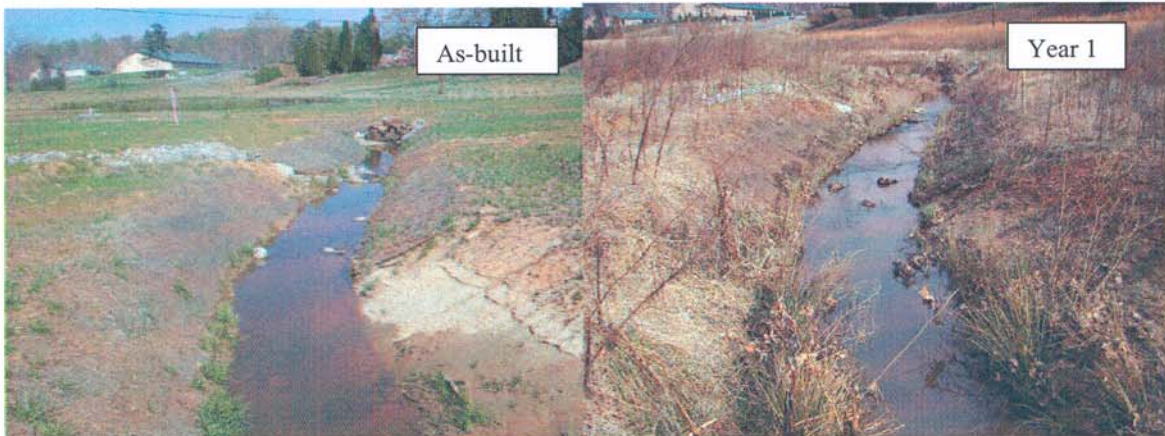
M14-DS: View from Meander 14 looking downstream. Note stone step-pool outfall to connecting roadway drainage to stream channel.

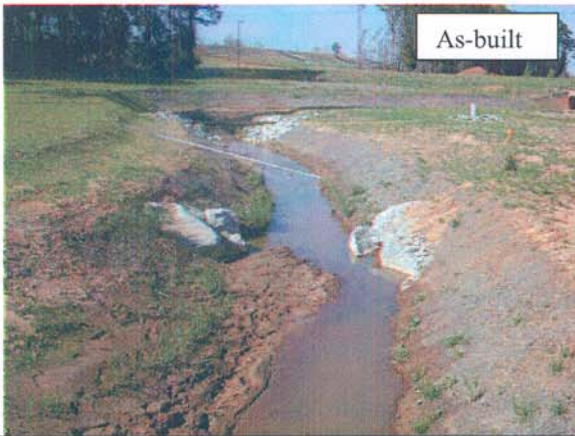
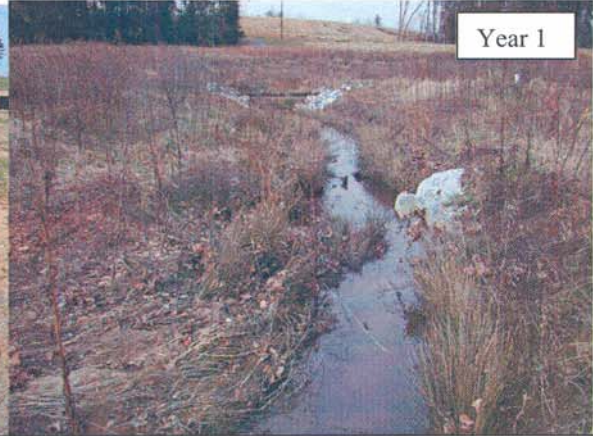
M15-DS: View from Meander 15 looking downstream. Note this cross-vane was moved upstream into the meander to avoid a gas line during construction. In effect, the upper portion of the cross vane has been covered up by the point bar.

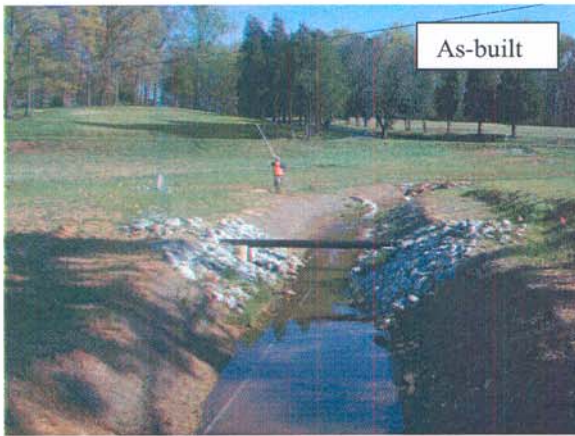
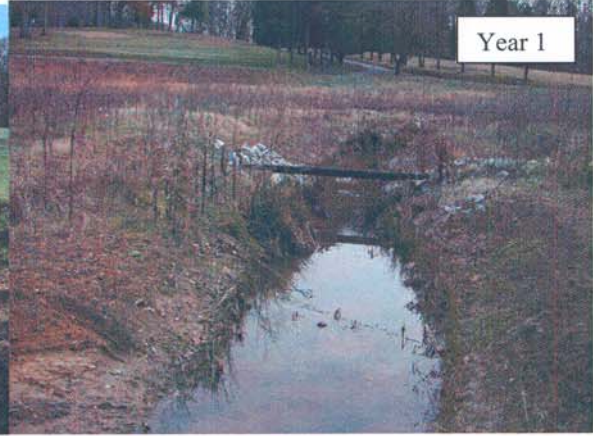
M16-US: View from Meander 16 looking upstream. The aerial sewer line was re-routed to make it perpendicular to the stream.

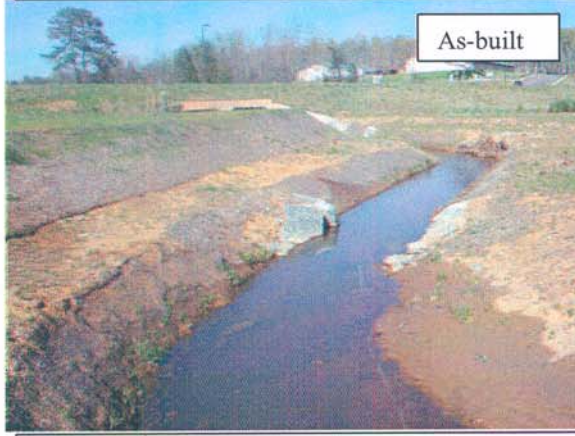
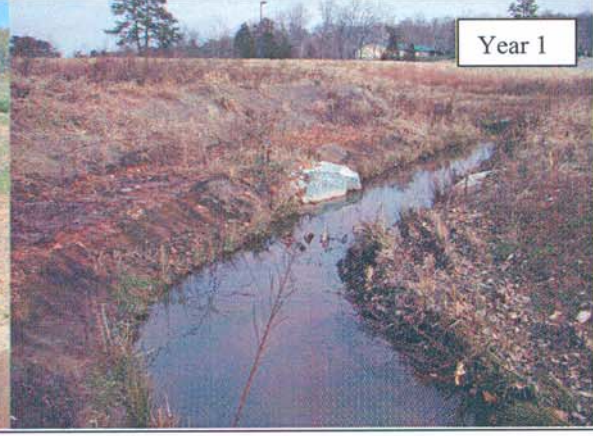
M16-DS: View from Meander 16 looking downstream. Cross-vane is drowned out due to backwater from the off-site lake downstream.

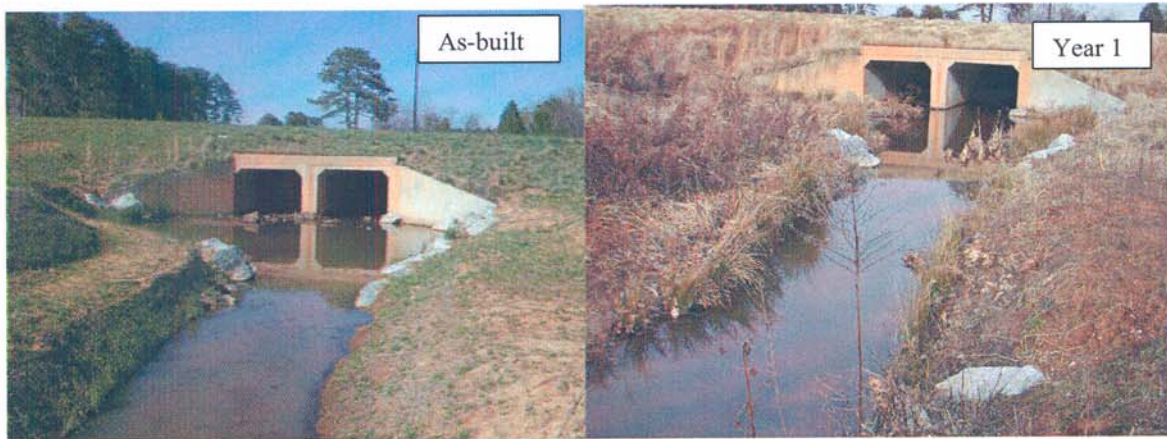
M17-DS: View from Meander 17 looking downstream towards the double 10' x 8' box culvert. Cross-vane is drowned out.

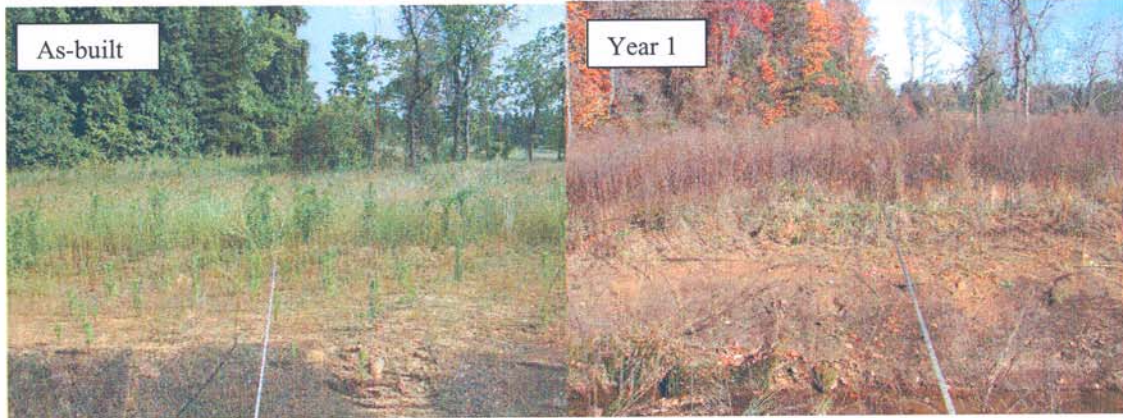
Transect 1 (BT1-L) – Left bank. Shows build-out bench above coir matting with thin herbaceous vegetation

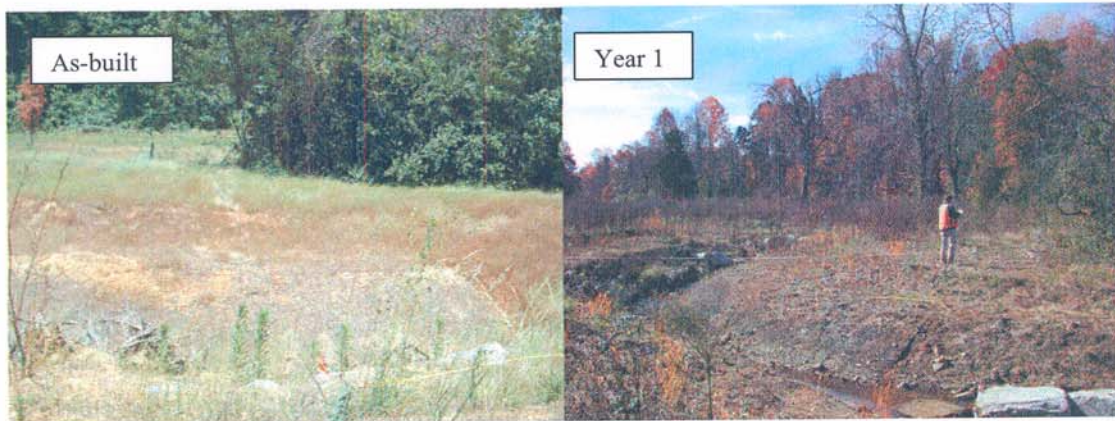
Transect 4 (BT4-L)– Left bank. Looking at area disturbed by construction of new structure.

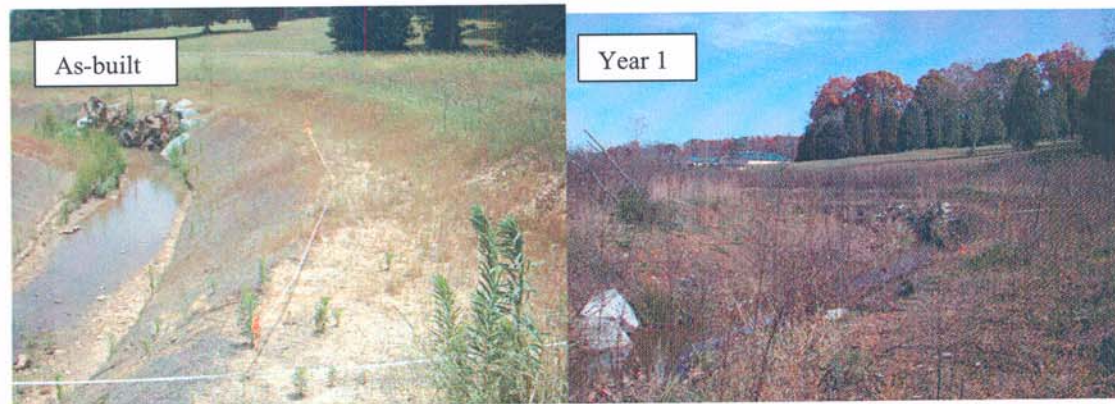
Transect 5 (BT5-D)– View of right build-out bench looking downstream. Note development of sedges and rushes on point bar above structure.

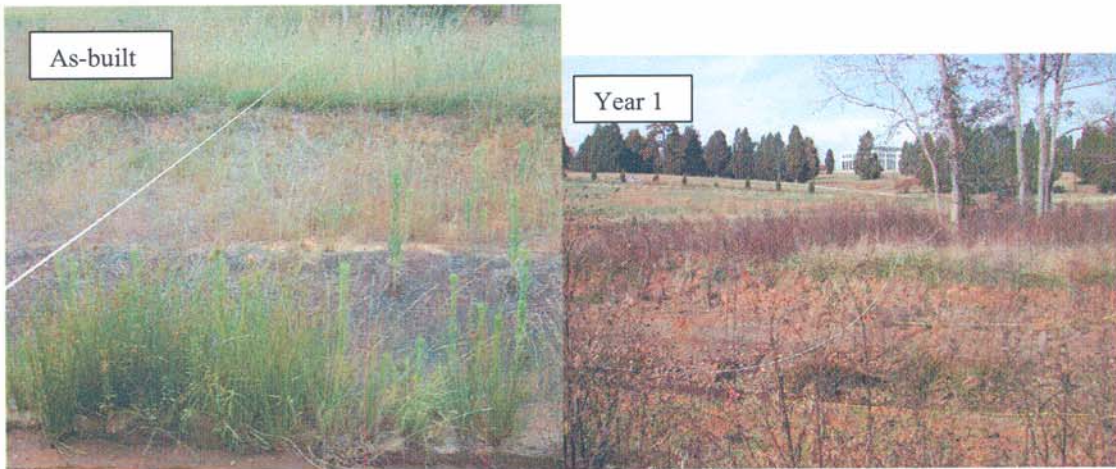
Transect 7 (BT7-L)– Left bank below bridge. Shows significant elevation change between build-out bench and buffer elevation.

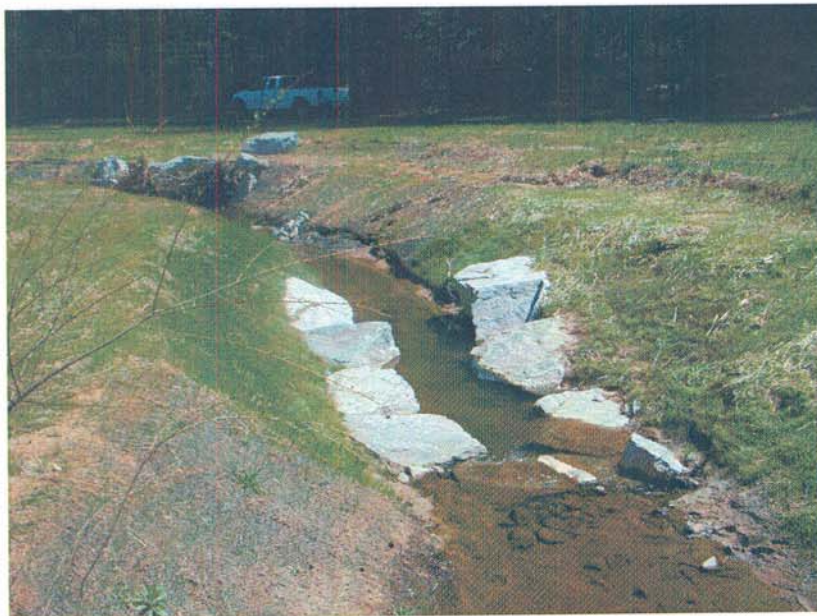
M3-DS: View from Meander 3 looking downstream towards a cross vane that was installed after the main construction period due to concerns with the grade downstream.

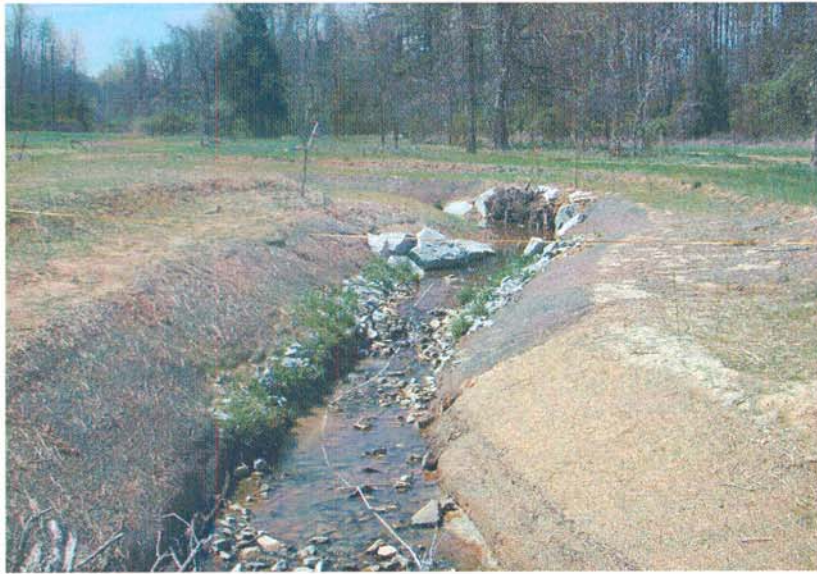
M6-US: View from Meander 6 looking upstream towards Meander 5. Note rip-rap was installed at the end of construction due to bed downcutting.

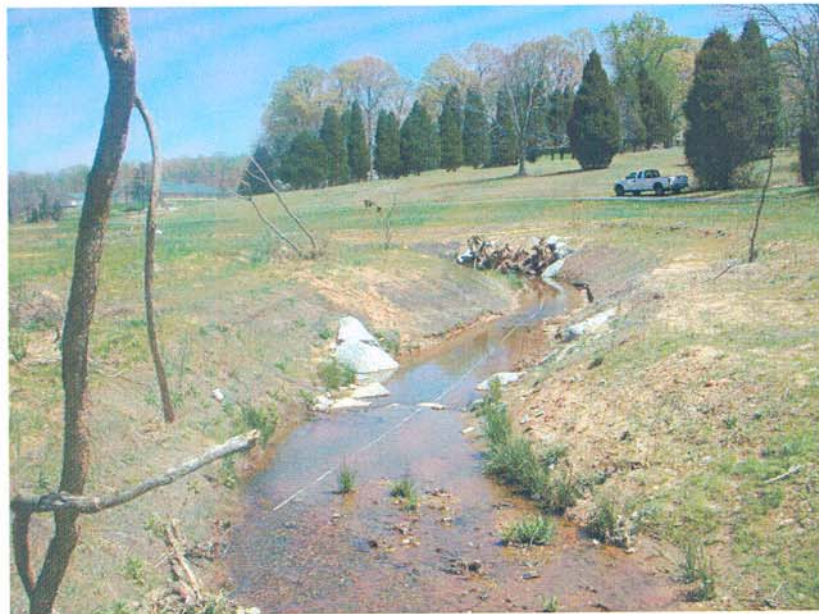
M7-DS: View from Meander 7 looking downstream.

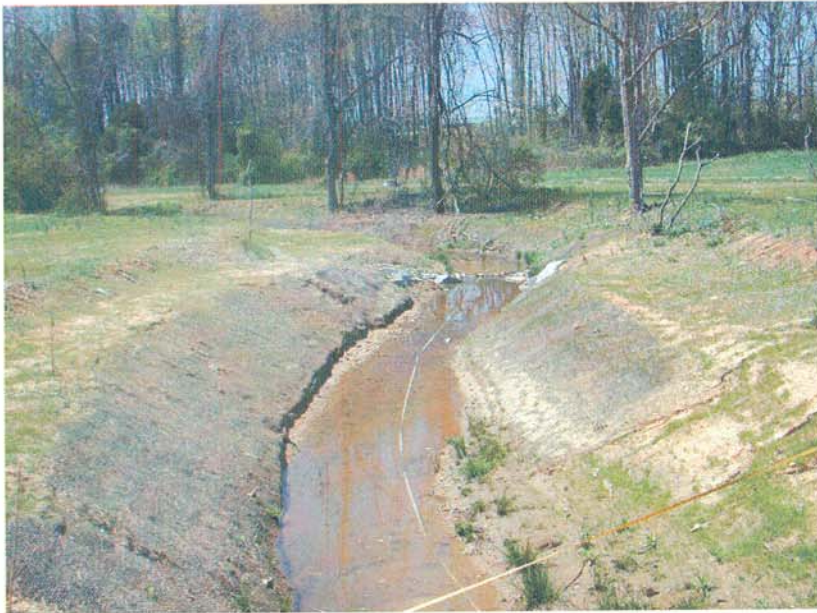
M8-US: View from Meander 8 looking upstream. Note the yellow fiberglass tape is pulled across the pool cross section in the foreground.

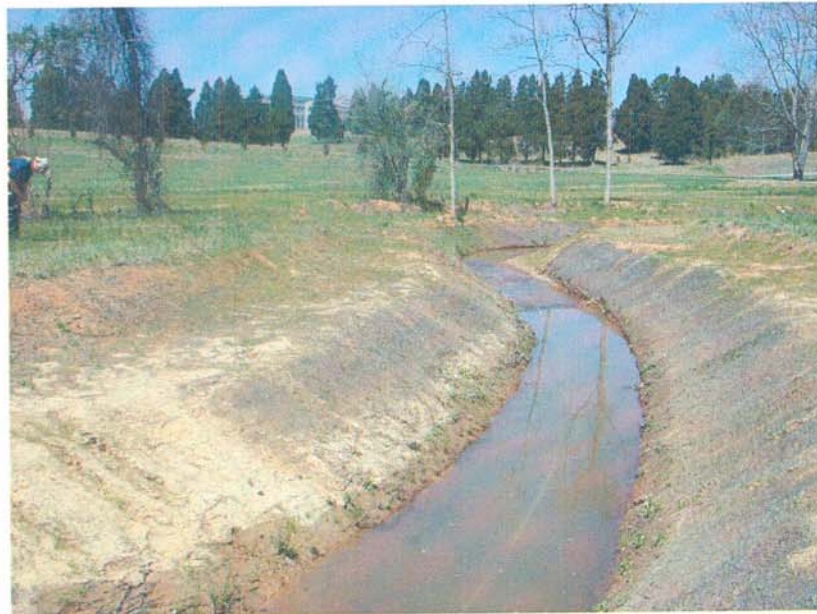
M8-DS: View from Meander 8 looking downstream towards Meander 9. Meander 9 does not have rootwads since the existing trees were salvaged.

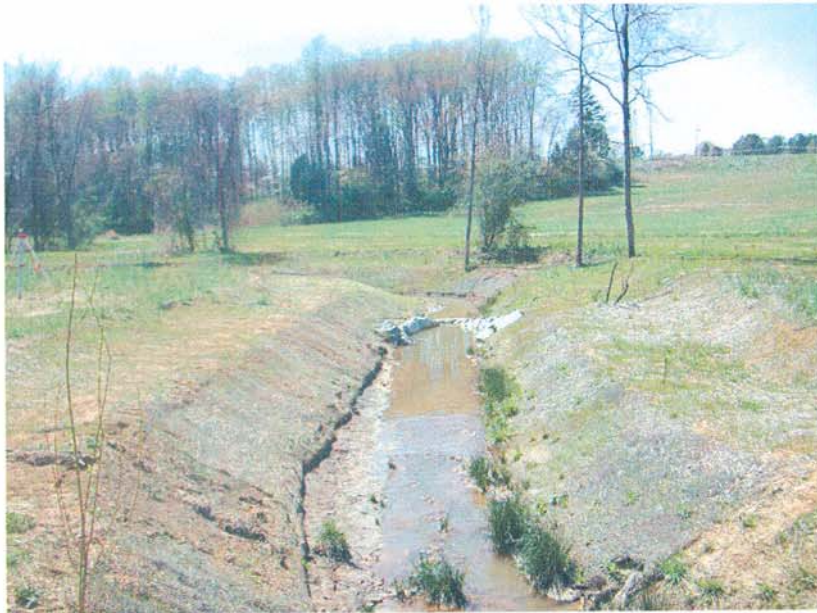
M10-US: View from Meander 10 looking upstream.

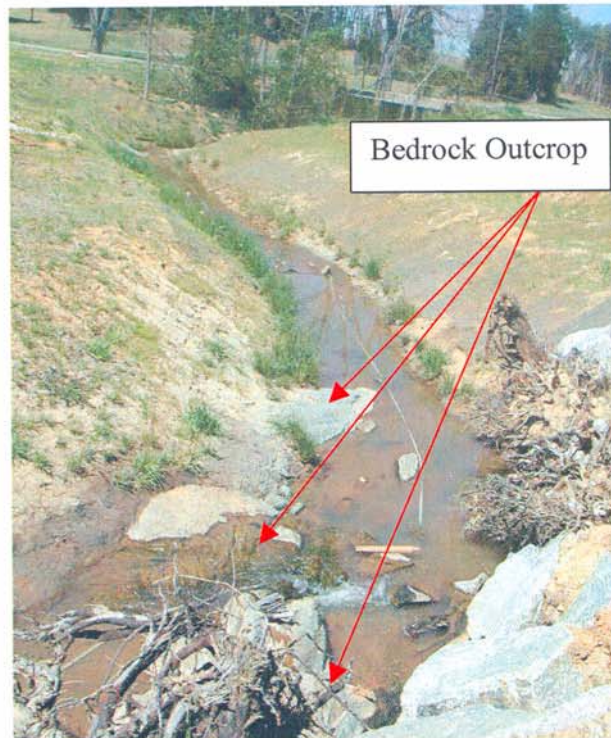
M10-DS: View from Meander 10 looking downstream. Note the bedrock in the bed of the channel exposed during construction.

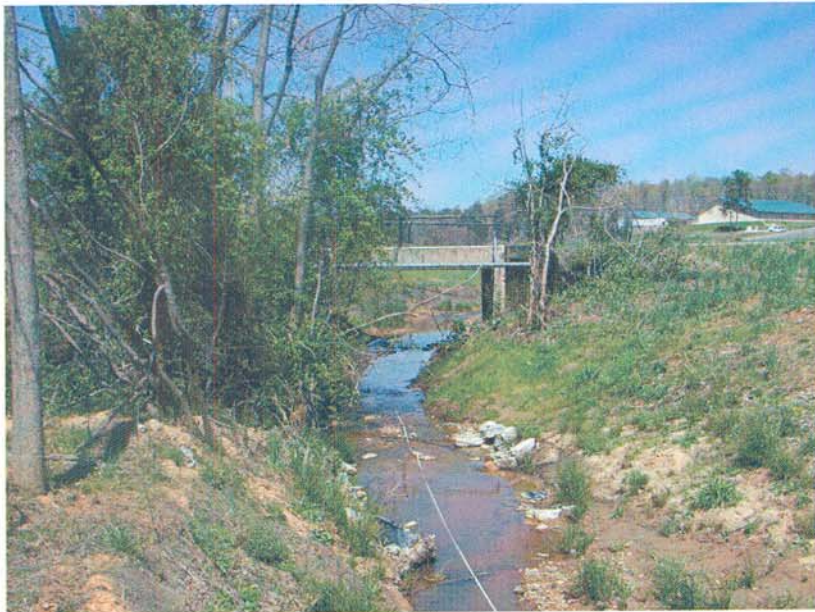
M11-DS: View from Meander 11 looking downstream. Jefferson Club Road crosses the stream via this 14' x 7.5 box culvert.

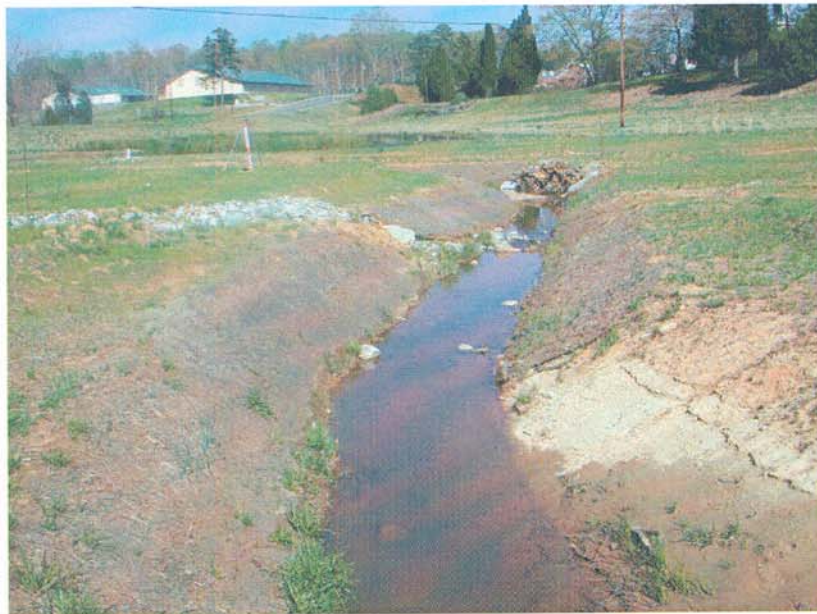
M14-DS: View from Meander 14 looking downstream. Note stone step-pool outfall to connect roadway drainage to stream.

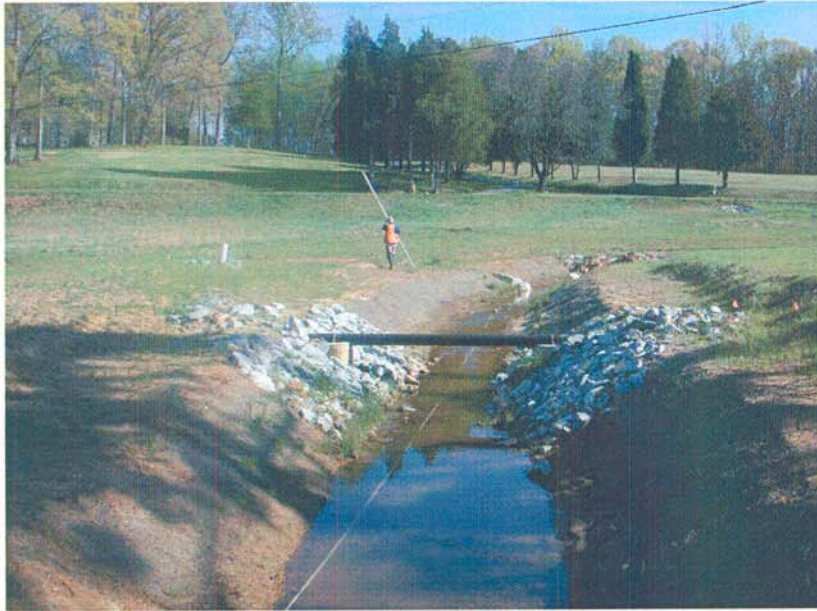
M15-DS: View from Meander 15 looking downstream. Note this cross-vane was moved upstream into the meander to avoid a gas line during construction. In effect, the upper portion of the cross vane has been covered up by the point bar since the cross vane slowed the water on the inside meander.

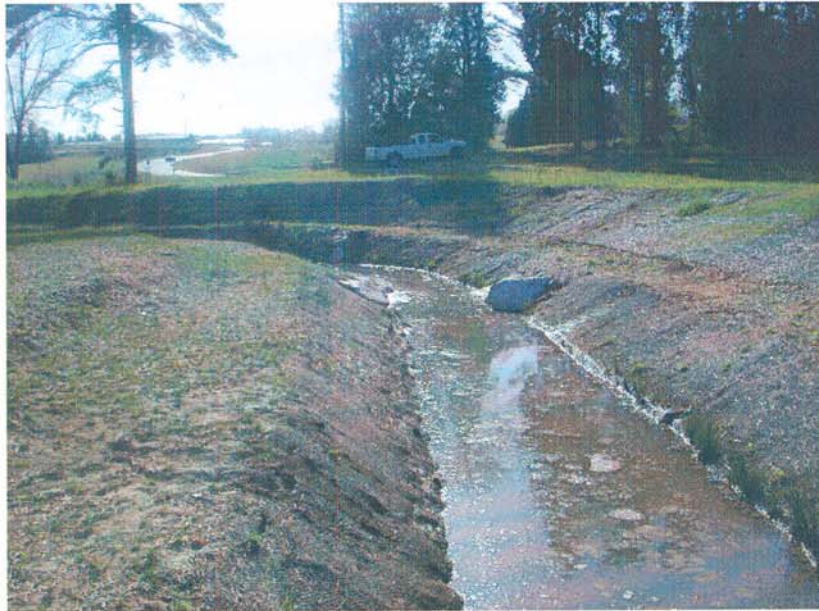
M16-DS: View from Meander 16 looking downstream. Cross-vane is drowned out due to backwater from the off-site lake downstream.

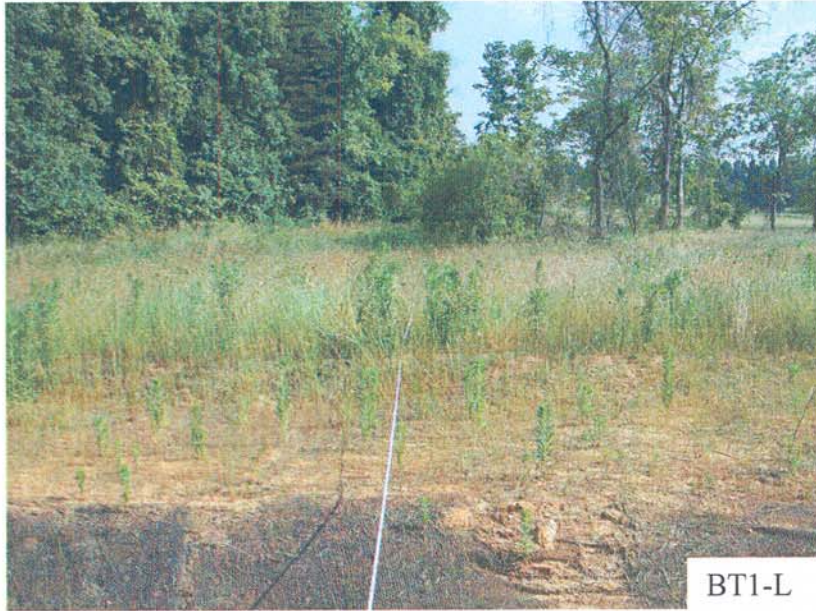
BT1-L

Transect 1 – Left bank. Shows build-out bench above coir matting with thin herbaceous vegetation

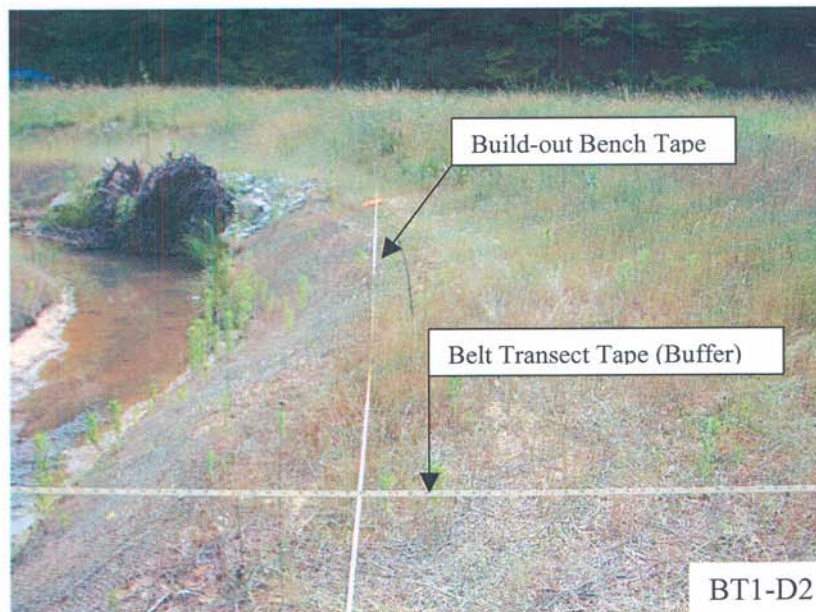
BT1-D2

Transect 1 – Right build-out bench looking downstream. Shows the right side build-out bench vegetation. Transect tape in foreground, suspended above bench

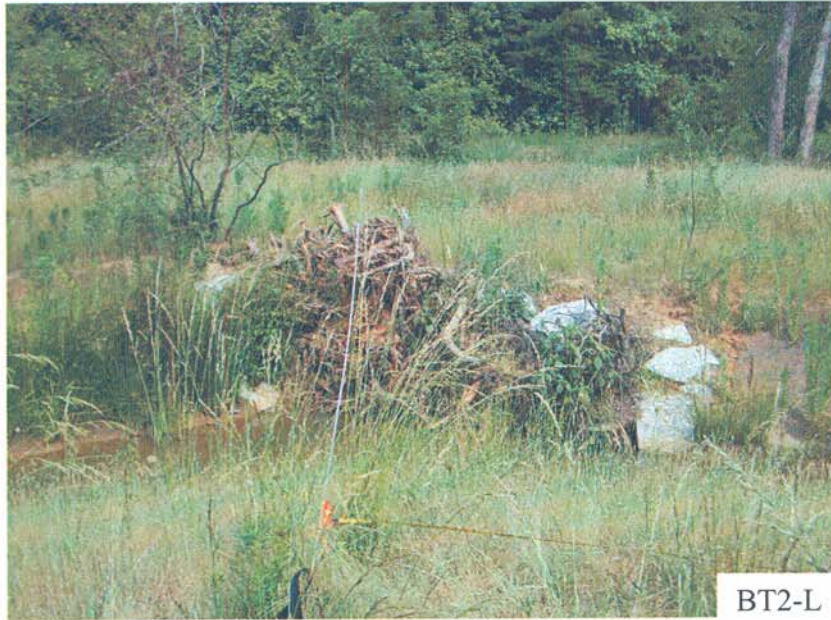
BT2-L

Transect 2 – Left bank. Shows belt transect tape crossing a root wad. Tape for build-out bench plot is in the foreground.

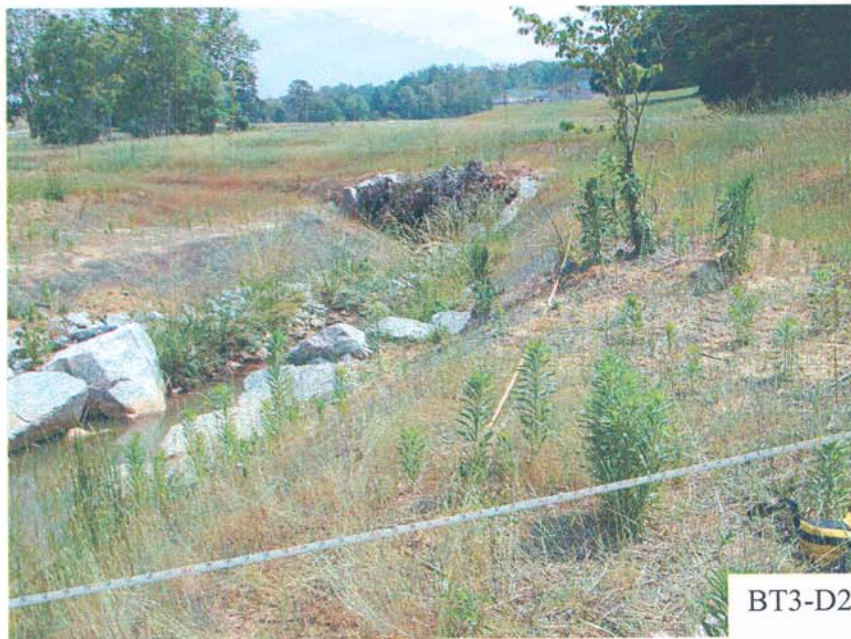
BT3-D2

Transect 3 – View of right build-out bench looking downstream. Shows herbaceous vegetation on build-out bench and transplant above structure in background.

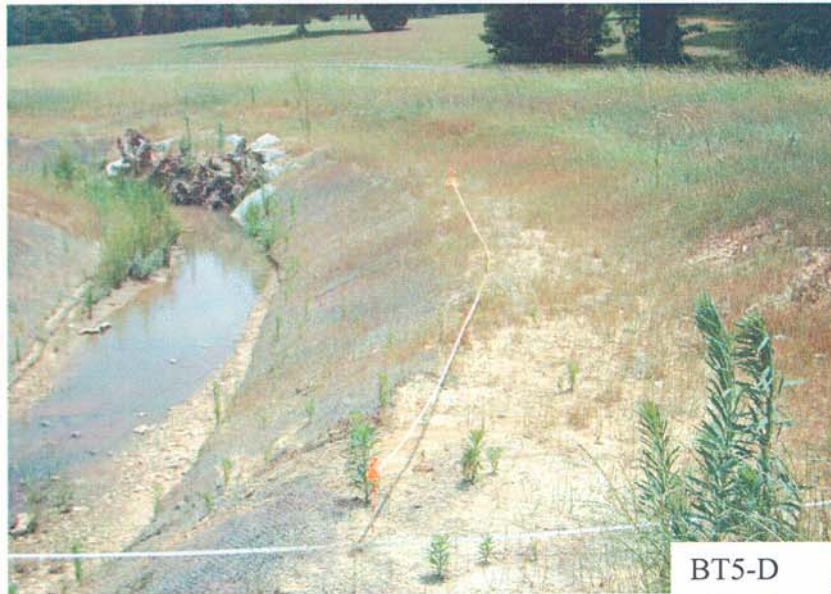
BT5-D

Transect 5 – View of right build-out bench looking downstream, showing tape setup for bench plot. Note development of sedges and rushes along edge of stream on point bar above structure.

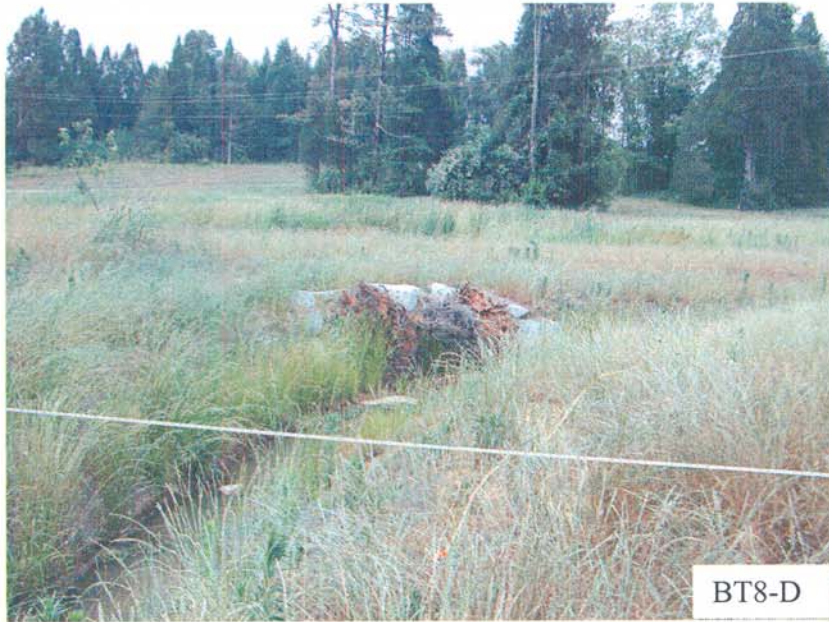
Transect 8 – Right build-out bench looking downstream. Shows relatively dense herbaceous vegetation, primarily Italian ryegrass.
