Price Park Stream Restoration

2003 Annual Monitoring Report

Prepared by: Biological & Agricultural Engineering
Water Resources Research Institute
North Carolina State University
Campus Box 7625
Raleigh, NC 27695

March, 2004

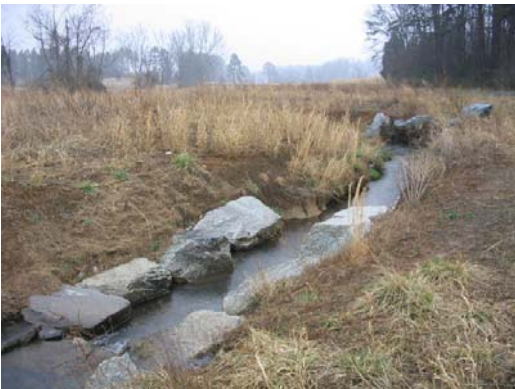
**Issue Photo 1 - Station 3+00.
Bank scour below cross vane**

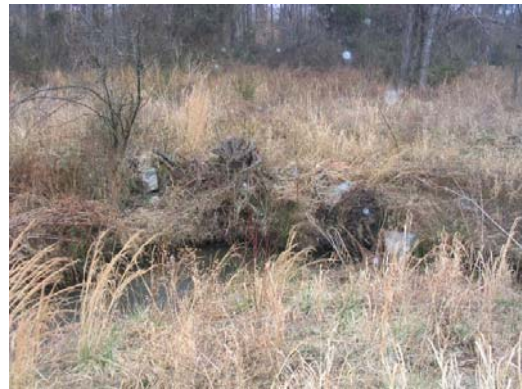
**Issue Photo 2 - Station 3+60.
Bank erosion behind rootwads.**

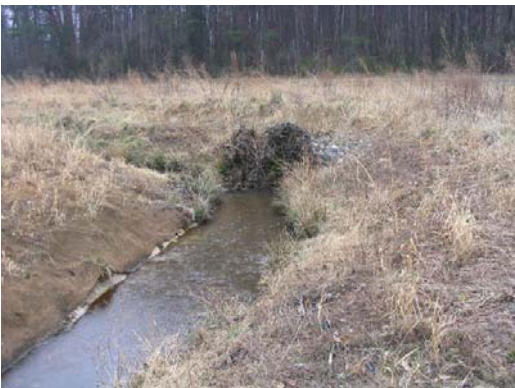
**Issue Photo 3 – Station 5+30
Unsecured matting and unvegetated bank.**

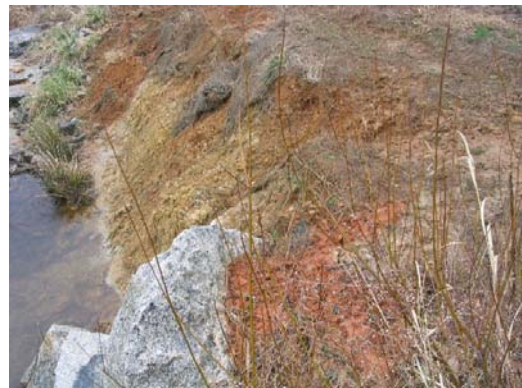
**Issue Photo 4 – Station 5+00
Erosion on bank below cross vane
and washed away matting**

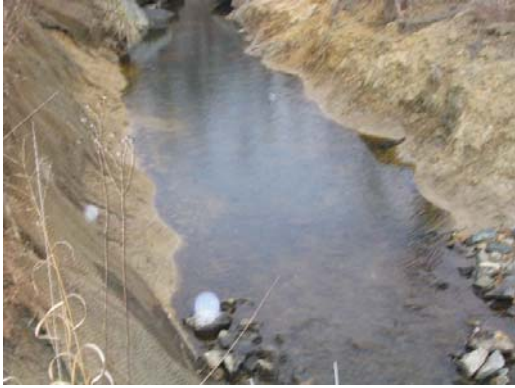
**Issue Photo 5 – Station 6+50
Unprotected bank**

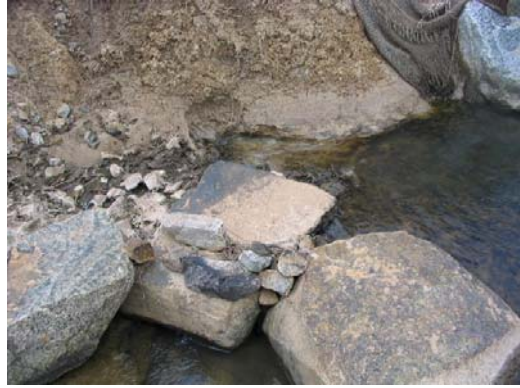
**Issue Photo 6 – Station 6+00
Cutting under cross vane**

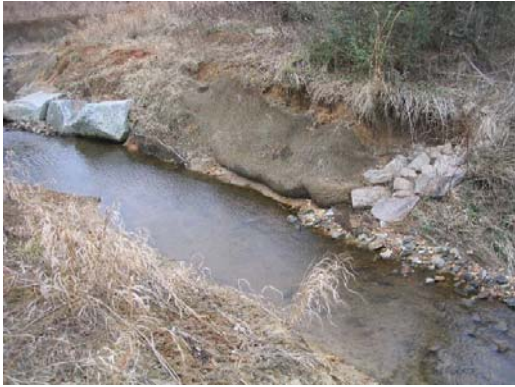
**Issue Photo 7 – Station 7+40
Bank slump due to over-bank wash**

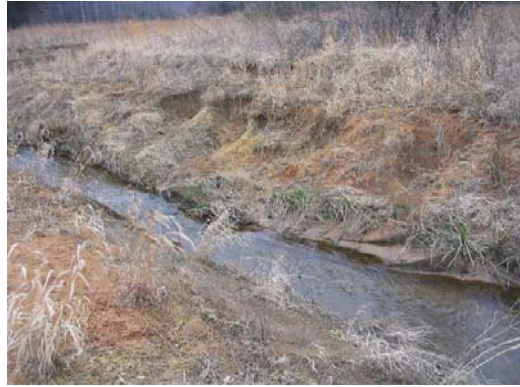
**Issue Photo 8 – Station 8+50
Bank slump due to over-bank wash**

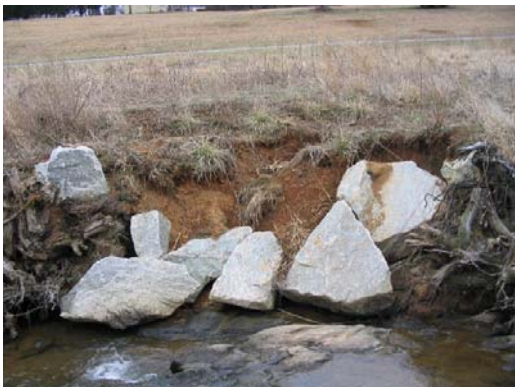
**Issue Photo 9 – Station 13+70
Bank slump between root wads resulting
from overland flow**

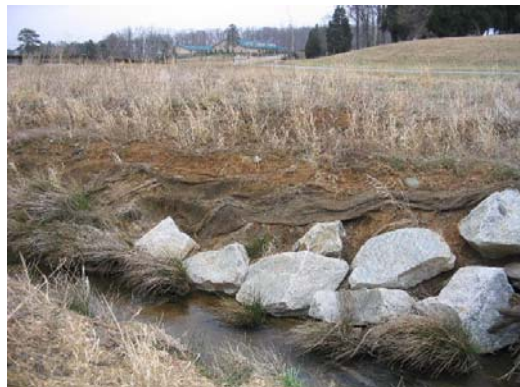
**Issue Photo 10 – Station 14+10
Bank washout**

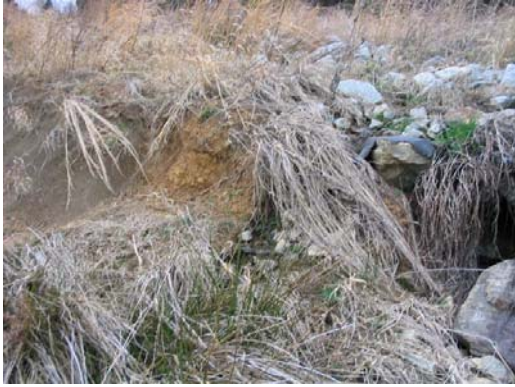
Issue Photo11 – Station 13+50
Erosion near drainage channel

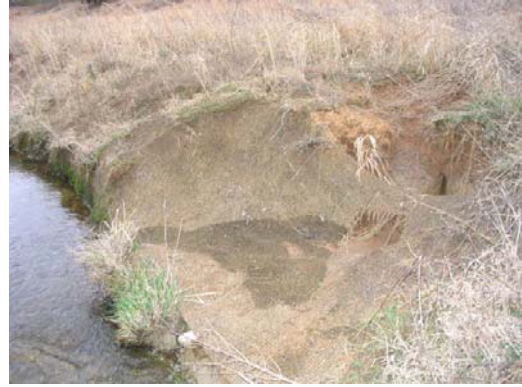
Issue Photo 12 – Station 13+60
Overland flow eroding channel bank
