Price Park Stream Restoration

2004 Annual Monitoring Report

February, 2005

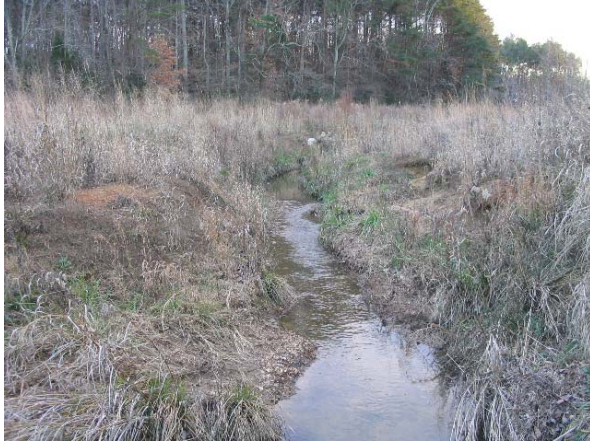
Typical Riffle.

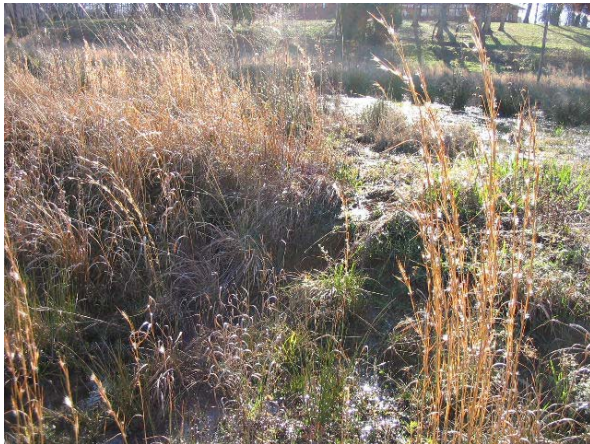
**Highlight Photo 1 - Station 16+00.
Floodplain Wetland off of right bank.
Not a concern area.**

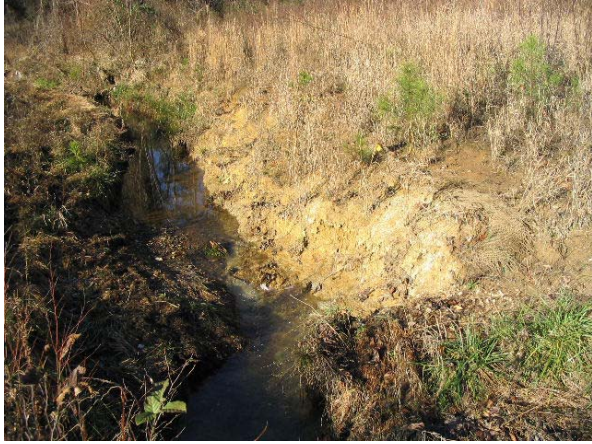
**Issue Photo 1 - Station 0+80
Left bank un-vegetated**

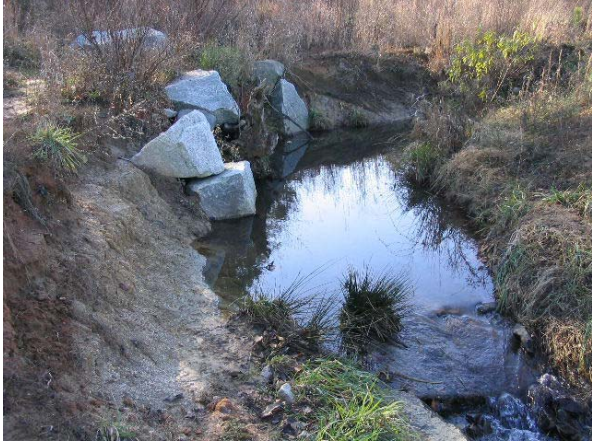
**Issue Photo 2 - Station 1+00
Un-vegetated right bank**

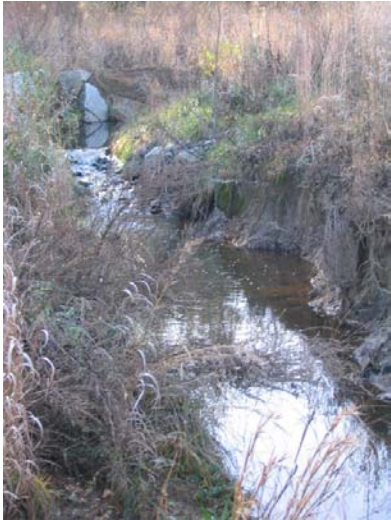
**Issue Photo 3 - Station 1+50
Vertical and un-vegetated left bank**

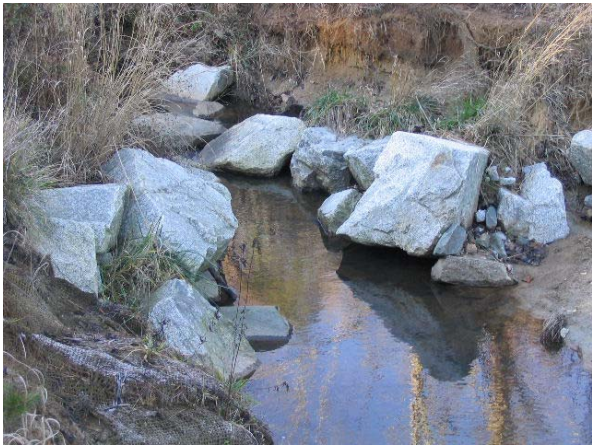
**Issue Photo 4 - Station 2+10. Cross vane with
footers undermined and boulders slumping**

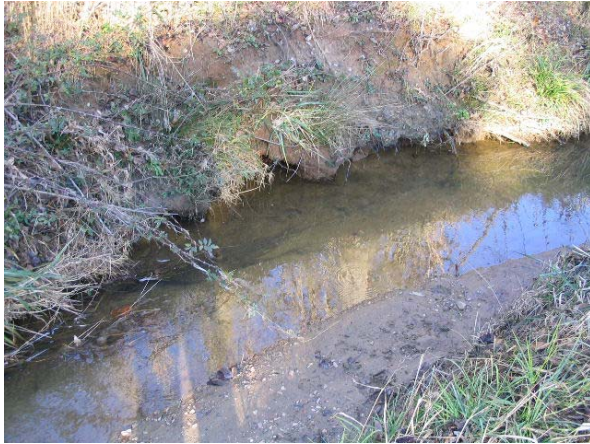
- Areas with bank erosion due to overland flow washing into the channel
 - Stations 3+90, 4+40, 12+20, 14+00 and 15+50
 - Station 12+20 has degraded to the point that the bank is not likely to heal with the addition of vegetation alone.

Issue Photo 7 - Station 3+90
Outside meander slump resulting from overland flow

- These areas should be monitored closely during upcoming site visits to monitor degradation.
- The lack of successful herbaceous cover along sections of the streambanks.

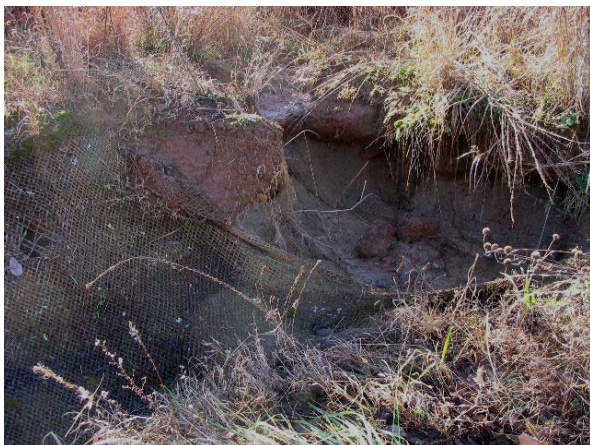
- Station 14+00 has degraded to the point that the bank is not likely to heal with the addition of vegetation alone.
- The lack of successful vegetation in the riparian buffer

Issue Photo 11 - Station 14+00
Right bank un-vegetated and scoured

In order to re-establish a stable stand of herbaceous cover on many of the degraded areas along the streambanks, soil preparation will be necessary because the exposed soil is nutrient poor and highly compacted.

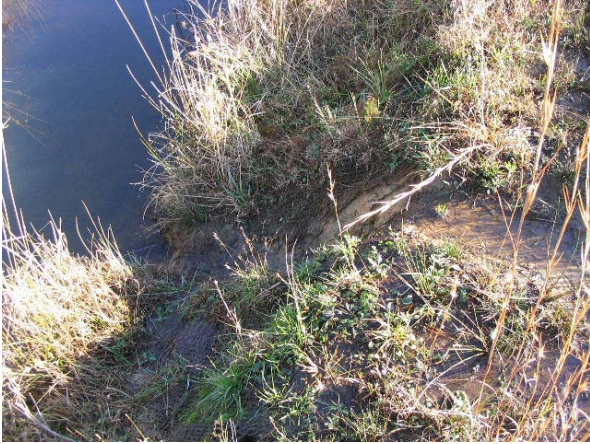
**Issue Photo 13 - Station 16+20.
Concentrated flow leaving wetland.
Scouring streambank.**

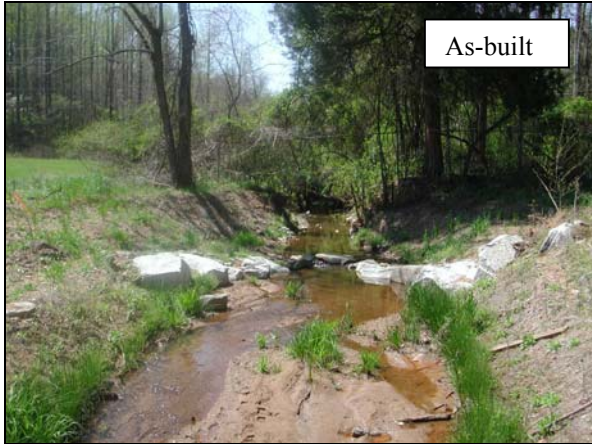
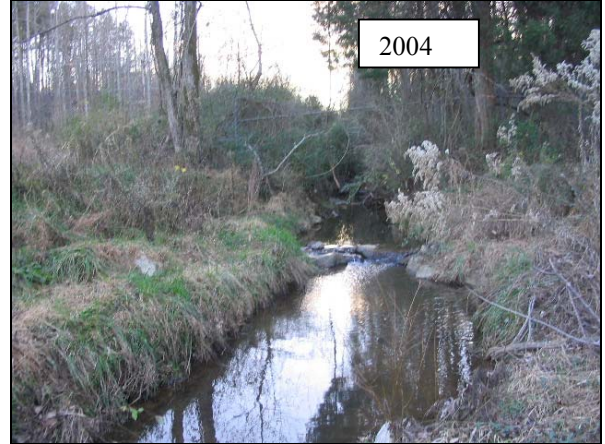
M1-US: Meander 1, looking in the upstream direction. Fenceline represents the beginning of the project and longitudinal profile. Note bar formation and vegetation establishment in this region.

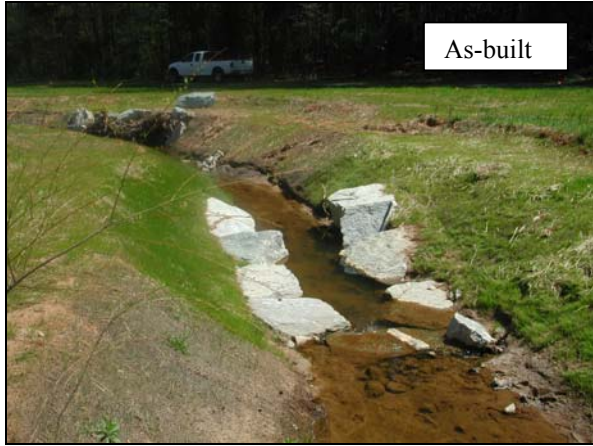
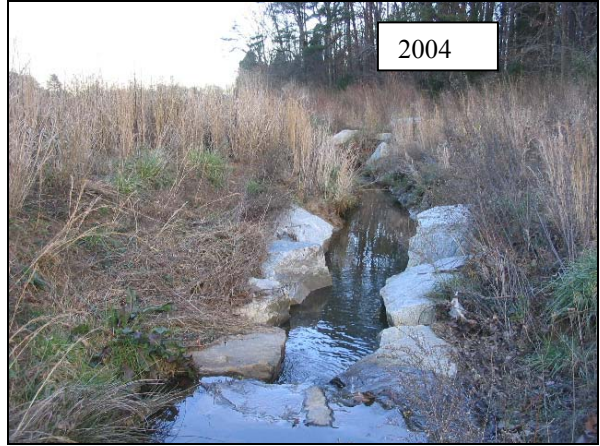
M3-DS: View from Meander 3 looking downstream towards a cross vane that was installed after the main construction period due to concerns with the grade downstream.

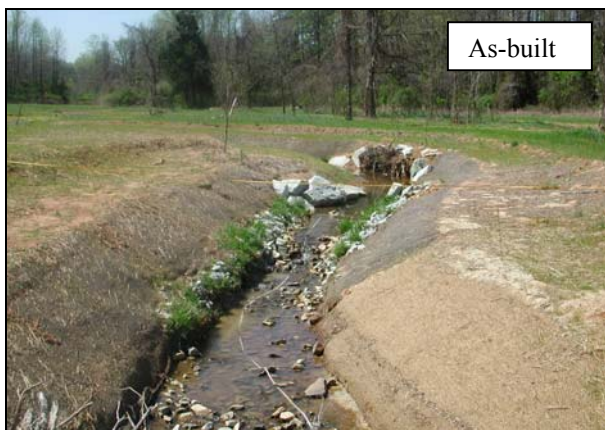
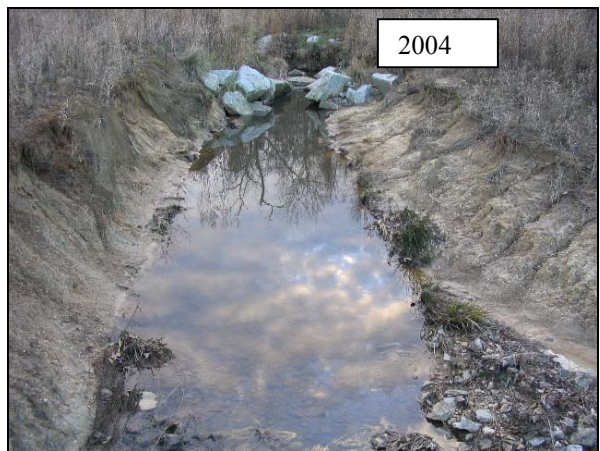
M6-US: View from Meander 6 looking upstream towards Meander 5. Note rip-rap was installed at the end of construction due to bed downcutting. 64

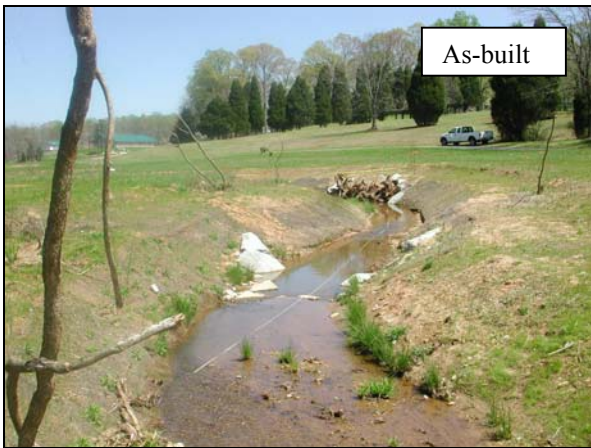
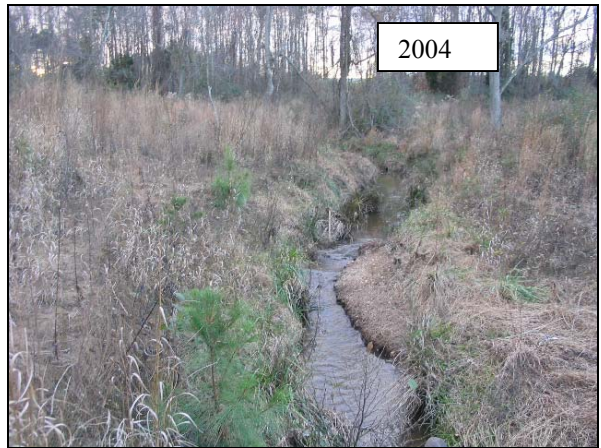
M7-US: View from Meander 7 looking upstream. 66

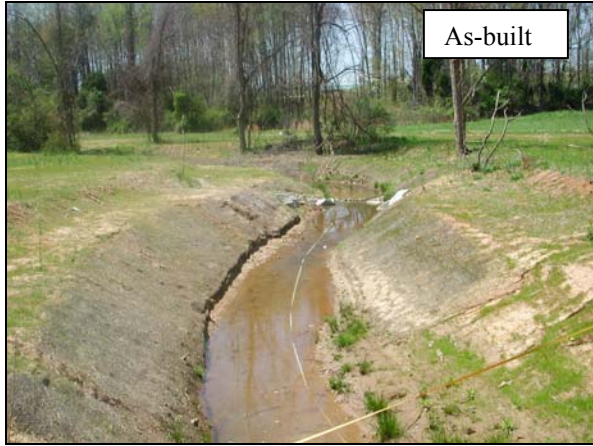
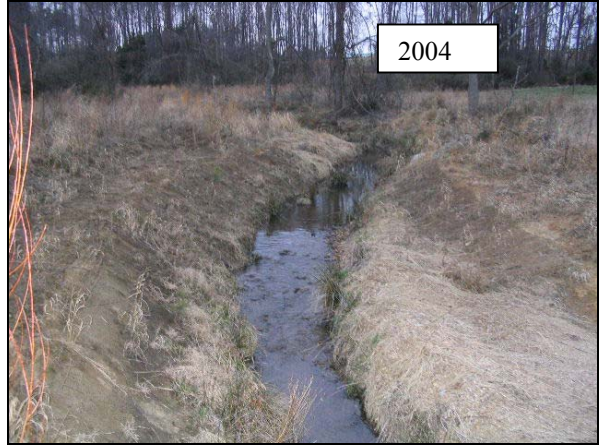
M7-DS: View from Meander 7 looking downstream.67

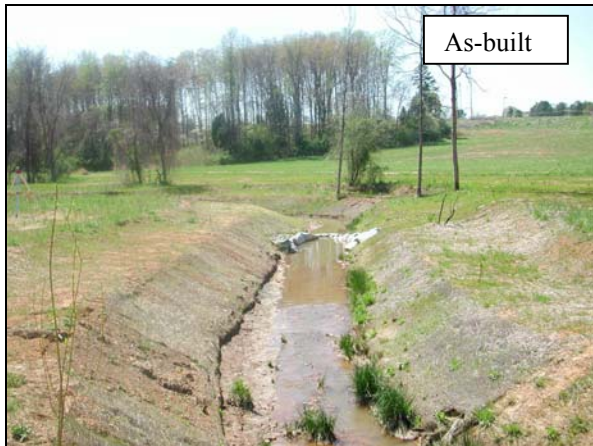
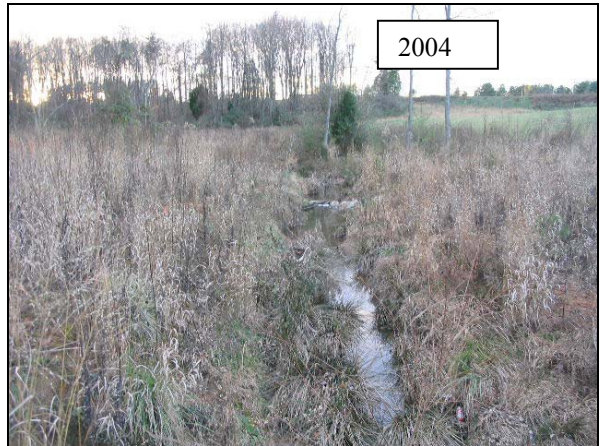
M9-DS: View from Meander 9 looking downstream. Note the point bar formation in the lower right corner of picture.71

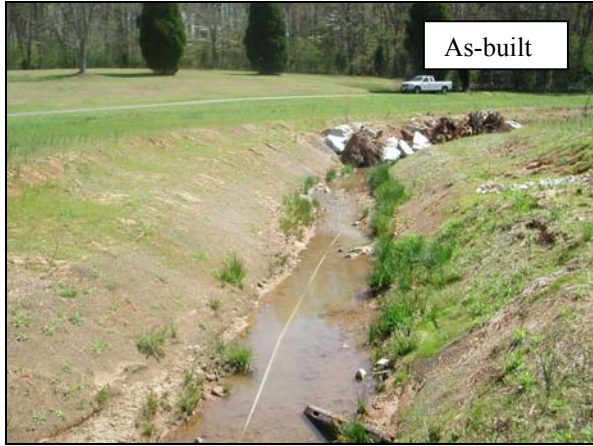
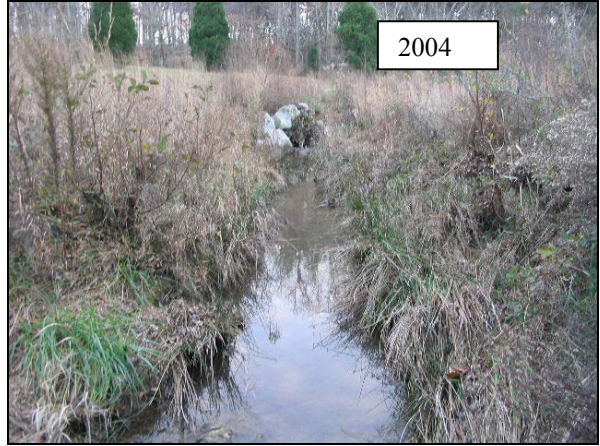
M10-DS: View from Meander 10 looking downstream. Note the bedrock in the bed of the channel exposed during construction.73

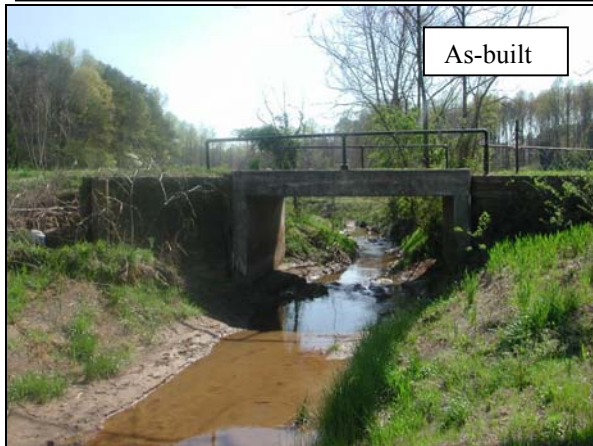
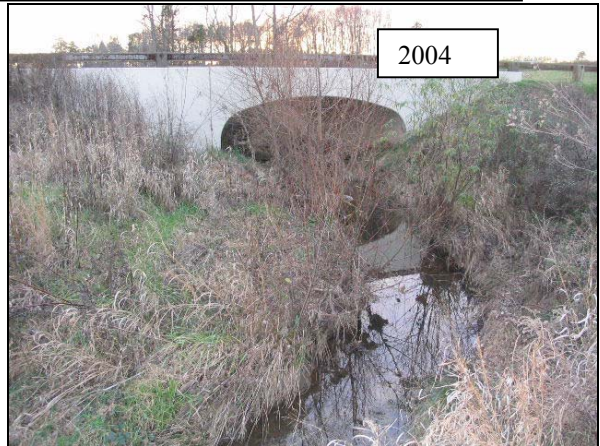
M11-DS: View from Meander 11 looking downstream. Jefferson Club Road crosses the stream via this 14' x 7.5 box culvert. 75

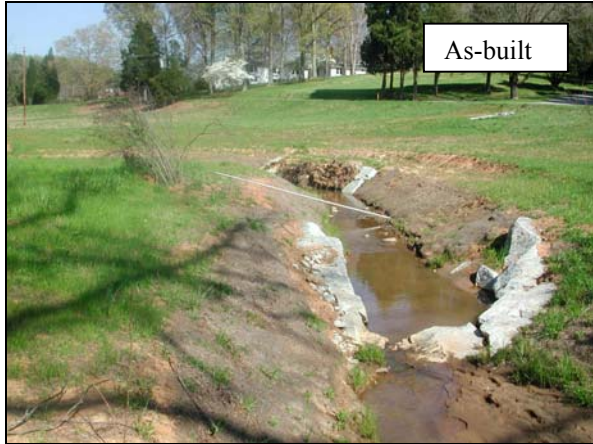
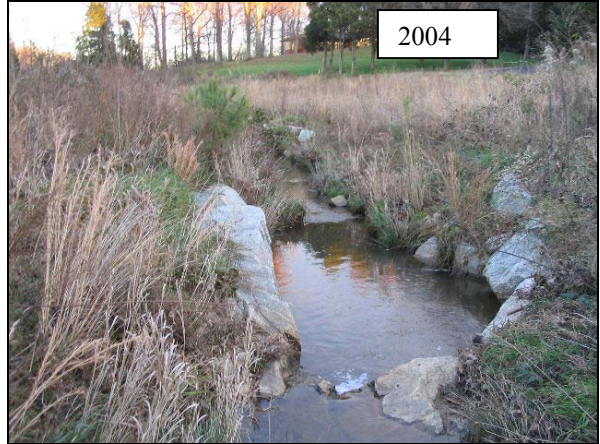
M12-US: View from Meander 12 looking upstream through the culvert. Note how the channel has narrowed and vegetated in the Year 1 photograph.76

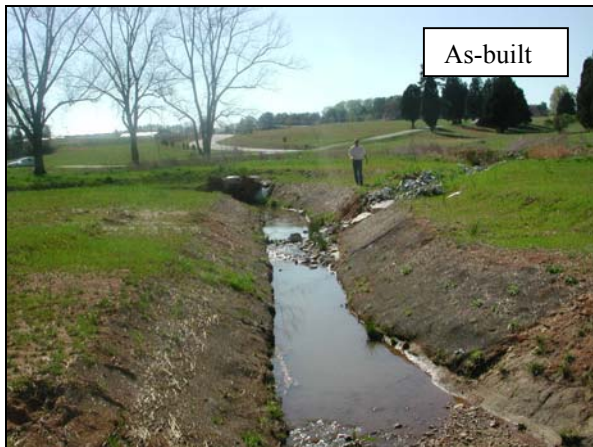
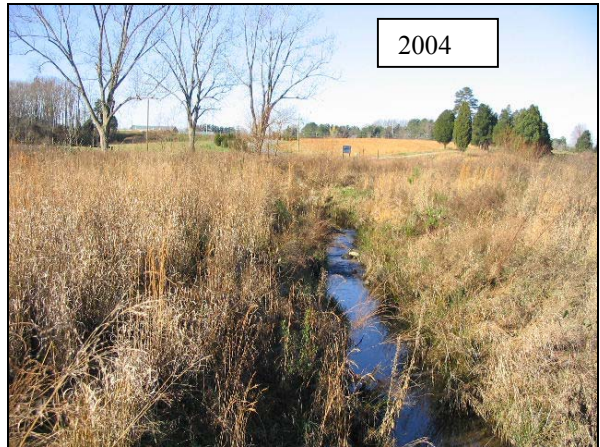
M14-DS: View from Meander 14 looking downstream. Note stone step-pool outfall to connecting roadway drainage to stream channel.82

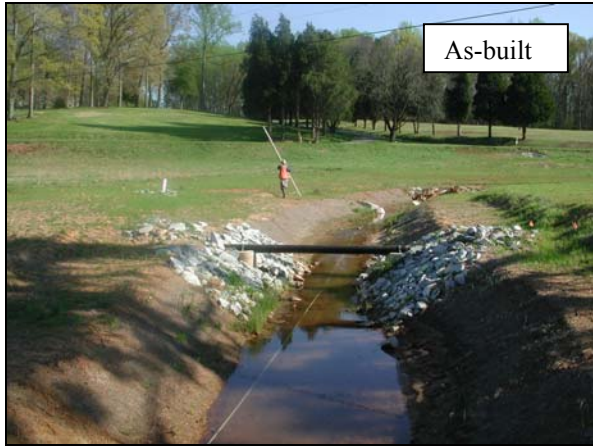
M15-DS: View from Meander 15 looking downstream. Note this cross-vane was moved upstream into the meander to avoid a gas line during construction. In effect, the upper portion of the cross vane has been covered up by the point bar.⁸⁴

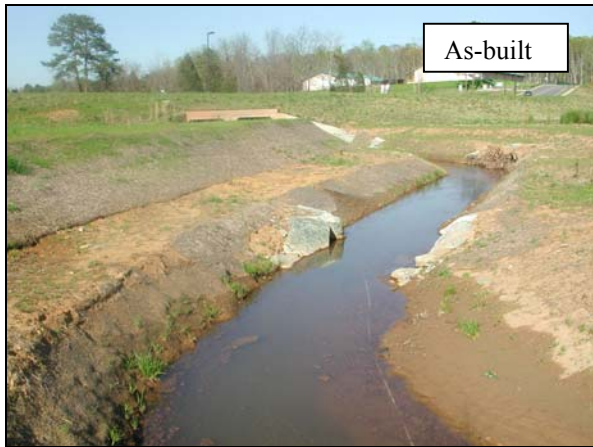
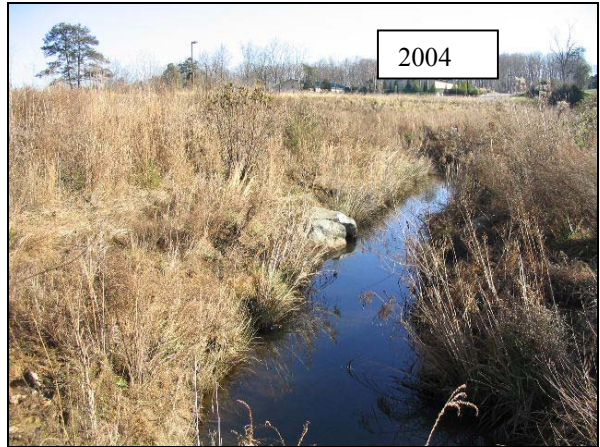
M16-US: View from Meander 16 looking upstream. The aerial sewer line was re-routed to make it perpendicular to the stream.⁸⁵

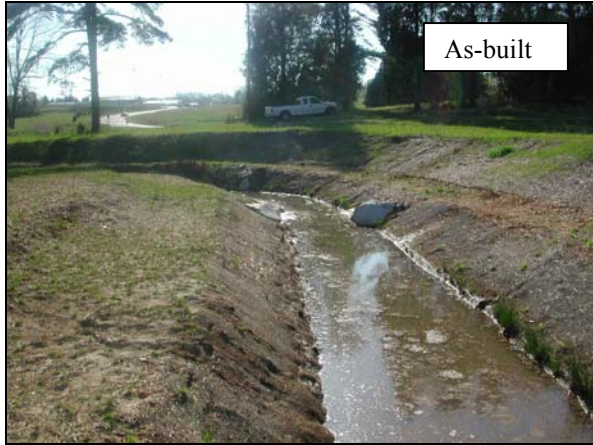
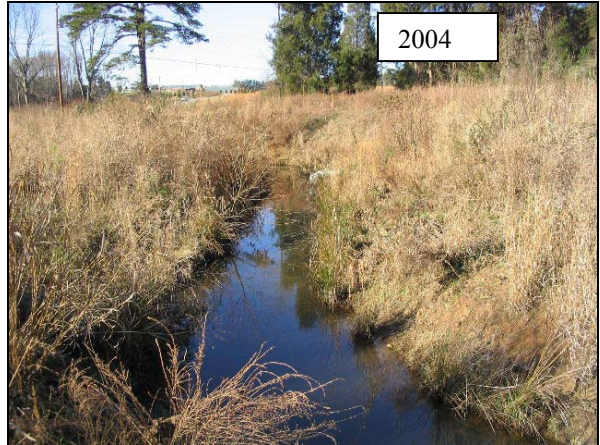
M16-DS: View from Meander 16 looking downstream. Cross-vane is drowned out due to backwater from the off-site lake downstream.⁸⁶

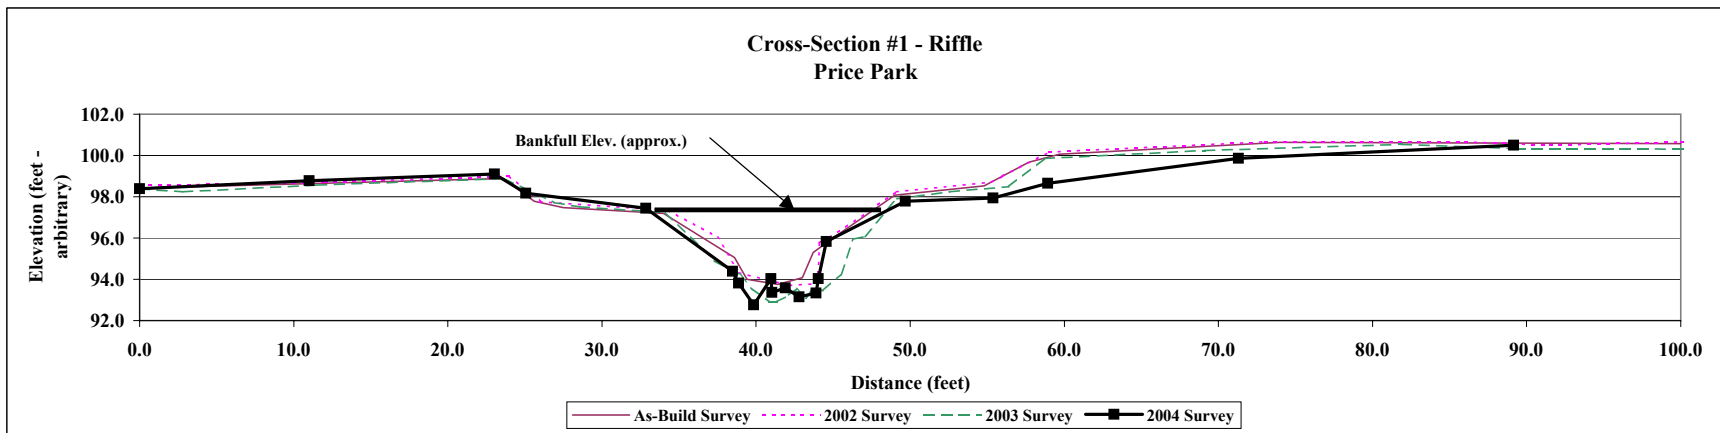
Photo of Cross-Section #1 - Looking Upstream

As-Built	2002	2003	2004
Area	24.1	25.64	36.31	36.52
Width	13.3	14.8	15.0	16.8
Mean Depth	1.8	1.7	2.4	2.2
Max Depth	3.5	3.6	4.3	4.3

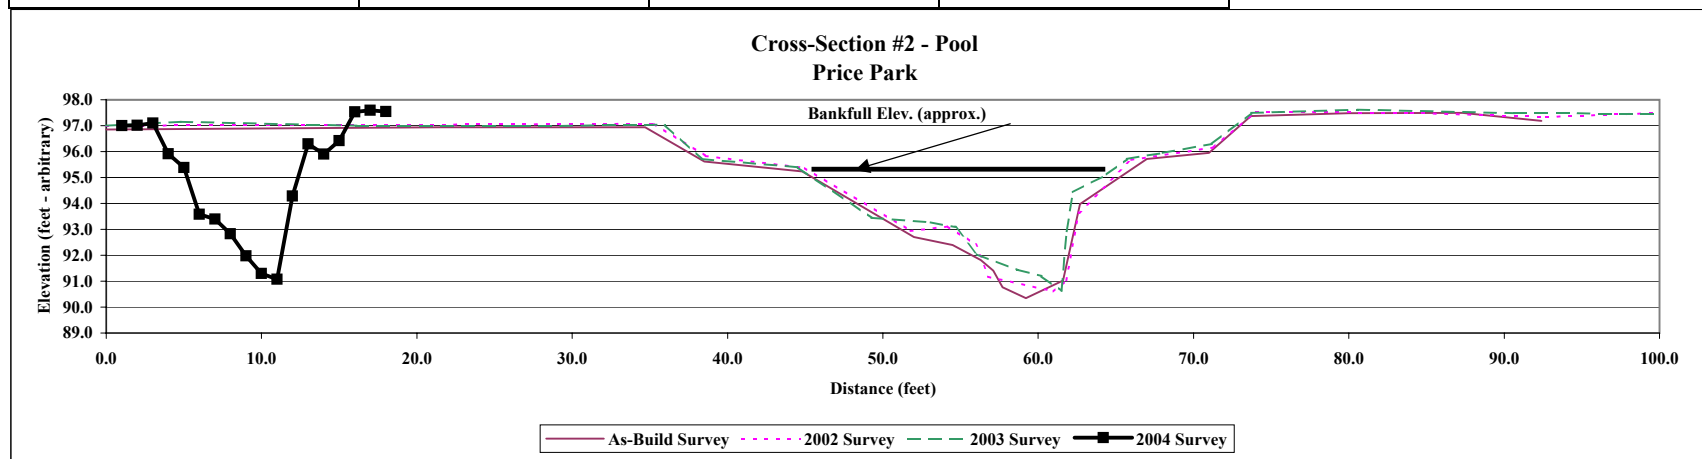
Photo of Cross-Section #2 - Looking Upstream

As-Built	2002	2003	2004
Area	50.6	49.28	44.90	47.04
Width	22.2	21.0	21.2	21.2
Mean Dept	2.3	2.3	2.1	2.2
Max Depth	4.9	4.8	4.8	4.3

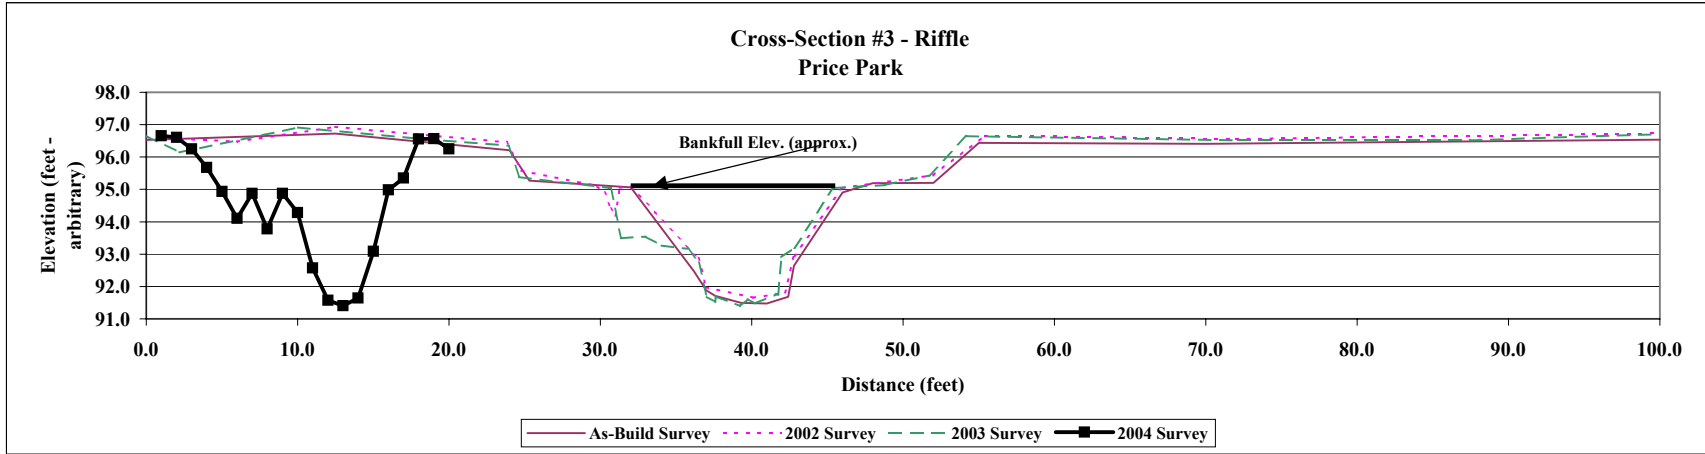
Photo of Cross-Section #3 - Looking Downstream

As-Built	2002	2003	2004
Area	31.9	28.41	31.93	29.98
Width	14.0	14.0	14.7	14.7
Mean Depth	2.3	2.0	2.2	2.0
Max Depth	3.6	3.4	3.6	3.6

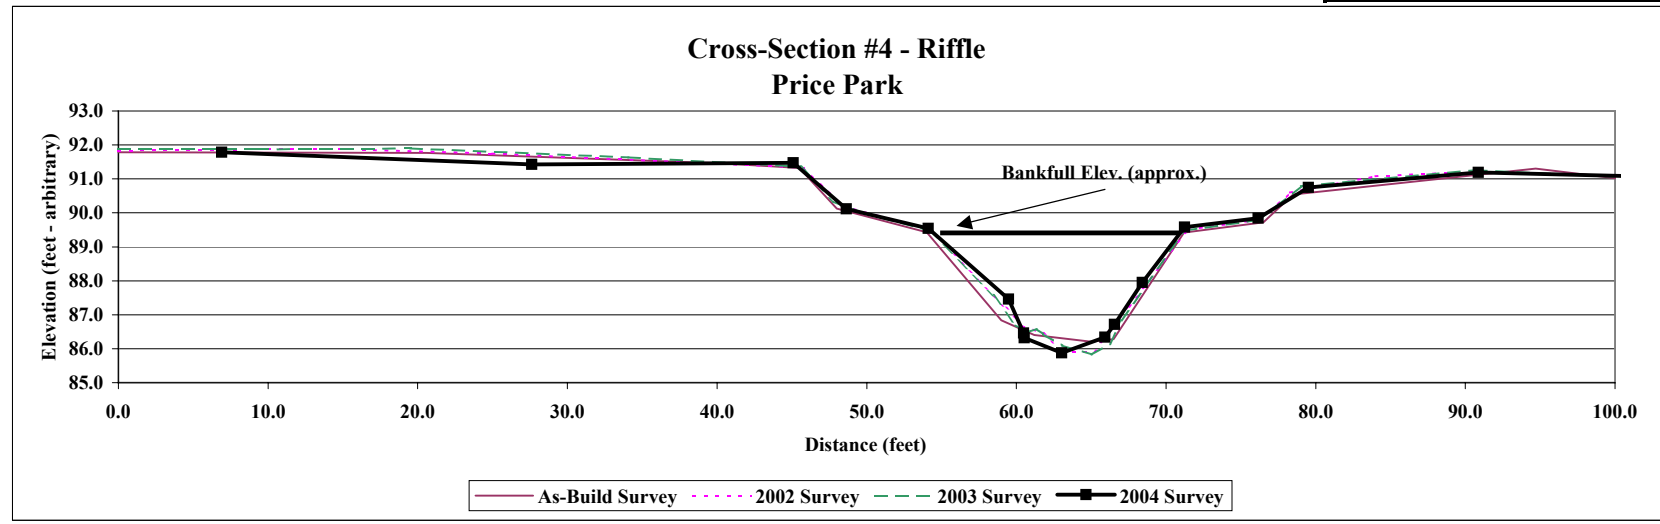
Photo of Cross-Section #4 - Looking Upstream

As-Built	2002	2003	2004
Area	36.7	36.69	36.28	35.05
Width	17.2	13.3	17.2	17.1
Mean Dept	2.1	2.8	2.1	2.0
Max Depth	3.2	3.6	3.7	3.7
