**Price Park  
Stream Restoration Monitoring Report  
EEP Project # 291  
Monitoring Year – 06  
2008**

**March 2009**

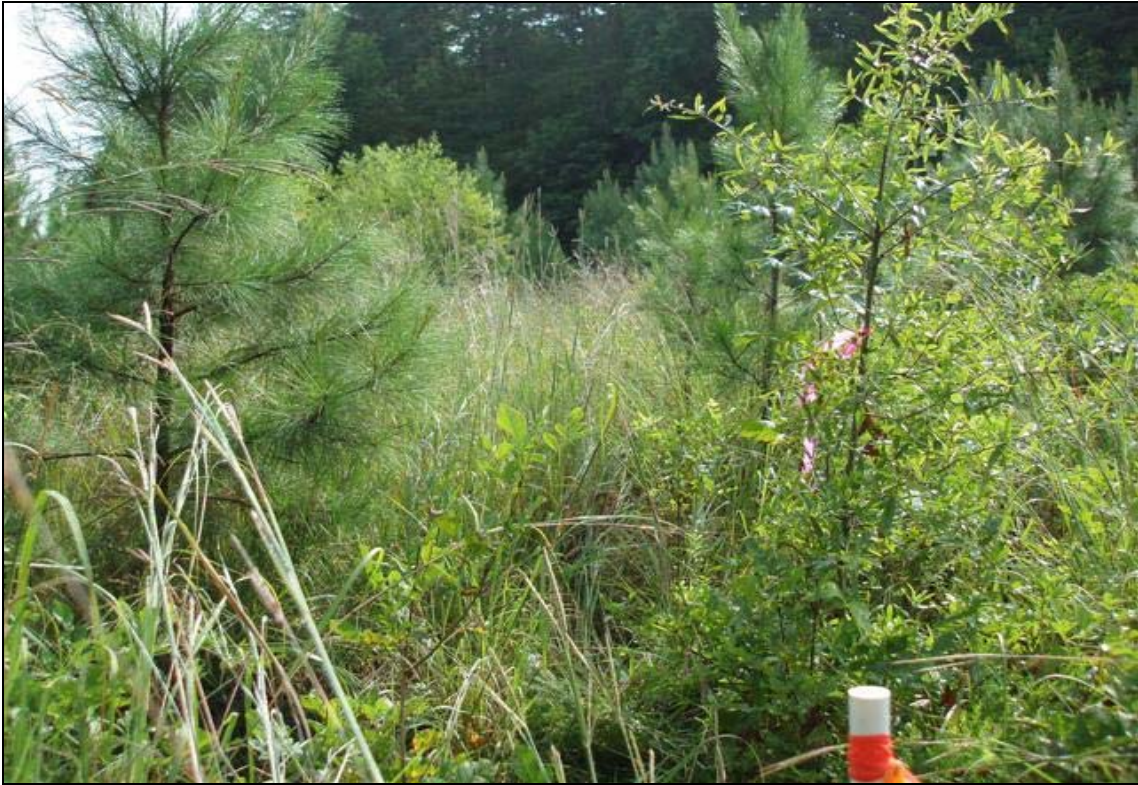
Vegetation Plot 1 – Taken looking southeast toward the center of the plot from the origin. 8/14/08 - MY 06

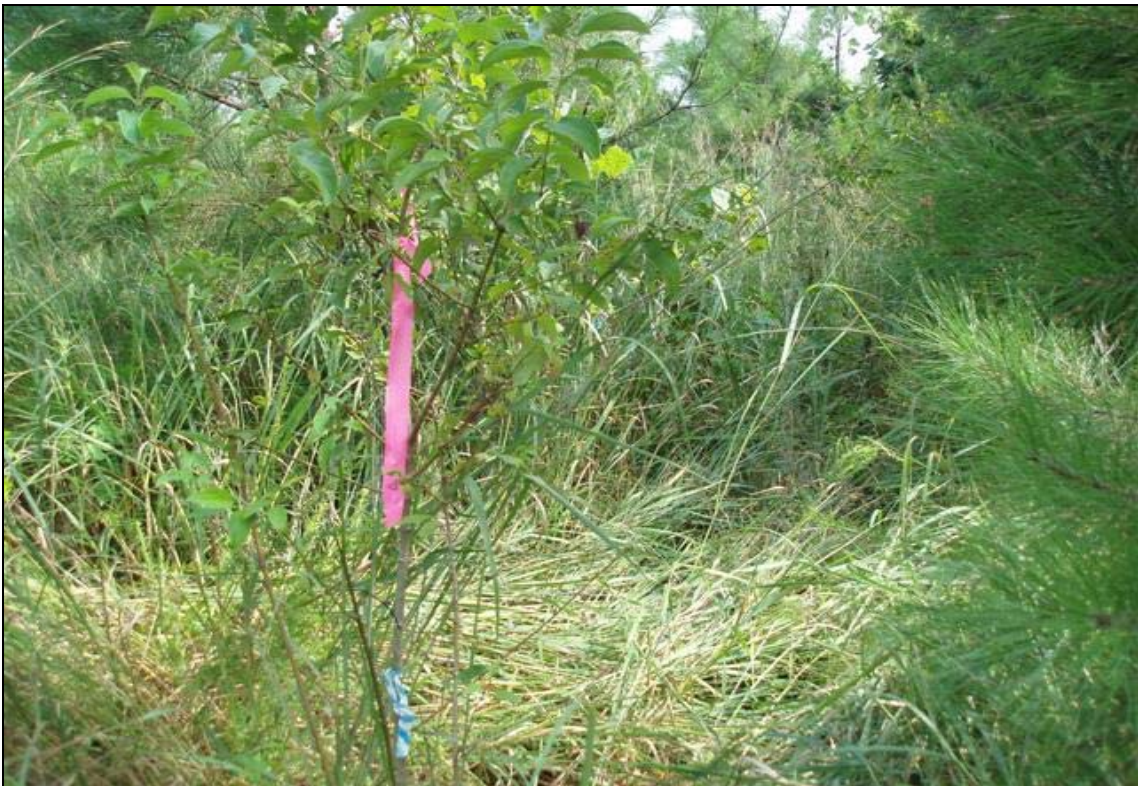
Vegetation Plot 2 – Taken looking northeast toward the center of the plot from the origin. 8/14/08 - MY 06

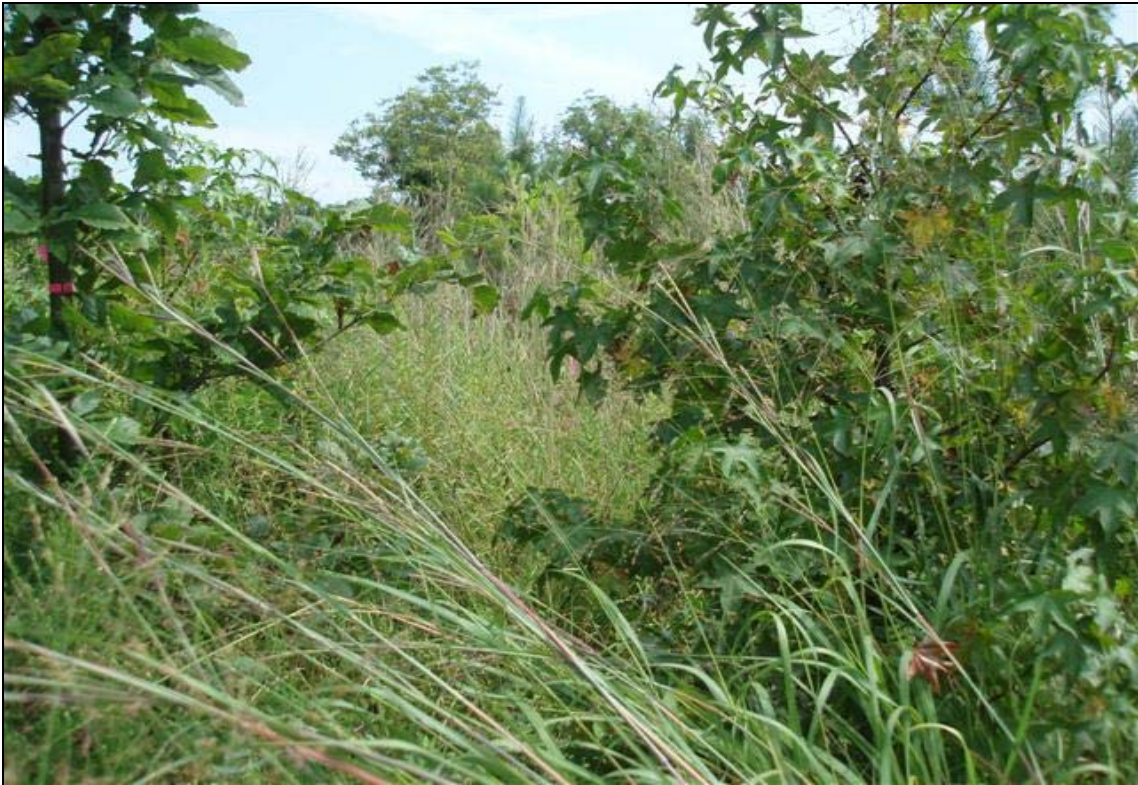
Vegetation Plot 3 – Taken looking east toward the center of the plot from the origin. 8/14/08 - MY 06

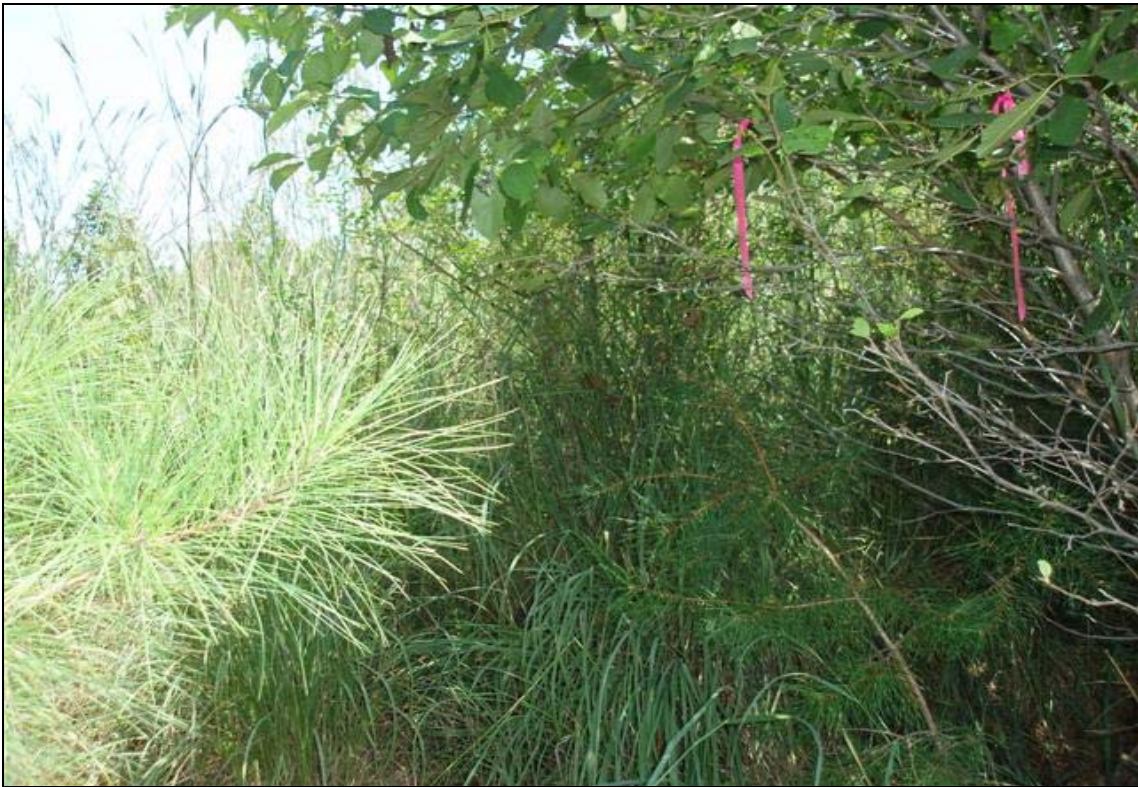
Vegetation Plot 4 – Taken looking east toward the center of the plot from the origin. 8/14/08 - MY 06

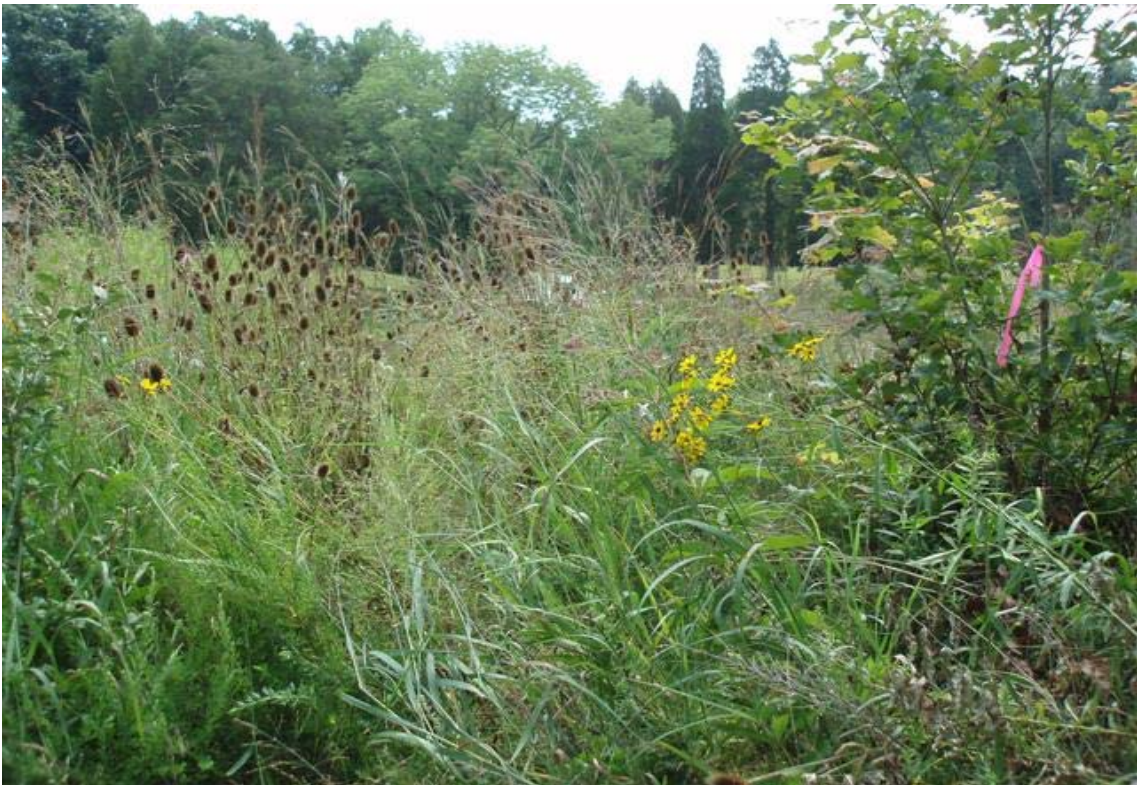
Vegetation Plot 5 – Taken looking south toward the center of the plot from the origin. 8/14/08 - MY 06

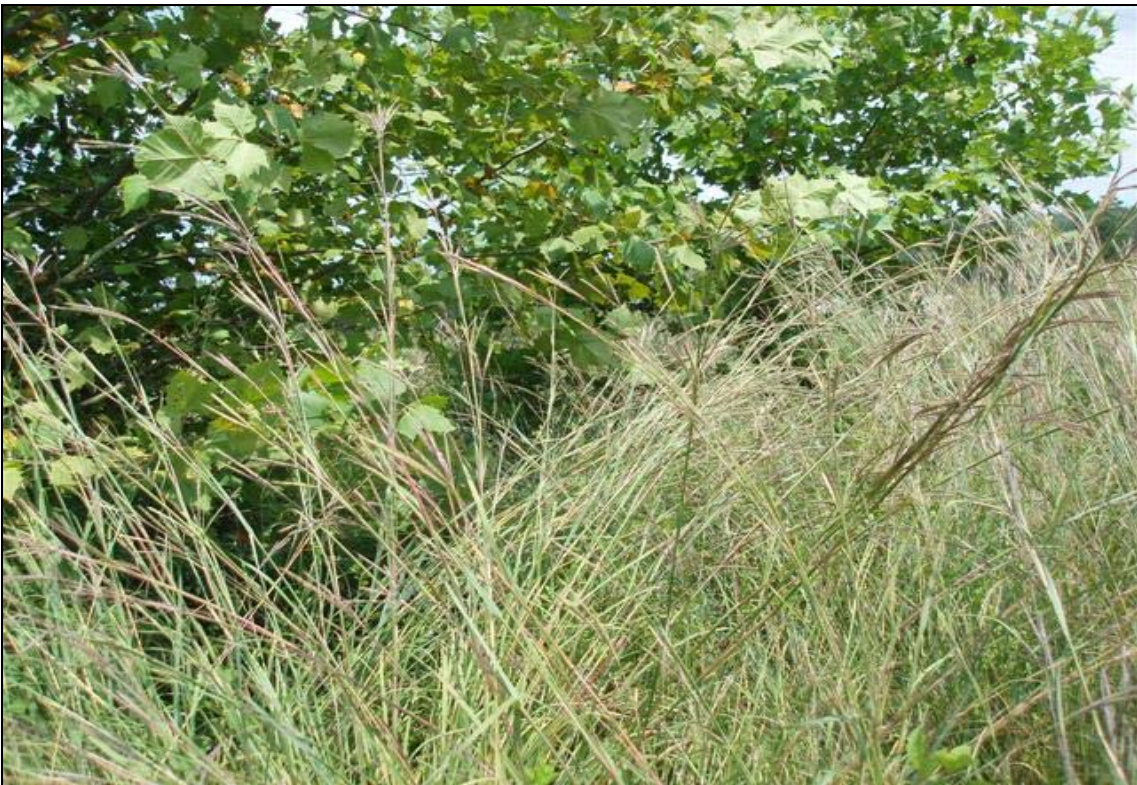
Vegetation Plot 6 – Taken looking east toward the center of the plot from the origin. 8/14/08 - MY 06

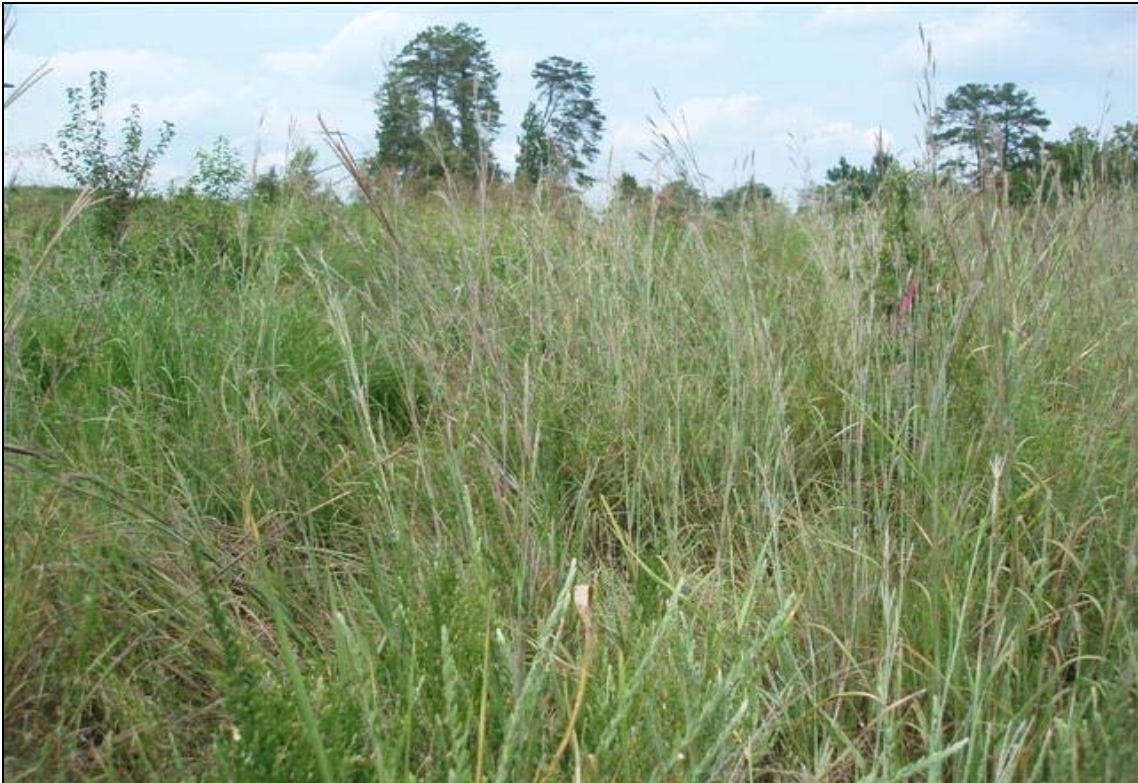
Vegetation Plot 7 – Taken looking northeast toward the center of the plot from the origin. 8/14/08 - MY 06

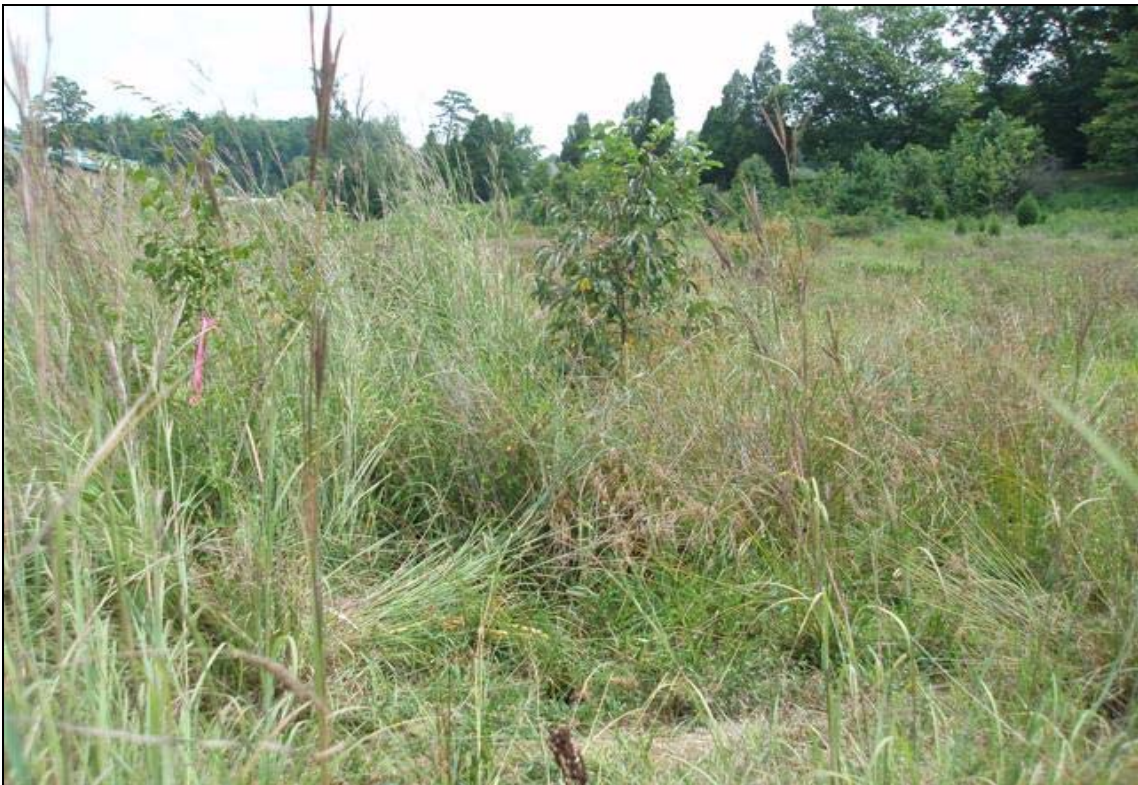
Vegetation Plot 8 – Taken looking south toward the center of the plot from the origin. 8/14/08 - MY 06
