Purlear Creek - Phase I Stream Restoration Annual Monitoring Report

Monitoring Year: 2005

NCEEP Project Number: 294

Prepared by: Biological & Agricultural Engineering, North Carolina State University
Campus Box 7625
Raleigh, NC 27695

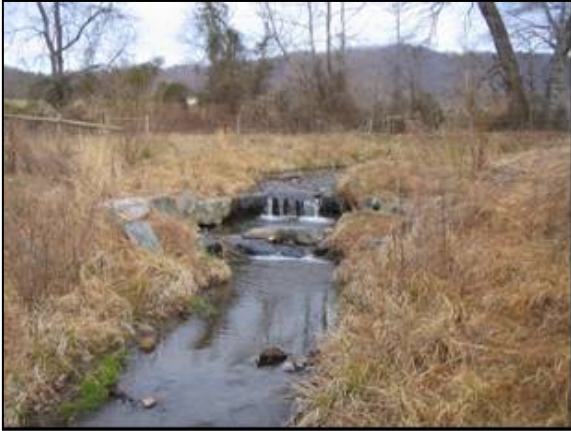
IP 1 Bed Elevation Drop (Upstream of Study Reach)

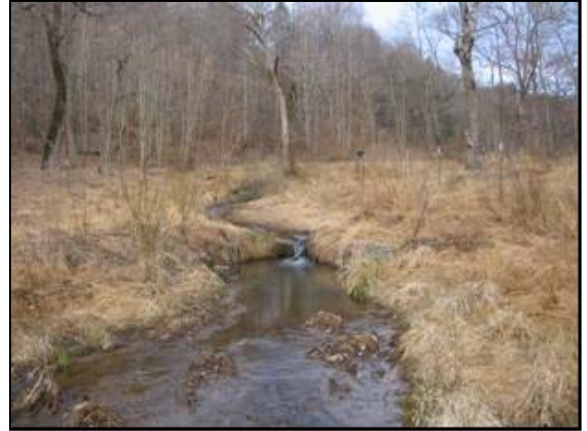
IP 2 Bed Elevation Drop (Upstream of Study Reach)

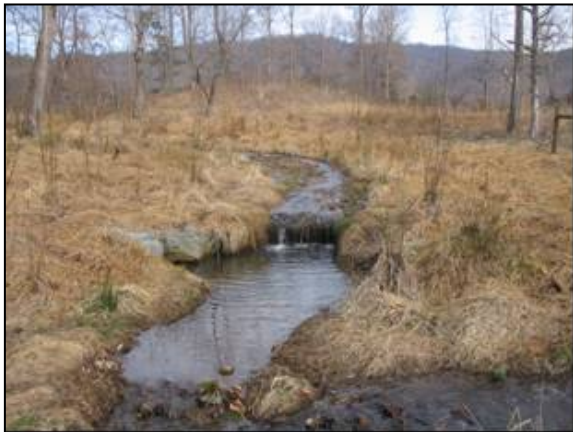
IP 3 Bed Elevation Drop (Upstream of Study Reach)

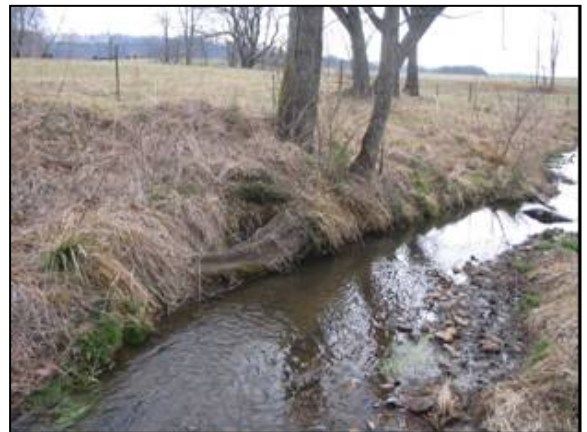
Reach	Problem/ Photo Number	Feature Issue	Station Numbers	Suspected Cause
Reach 1	IP6	Bank Erosion	(4+25)	High shear stress, poor vegetation
Reach 3	IP17	Double Drop Vane w/ Bank Erosion	Above Study Reach	Constriction of Flow
	IP 18	Slump Arm	(0+00)	Poor Soils, Lack of sufficient footers
	IP20	Erosion / Ground Hog Tunnels	(4+00)	Ground Hogs
	IP22	Slump Arm and Piping	Below Study Reach	Poor Soils, Lack of sufficient footers
	IP24	Excess Nutrients through Buffer	Below Study Reach	Farmer
Reach 4	IP25	Excess Nutrients through Buffer	(0+50)	Farmer
Reach 6	IP36	Tile	Above Study Reach	Farmer
	IP38	Vane Slump and Erosion	(1+00)	Poor Soils, Lack of sufficient footers
	IP39	Tile	(2+10)	Farmer
	IP40	Vane Undermine Rt. Arm	(3+50)	Poor Soils, Lack of sufficient footers
	IP41	Bank Erosion	(4+00)	High shear stress, poor vegetation
	IP44	Bank Erosion	(7+50)	High shear stress, poor vegetation

IP 6 Bank Erosion (Station 4+25)

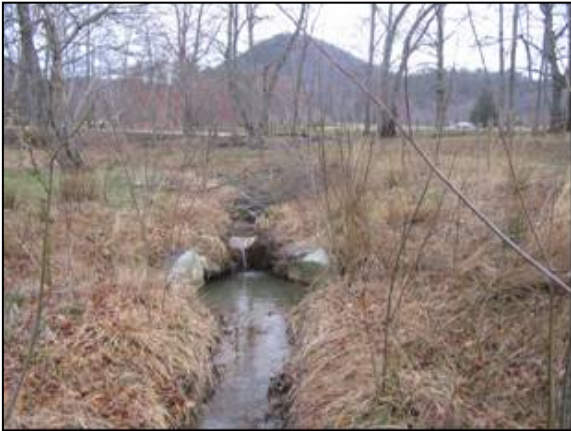
IP 9 Bed Elevation Drop (Upstream of Study Reach)

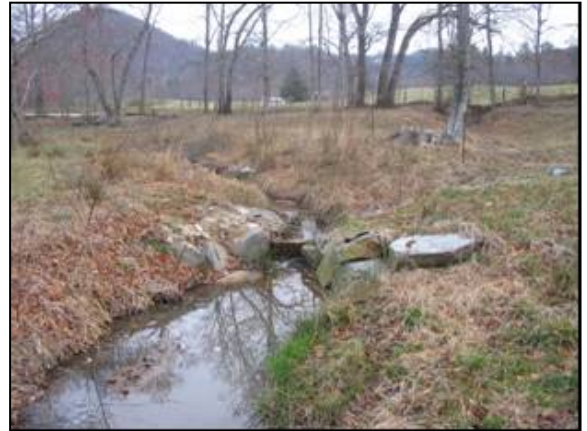
IP 10 Bed Elevation Drop (Upstream of Study Reach)

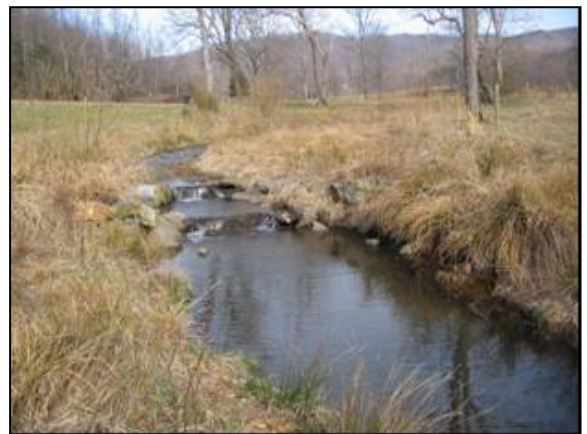
IP 17 Double Drop Vane w/ Erosion (Above Study Reach)

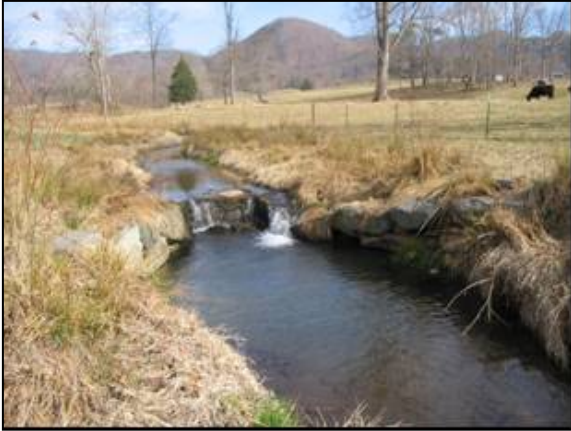
In addition to the elevation drops at the 5 cross vanes, two cross vanes are showing impairment. The cross vane at station 1+00 has significant erosion along the right vane arm and the arm is slumping due to the depth of scour near the arm. This appears localized and is not in need of repair at this time. The cross vane at station 3+50 also has some slumping of the left vane arm and is beginning to pipe water through the left arm. This area should continue to be observed to see if further degradation will occur. Two areas of additional bank erosion occur on this reach at stations 4+00 and 7+50. Both areas appear localized if vegetation becomes established. These areas should be observed in upcoming monitoring periods.

IP 18 Slump Arm (Station 0+00)

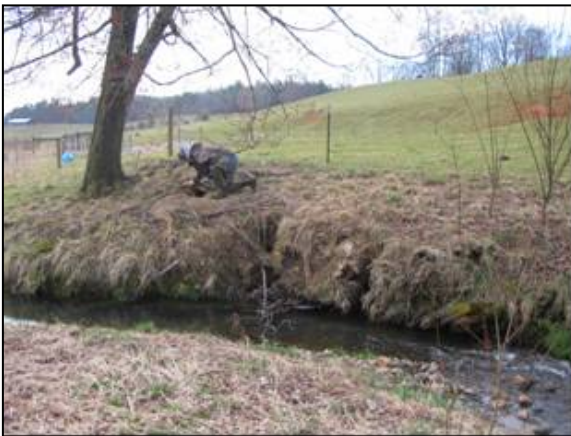
IP 20 Erosion Ground Hog Tunnels (Station 4+00)

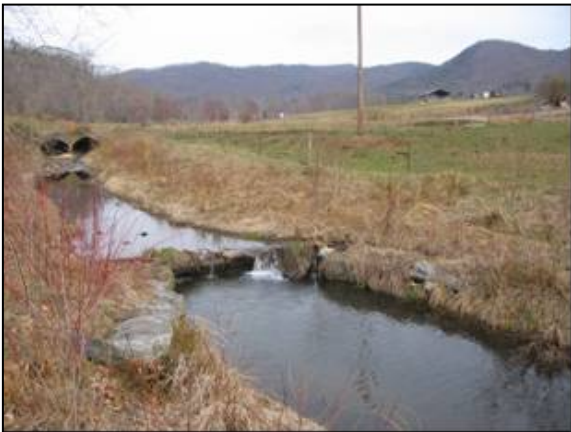
IP 22 Slump Arm and Piping (Below Study Reach)

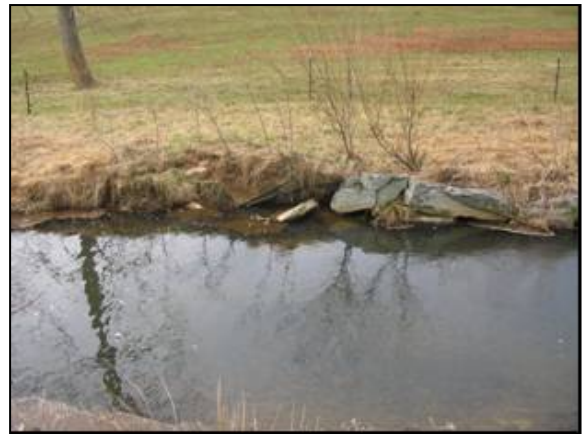
IP 38 Vane Slump and Erosion (Station 1+00)

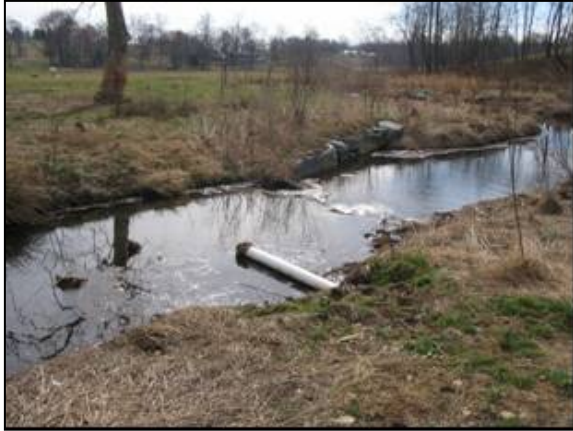
IP 39 Tile (Station 2+10)

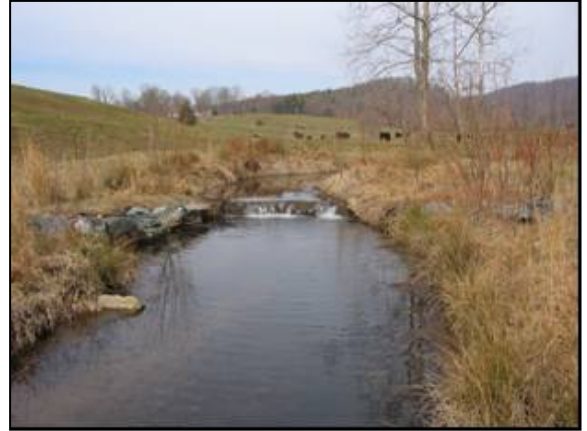
IP 40 Vane Undermine Rt. Arm (Station 3+50)

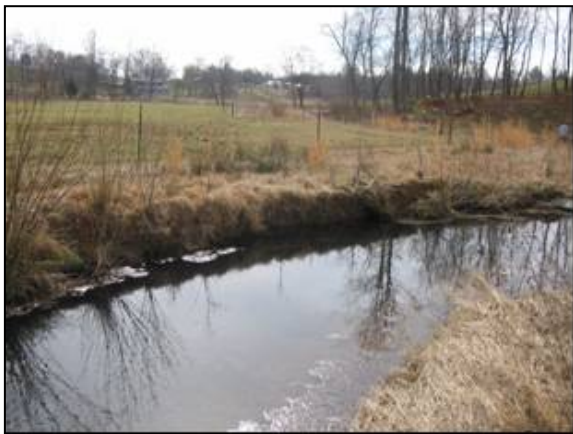
IP 41 Bank Erosion (Station 4+70)

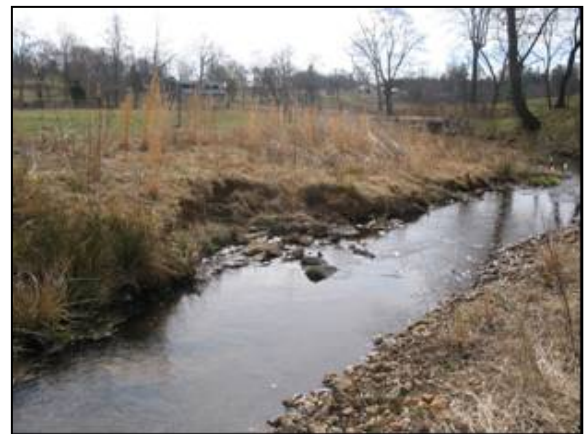
IP 44 Bank Erosion (Station 7+50)
