Purlear Creek - Phase I Stream Restoration Annual Monitoring Report

Monitoring Year: 2006

NCEEP Project Number: 294

PURLEAR CREEK - PHASE 1 STREAM RESTORATION 2006 MONITORING REPORT

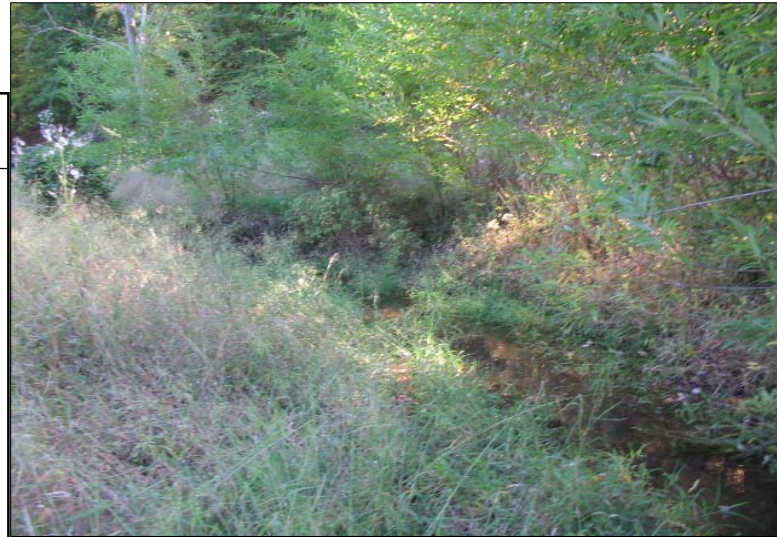
Photo of Area 1 Cross-Section #1 - Looking Downstream

As-Built	2005	2006
Area	36.7	35.5	14.8
Width	29.9	29.6	22.7
Mean Depth	1.2	1.2	0.6
Max Depth	2.3	2.6	1.9

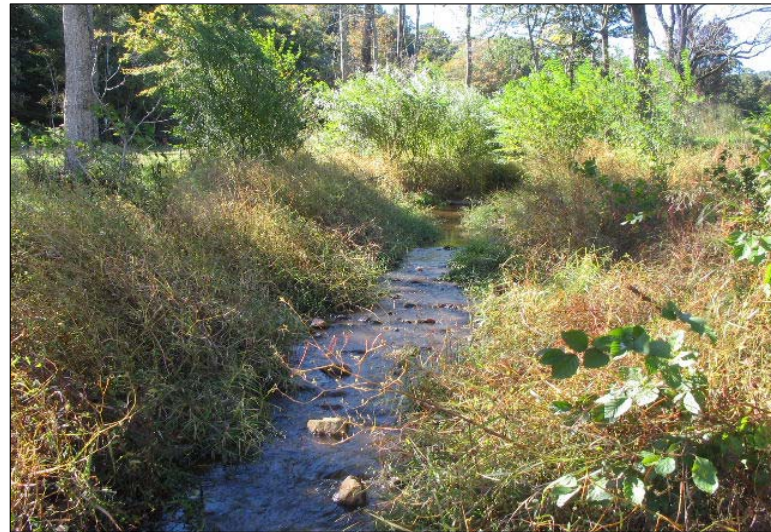
Photo of Area 1 Cross-Section #2 - Looking Downstream

As-Built	2005	2006
Area	39.6	39.6	41.0
Width	26.7	26.4	31.4
Mean Depth	1.5	1.5	1.3
Max Depth	2.3	2.3	2.5
w/d ratio	18.1	17.6	24.1
FPW	53	53	53
ER (greater than)	2.0	2.0	1.7
Stream Type	C4	C4	C4

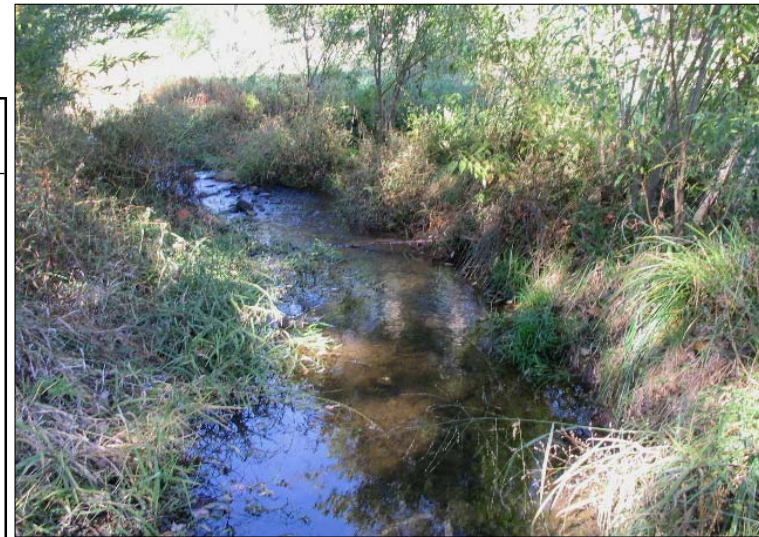
Photo of Area 3 Cross-Section #1 - Looking Downstream

As-Built	2005	2006
Area	43.7	44.8	37.0
Width	22.6	26.2	24.2
Mean Depth	1.9	1.7	1.5
Max Depth	3.1	3.3	2.5

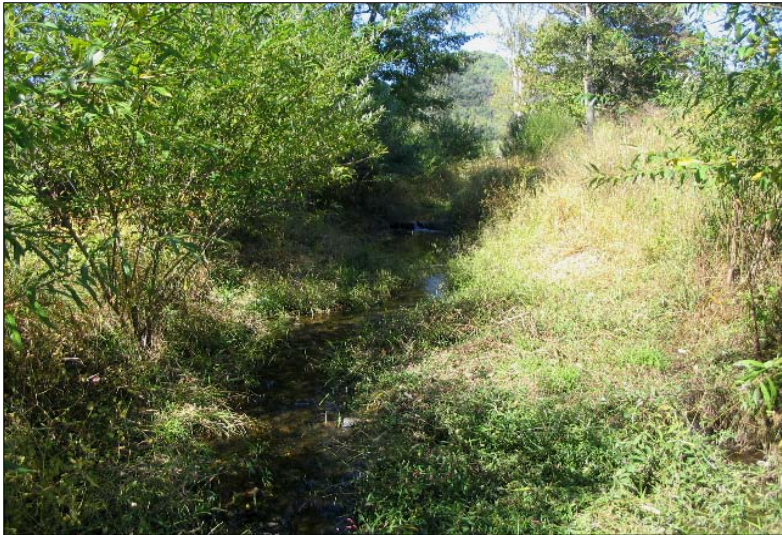
Area 3 Cross-Section #2 - Riffle Station 3+45
Purlear Phase I - Middle Main

Photo of Area 3 Cross-Section #2 - Looking Downstream

As-Built	2005	2006
Area	28.3	28.1	27.2
Width	24.5	24.2	25.1
Mean Depth	1.2	1.2	1.1
Max Depth	2.1	2.1	2.4
w/d ratio	21.3	20.9	23.0
FPW	60	60	60
ER (greater than)	2.4	2.5	2.4
Stream Type	C4	C4	C4

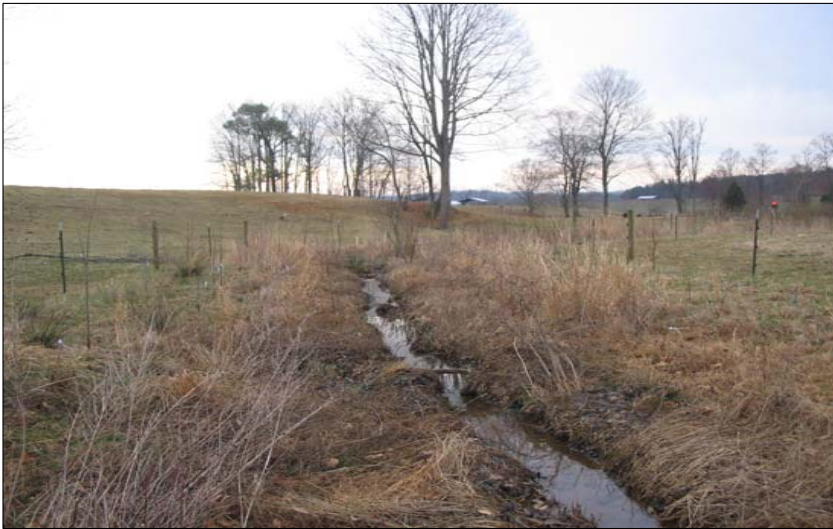
Photo of Area 2 Cross-Section #1 - Looking Downstream

As-Built	2005	2006
Area	11.9	12.4	8.6
Width	17.4	16.2	17.3
Mean Depth	0.7	0.8	0.5
Max Depth	1.5	1.7	1.4
w/d ratio	25.5	21.1	34.6
FPW	40	40	40
ER (greater than)	2.3	2.5	2.3
Stream Type	C4	C4	C4

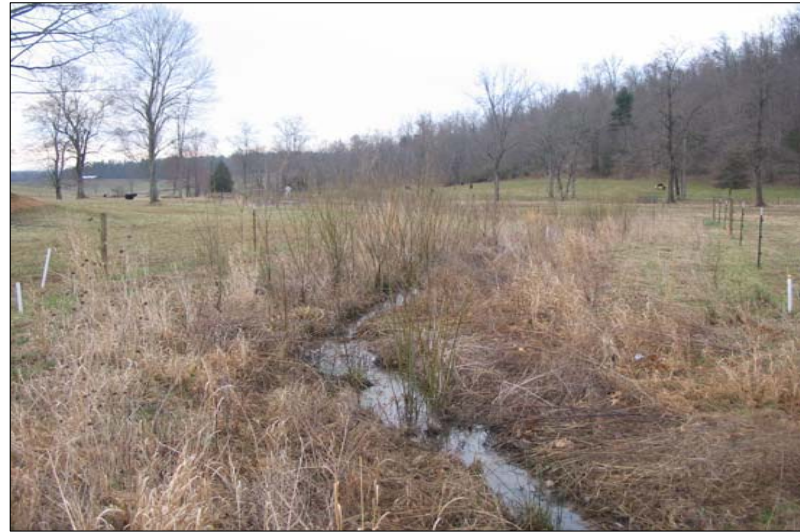
Area 2 Cross-Section #2 - Pool Station 1+15
Purlear Phase I - Upper Middle Trib

Photo of Area 2 Cross-Section #2 - Looking Downstream

As-Built	2005	2006
Area	12.8	13.4	7.6
Width	19.4	19.3	18.5
Mean Depth	0.7	0.7	0.4
Max Depth	1.6	1.6	1.1

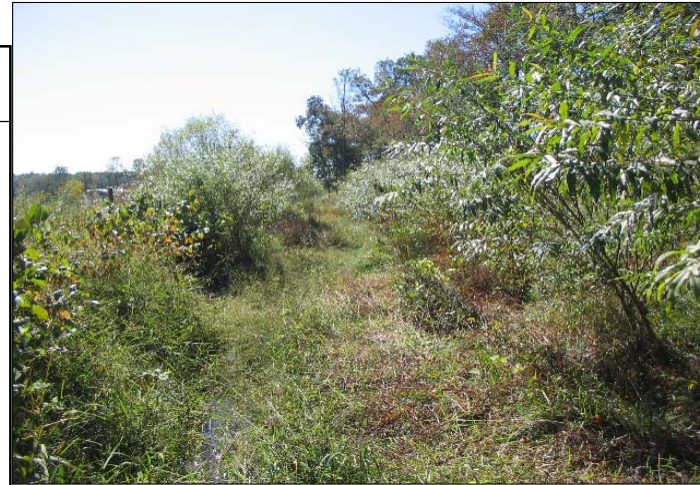
Photo of Area 4 Cross-Section #1 - Looking Downstream

As-Built	2005	2006
Area	21.8	19.1	18.8
Width	25.1	25.1	22.3
Mean Depth	0.9	0.8	0.8
Max Depth	1.6	1.5	2.2
w/d ratio	28.9	32.9	26.5
FPW	50	50	50
ER (greater than)	2.0	2.0	2.2
Stream Type	C4	C4	C4

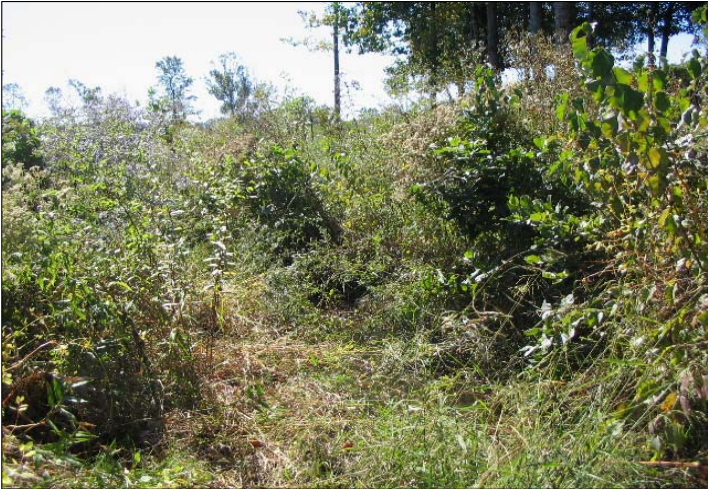
Area 4 Cross-Section #2 - Pool Station 5+45
Purlear Phase I - Lower Middle Trib (Upper Section)

Photo of Area 4 Cross-Section #2 - Looking Downstream

As-Built	2005	2006
Area	21.5	18.1	13.9
Width	22.6	21.2	20.3
Mean Depth	1.0	0.9	0.7
Max Depth	2.3	2.2	2.2

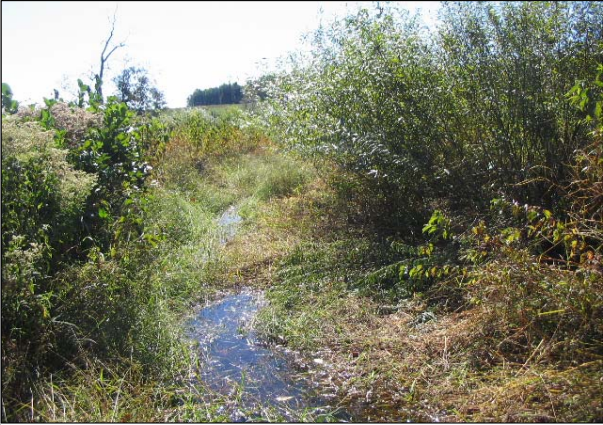
Photo of Area 5 Cross-Section #1 - Looking Downstream

As-Built	2005	2006
Area	26.8	29.4	27.4
Width	21.4	21.4	23.7
Mean Depth	1.3	1.4	1.2
Max Depth	2.5	3.3	2.9

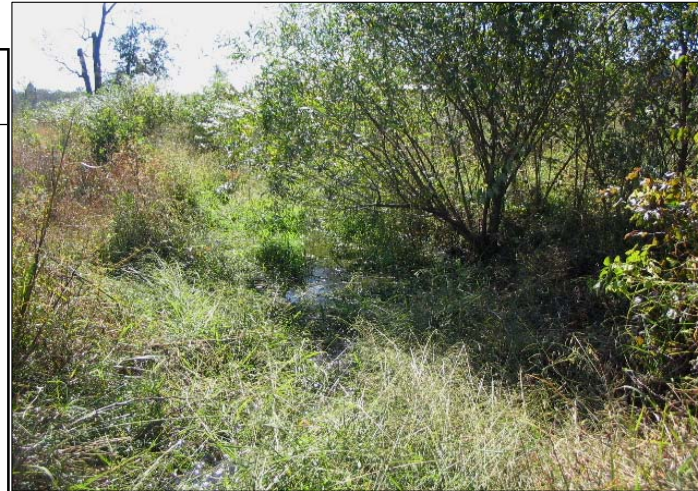
Area 5 Cross-Section #2 - Riffle Station 3+85
Purlear Phase I - Lower Middle Trib (Lower Section)

Photo of Area 5 Cross-Section #2 - Looking Downstream

As-Built	2005	2006
Area	23.1	19.8	17.9
Width	26.3	25.0	23.5
Mean Depth	0.9	0.8	0.8
Max Depth	1.7	1.7	1.4
w/d ratio	30.0	31.7	30.9
FPW	60	60	60
ER (greater than)	2.3	2.4	2.6
Stream Type	C4	C4	C4

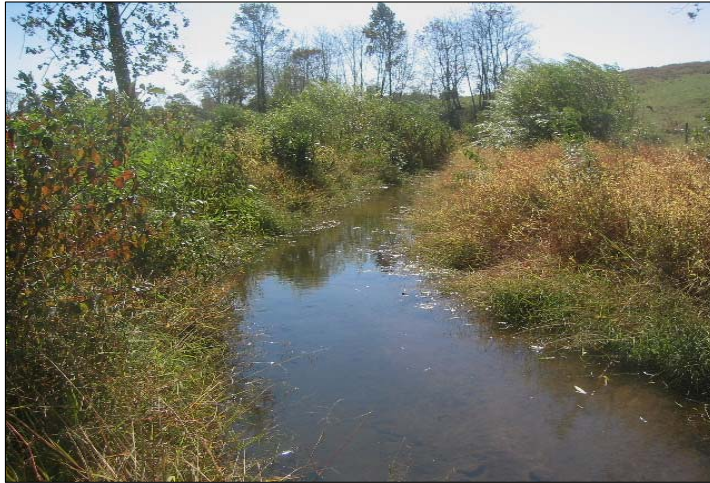
Photo of Area 6 Cross-Section #1 - Looking Downstream

As-Built	2005	2006
Area	43.6	36.3	33.2
Width	18.9	19.2	17.9
Mean Depth	2.3	1.9	1.9
Max Depth	3.8	3.5	3.3

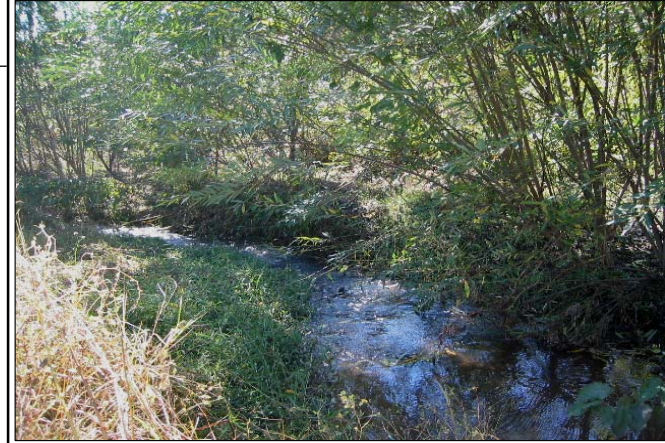
Area 6 Cross-Section #2 - Riffle Station 5+85
Purlear Phase I - Lower Main

Photo of Area 6 Cross-Section #2 - Looking Downstream

As-Built	2005	2006
Area	40.2	37.8	35.2
Width	27.1	26.9	34.3
Mean Depth	1.5	1.4	1.0
Max Depth	2.5	2.9	3.0
w/d ratio	18.3	19.2	33.4
FPW	60	60	60
ER (greater than)	2.2	2.2	1.7
Stream Type	C4	C4	C4
