Purlear Creek - Phase I Stream Restoration Annual Monitoring Report

Monitoring Year: 2008

NCEEP Project Number: 294

PURLEAR CREEK - PHASE I STREAM RESTORATION 2008 MONITORING REPORT

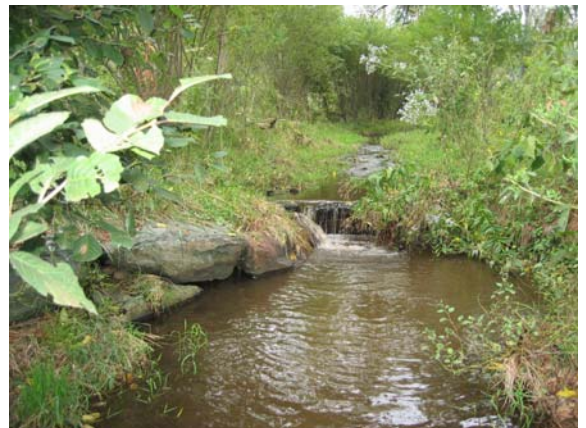
IP 7 Bed Elevation Drop (Station 5+50)
