Purlear Creek - Phase II Stream Restoration Annual Monitoring Report

Monitoring Year: 2007

NCEEP Project Number: 010559701

PURLEAR CREEK - PHASE II STREAM RESTORATION 2007 MONITORING REPORT

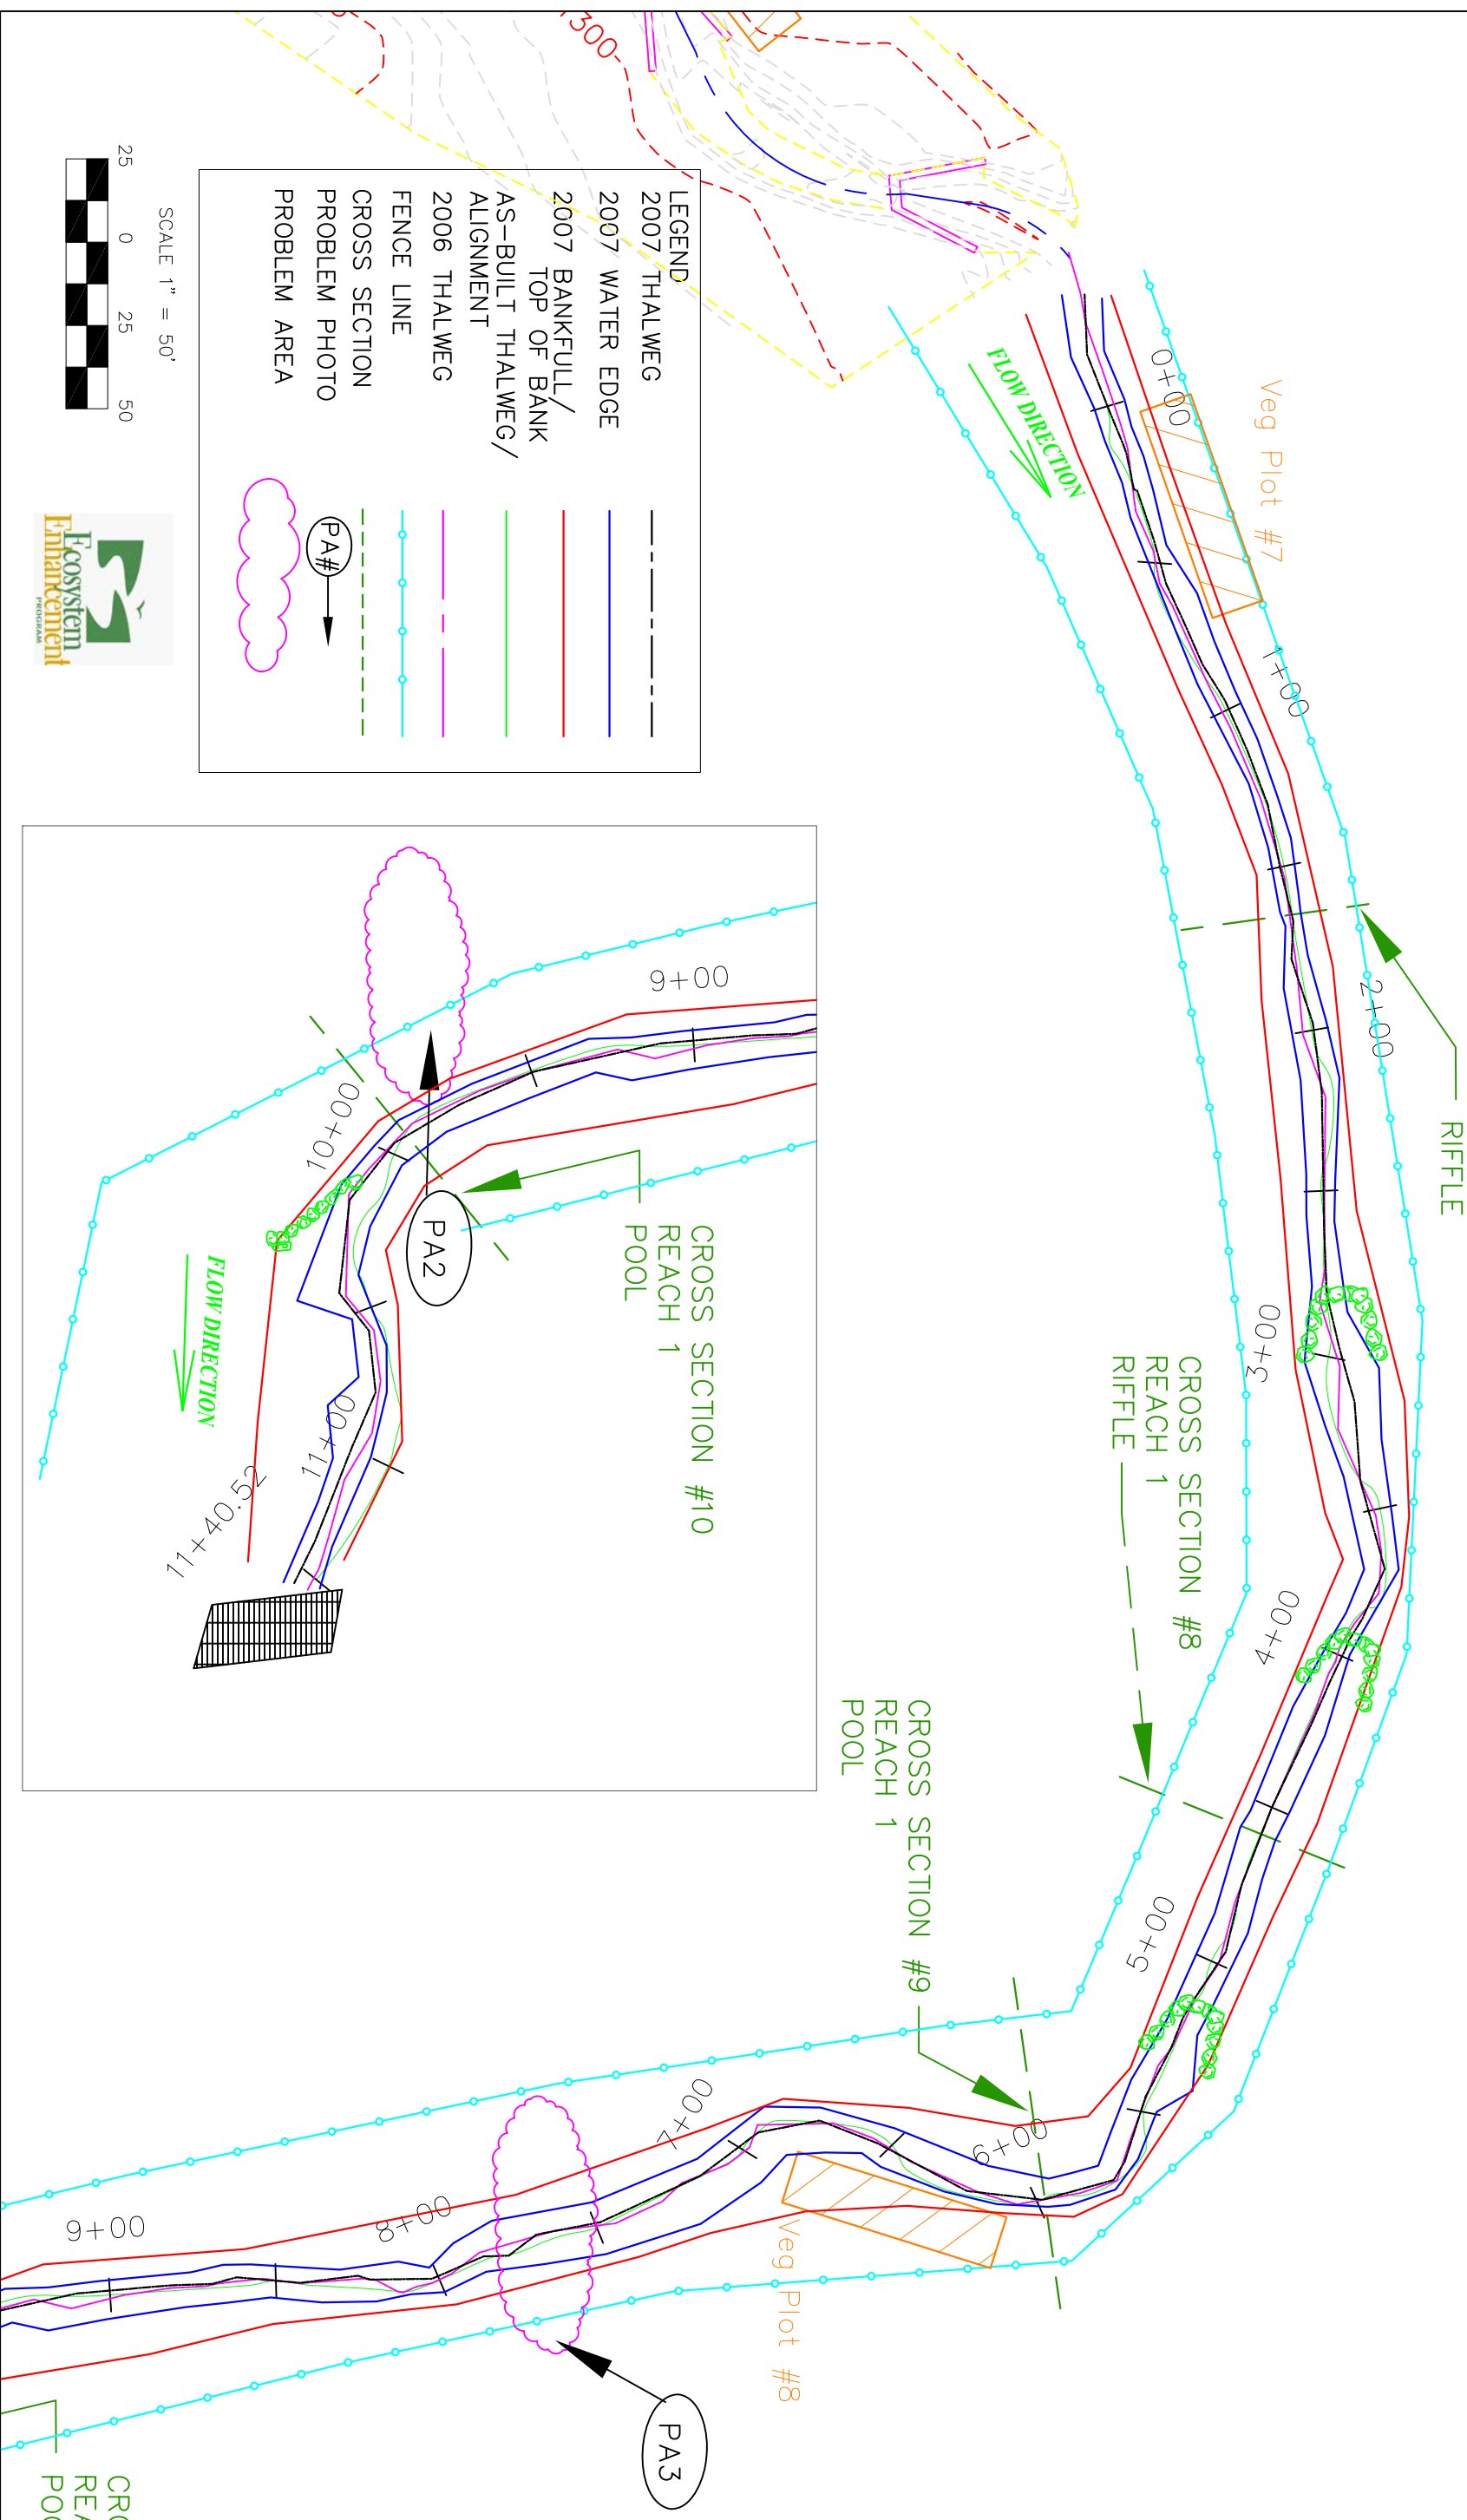
CROSS SECTION #7 REACH 1 RIFFLE MAIN STEM REACH NORTH

The problem area Table B1, plan sheet and photographs can be found in Appendix B. Two problem areas were identified in the 2006 monitoring report in Reach 1. Problem area 1 appeared to stabilize in 2007. Problem area 2 was less of an issue in 2007 due to the drought conditions. Both areas shall continue to be monitored. An additional problem area was identified on Reach 1 in 2007. Problem area 3 consists of a beaver dam on Reach 1, which is backing up water and obstructing flow. It is recommended that the beaver dam be removed so the stream can flow as intended.

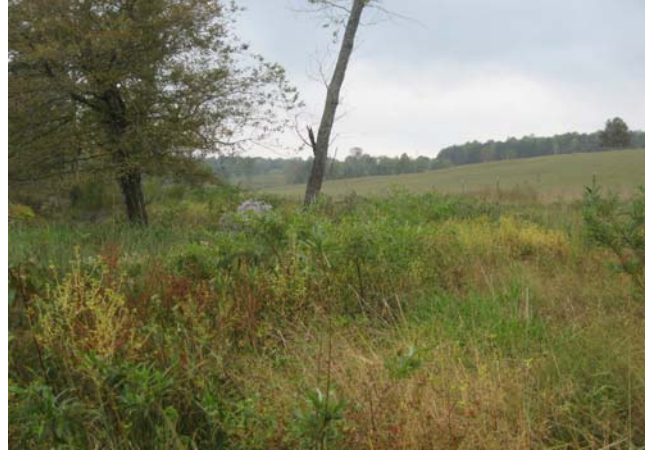
Photo of Cross-Section #1 - Looking Downstream

As-Built	2006
Area	7.31	6.7
Width	17.5	11.1
Mean Depth	0.4	0.6
Max Depth	1.3	1.3
w/d ratio	41.8	18.3
FPW	72	72
ER (greater than)	4.1	6.5
Stream Type	C	C

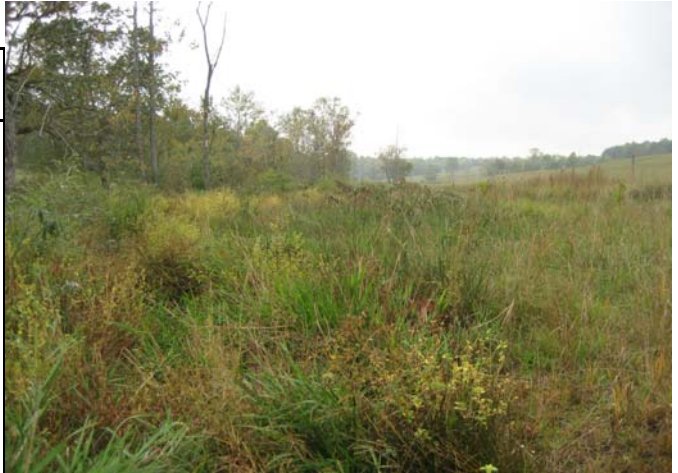
Photo of Cross-Section #2 - Looking Downstream

As-Built	2006	2007
Area	4.9	4.2	5.9
Width	6.2	9.4	10.8
Mean Depth	0.8	0.4	0.6
Max Depth	1.1	1.0	0.9

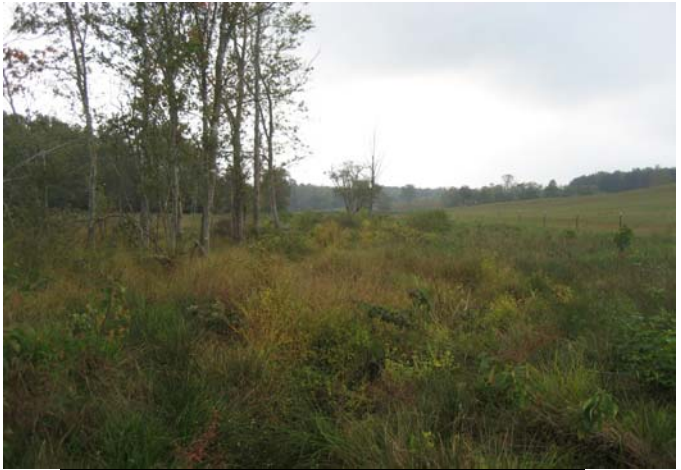
Photo of Cross-Section #3 - Looking Downstream

As-Built	2006	2007
Area	4.93	4.8	4.3
Width	10.3	7.8	7.3
Mean Depth	0.5	0.6	0.6
Max Depth	1.5	1.4	1.4
w/d ratio	21.5	12.9	12.3
FPW	72	72	72
ER (greater than)	7.0	9.2	9.9
Stream Type	C	C	C

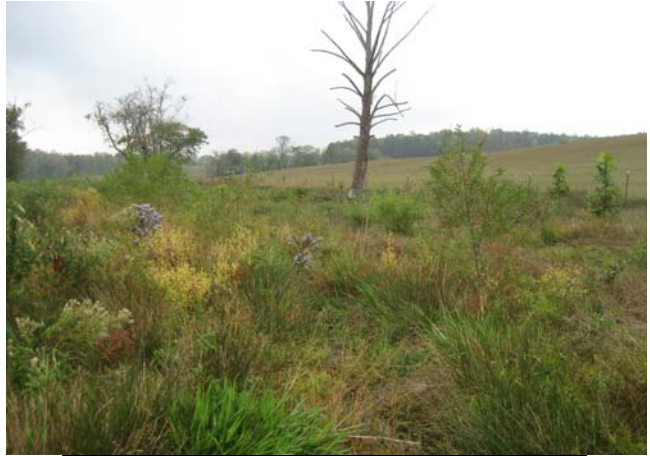
**Reach 4 Pool Cross Section #4 - Station 7+60
Purlear Phase II**

Photo of Cross-Section #4 - Looking Downstream

As-Built	2006	2007
Area	12.1	14.2	13.3
Width	11.3	13.7	10.3
Mean Depth	1.1	1.0	1.3
Max Depth	2.2	2.5	2.6

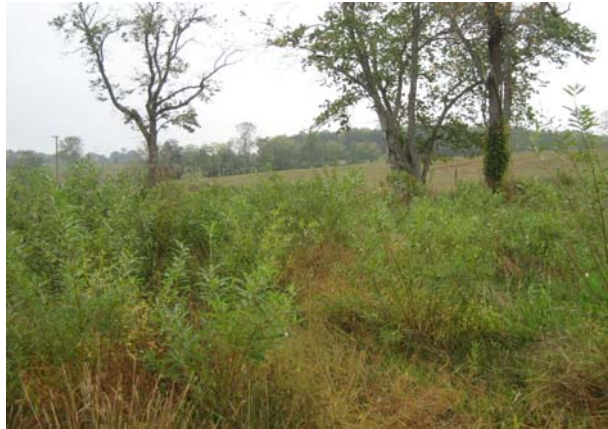
Reach 4 Riffle Cross Section #5 - Station 10+75 Purlear Phase II

Photo of Cross-Section #5 - Looking Downstream

As-Built	2006	2007
Area	5.1	7.0	6.2
Width	10.1	9.9	8.8
Mean Depth	0.5	0.7	0.7
Max Depth	0.9	1.4	1.3
w/d ratio	20.0	14.0	12.5
FPW	46	46	46
ER (greater than)	4.5	4.6	5.2
Stream Type	C	C	C

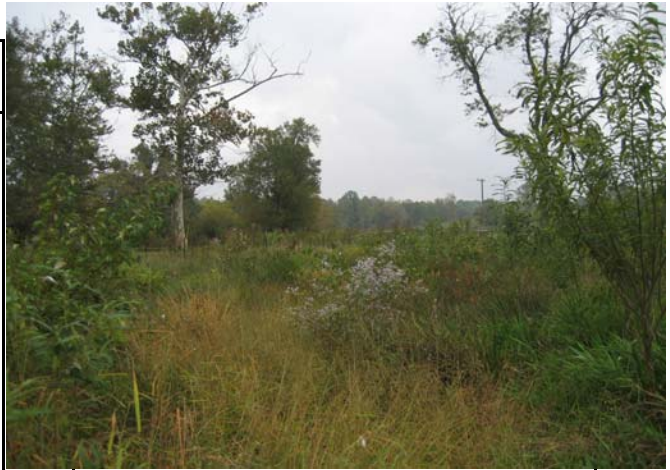
Project Name	Purlear Phase II
Cross Section	X6 Reach 4
Feature	Pool
Date	8/6/2007
Crew	Roberts, Price, Zink

Photo of Cross-Section #6 - Looking Downstream

As-Built	2006	2007
Area	6.1	7.9	8.2
Width	8.4	8.0	10.9
Mean Depth	0.7	1.0	0.8
Max Depth	1.3	1.7	1.9

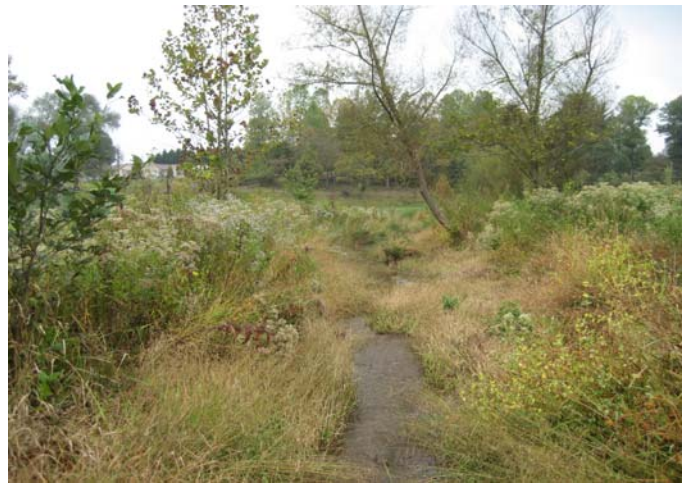
Reach 1 Riffle Cross Section #7 - Station 1+65 Purlear Phase II

Photo of Cross-Section #7 - Looking Downstream

As-Built	2006	2007
Area	49.9	50.7	46.9
Width	35.2	42.3	40.0
Mean Depth	1.4	1.2	1.2
Max Depth	2.7	2.7	2.7
w/d ratio	24.9	35.2	34.2
FPW	100	100	100
ER (greater than)	2.8	2.4	2.5
Stream Type	C	C	C

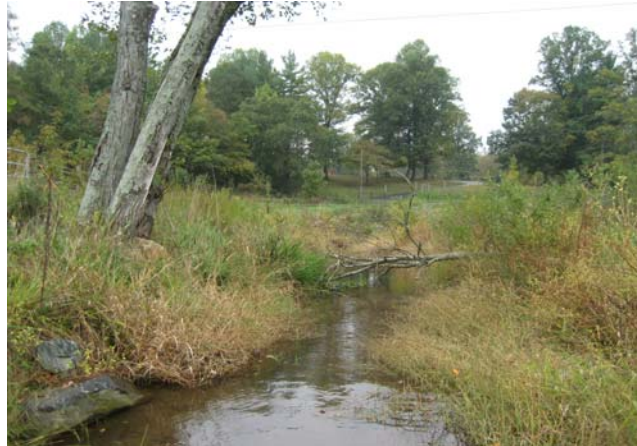
Reach 1 Riffle Cross Section # 8 - Station 4+60 Purlear Phase II

Photo of Cross-Section #8 - Looking Downstream

As-Built	2006	2007
Area	48.59	54.8	57.9
Width	23.7	31.3	30.2
Mean Depth	2.0	1.8	1.9
Max Depth	3.4	3.5	3.5
w/d ratio	11.6	17.9	15.7
FPW	98	98	98
ER (greater than)	4.1	3.1	3.2
Stream Type	C	C	C

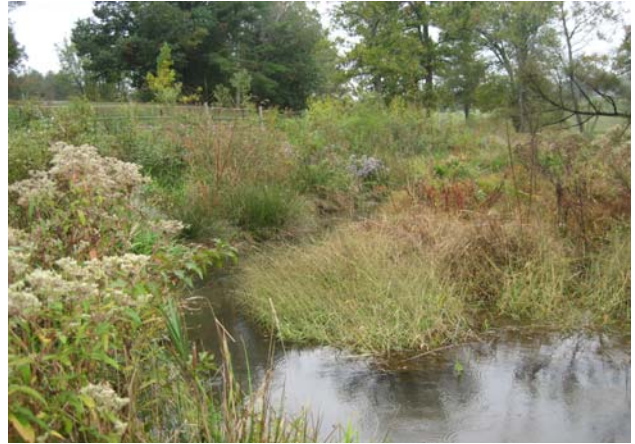
Project Name	Purlear Phase II
Cross Section	X9 Reach 1
Feature	Pool
Date	8/6/2007
Crew	Roberts, Price, Zink

Photo of Cross-Section #9 - Looking Downstream

As-Built	2006	2007
Area	33.8	31.5	28.6
Width	29.2	28.8	29.3
Mean Depth	1.2	1.1	1.0
Max Depth	3.4	3.2	3.4

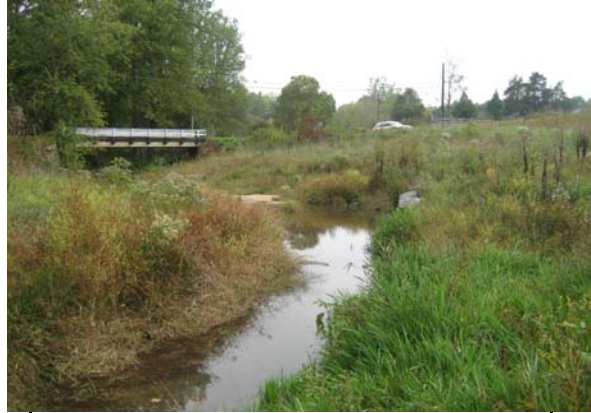
Project Name	Purlear Phase II
Cross Section	X10 Reach 1
Feature	Pool
Date	8/6/2007
Crew	Roberts, Price, Zink

Photo of Cross-Section #10 - Looking Downstream

As-Built	2006	2007
Area	40.0	42.4	45.2
Width	28.3	34.5	30.0
Mean Depth	1.4	1.2	1.5
Max Depth	2.9	3.0	3.1
