# Puzzle Creek Mitigation Project

## Year 3 Monitoring Report

Rutherford County, North Carolina

Report Submitted: June 2014

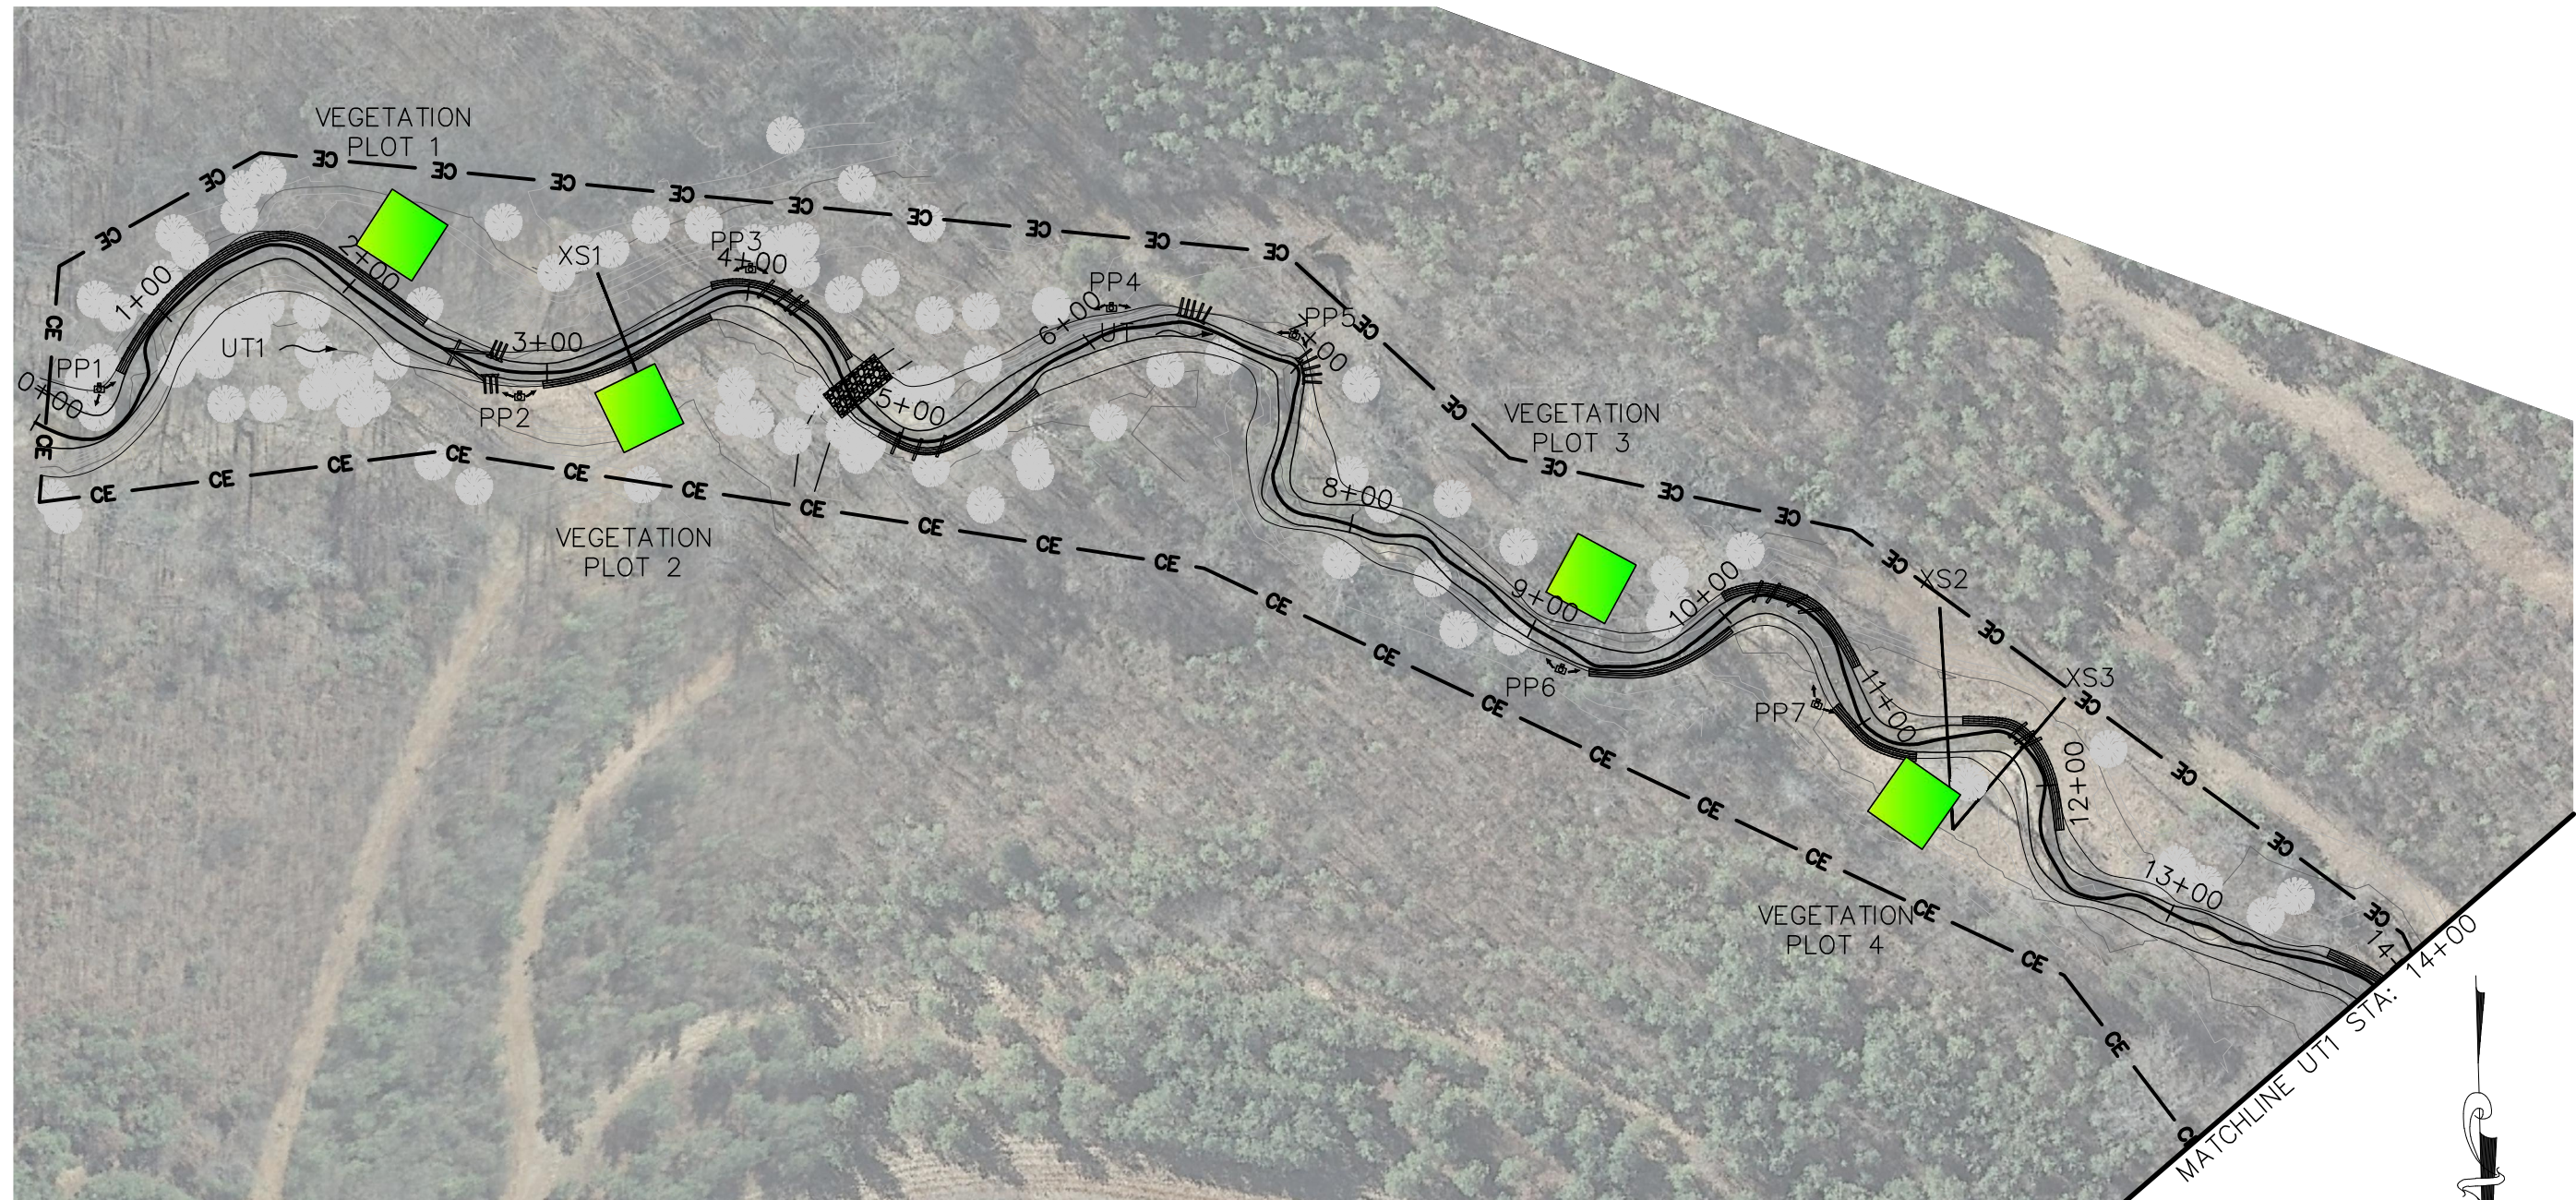
UT1  
 CURRENT CONDITION  
 PLAN VIEW  
 0+00-14+00  
 YEAR 3 MONITORING

- VEG PLOT CRITERIA MET
- VEG PLOT CRITERIA UNMET (NO PLOTS CURRENTLY MEETING THIS CRITERIA)
- STREAM PROBLEM AREA (SPA) BANKS WITH MINOR SCOUR/EROSION

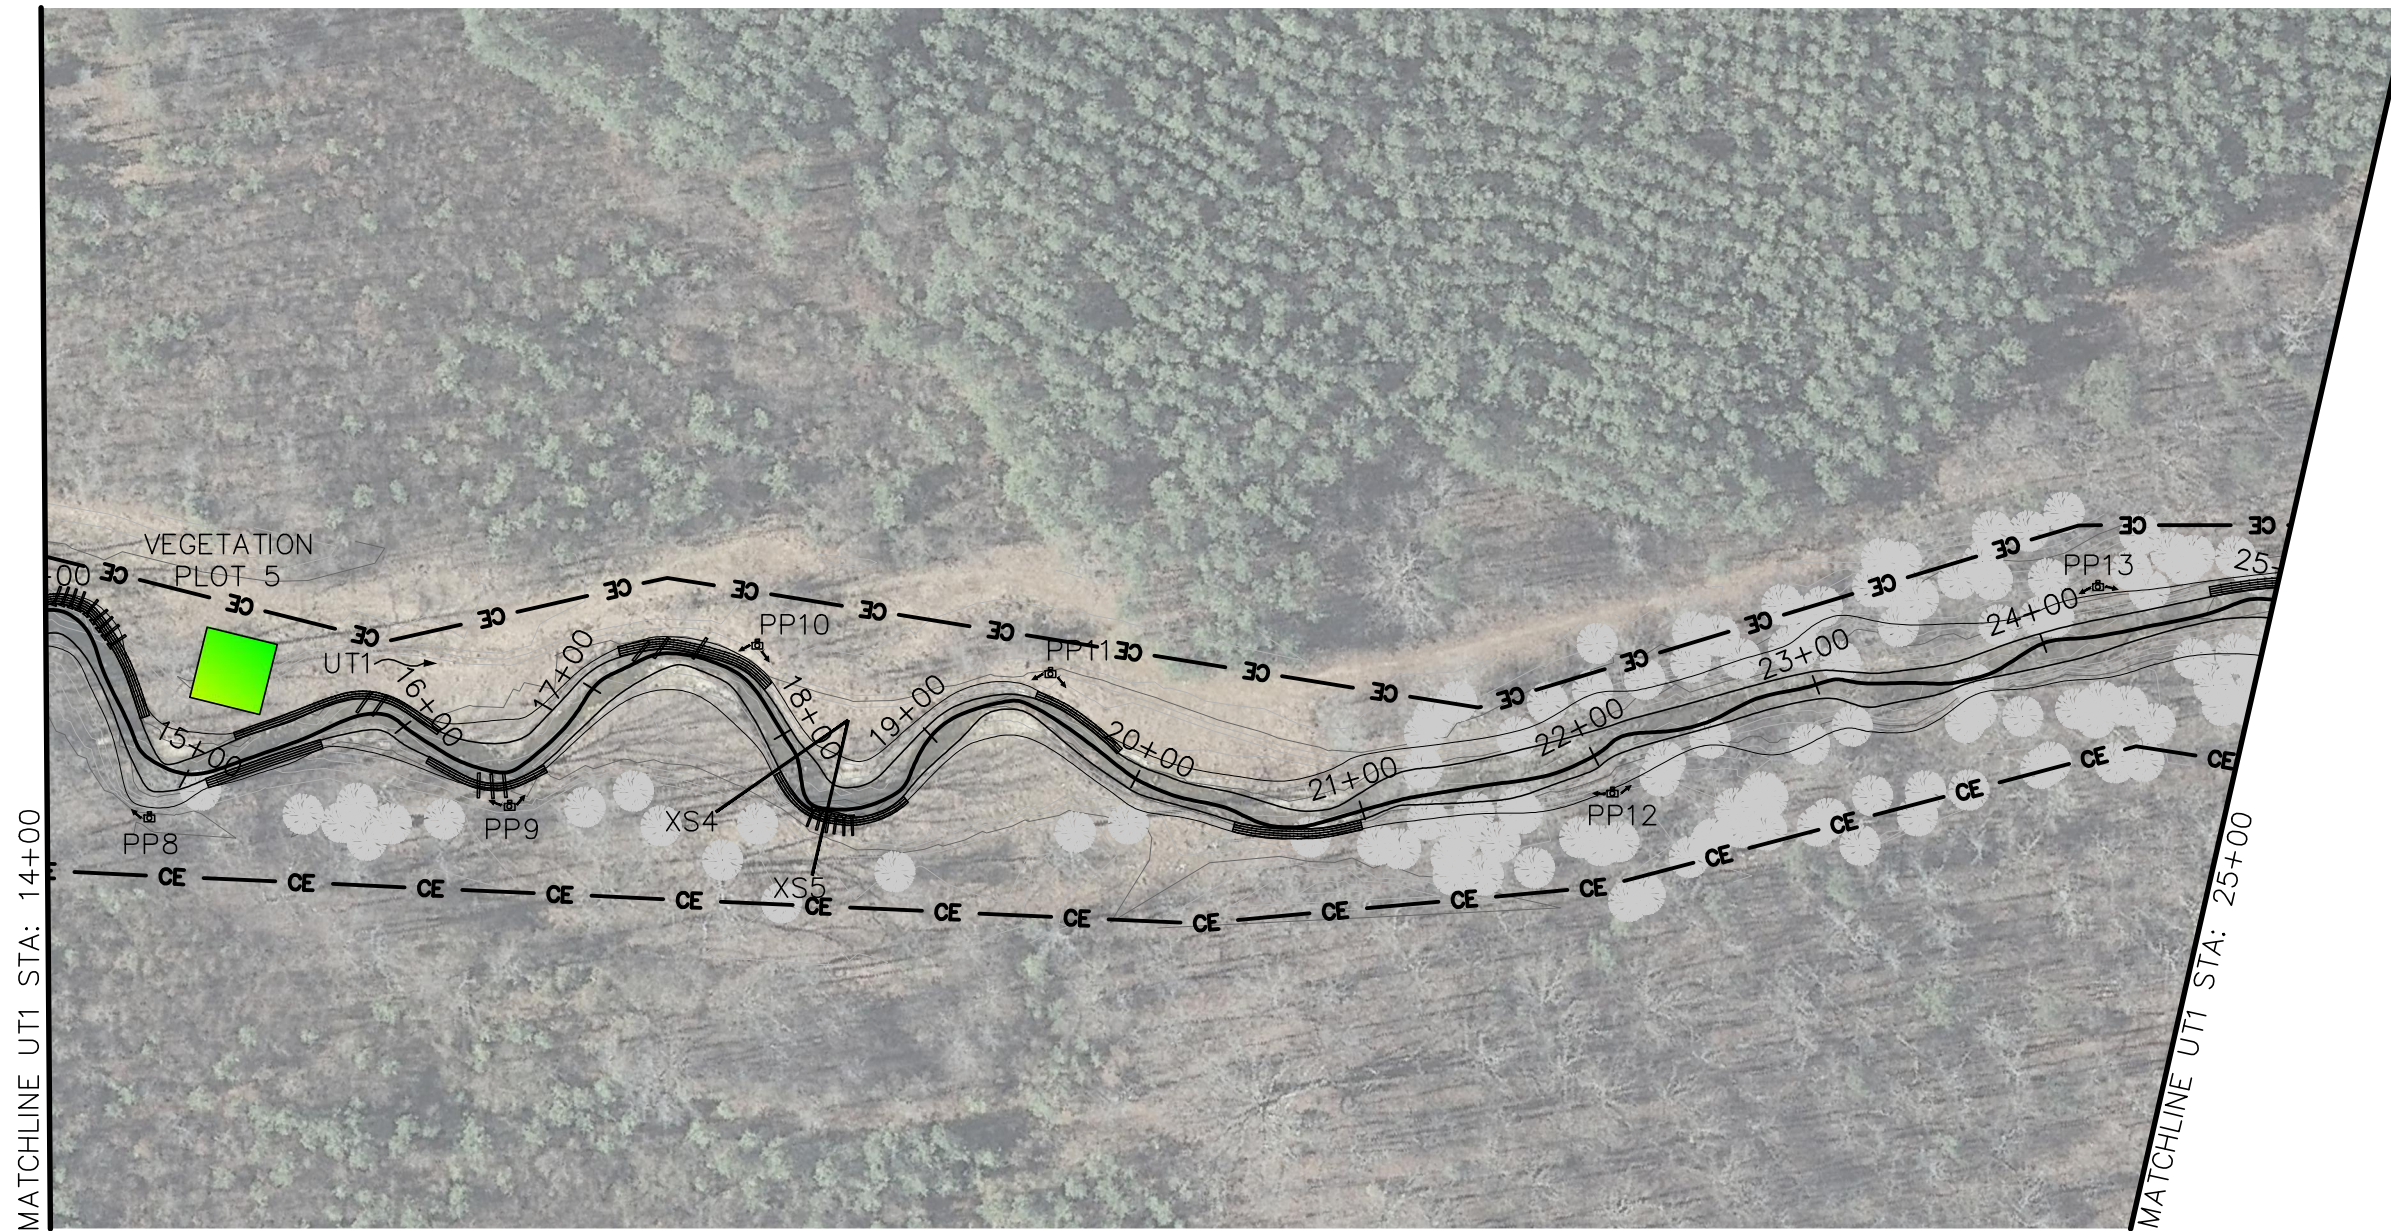
UT1  
CURRENT CONDITION  
PLAN VIEW  
14+00-25+00  
YEAR 3 MONITORING

PROJECT CONDITION	
	VEG PLOT CRITERIA MET
	VEG PLOT CRITERIA UNMET (NO PLOTS CURRENTLY MEETING THIS CRITERIA)
	STREAM PROBLEM AREA (SPA) BANKS WITH MINOR SCOUR/EROSION

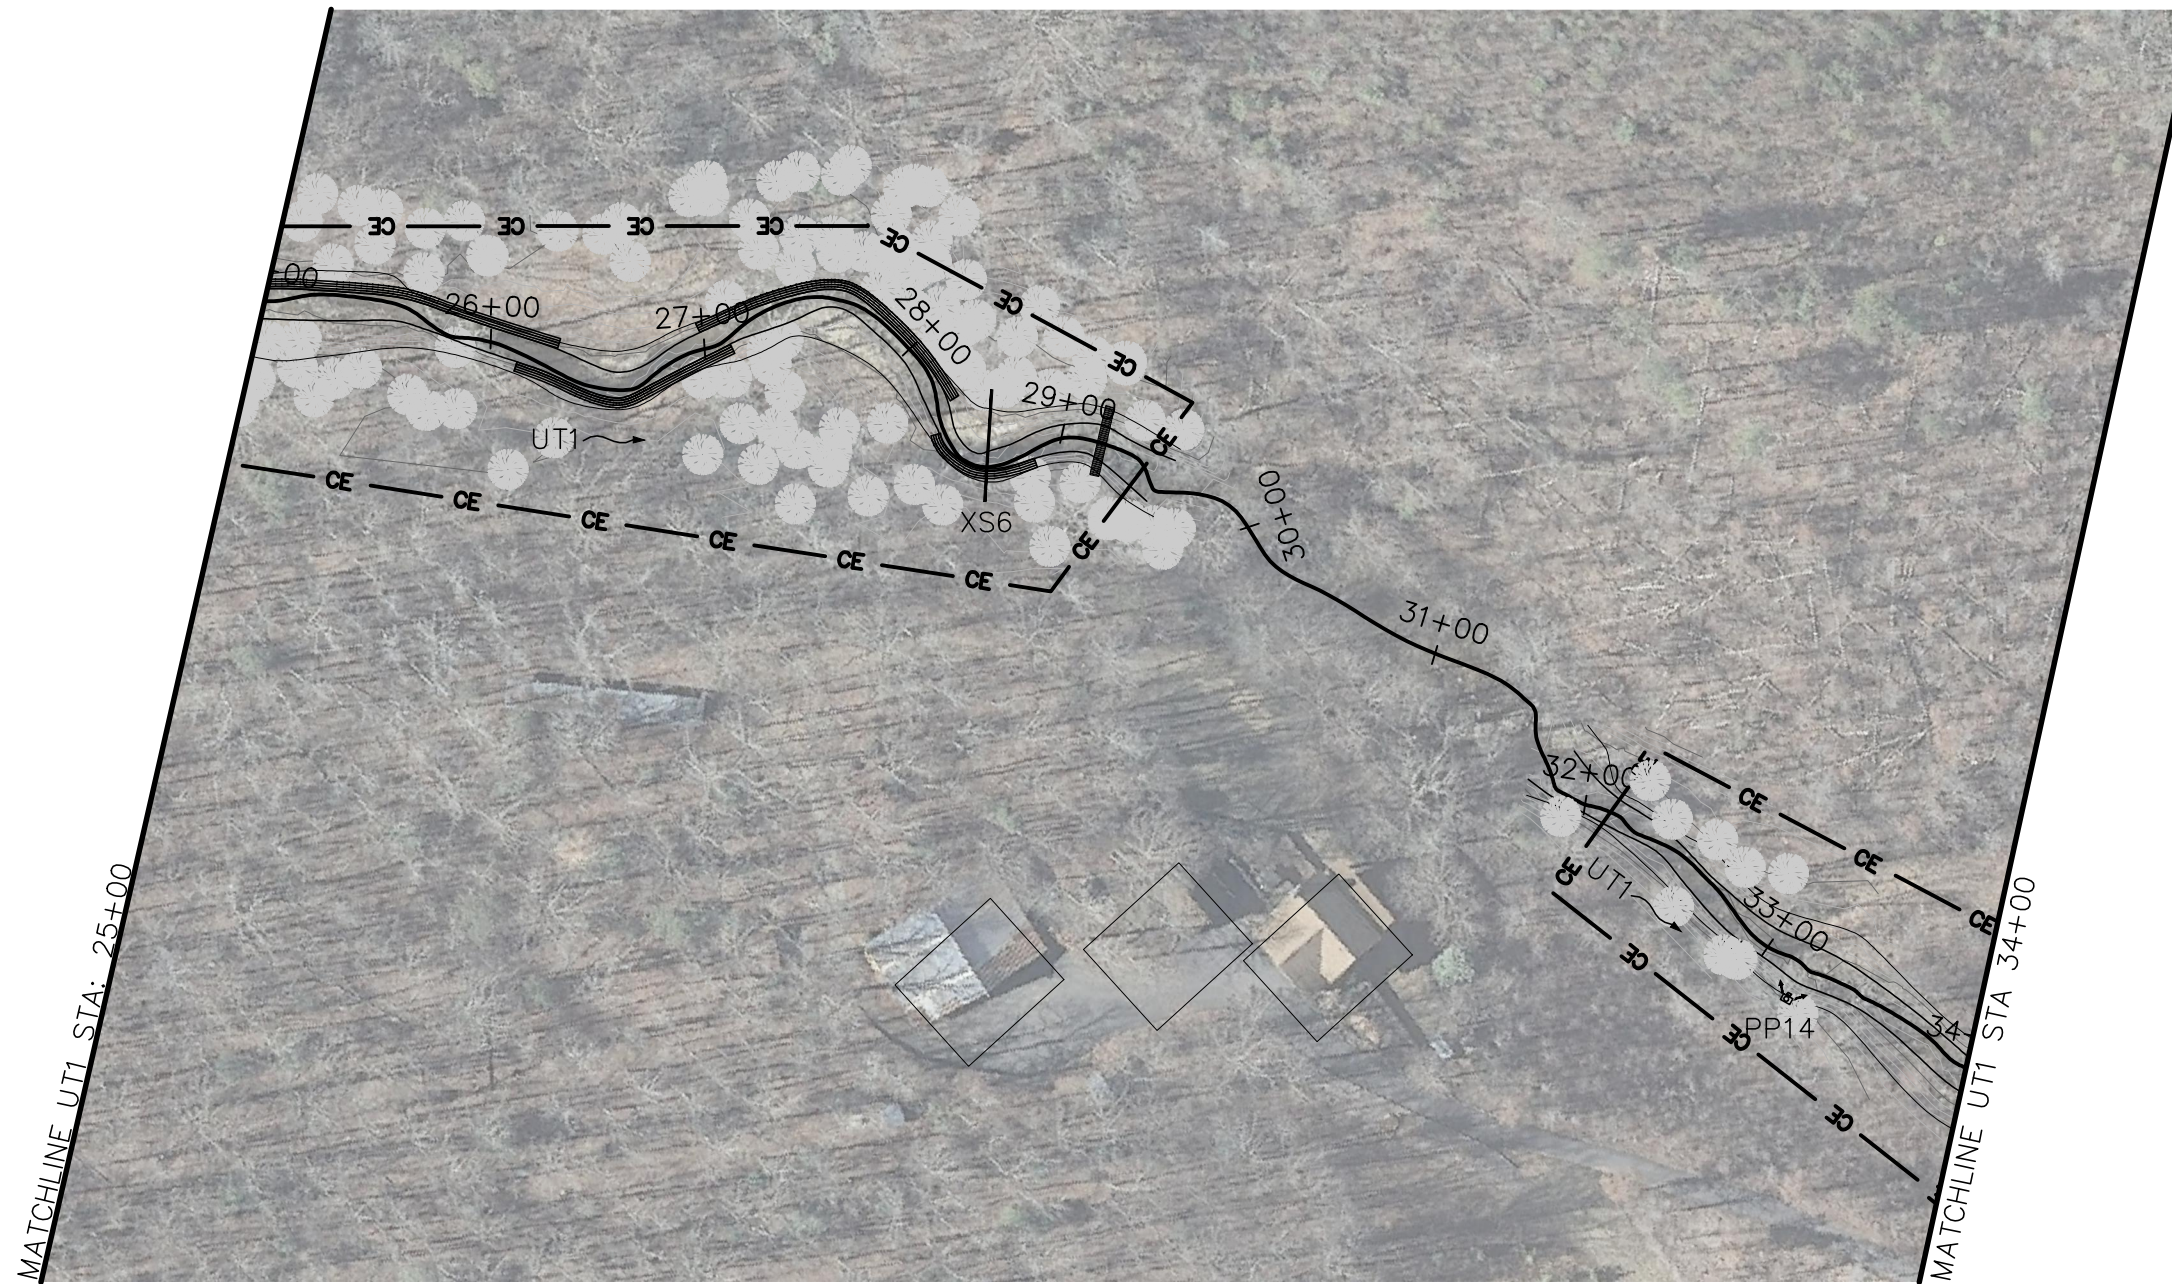
UT1  
CURRENT CONDITION  
PLAN VIEW  
25+00-34+00  
YEAR 3 MONITORING

PROJECT CONDITION	
	VEG PLOT CRITERIA MET
	VEG PLOT CRITERIA UNMET (NO PLOTS CURRENTLY MEETING THIS CRITERIA)
	STREAM PROBLEM AREA (SPA) BANKS WITH MINOR SCOUR/EROSION
