Puzzle Creek Mitigation Project

Year 4 Monitoring Report - Final

Rutherford County, North Carolina

Report Submitted: April 2015

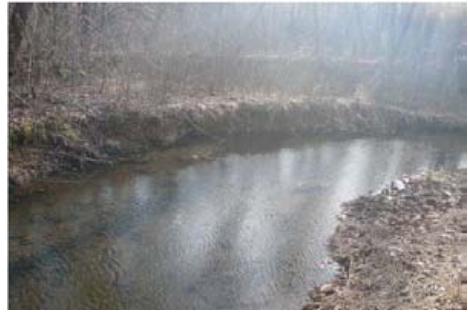
Photo 3. View downstream at area listed last year as an unstable, bare bank near confluence with UT1. It is stabilized by many trees along the top and vegetation growing on the surface.
