# Puzzle Creek Mitigation Project

## Year 5 Monitoring Report

Rutherford County, North Carolina

Report Submitted: November 2015

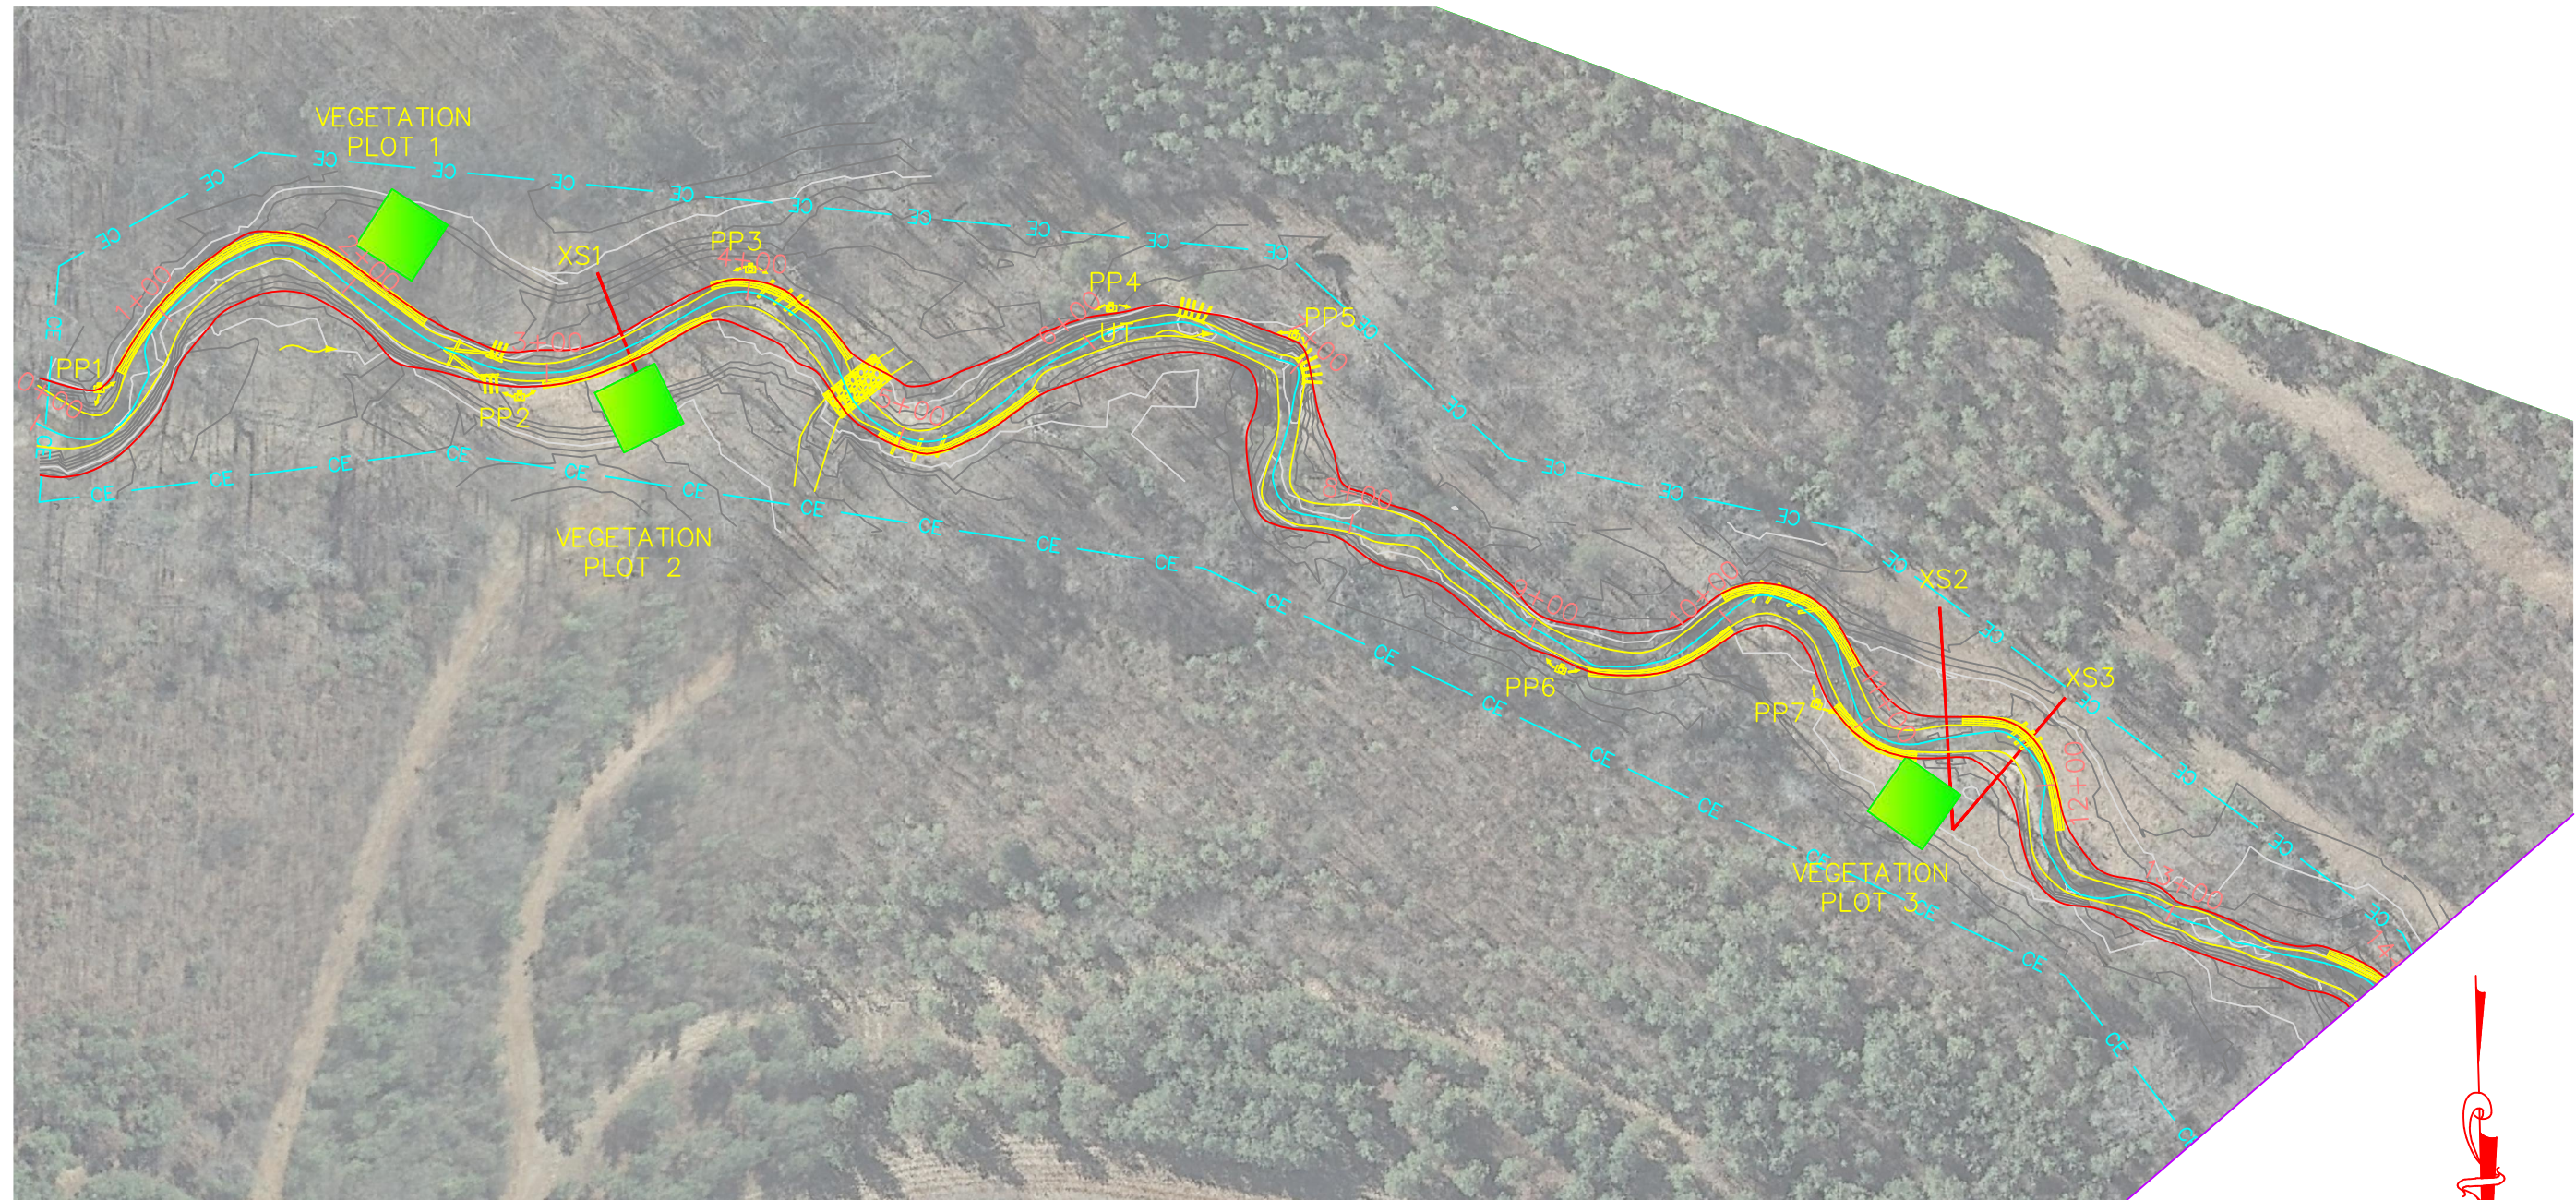
UT1  
 CURRENT CONDITION  
 PLAN VIEW  
 0+00-14+00  
 YEAR 5 MONITORING

- VEG PLOT CRITERIA MET
- VEG PLOT CRITERIA UNMET  
(NO PLOTS CURRENTLY MEETING THIS CRITERIA)
- STREAM PROBLEM AREA (SPA)  
BANKS WITH MINOR SCOUR/EROSION

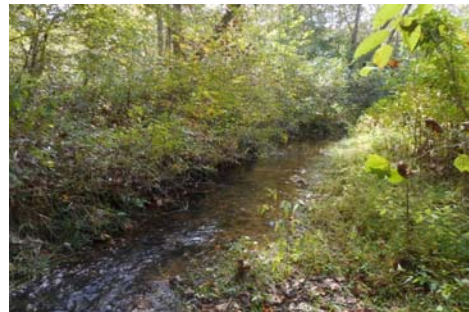
Photo 3. Bank is near confluence with UT1. View is downstream, to area listed two years ago as unstable. It is now stabilized with many trees along the top of the bank and vegetation growing on the floodplain.

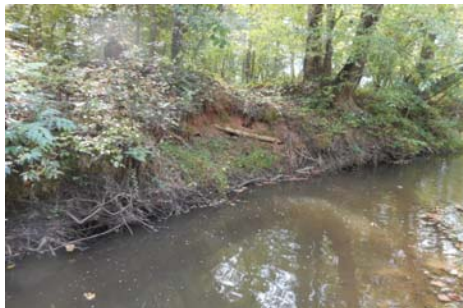
Photo 2. Area at Station 16+00 called a Vegetation Problem Area in past but has been stable over the last two years even though a small area of bare bank remains.

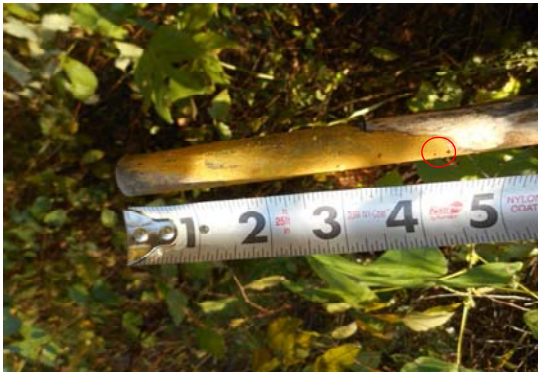
Photo 1. Crest gauge staff showing cork deposition in red circle, at 4.25 inches above the bottom of the staff, which is at the bankfull elevation.
