**As-built report for the Racey Mitigation Site,  
Laxon Creek, Watauga County**

North Carolina Wildlife Resources Commission

May 2001

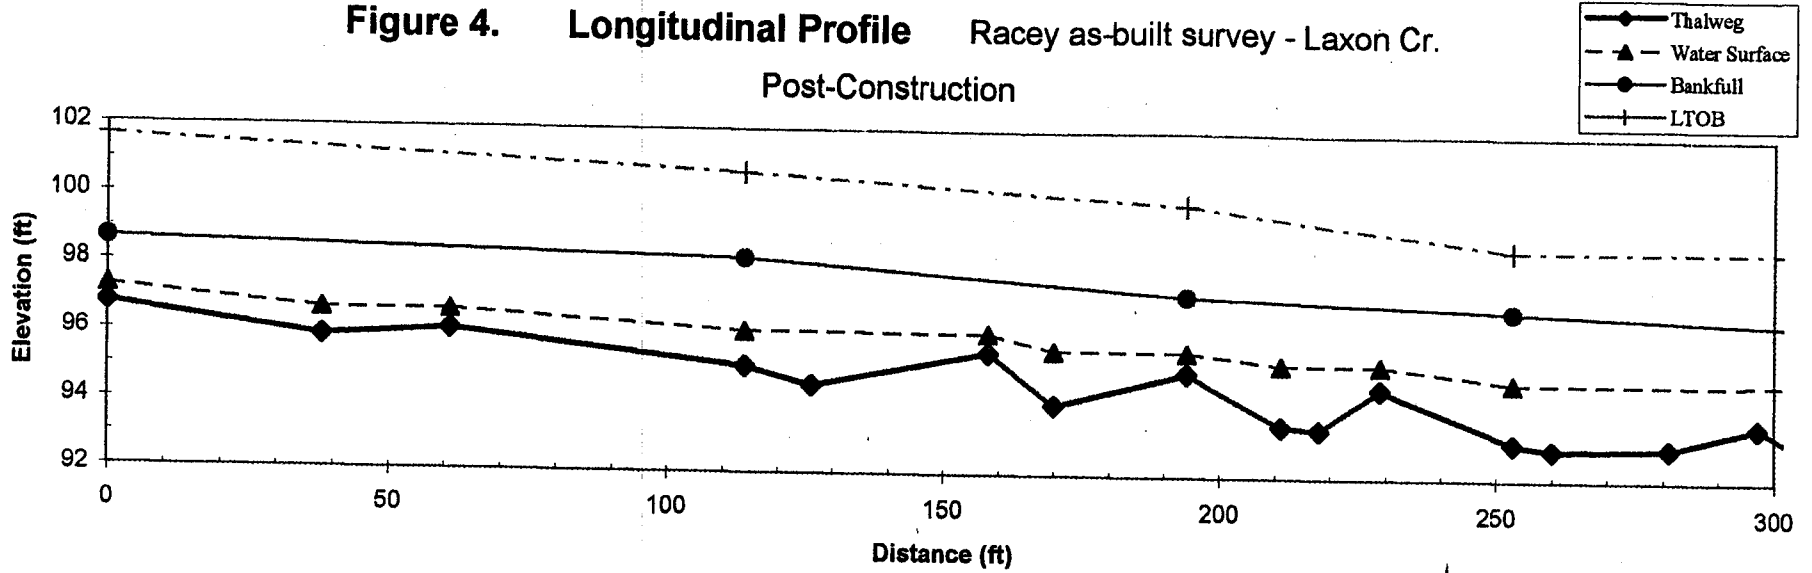
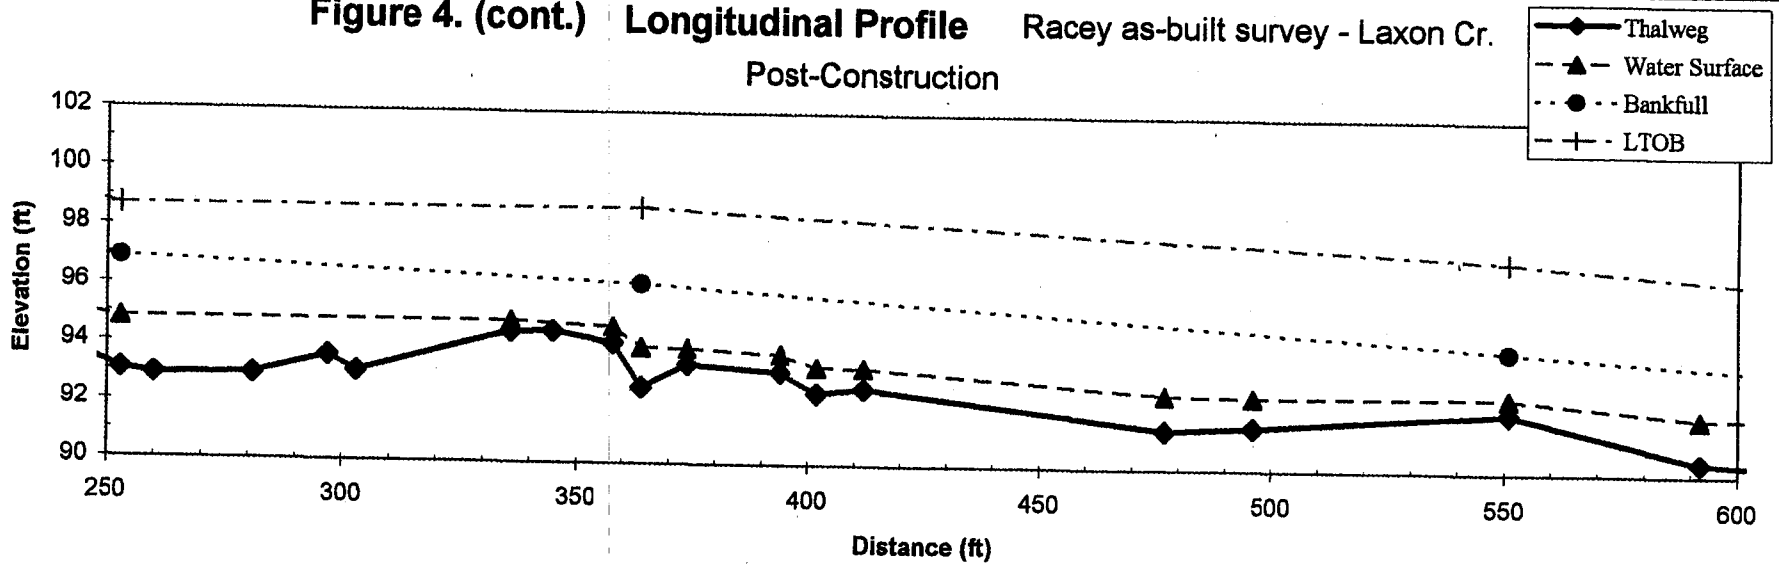
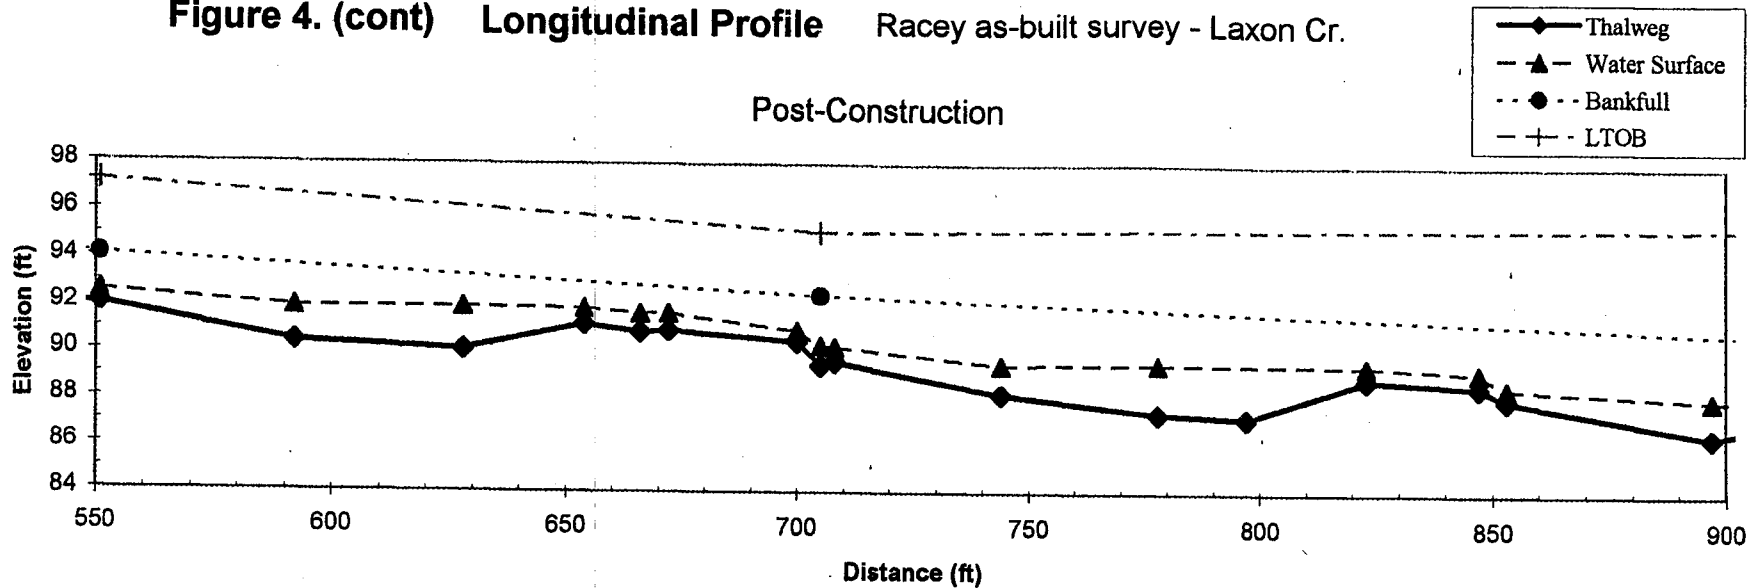
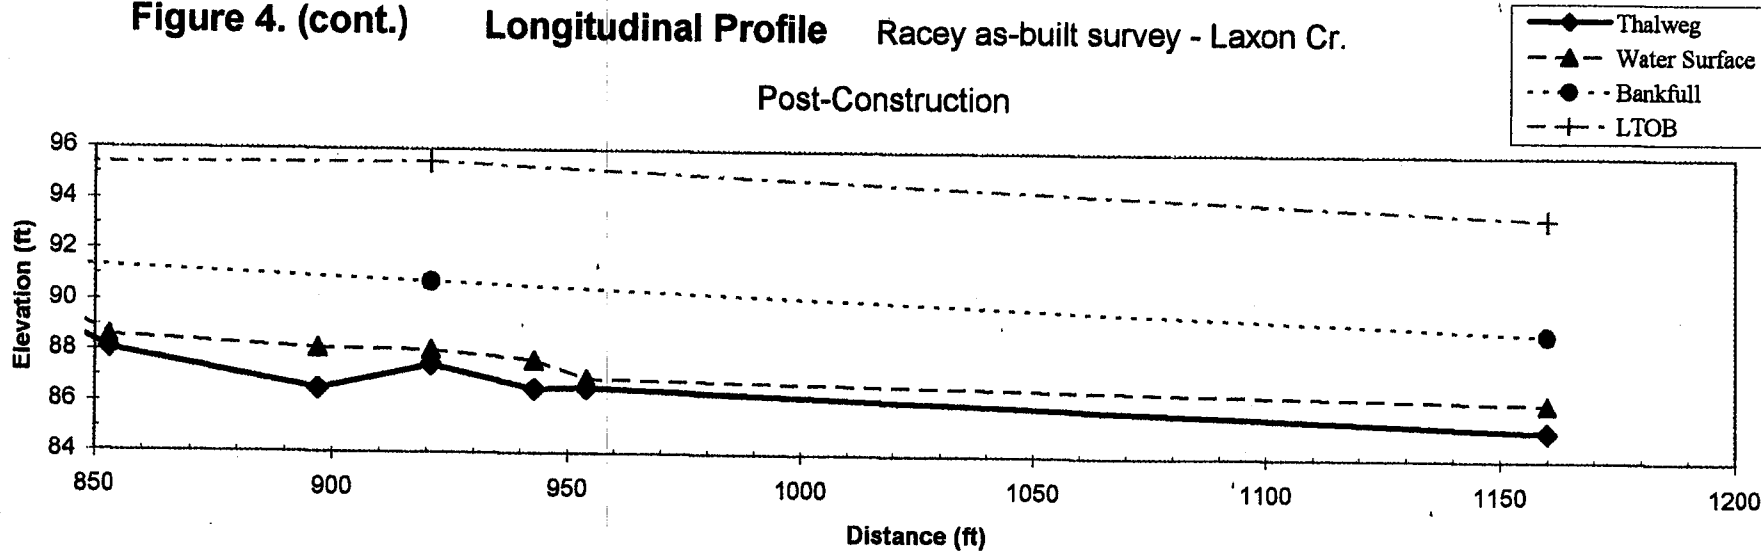
**Figure 4. Longitudinal Profile** Racey as-built survey - Laxon Cr.  
Post-Construction

The pre-construction and post-construction thalweg longitudinal profiles (Figures 3) show how the project increased pool and deep-water habitat. Pool habitat has increased from 26% to 40%. The scour action of root wad meanders, rock weirs, and rock and log vanes can be observed from the as-built profile (Figure 4). The weirs and vanes are creating the desired deep-water habitat and sorting bed material in a way that will provide needed fish spawning gravel.

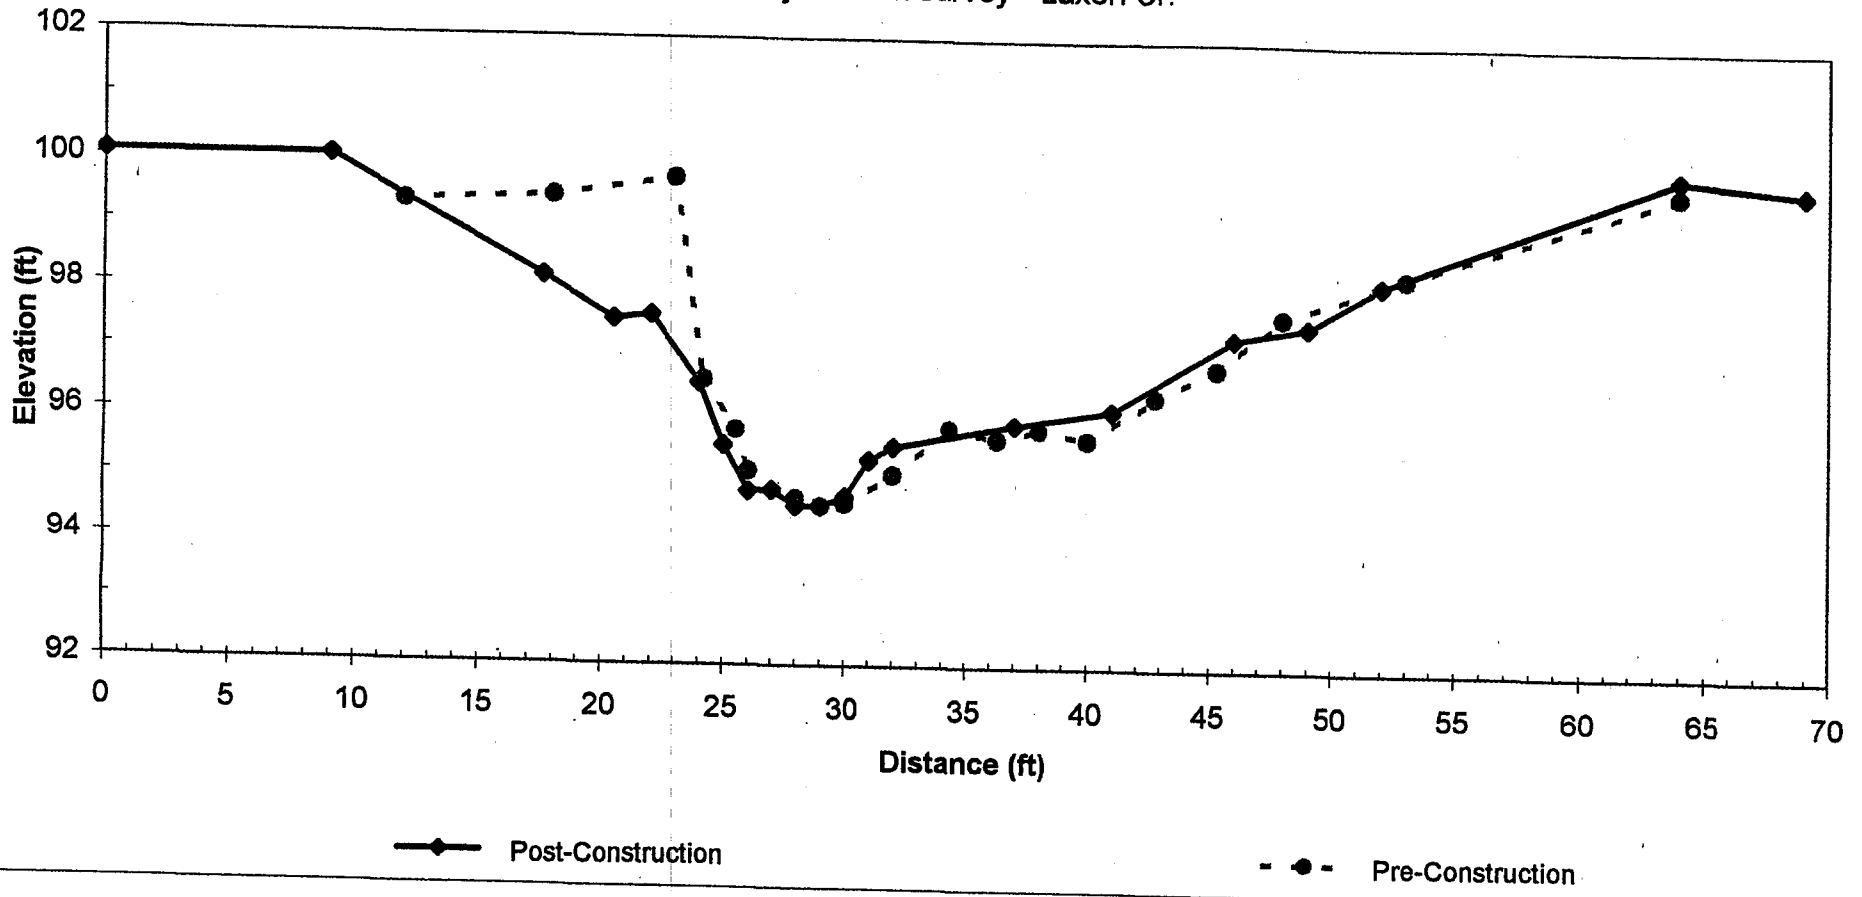
**Figure 6a. Cross Section STN 1+88**  
 Racey as-built survey - Laxon Cr.

Figures 6a-e show post construction cross-sections of the new channel. These cross-sections will be used to monitor long-term channel stability. Based on data from the pre-and post cross-sections, the channel is classified as a C<sub>4</sub> in the upper sections (Figures 6a & 6c) above station 8+40 (Figure 6e) (Table 1). Below station 8+40 to the South Fork New River the stream is a F<sub>4</sub> type.

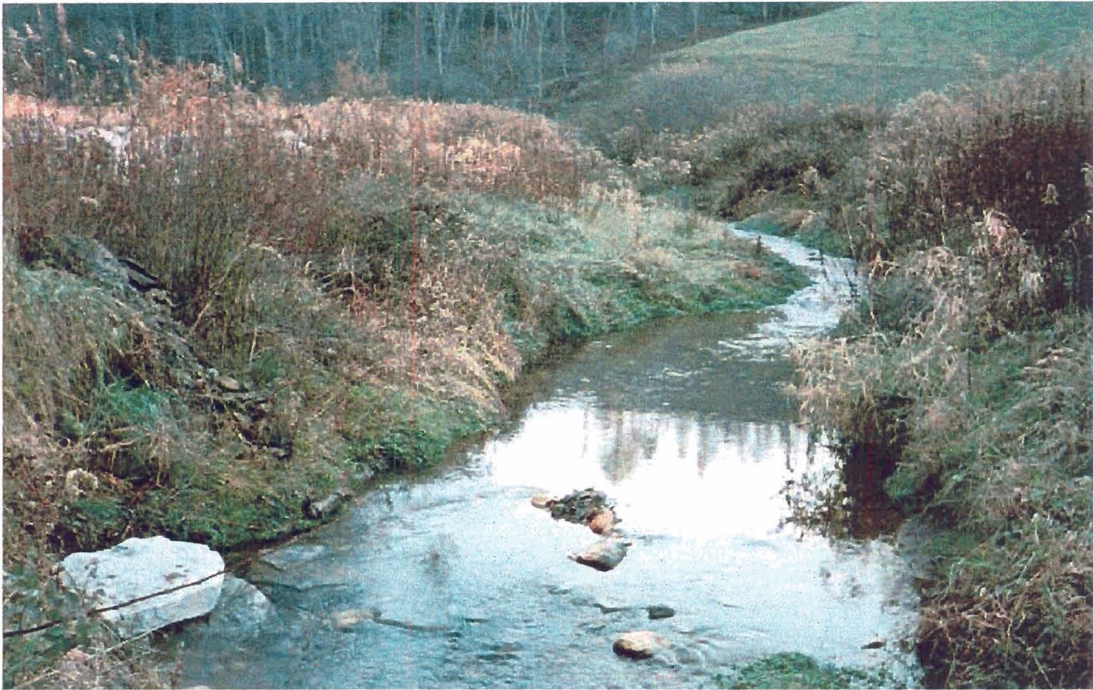
Looking upstream towards upper end of conservation easement. Laxon Creek before stream restoration work. This area contained a badly eroding bank and a riffle where a pool should have been. Banks were sloped and rock weirs installed to create a step/pool habitat. Location of cross-section 1+88.
