**RACEY MITIGATION SITE ON LAXON CREEK,
WATAUGA COUNTY**

Year 3 (2004) and 4 (2005) Monitoring Report

Transportation Improvement Project R-0529

Period Covered, January 9, 2001 – September 27, 2005

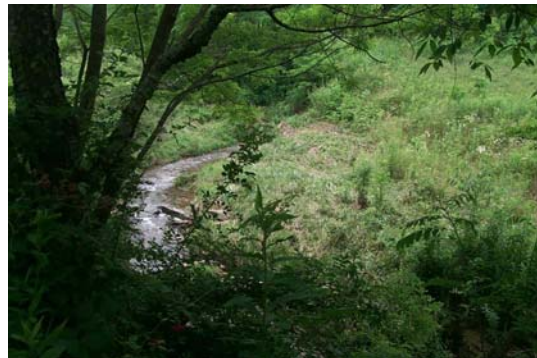
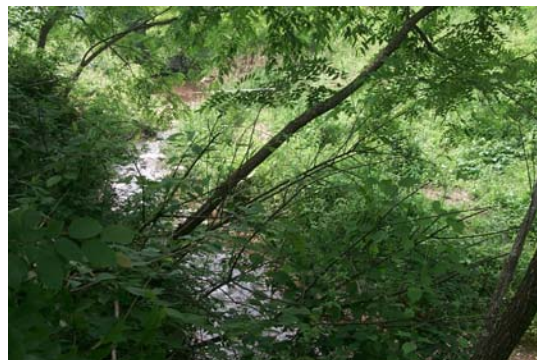
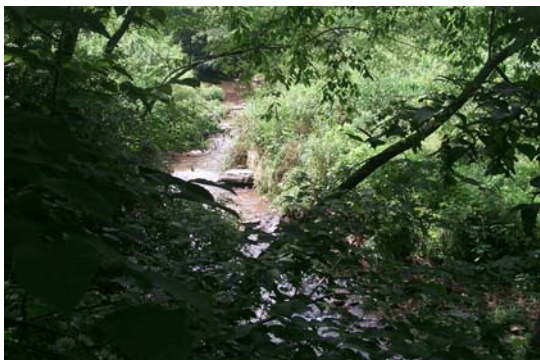
CROSS-SECTION 7+13 – step pool (Figure 3.3): The thalweg has deepened and the channel has widened considerably, probably due to storm events and the failure of a beaver dam located above the cross-section. However, the streambanks are stable and well vegetated. While the banks are stable, the steep right bank should be visually monitored for potential bank erosion problems during the yearly conservation easement inspection.

APPENDIX 2.—Photographic log of the Racey mitigation site looking upstream at cross-section 7+13, Watauga County, October 2000-July 2005.

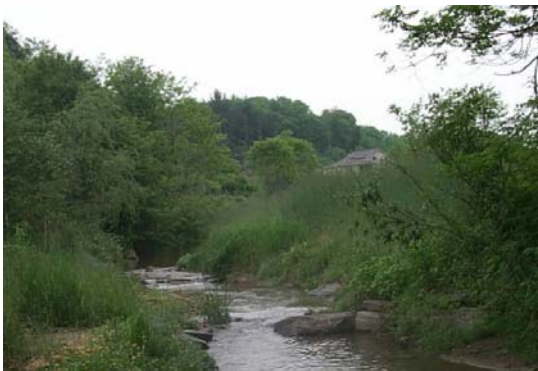
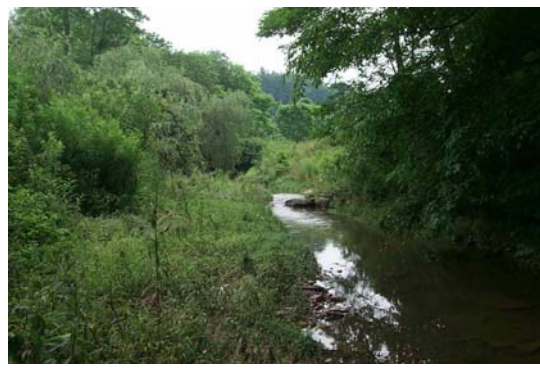
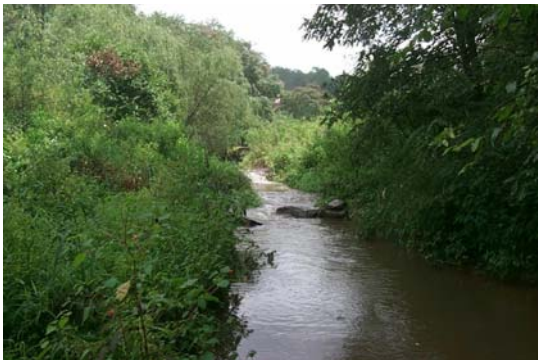
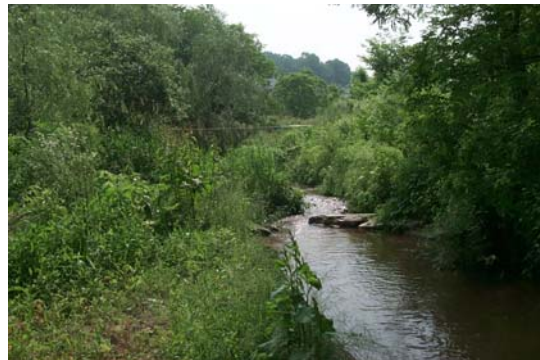
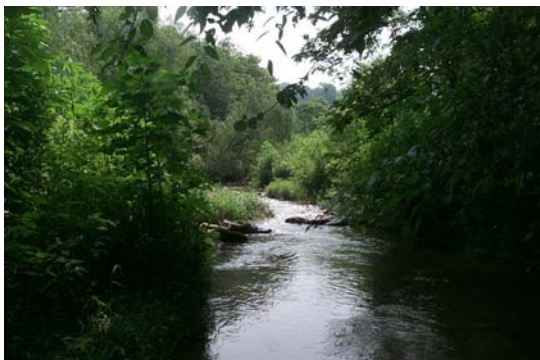
CROSS-SECTION 8+40 – run (Figure 3.4): The thalweg has deepened to the level found in 2003. Immediately below the transect, the left bank has migrated slightly and a central bar has developed creating a separate channel along the right bank. These channel adjustments are the direct result of beaver activity during 2003 - 2004. Both banks are well vegetated and stable. If the central bar becomes larger, there is the potential risk of bank erosion developing along the right bank. This location should be monitored for potential bank erosion problems during the yearly conservation easement inspection.

APPENDIX 3: Photographic log of the Racey mitigation site looking upstream at cross-section 8+40, Watauga County, October 2000-July 2005.
