**REEDY BRANCH
FINAL MONITORING REPORT
YEAR 2 OF 5
2006**

EEP Project # 301
Alamance County, North Carolina

This report documents the data collected for Year 2 monitoring. The data includes geomorphic and vegetative components. The geomorphic data collected includes: longitudinal profiles, cross-sections, pebble counts, and photo points along the segment of restored stream. The vegetation data collected includes: stem count species and numbers for all of the vegetative plots throughout the project. The geomorphic data collected for Year 2 was compared to previous data collected in Year 1 by overlays of graphs for the longitudinal and cross-section surveys.

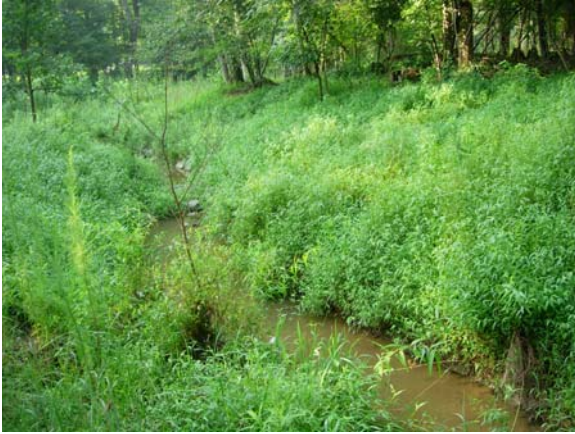
There is good herbaceous vegetation growth along all of the monitored stream reach. Japanese grass (*Microstegium viminium*) has established along the entire stream reach with limited areas where it does not dominate. The plan sheets in Appendix D show the location of the vegetation plots.

Photo 1: Japanese grass along both banks near Vegetation Plot 10

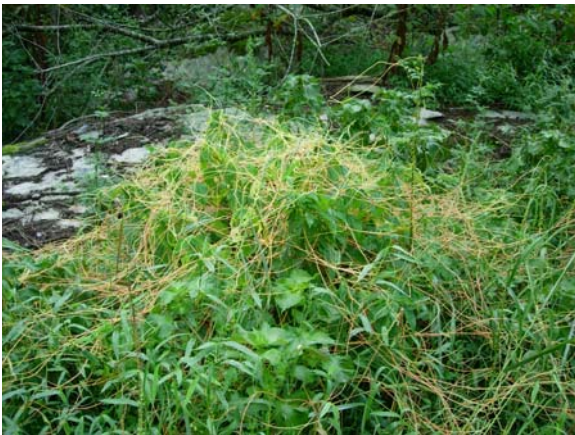
Another exotic, dodder (*Cuscuta* and *Grammica*), was noted at Station No. 23+50 right bank. This exotic is limited only to this area. However, this plant can overtake an area.

Photo 2: Dodder

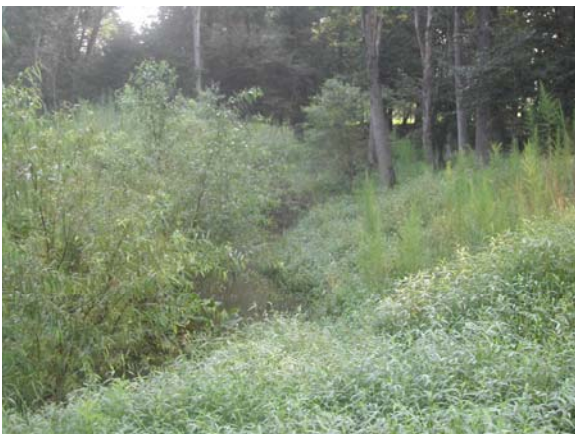
Photo 3: Japanese grass
