**REEDY BRANCH
2007 FINAL MONTORING REPORT
YEAR 3 OF 5
2007**

EEP Project # 301
Alamance County, North Carolina

**REEDY BRANCH STREAM RESTORATION
YEAR 3 MONITORING REPORT**

CONDUCTED FOR:
NCDENR ECOSYSTEM ENHANCEMENT PROGRAM

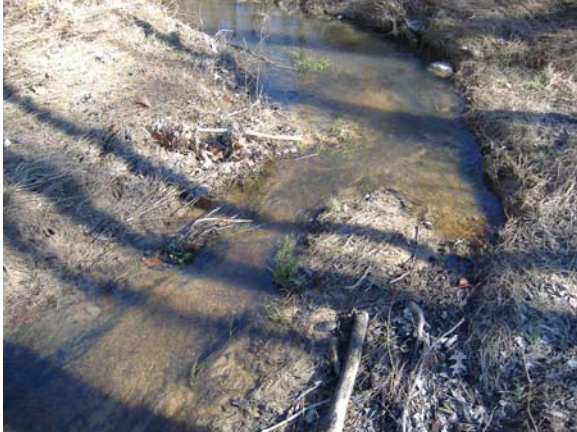
Photo 1: Representative grass aggradation problem area (Station 30+11 along plan view).

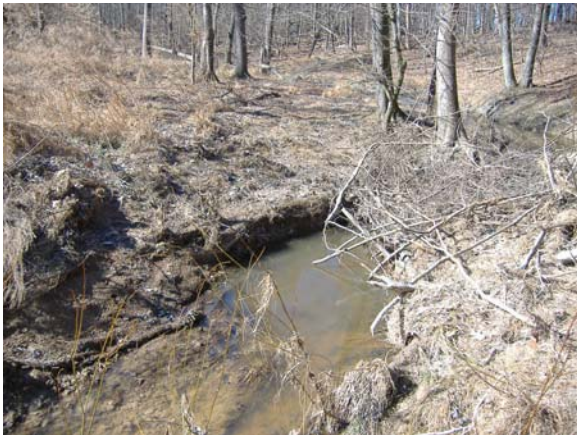
Photo 3: Representative bank erosion problem area (Station 35+98 along plan view).

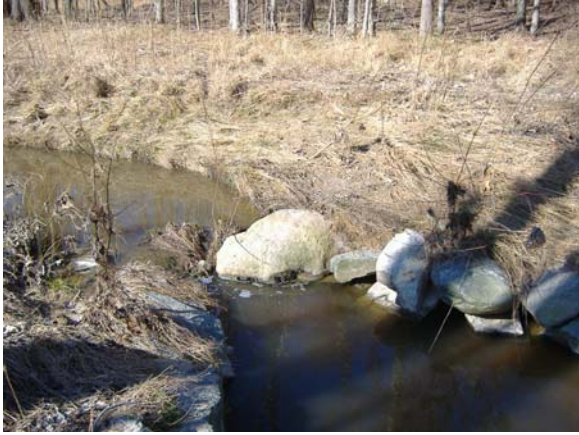
Photo 5: Representative problem crossvane (Station 29+88 along plan view).

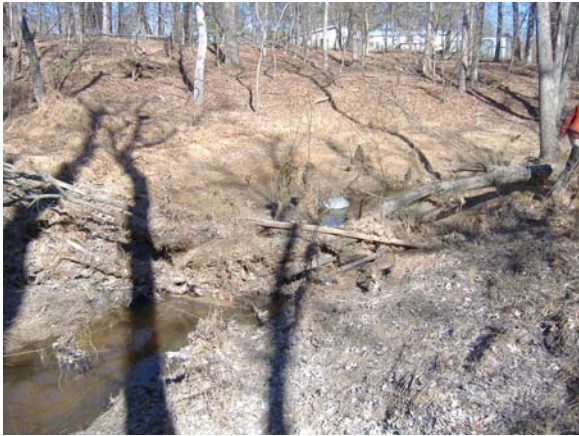
Photo 7: Representative debris jam (Station 34+73 along plan view).
