**REEDY BRANCH
FINAL MONITORING REPORT
MONITORING YEAR 4**

EEP Project # 301
Alamance County, North Carolina

**REEDY BRANCH STREAM RESTORATION
MONITORING YEAR 4 REPORT**

CONDUCTED FOR:
NCDENR ECOSYSTEM ENHANCEMENT PROGRAM

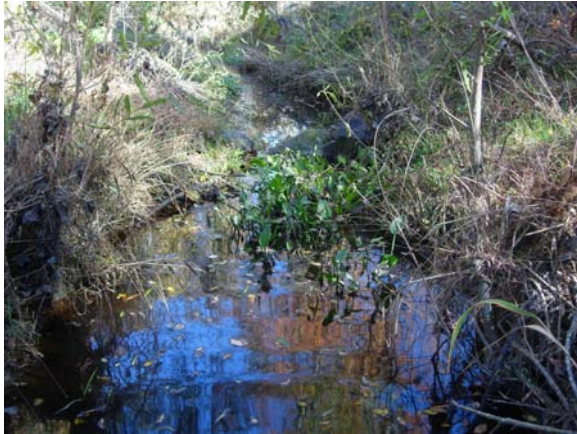
Photo 1. Representative Pickerelweed (*Pontederia cordata*) growing in the center portion of the picture (Station No. 11+88; view upstream; 11-6-2008).

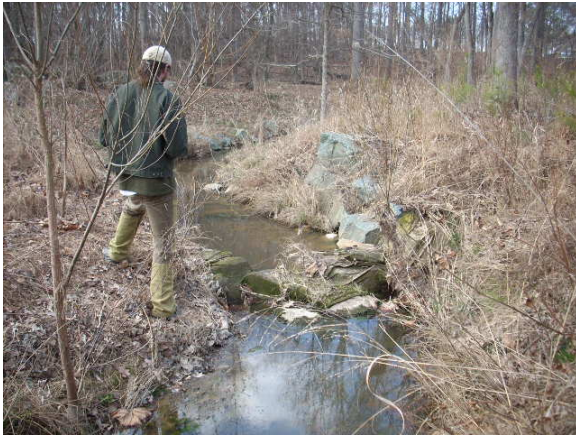
Much of the bank erosion listed in previous monitoring years has healed over time and much of the aggradation has cleared. There are several continuing problems with in-stream structures. Several crossvanes were rated severe, and there were several rootwads noted to be placed too high on the bank.

Photo 3: Representative cross-vane problem area (Station No. 32+85; view downstream; 2-25-2008).

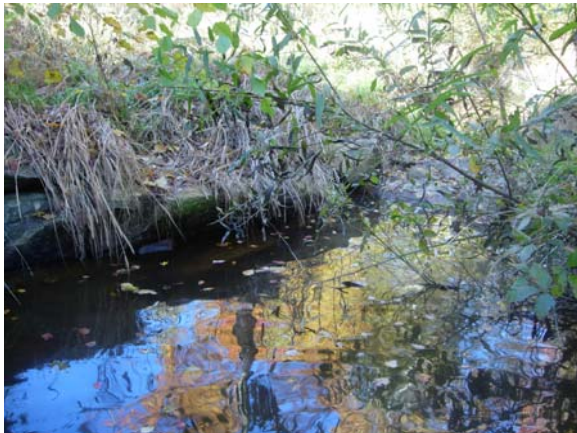
Photo 7: Representative problem jhook; Piping is occurring around right arm of j-hook (Station No. 13+07, view upstream on 11-6-2008).

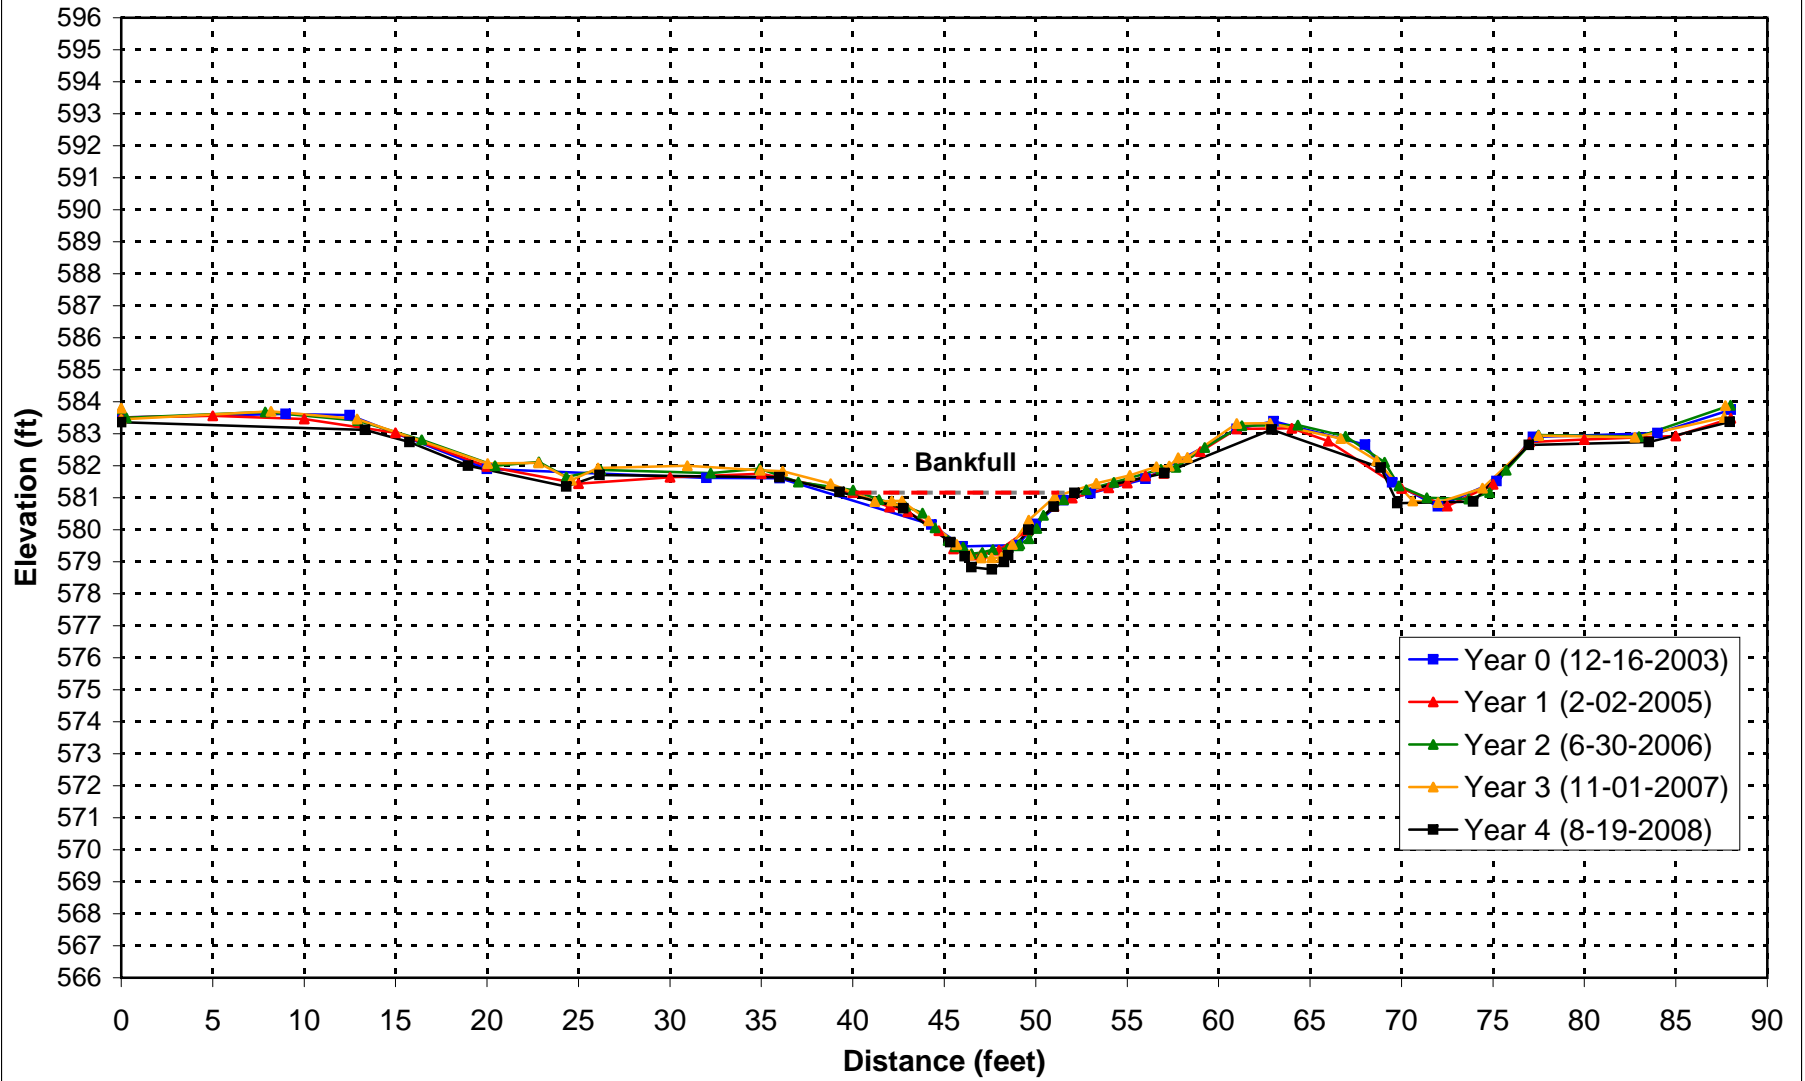
Cross Section Overlay (Years 0 - 4)
Reedy Branch
Cross Section #1 (Riffle)

The overall pattern, dimension, and profile have remained stable through Monitoring Year 4. The channel bed substrate size distributions have remained fairly consistent through Monitoring Year 4, with the exception of cross sections 1 and 3 where a silt fining effect was observed between monitoring years. This silt presumably came from an upstream source as these two cross sections are on the upstream end of the project and probably collects in the riffles as they dry up and the silt (i.e. last particles to be entrained in the water column) are filtered out by grass that grows in the channel at these riffles. In addition, a significant coarsening was observed a cross section 5 (pool) where fining was observed in Monitoring Year 3.

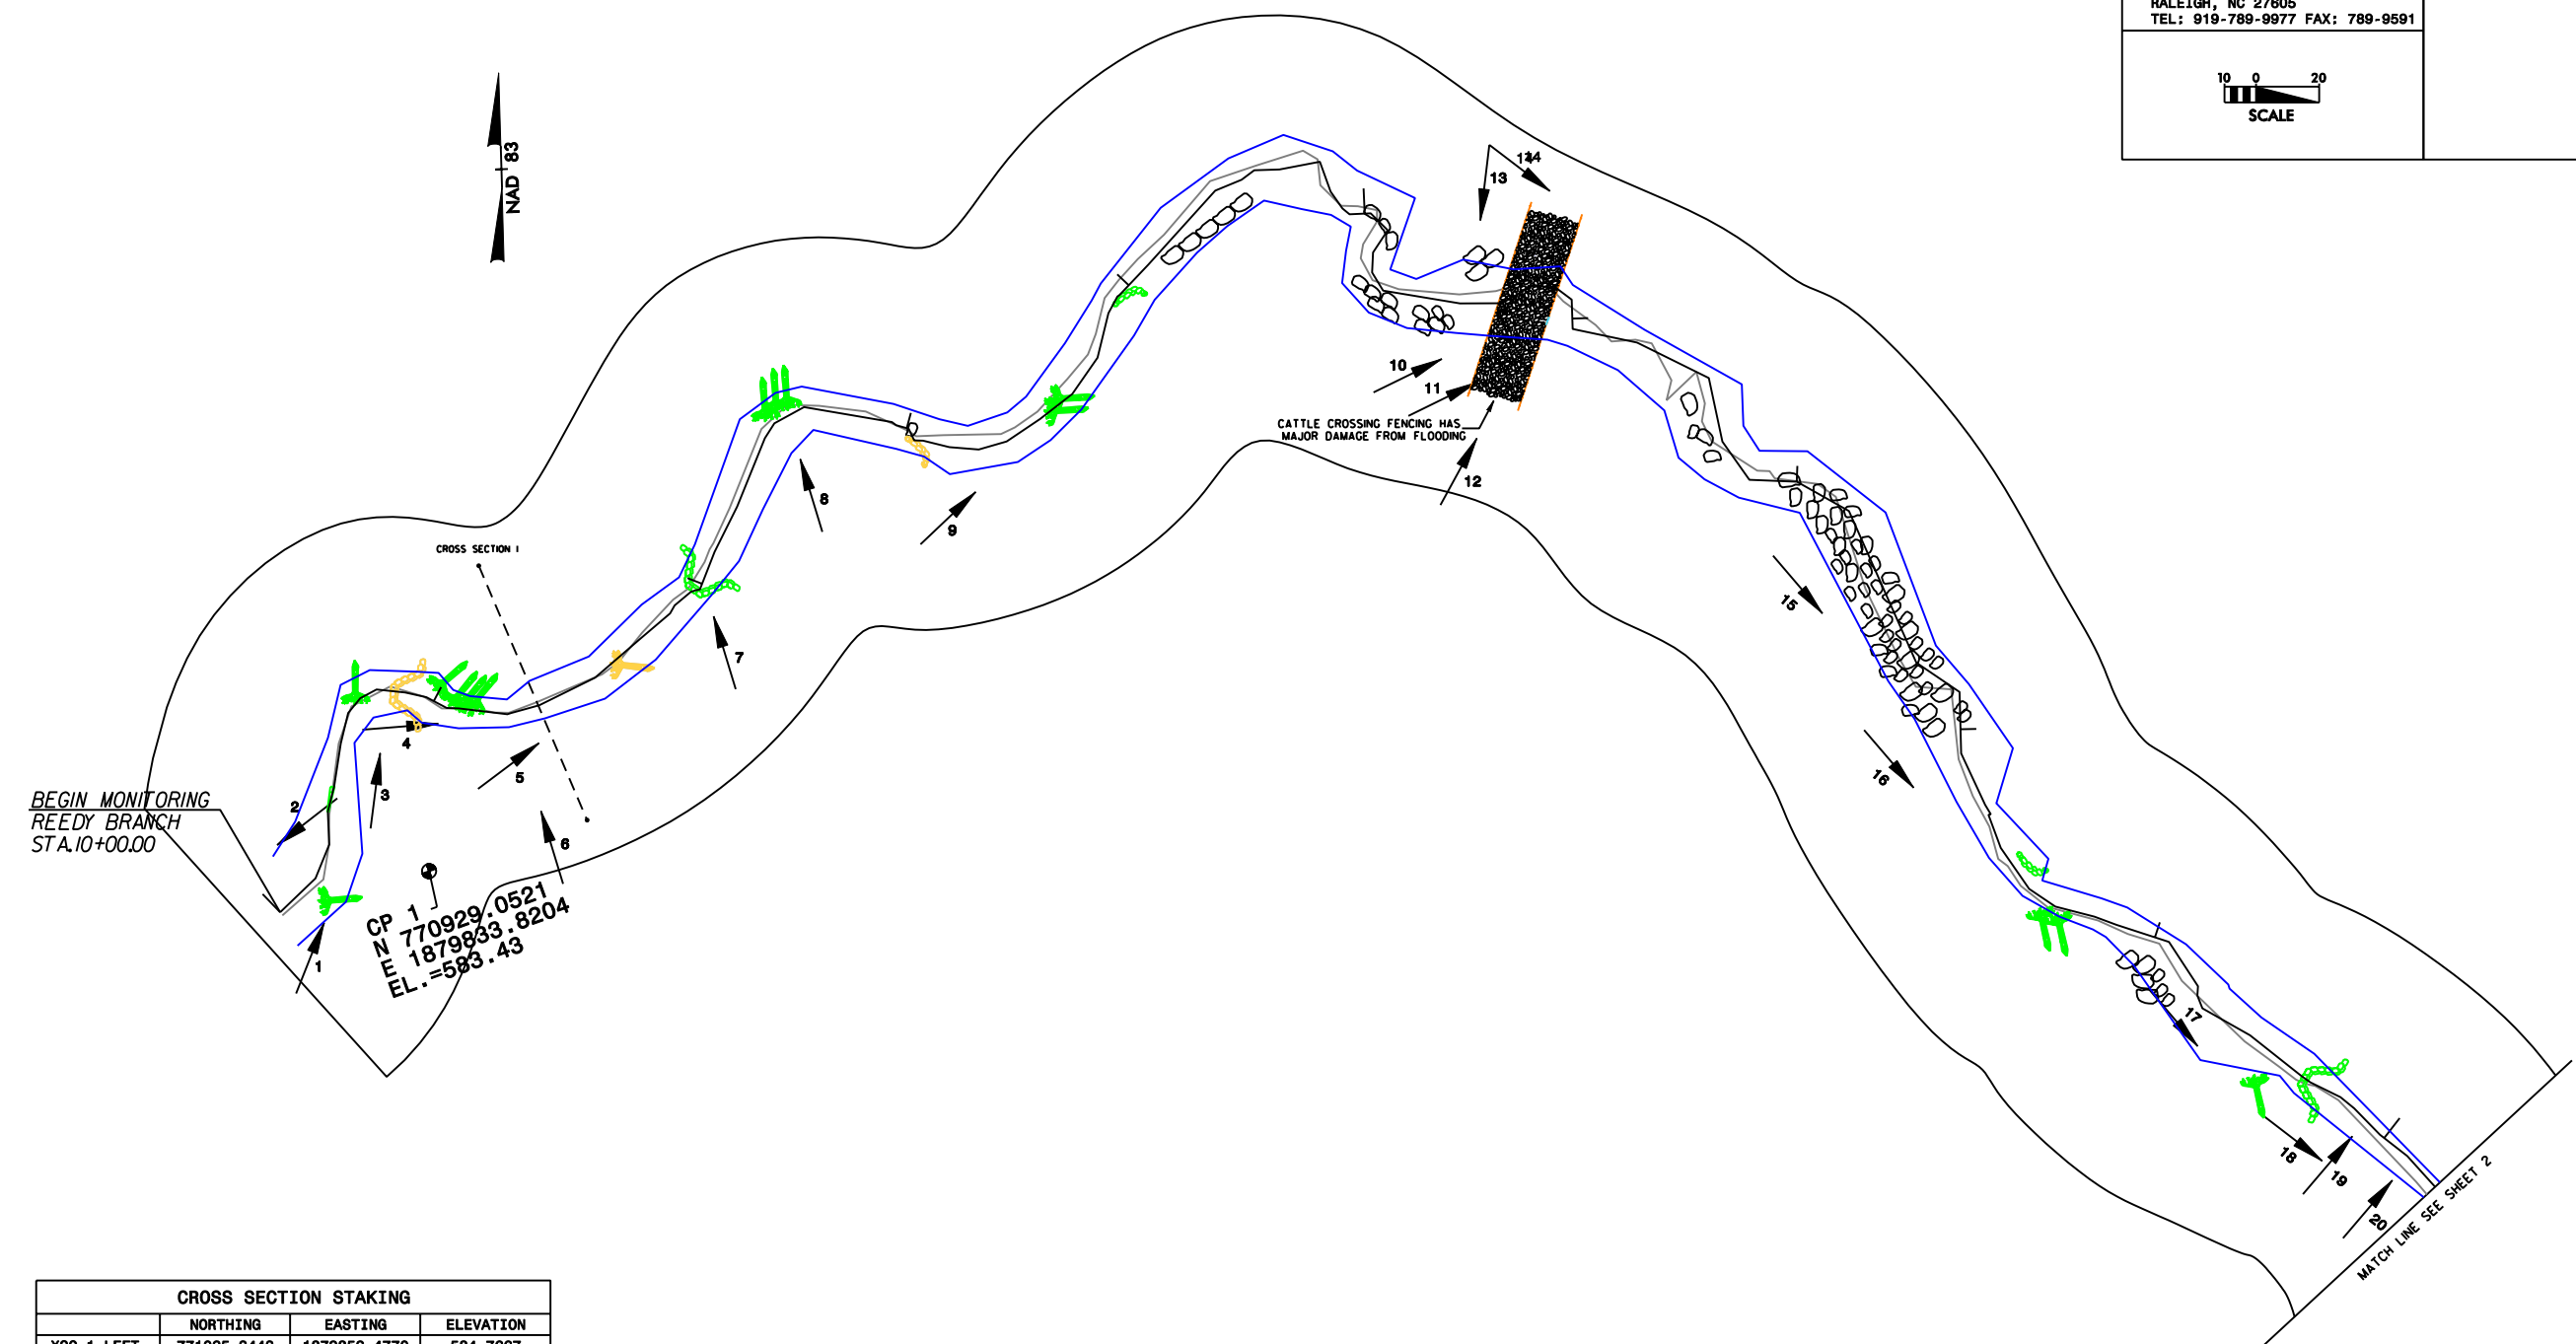
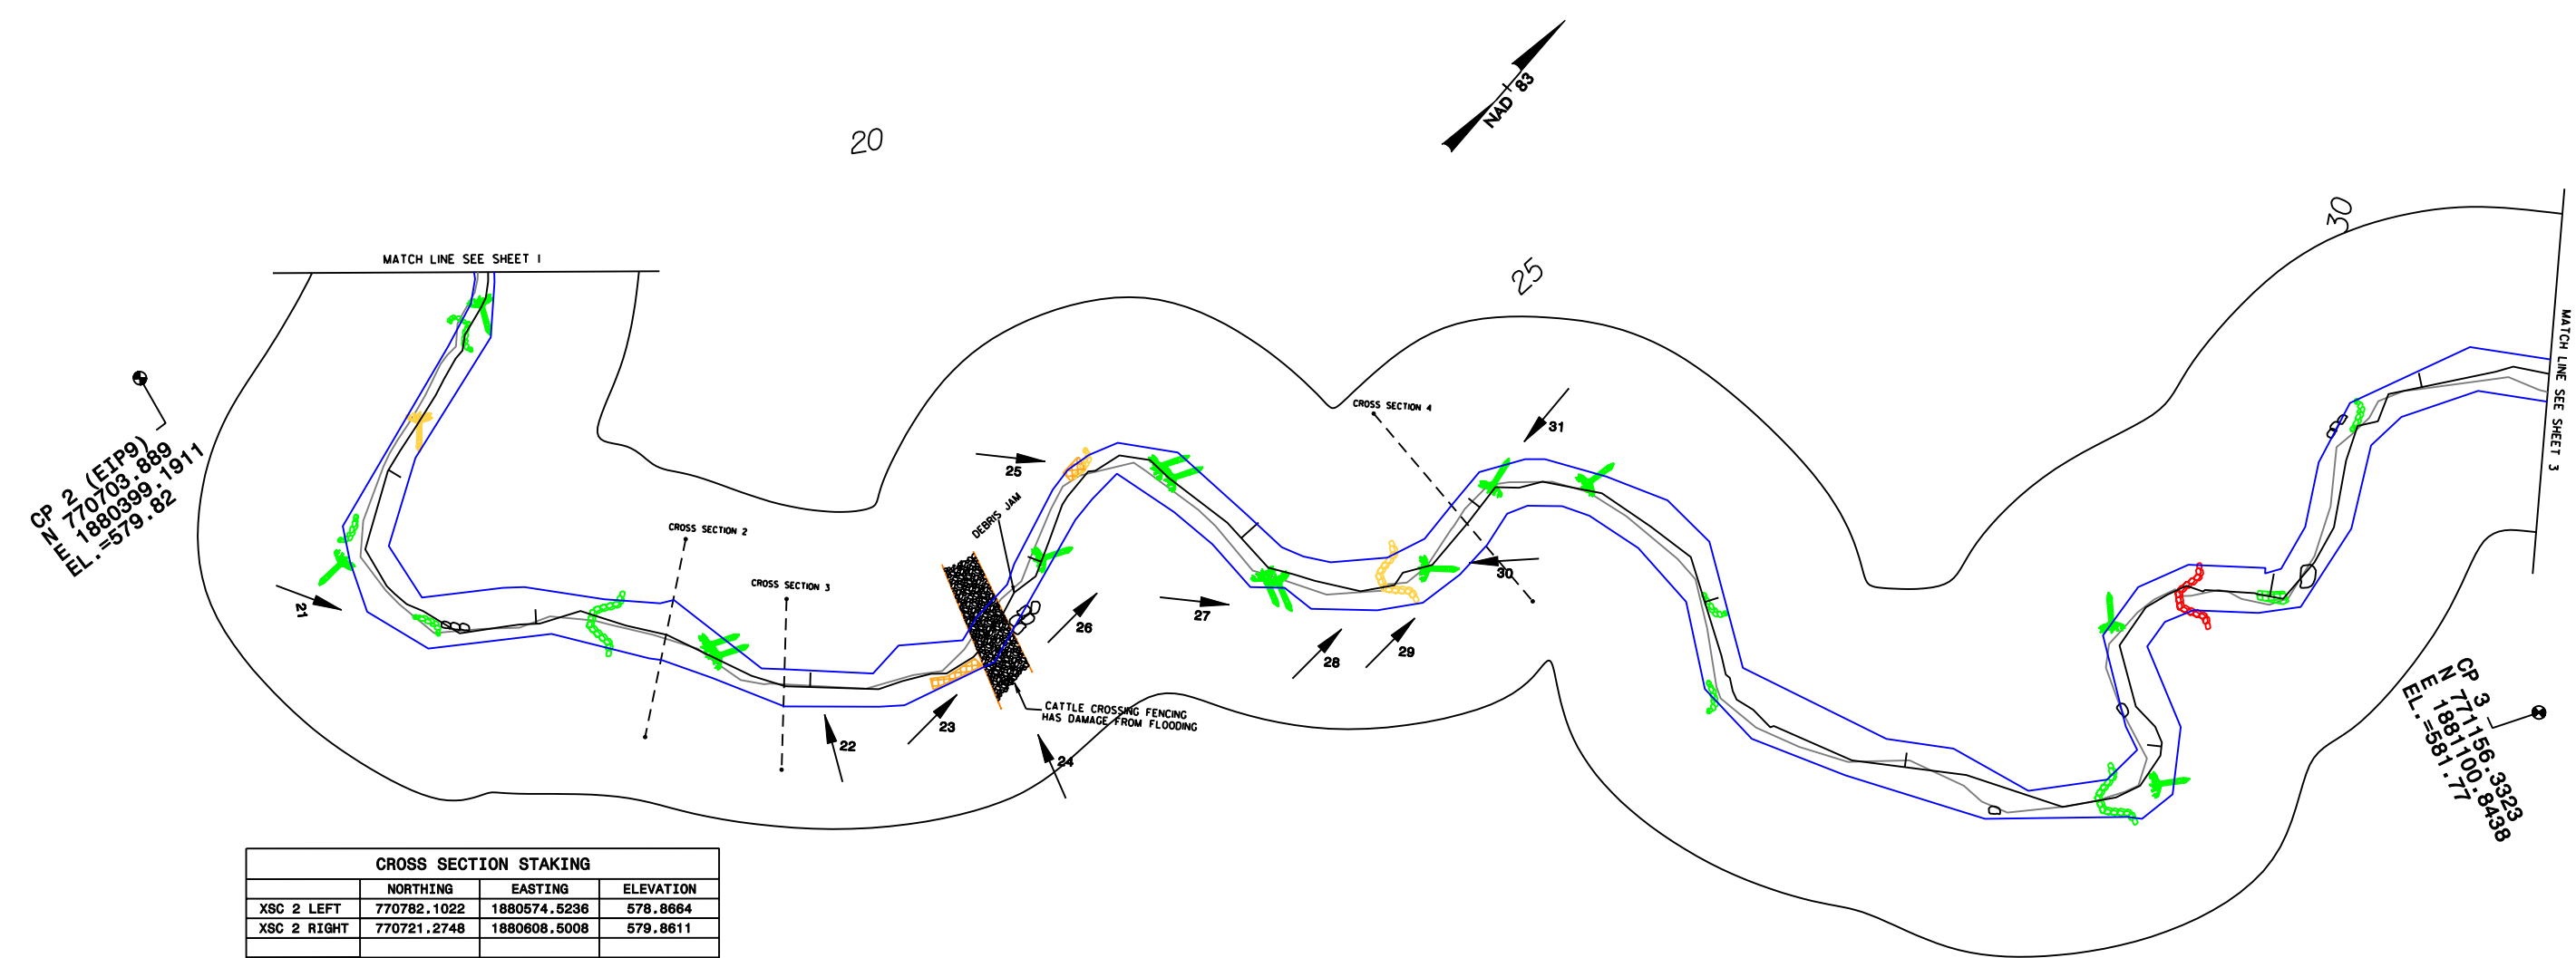
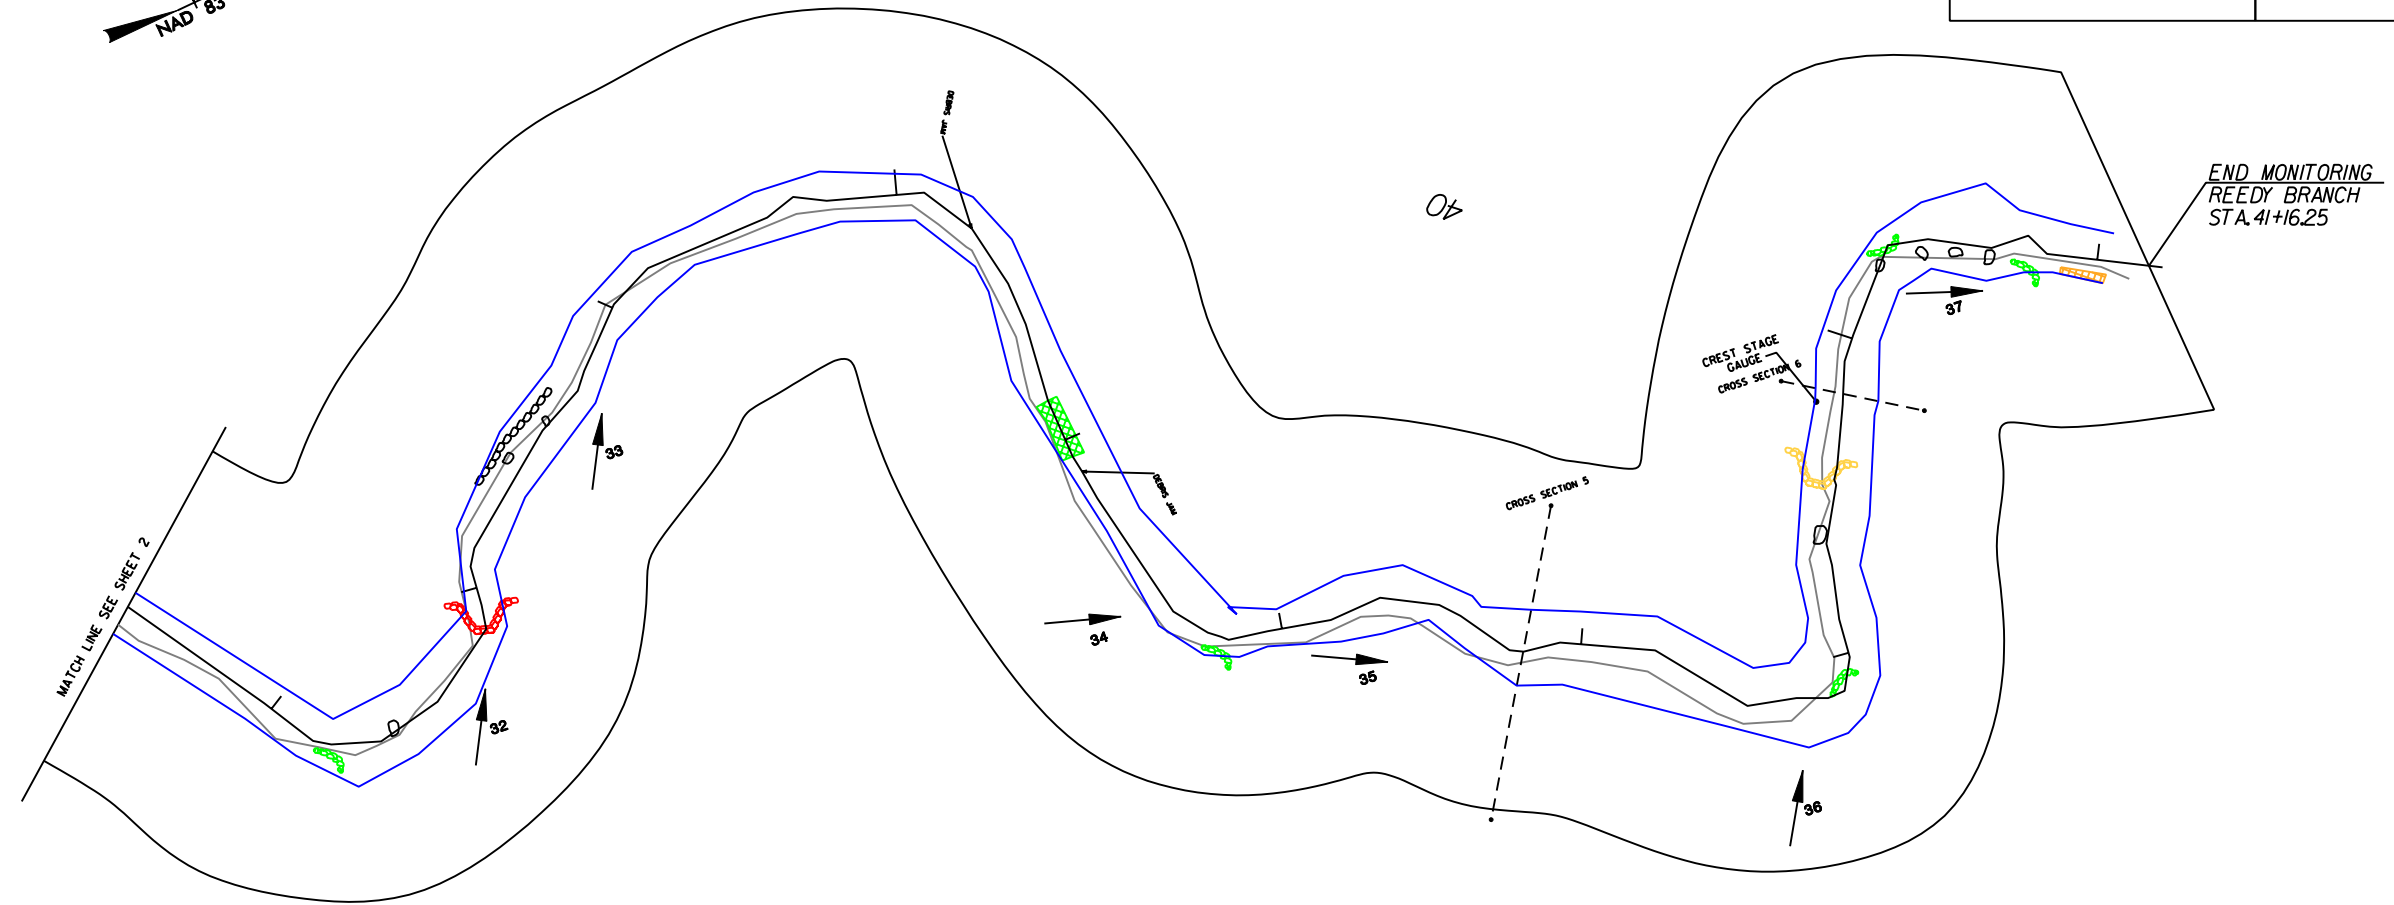
LOCATION:	REEDY BRANCH	
	CURRENT CONDITIONS PLAN VIEW	
	STREAM MONITORING - YEAR 4	
PROJ #:	301	COUNTY: ALAMANCE
PREPARED BY:	IPJ	
CHECKED BY:	PDB	DATE: 10/1/2008

It appears that many of the bank erosion areas identified in previous monitoring years have healed, as only 38 total feet of eroding bank along the project in Monitoring Year 4, as compared to 223 feet in Monitoring Year 3. This decrease in bank erosion can best be explained by a noticeable boost in vegetation density within the project corridor between monitoring years. Many of the erosional areas have stabilized with rooted vegetation. The total length of observed aggraded sections has reduced greatly as well (approximately 38 feet in Monitoring Year 4, compared to 293 feet in Monitoring Year 3). The best explanation for this reduction in aggradation is two-fold. First, there were several over-bankfull flows during Monitoring Year 4 that probably flushed fines downstream. Second, several of the areas identified as aggradation during Monitoring Year 3 were actually just areas where grasses had overtaken the channel due to the channel being dry for extended periods of time (2007 drought). These grasses were taken as evidence of aggradation, when in fact, little actual aggradation occurred. This interpretation was corrected in Monitoring Year 4.

Table B1. Stream Problem Areas			
Reedy Branch (EEP Project #301)			
Feature Issue	Station numbers	Suspected Cause	Photo number
Aggradation	10+37.34	Channel built too wide; narrowing to a stable dimension.	
	10+45.80		
Crossvane	10+87.16	Minor piping around structure.	
Rootwad	11+64.31	Possibly placed too high.	8
J-Hook	13+07.02	Piping around right arm/bank.	7
Cattle Crossing	15+75	Fencing on downstream end of cattle crossing has major damage from flood.	4
Root Wad	20+83.29	Angle or placement location is possible cause of erosion of both banks just upstream.	
Bank Erosion (right)	23+41.73	Inadequate bank protection; soil stability characteristics.	2
	23+58.71		
Cattle Crossing	23+70	Fencing on downstream end of cattle crossing has damage from flood.	
Debris Jam	23+85.22	Dead tree deposited during flood causing jam.	
Bank Erosion (left)	24+29.24	Bank just upstream of rock vane has inadequate protection during high flows and has been stripped of most vegetation.	1

24+35.50		
Rock Vane	24+35.50	Placed too far along the meander to protect the eroding bank on the upstream end of this structure.	
Crossvane	25+55	Piping under center stone.	
Crossvane (severe)	29+66.87	The bulk of the flow is piping around/under the large rock on the left side of the structure.	
Aggradation	29+95.53	Channel built too wide; narrowing to a stable dimension. Grass spanning channel.	
	30+06.18		
Crossvane (severe)	32+85.55	Significant back arm scour on right side of structure. Some rocks appear to have come loose, leaving exposed matting.	3 & 5
Debris Jam	35+27.19	Tree (DBH approximately 25") fell into channel to cause jam.	6
Aggradation	35+86.58	Resultant sediment deposition from adjacent bank erosion.	
	36+05.71		
Debris Jam	36+11.17	Dead tree deposited during flood causing jam.	
Crossvane	39+55.30	Angle or placement location is possible cause of erosion of both banks just downstream.

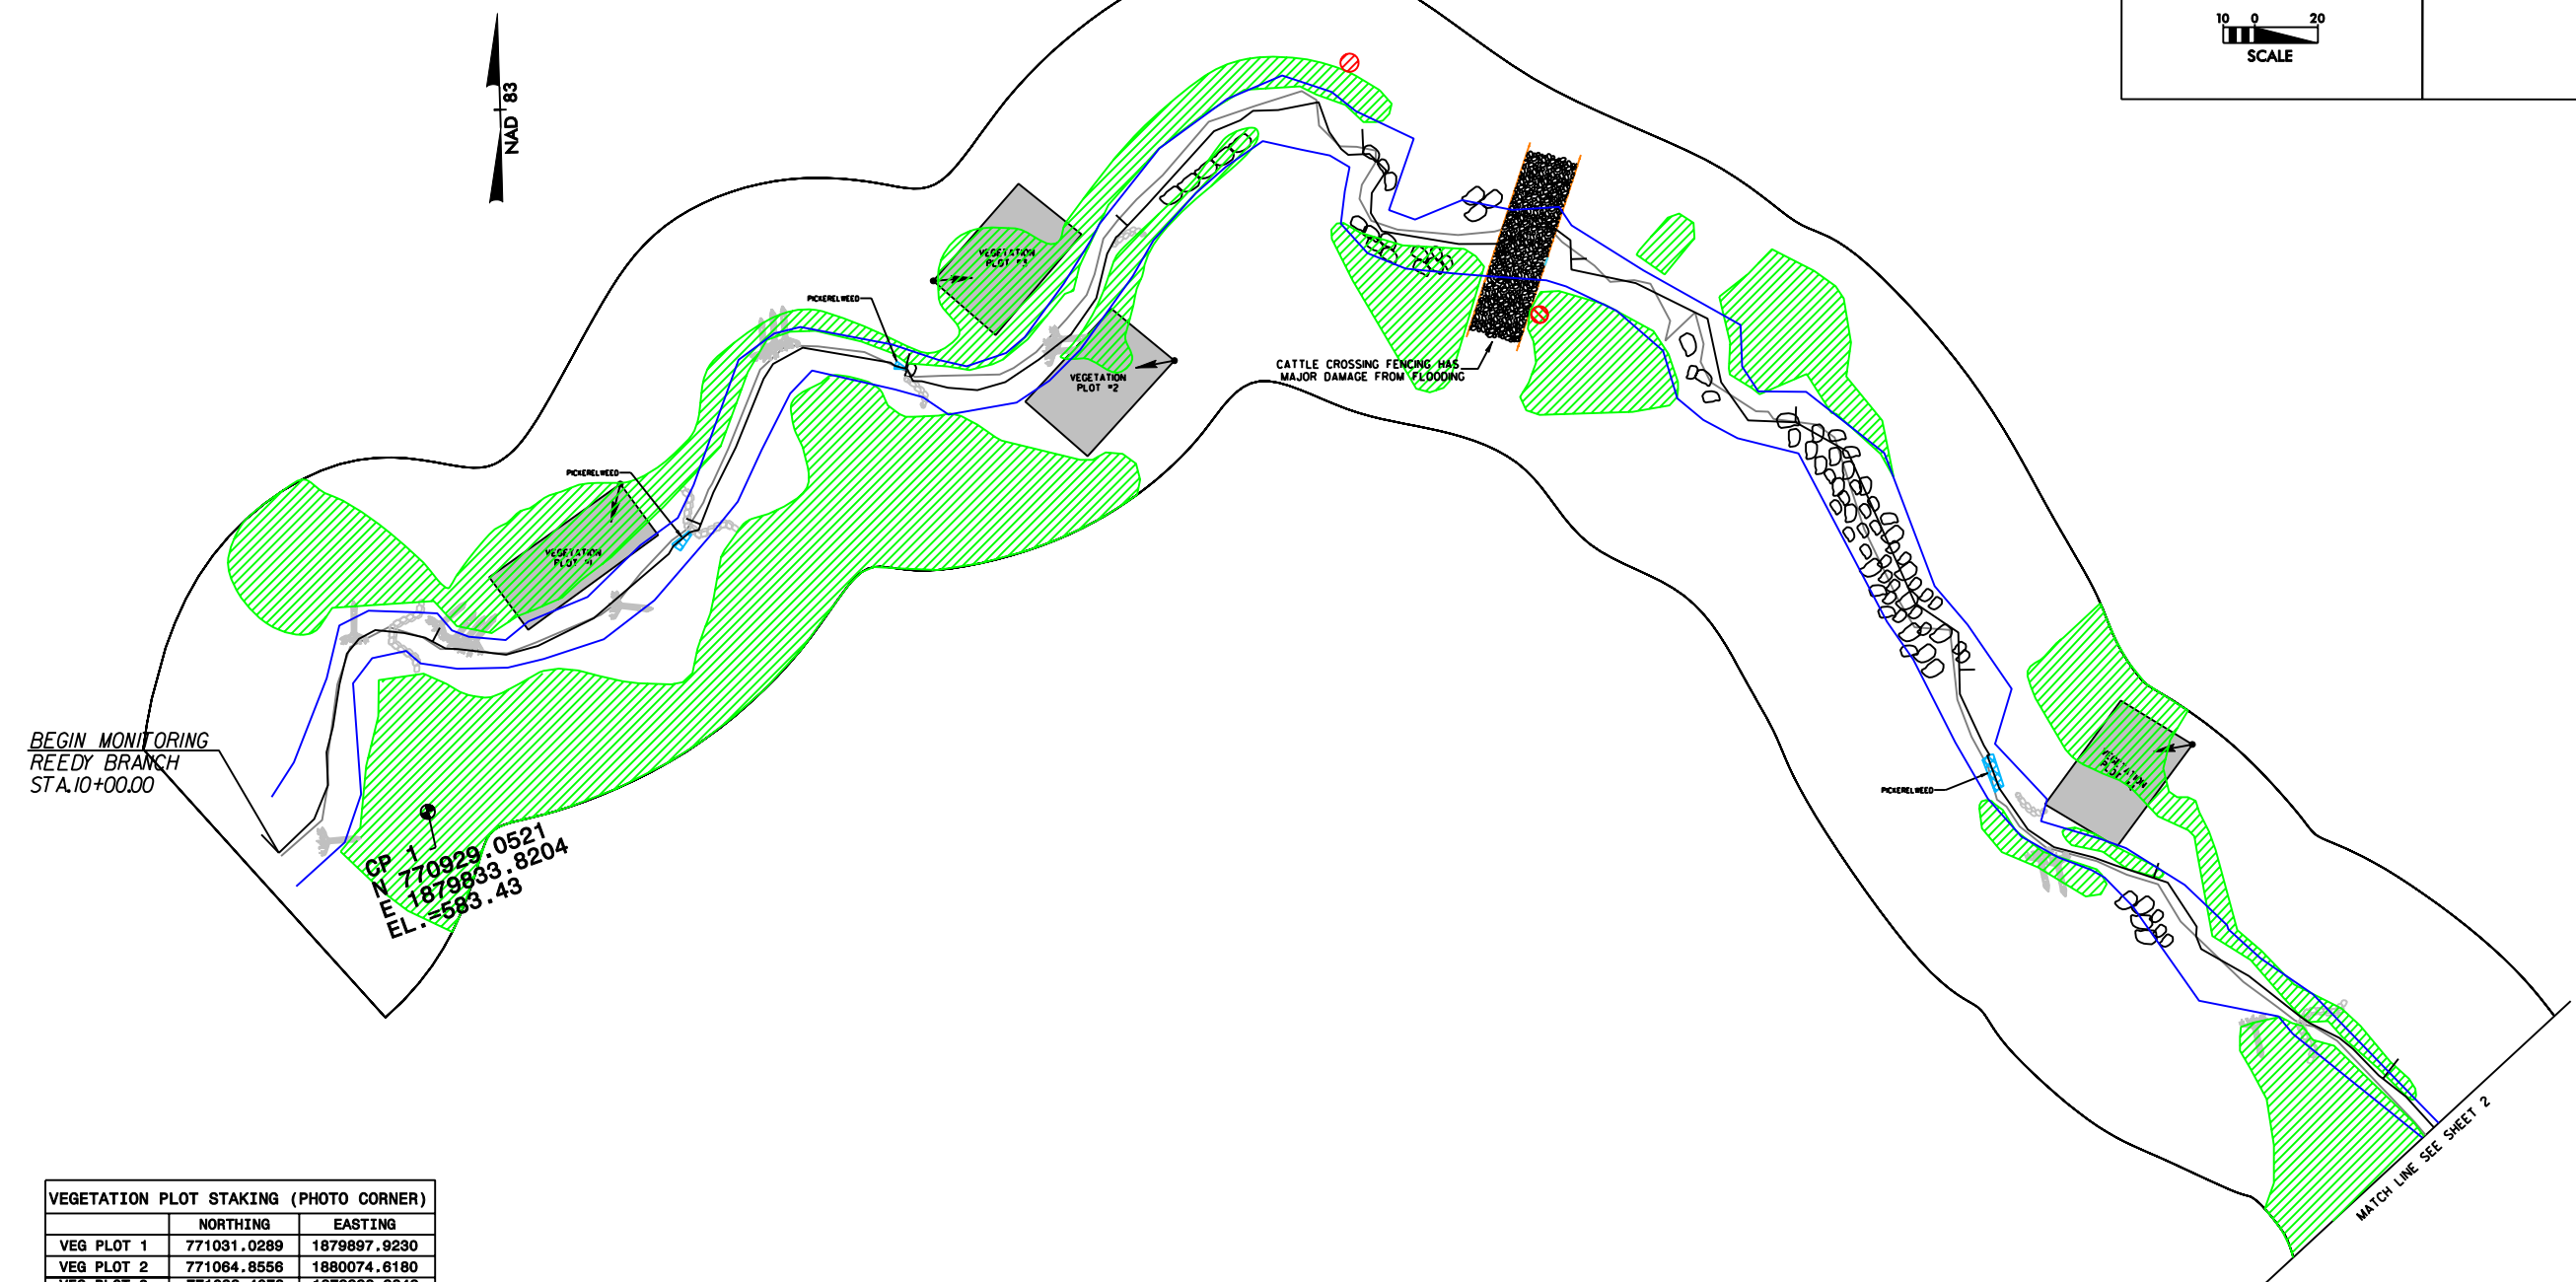
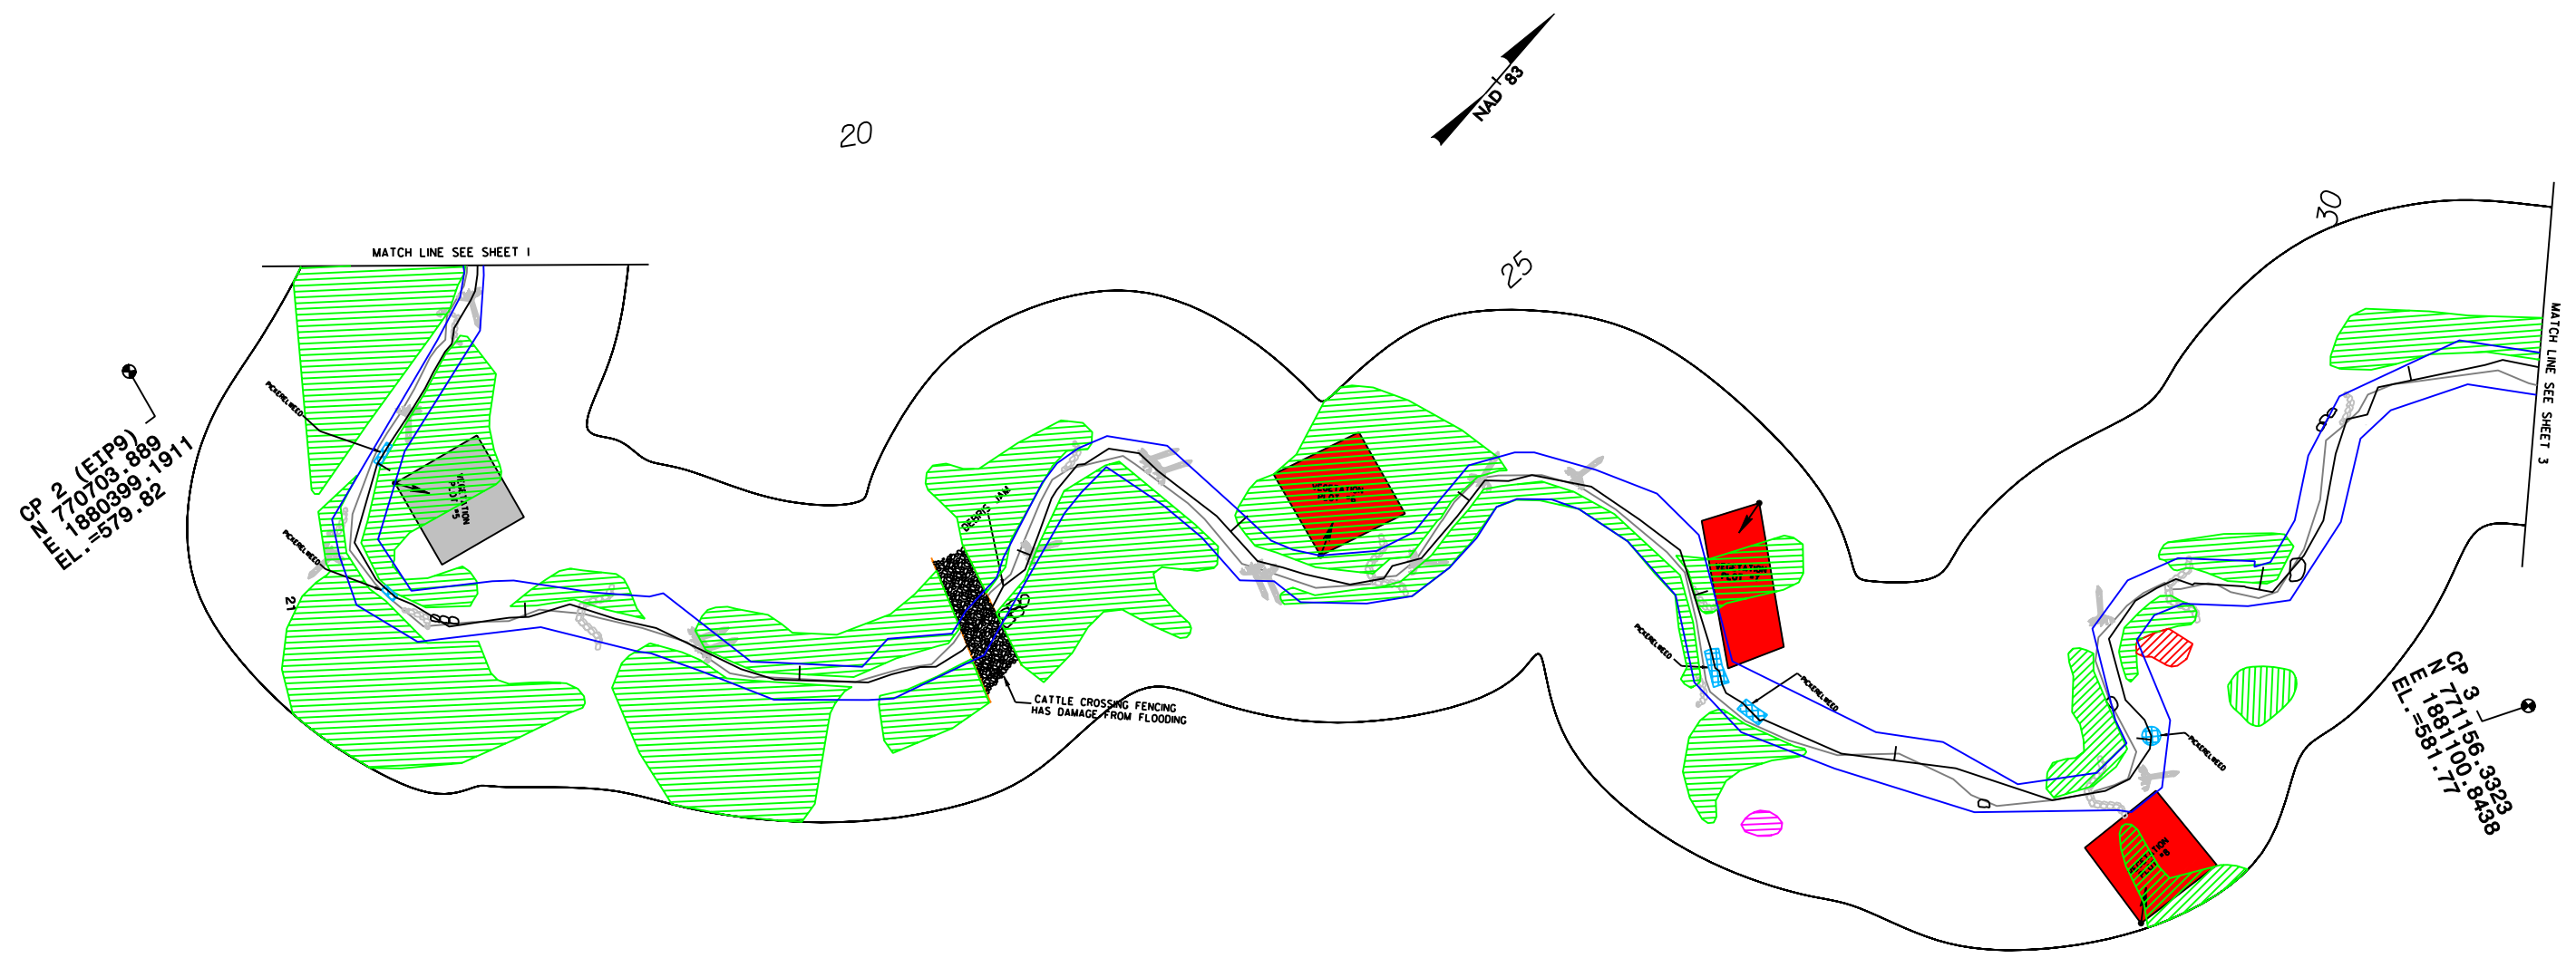
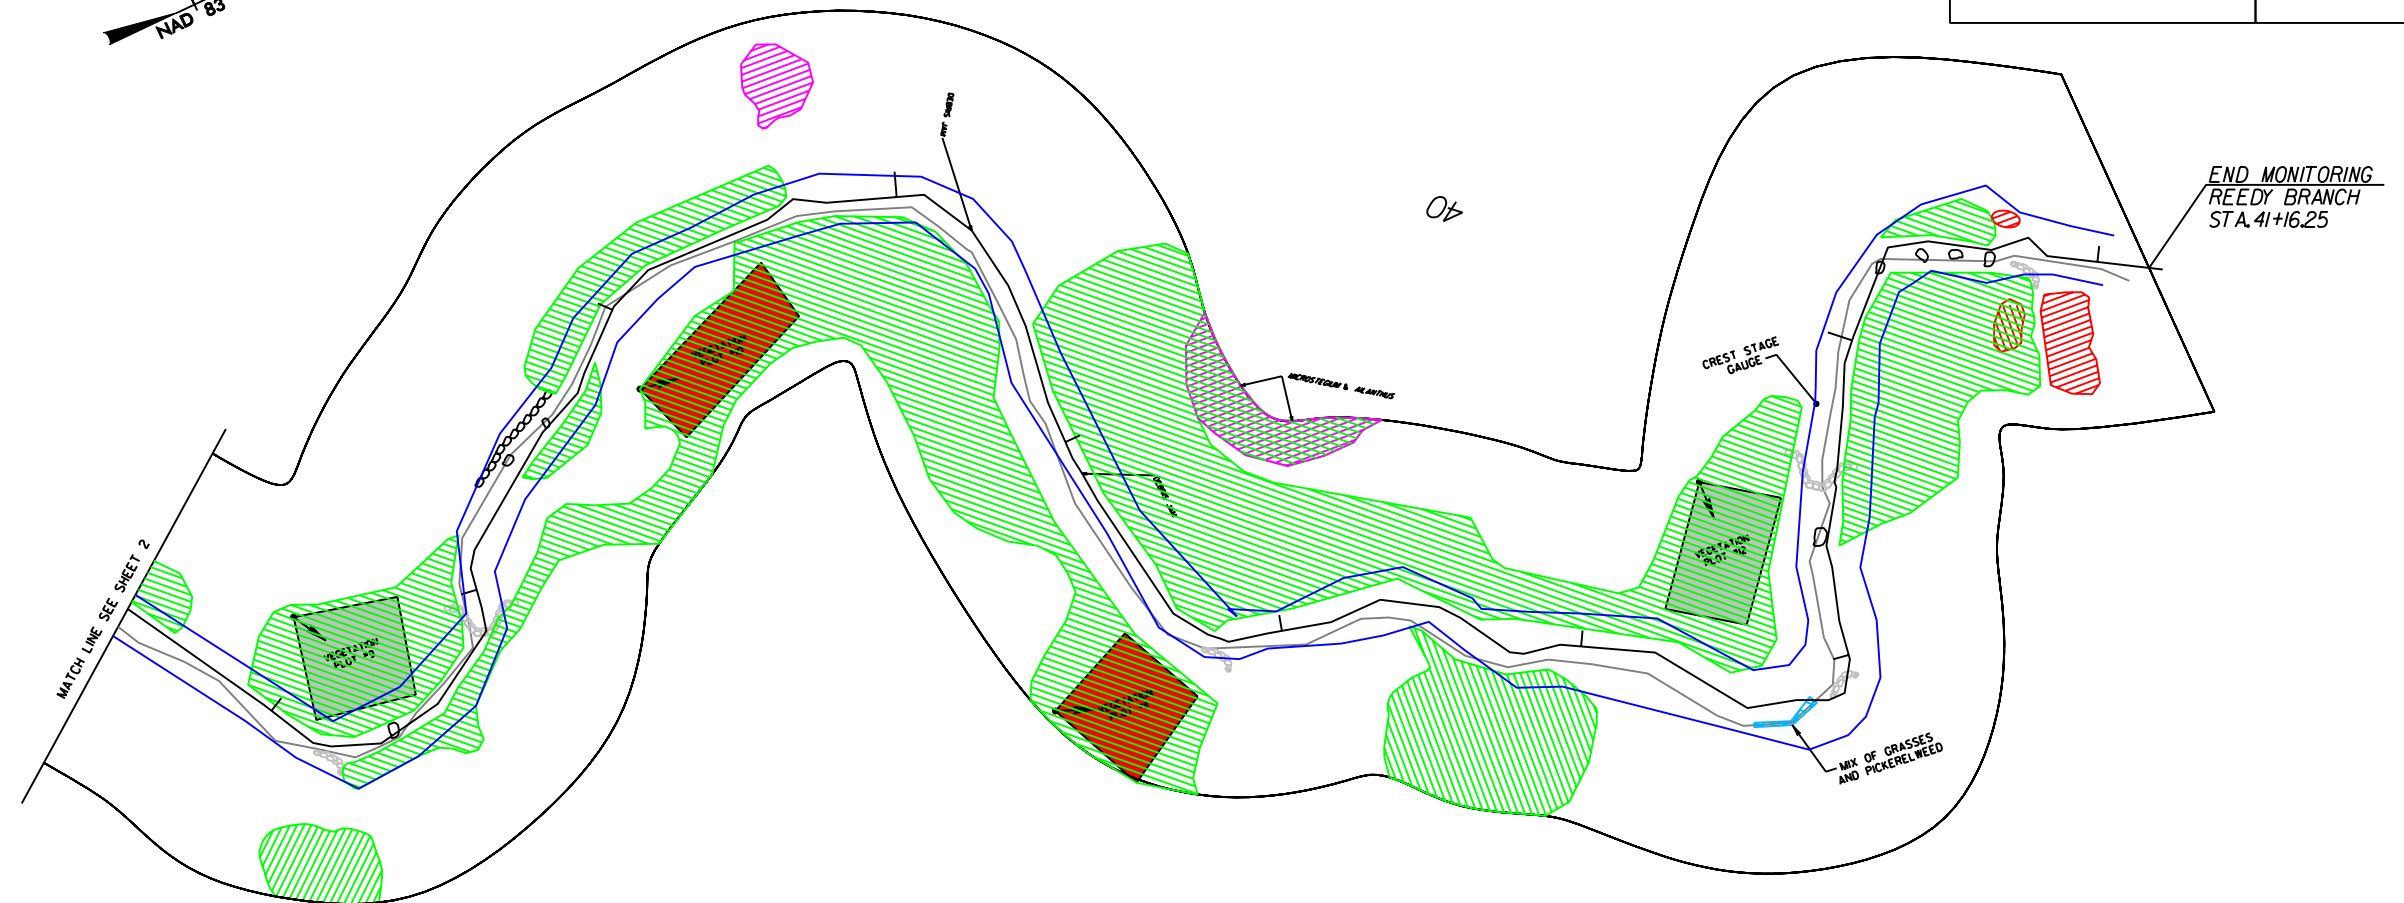
LOCATION:	REEDY BRANCH	
	CURRENT CONDITIONS PLAN VIEW	
	VEGETATION ASSESSMENT - YEAR 4	
PROJ #:	301	COUNTY: ALAMANCE
MONITORED BY:	IPJ	
CHECKED BY:	PDB	DATE: 10/1/08

There is good herbaceous vegetation growth along all of the monitored stream reach. Japanese stilt grass (*Microstegium vimineum*) has been established along the entire stream reach with limited areas where it does not dominate. Multiflora rose (*Rosa multiflora*) also was found in several spots along the project corridor, and there are several areas within the channel that are exhibiting pickerelweed (*Pontederia cordata*) growth (Table VI). Although not considered a ‘problem,’ it should be noted that cattails, which are sometimes considered to be invasive, were noted within the channel in several locations. The vegetation problem area plan view sheets (Appendix C) show the location of the vegetation plots and areas not dominated by Japanese stilt grass.

Overall, the project had high stem densities, especially with the inclusion of ‘volunteer’ species noted in the plot count table of Appendix A. The stem density goal at Monitoring Year 5 is 260 trees/acre. In Monitoring Year 4, all plots except plots 6, 7, 8, 10, and 11 had “planted stem” densities above this goal (see Table VII of Appendix A). However, it should be noted that there were several species for which several-to-many additional stems were counted for a given species within a given plot relative to previous monitoring years. These were not counted as ‘planted’ even if they appeared to be. We assumed that all of these stems were ‘volunteers.’ With the inclusion of these ‘volunteer’ species, all of the vegetation plots would probably meet the Monitoring Year 5 stem density goal. Volunteer species found at Reedy Branch included the following: *Quercus rubra*, *Acer rubrum*, *Betula nigra*, *Carpinus caroliniana*, *Liriodendron tulipifera*, *Quercus michauxii*, *Juglans nigra*, *Platanus occidentalis*, *Baccharis halimifolia*, *Prunus serotina*, *Salix nigra*, *Liquidambar styraciflua*, *Quercus sp.*, *Quercus alba*, *Quercus phellos*, *Sambucus canadensis*, *Ulmus alata*, *Pinus taeda*, and *Juniperus virginiana*. *Liquidambar styraciflua* were too numerous to count in several of the plots. The location of the vegetation plots are shown on the vegetative problem area plan view in Appendix C.
