**REEDY BRANCH
FINAL MONITORING REPORT
MONITORING YEAR 5 OF 5
2009**

EEP Project # 301
Alamance County, North Carolina

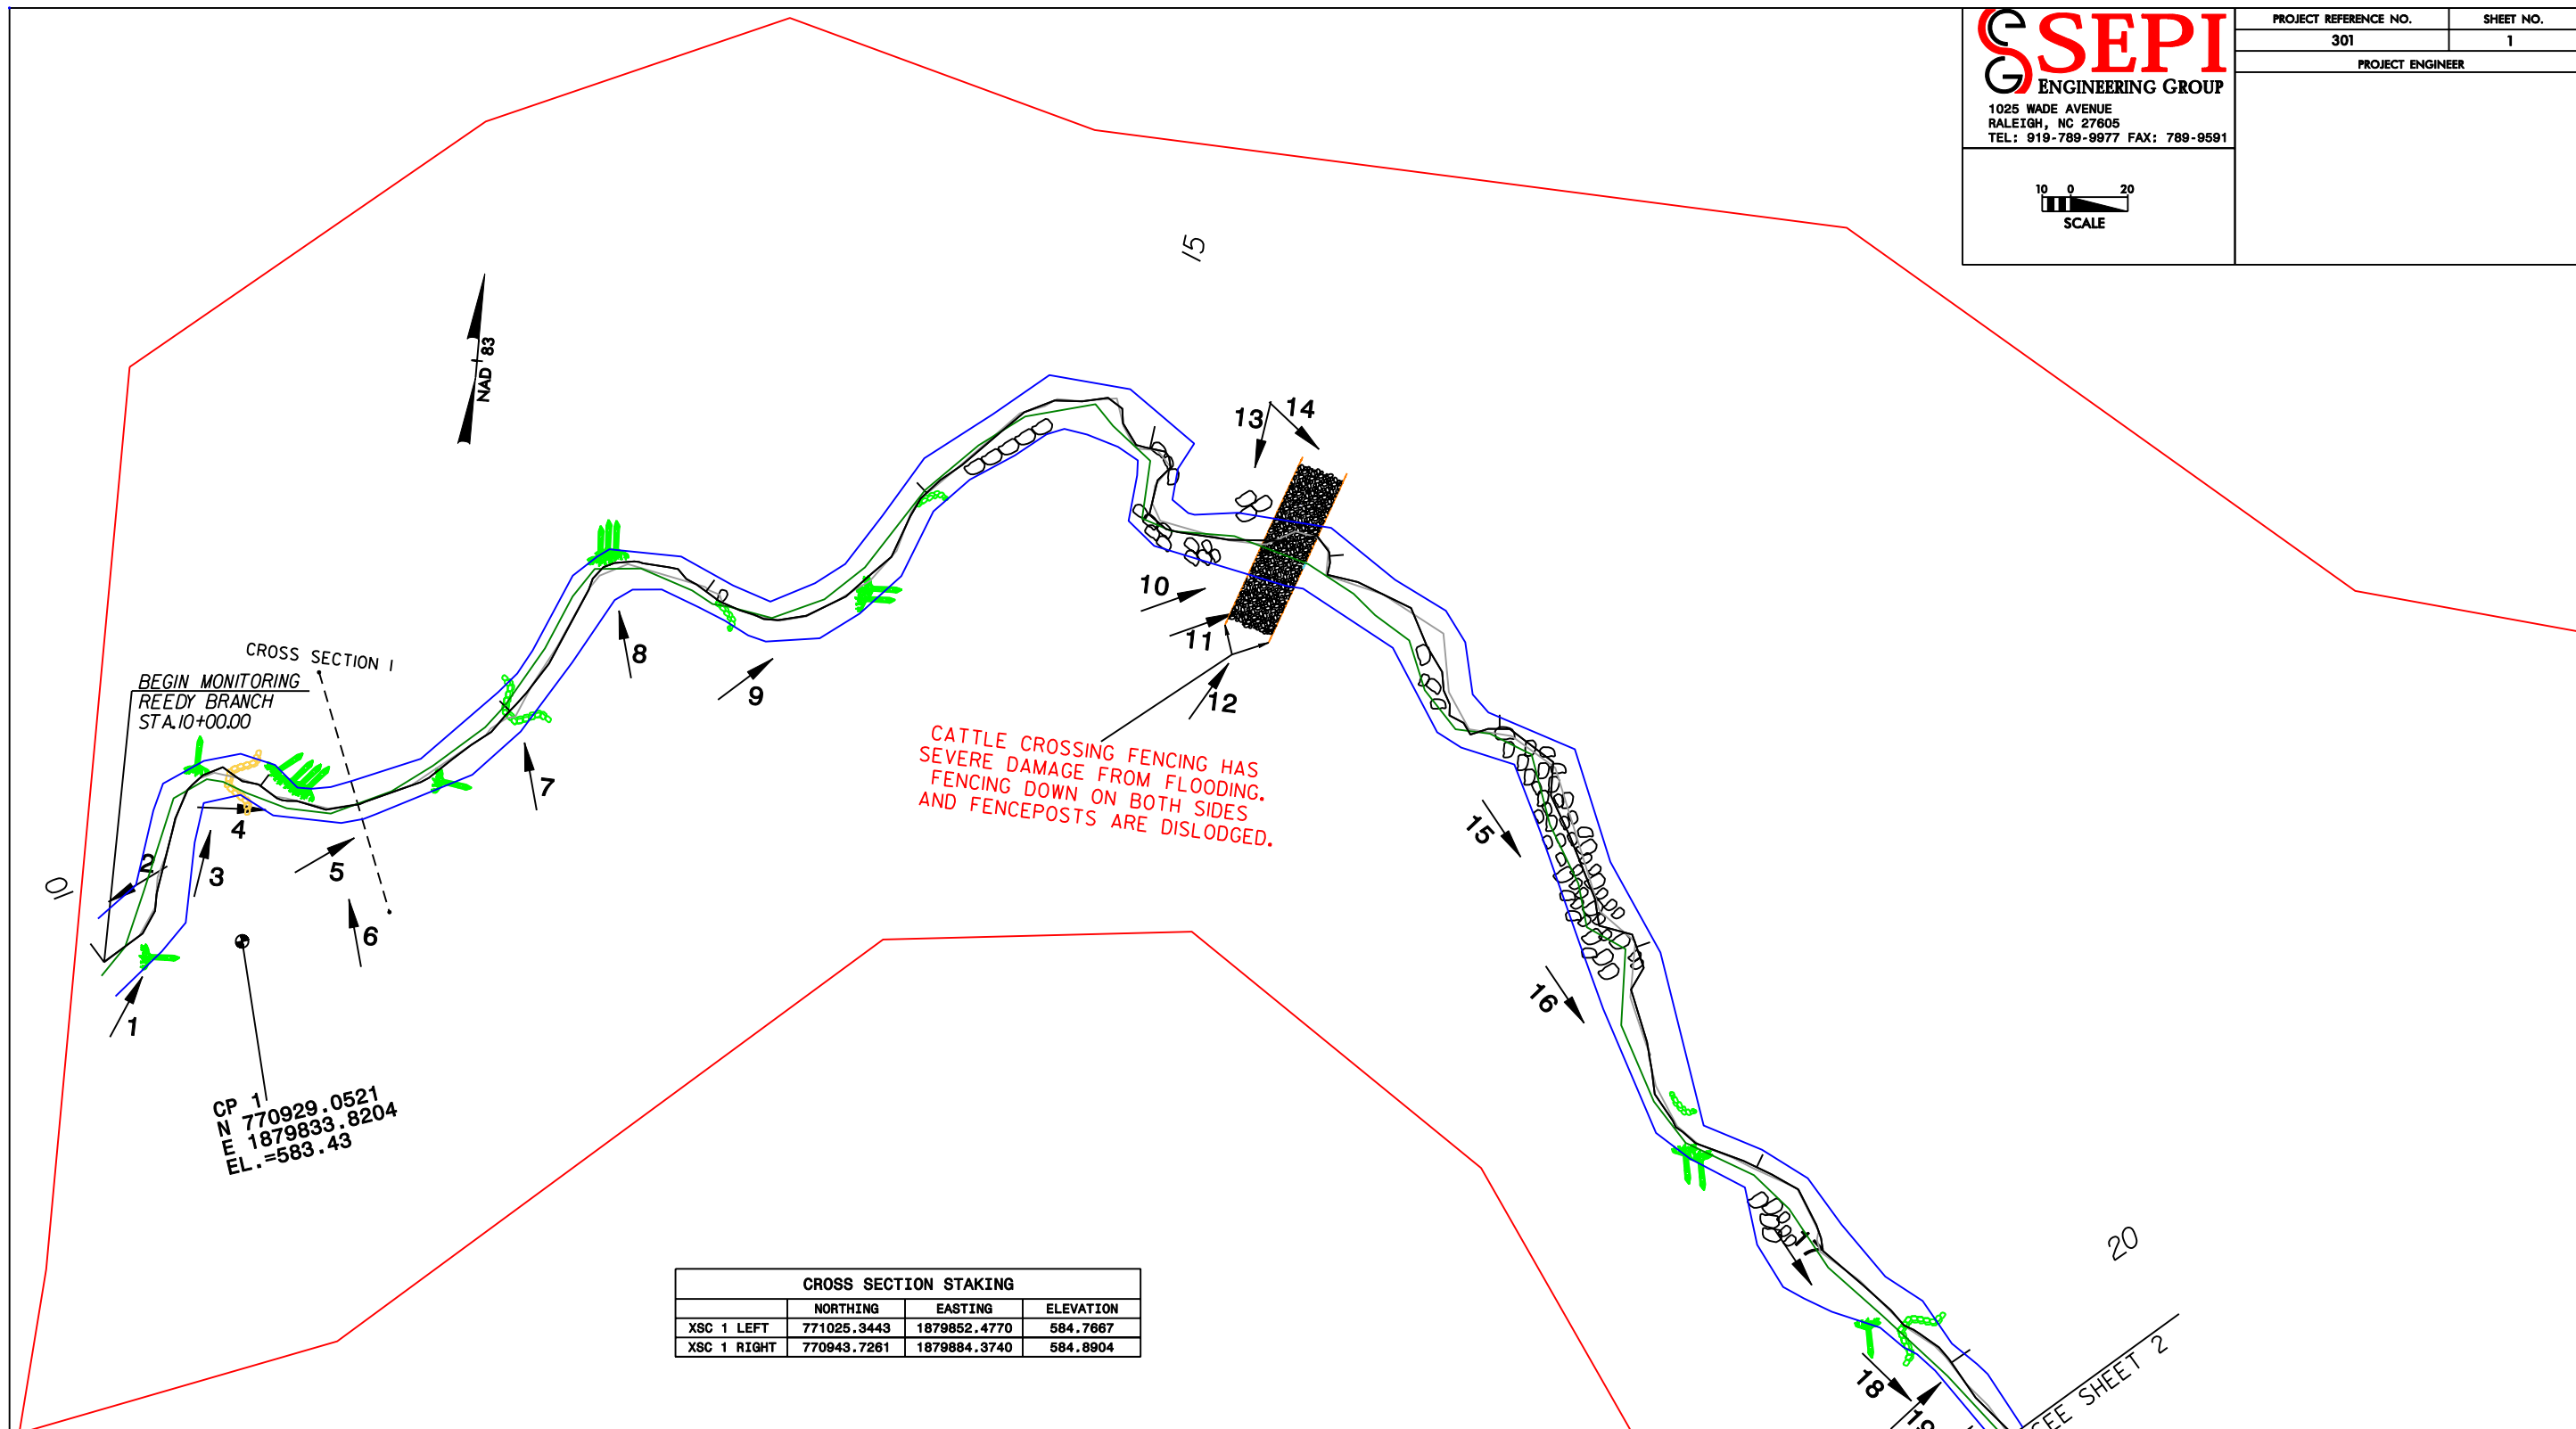
LOCATION:	REEDY BRANCH CURRENT CONDITIONS PLAN VIEW INITIAL STREAM - YEAR 5		
PROJ #:	301	COUNTY:	ALAMANCE
PREPARED BY:	IPJ	CHECKED BY:	PDB
		DATE:	1/13/2010

CATTLE CROSSING FENCING HAS SEVERE DAMAGE FROM FLOODING. FENCING DOWN ON BOTH SIDES AND FENCEPOSTS ARE DISLODGED.
