**Baseline Monitoring Document and As-Built Report
Final
Paschal Golf Course (Richland Creek) Stream Restoration
EEP Project #276
2010**

December 2010

Monitoring Firm

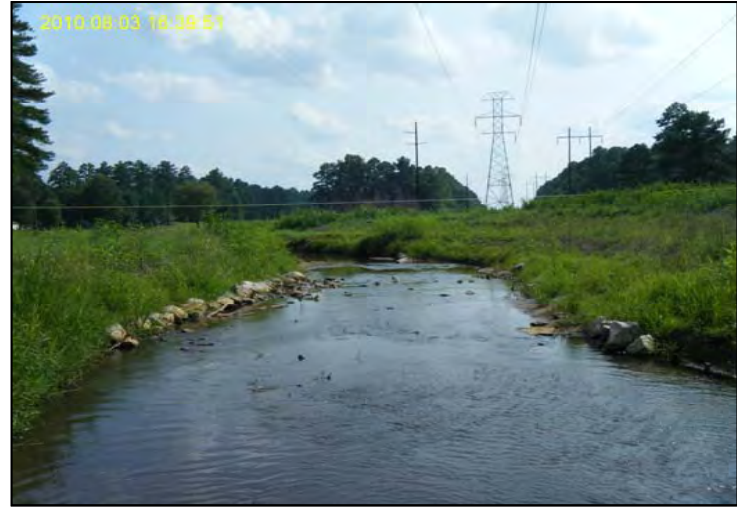
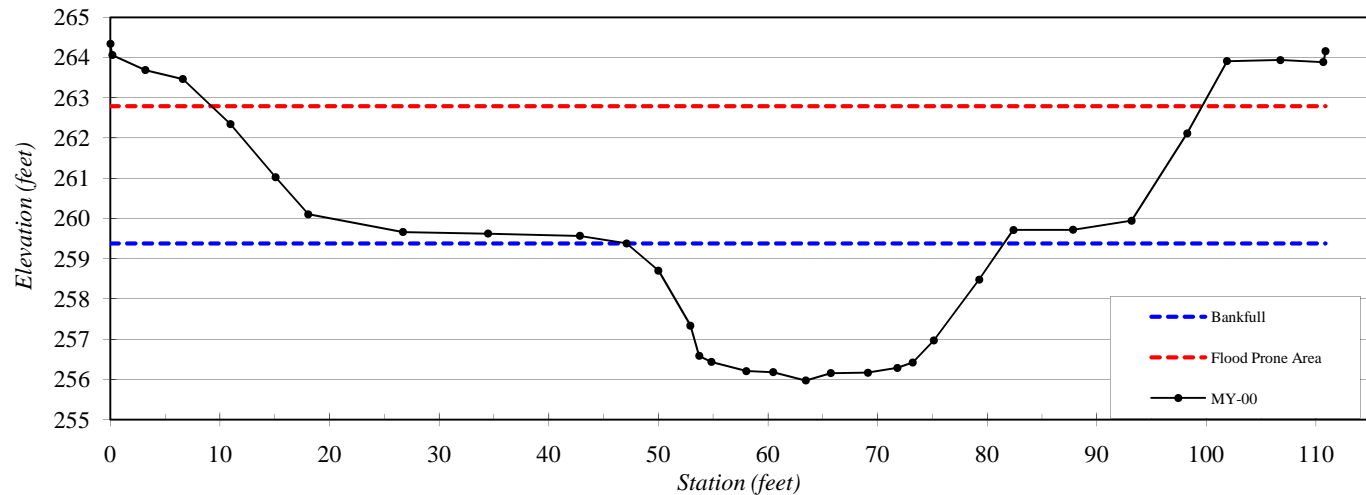
Neuse River Basin, Richland Creek, MY-00, XS - 1, Riffle

SUMMARY DATA	
Bankfull Elevation:	259.4
Bankfull Cross-Sectional Area:	81.7
Bankfull Width:	34.4
Flood Prone Area Elevation:	262.8
Flood Prone Width:	>90
Max Depth at Bankfull:	3.4
Mean Depth at Bankfull:	2.4
W / D Ratio:	14.5
Entrenchment Ratio:	2.6
Bank Height Ratio:	1.0

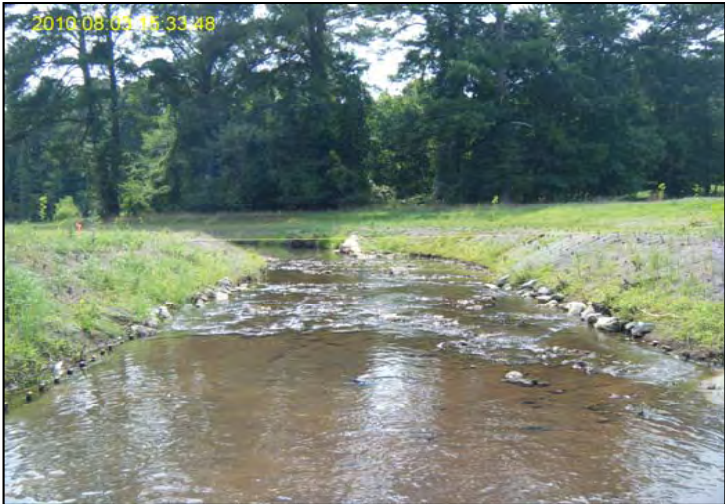
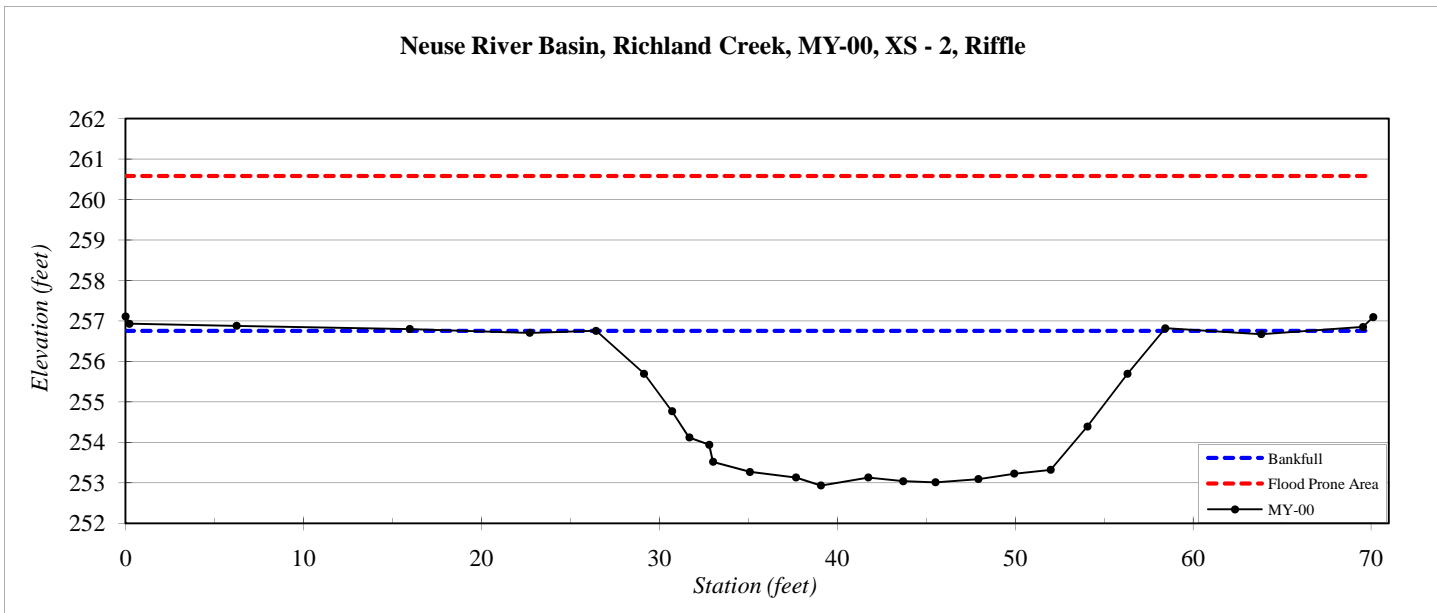
Neuse River Basin, Richland Creek, MY-00, XS - 2, Riffle

SUMMARY DATA	
Bankfull Elevation:	256.8
Bankfull Cross-Sectional Area:	85.6
Bankfull Width:	30.6
Flood Prone Area Elevation:	260.6
Flood Prone Width:	>70
Max Depth at Bankfull:	3.8
Mean Depth at Bankfull:	2.8
W / D Ratio:	10.9
Entrenchment Ratio:	2.3
Bank Height Ratio:	1.0

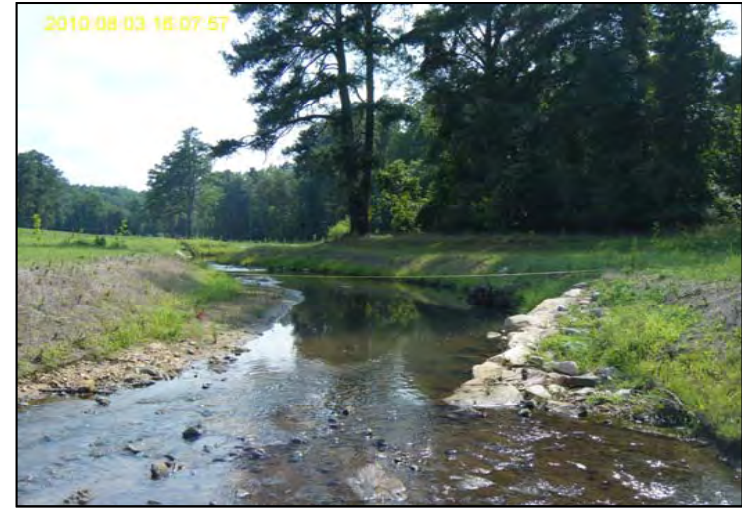
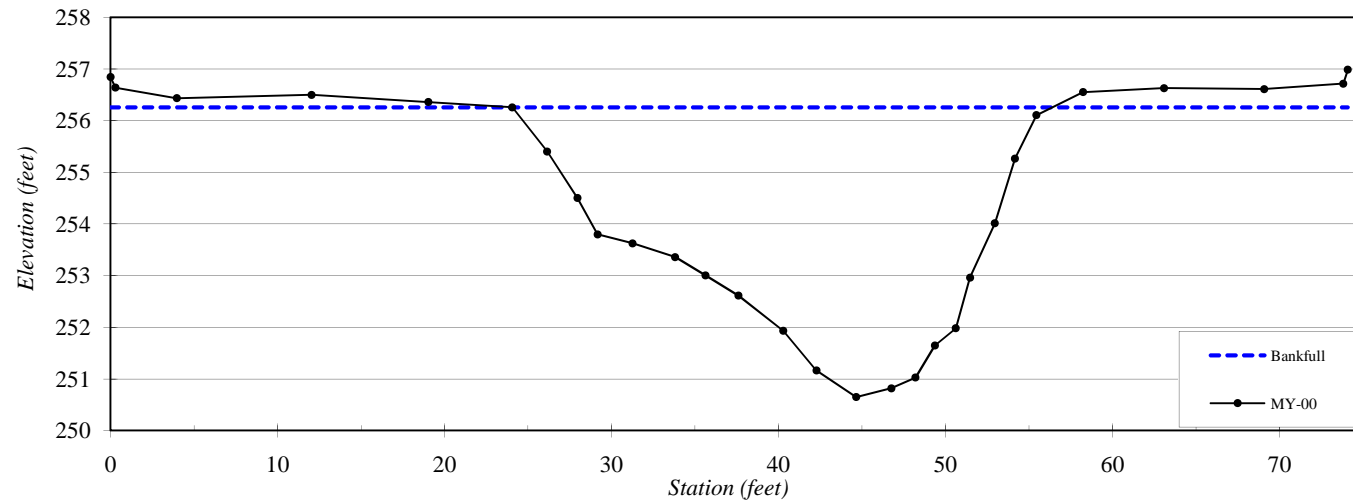
Neuse River Basin, Richland Creek, MY-00, XS - 3, Pool

SUMMARY DATA	
Bankfull Elevation:	256.3
Bankfull Cross-Sectional Area:	104.0
Bankfull Width:	31.4
Flood Prone Area Elevation:	-
Flood Prone Width:	-
Max Depth at Bankfull:	5.6
Mean Depth at Bankfull:	3.3
W / D Ratio:	-
Entrenchment Ratio:	-
Bank Height Ratio:	1.0

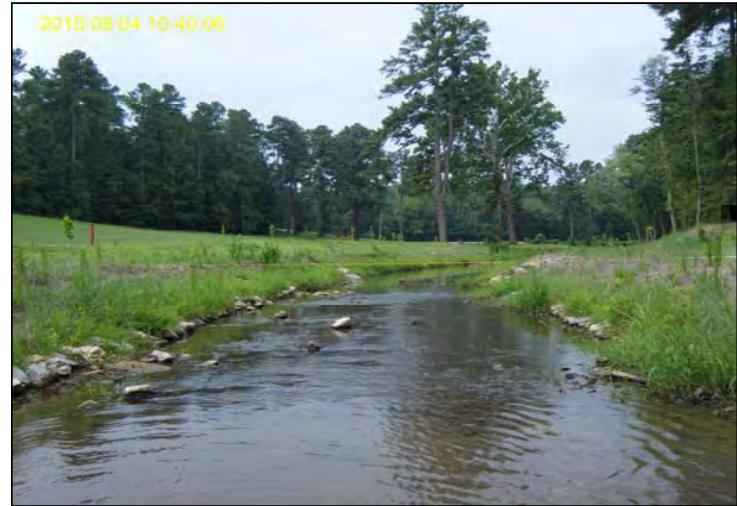
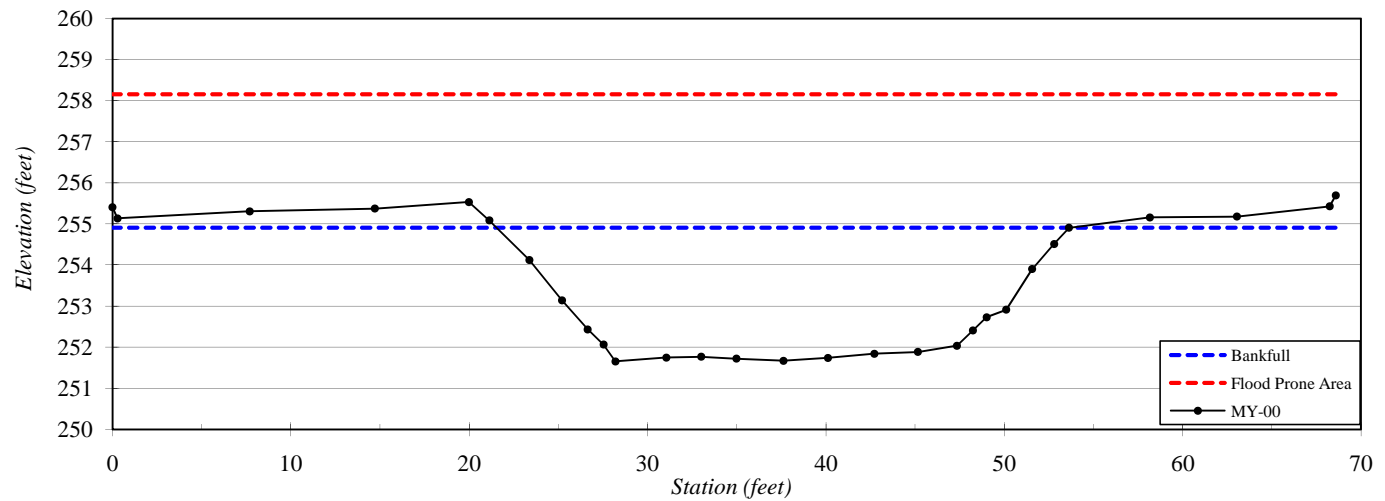
Neuse River Basin, Richland Creek, MY-00, XS - 4, Riffle

SUMMARY DATA	
Bankfull Elevation:	254.9
Bankfull Cross-Sectional Area:	80.2
Bankfull Width:	32.1
Flood Prone Area Elevation:	258.2
Flood Prone Width:	>68
Max Depth at Bankfull:	3.3
Mean Depth at Bankfull:	2.5
W / D Ratio:	12.8
Entrenchment Ratio:	2.1
Bank Height Ratio:	1.0

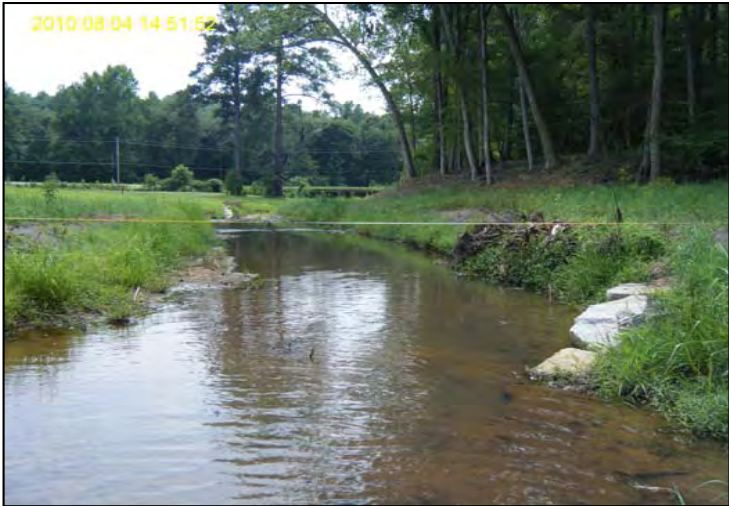
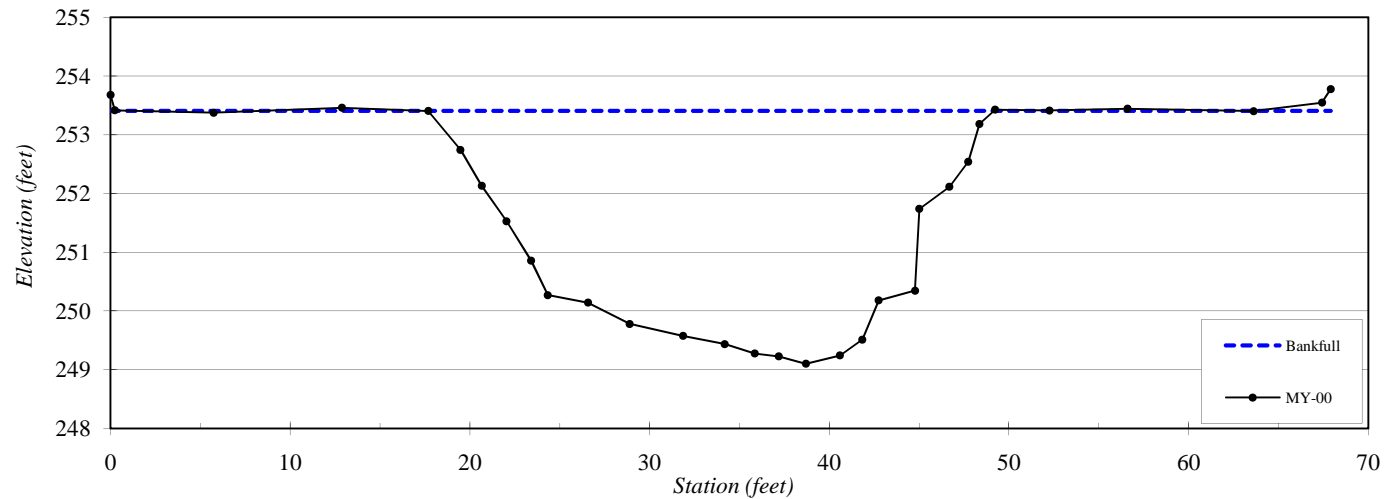
Neuse River Basin, Richland Creek, MY00, XS - 5, Pool

SUMMARY DATA	
Bankfull Elevation:	253.4
Bankfull Cross-Sectional Area:	90.8
Bankfull Width:	31.5
Flood Prone Area Elevation:	-
Flood Prone Width:	-
Max Depth at Bankfull:	4.3
Mean Depth at Bankfull:	2.9
W / D Ratio:	-
Entrenchment Ratio:	-
Bank Height Ratio:	1.0

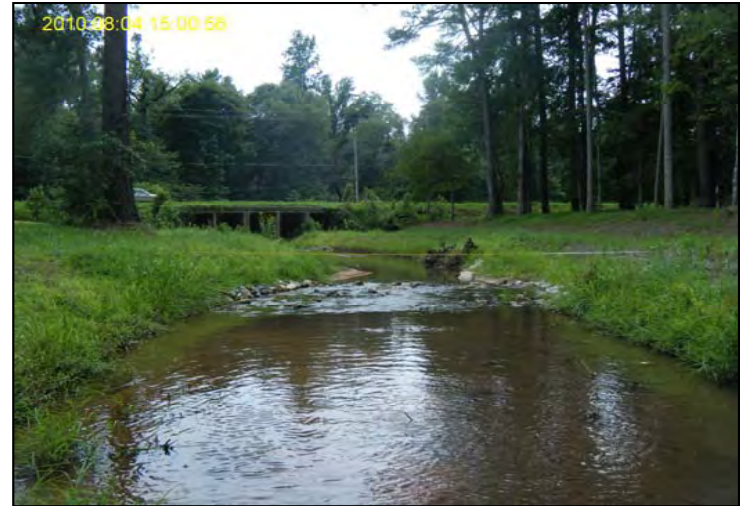
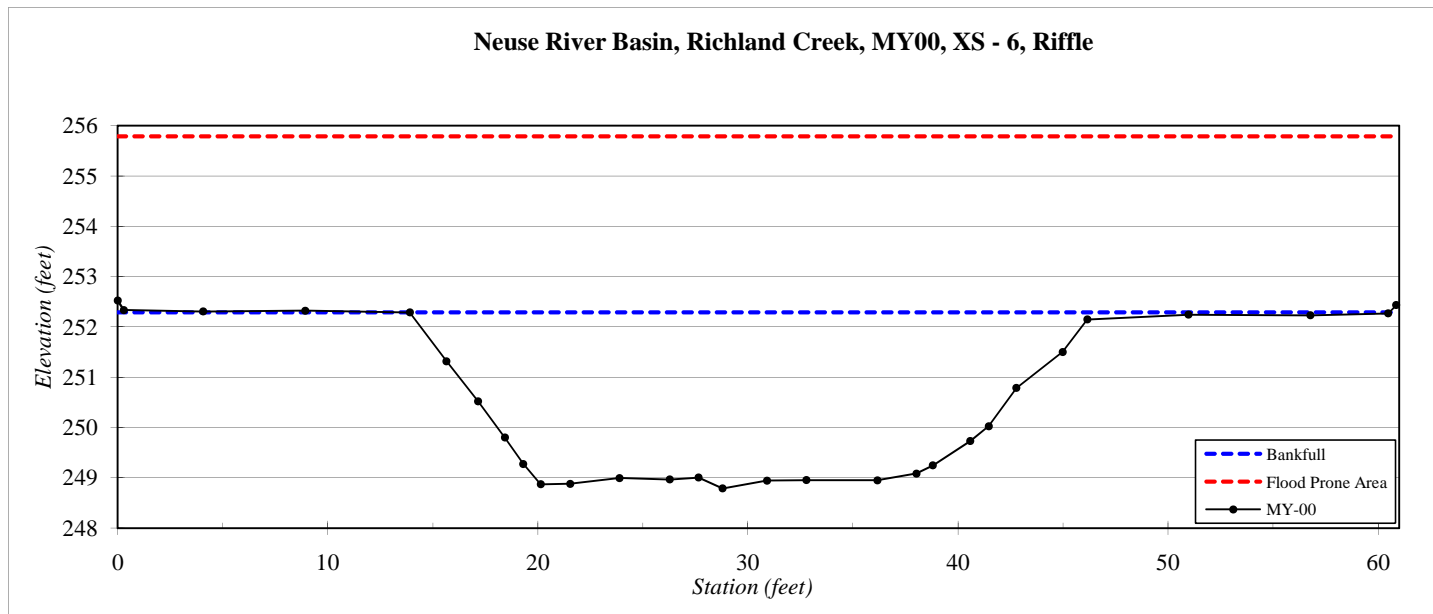
Neuse River Basin, Richland Creek, MY00, XS - 6, Riffle

SUMMARY DATA	
Bankfull Elevation:	252.3
Bankfull Cross-Sectional Area:	85.6
Bankfull Width:	32.2
Flood Prone Area Elevation:	255.8
Flood Prone Width:	>60
Max Depth at Bankfull:	3.5
Mean Depth at Bankfull:	2.7
W / D Ratio:	12.1
Entrenchment Ratio:	1.9
Bank Height Ratio:	1.0
