As-Built Mitigation Plan

ROCKY BRANCH STREAM RESTORATION

Yadkin County, North Carolina

February 20, 2008

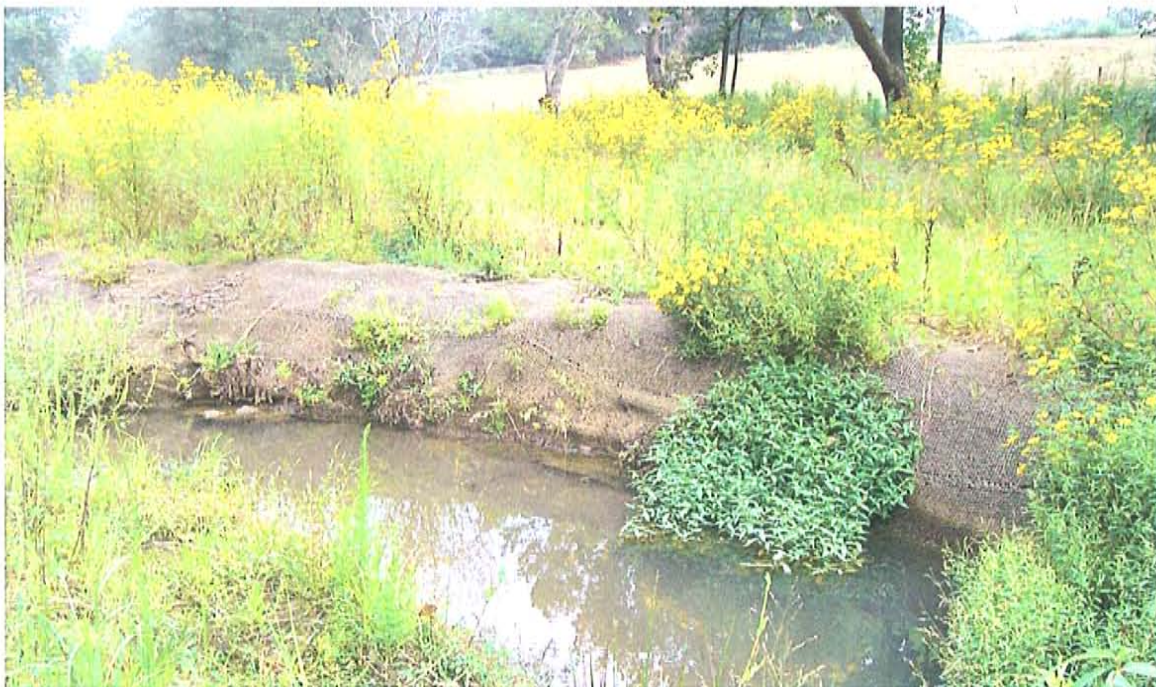
Rocky Branch (Stations 32+80 – 33+00) Area of sloughing banks. View looking across channel from left to right.
