Rocky Branch Stream Restoration

Yadkin County, North Carolina

2008 Year 1 Monitoring Report

EEP Project Number: 308

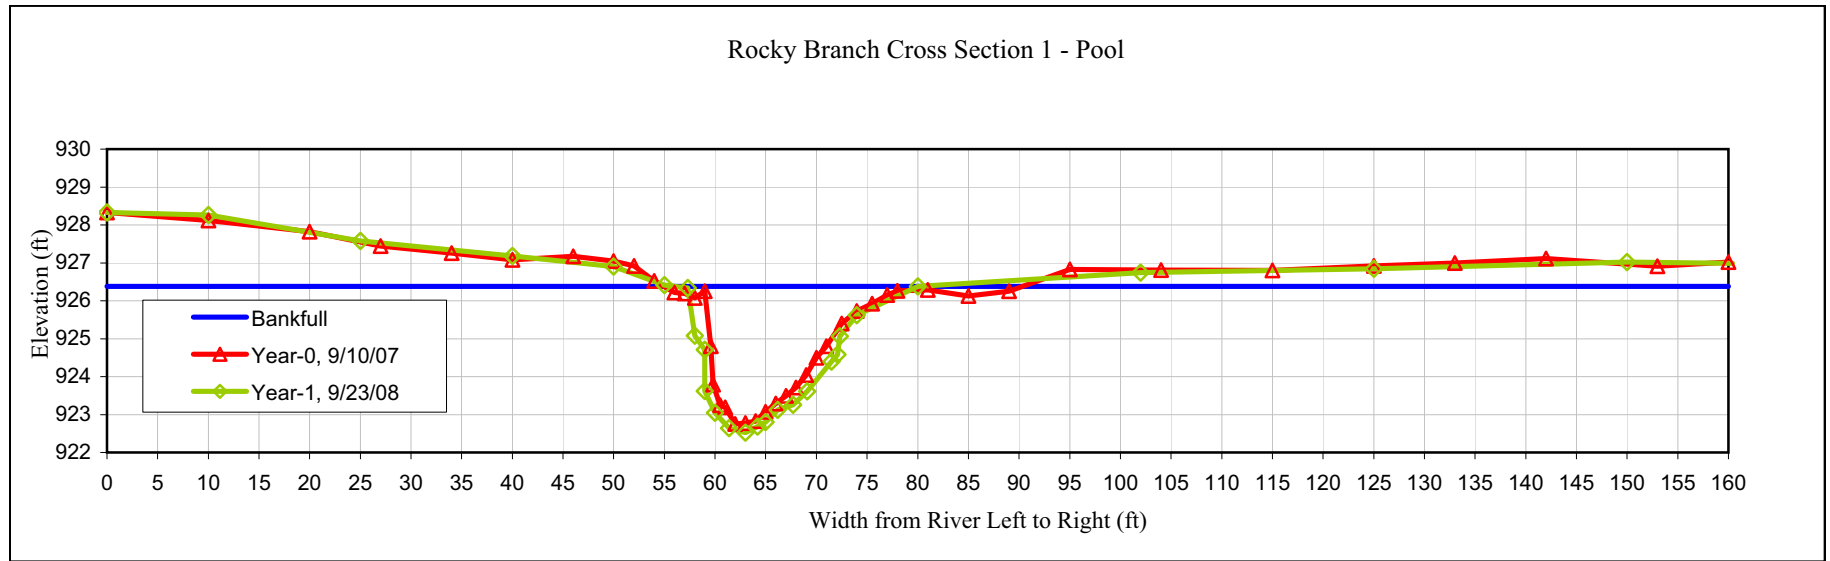
CROSS SECTION PLOT - LOOKING DOWNSTREAM

YEAR-1, 2008 SURVEY DATA **CROSS-SECTION:** 1
PROJECT ROCKY BRANCH **FEATURE:** Pool
TASK CROSS SECTION
REACH ROCKY BRANCH
DATE 9/23/2008 to 9/25/2008
CREW ALTIZER/BUCHHOLZ/HALLEY/FURRY

Bankfull X-sec area	47.7	sq. ft.
Bankfull Width	24.0	ft.
Bankfull Mean Depth	2.0	ft.
Bankfull Max Depth	3.9	ft.
Width/Depth Ratio	12.4	
Entrenchment Ratio	>2.2	
Classification	n/a	
Bank Height Ratio	1.0	
Bankfull Elevation:	926.38	ft.

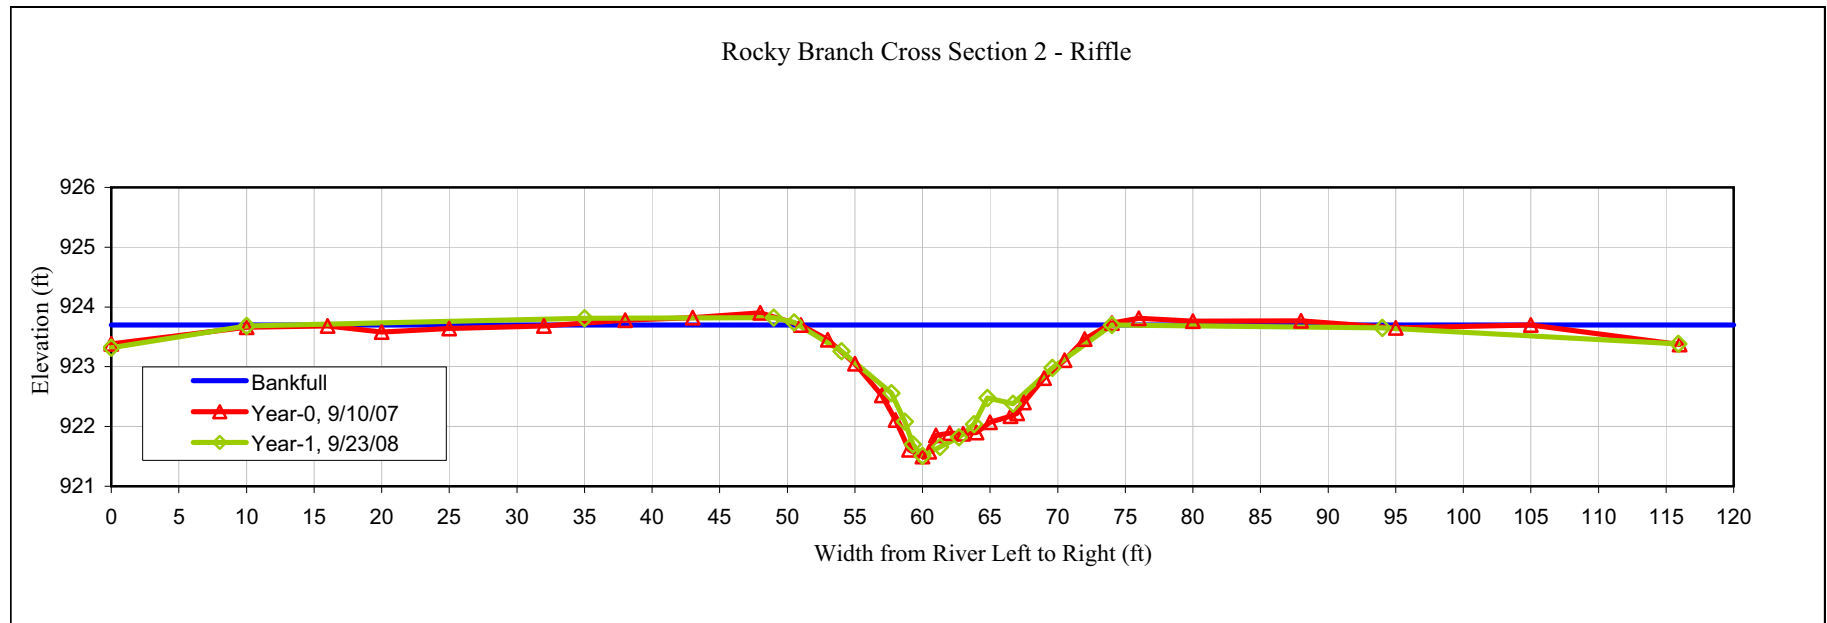
CROSS SECTION PLOT - LOOKING DOWNSTREAM

YEAR-1, 2008 SURVEY DATA
PROJECT ROCKY BRANCH
TASK CROSS SECTION
REACH ROCKY BRANCH
DATE 9/23/2008 to 9/25/2008
CREW ALTIZER/BUCHHOLZ/HALLEY/FURRY

Bankfull X-sec area	23.4	sq. ft.
Bankfull Width	23.2	ft.
Bankfull Mean Depth	1.0	ft.
Bankfull Max Depth	2.2	ft.
Width/Depth Ratio	>12	
Entrenchment Ratio	>2.2	
Classification	C	
Bank Height Ratio	1.0	
Bankfull Elevation:	923.70	ft.

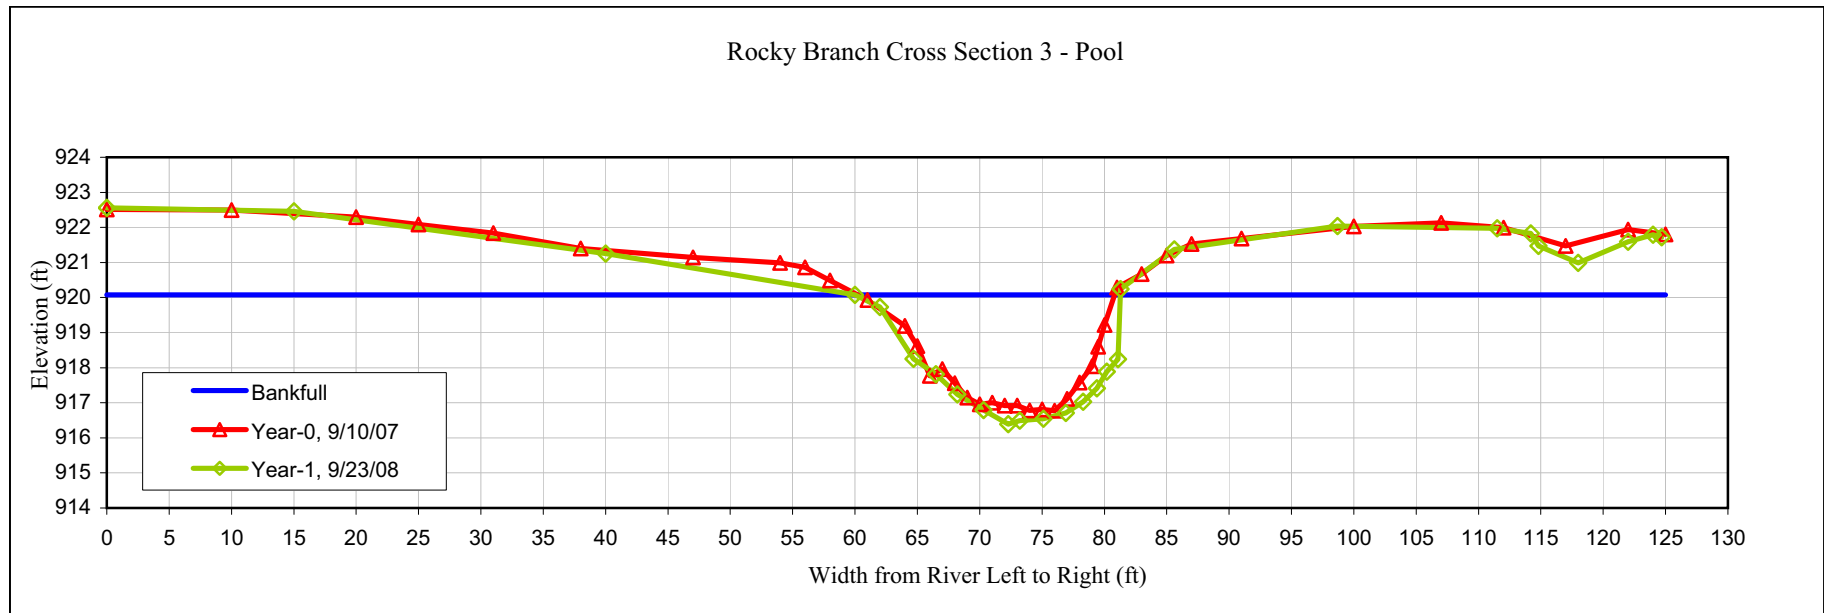
CROSS SECTION PLOT - LOOKING DOWNSTREAM

YEAR-1, 2008 SURVEY DATA **CROSS-SECTION:** 3
PROJECT ROCKY BRANCH **FEATURE:** Pool
TASK CROSS SECTION
REACH ROCKY BRANCH
DATE 9/23/2008 to 9/25/2008
CREW ALTIZER/BUCHHOLZ/HALLEY/FURRY

Bankfull X-sec area	52.6	sq. ft.
Bankfull Width	21.3	ft.
Bankfull Mean Depth	2.5	ft.
Bankfull Max Depth	3.7	ft.
Width/Depth Ratio	8.6	
Entrenchment Ratio	>2.2	
Classification	n/a	
Bank Height Ratio	1.0	
Bankfull Elevation:	920.08	ft.
