YEAR 1 MONITORING REPORT

ROSES CREEK STREAM MITIGATION SITE
Burke County, North Carolina
NC DMS Project # 96309

Construction Completed: May 2016
Morphology Data Collected: November 22, 2016
Vegetation Data Collected: October 5, 2016
Submitted: December 2016

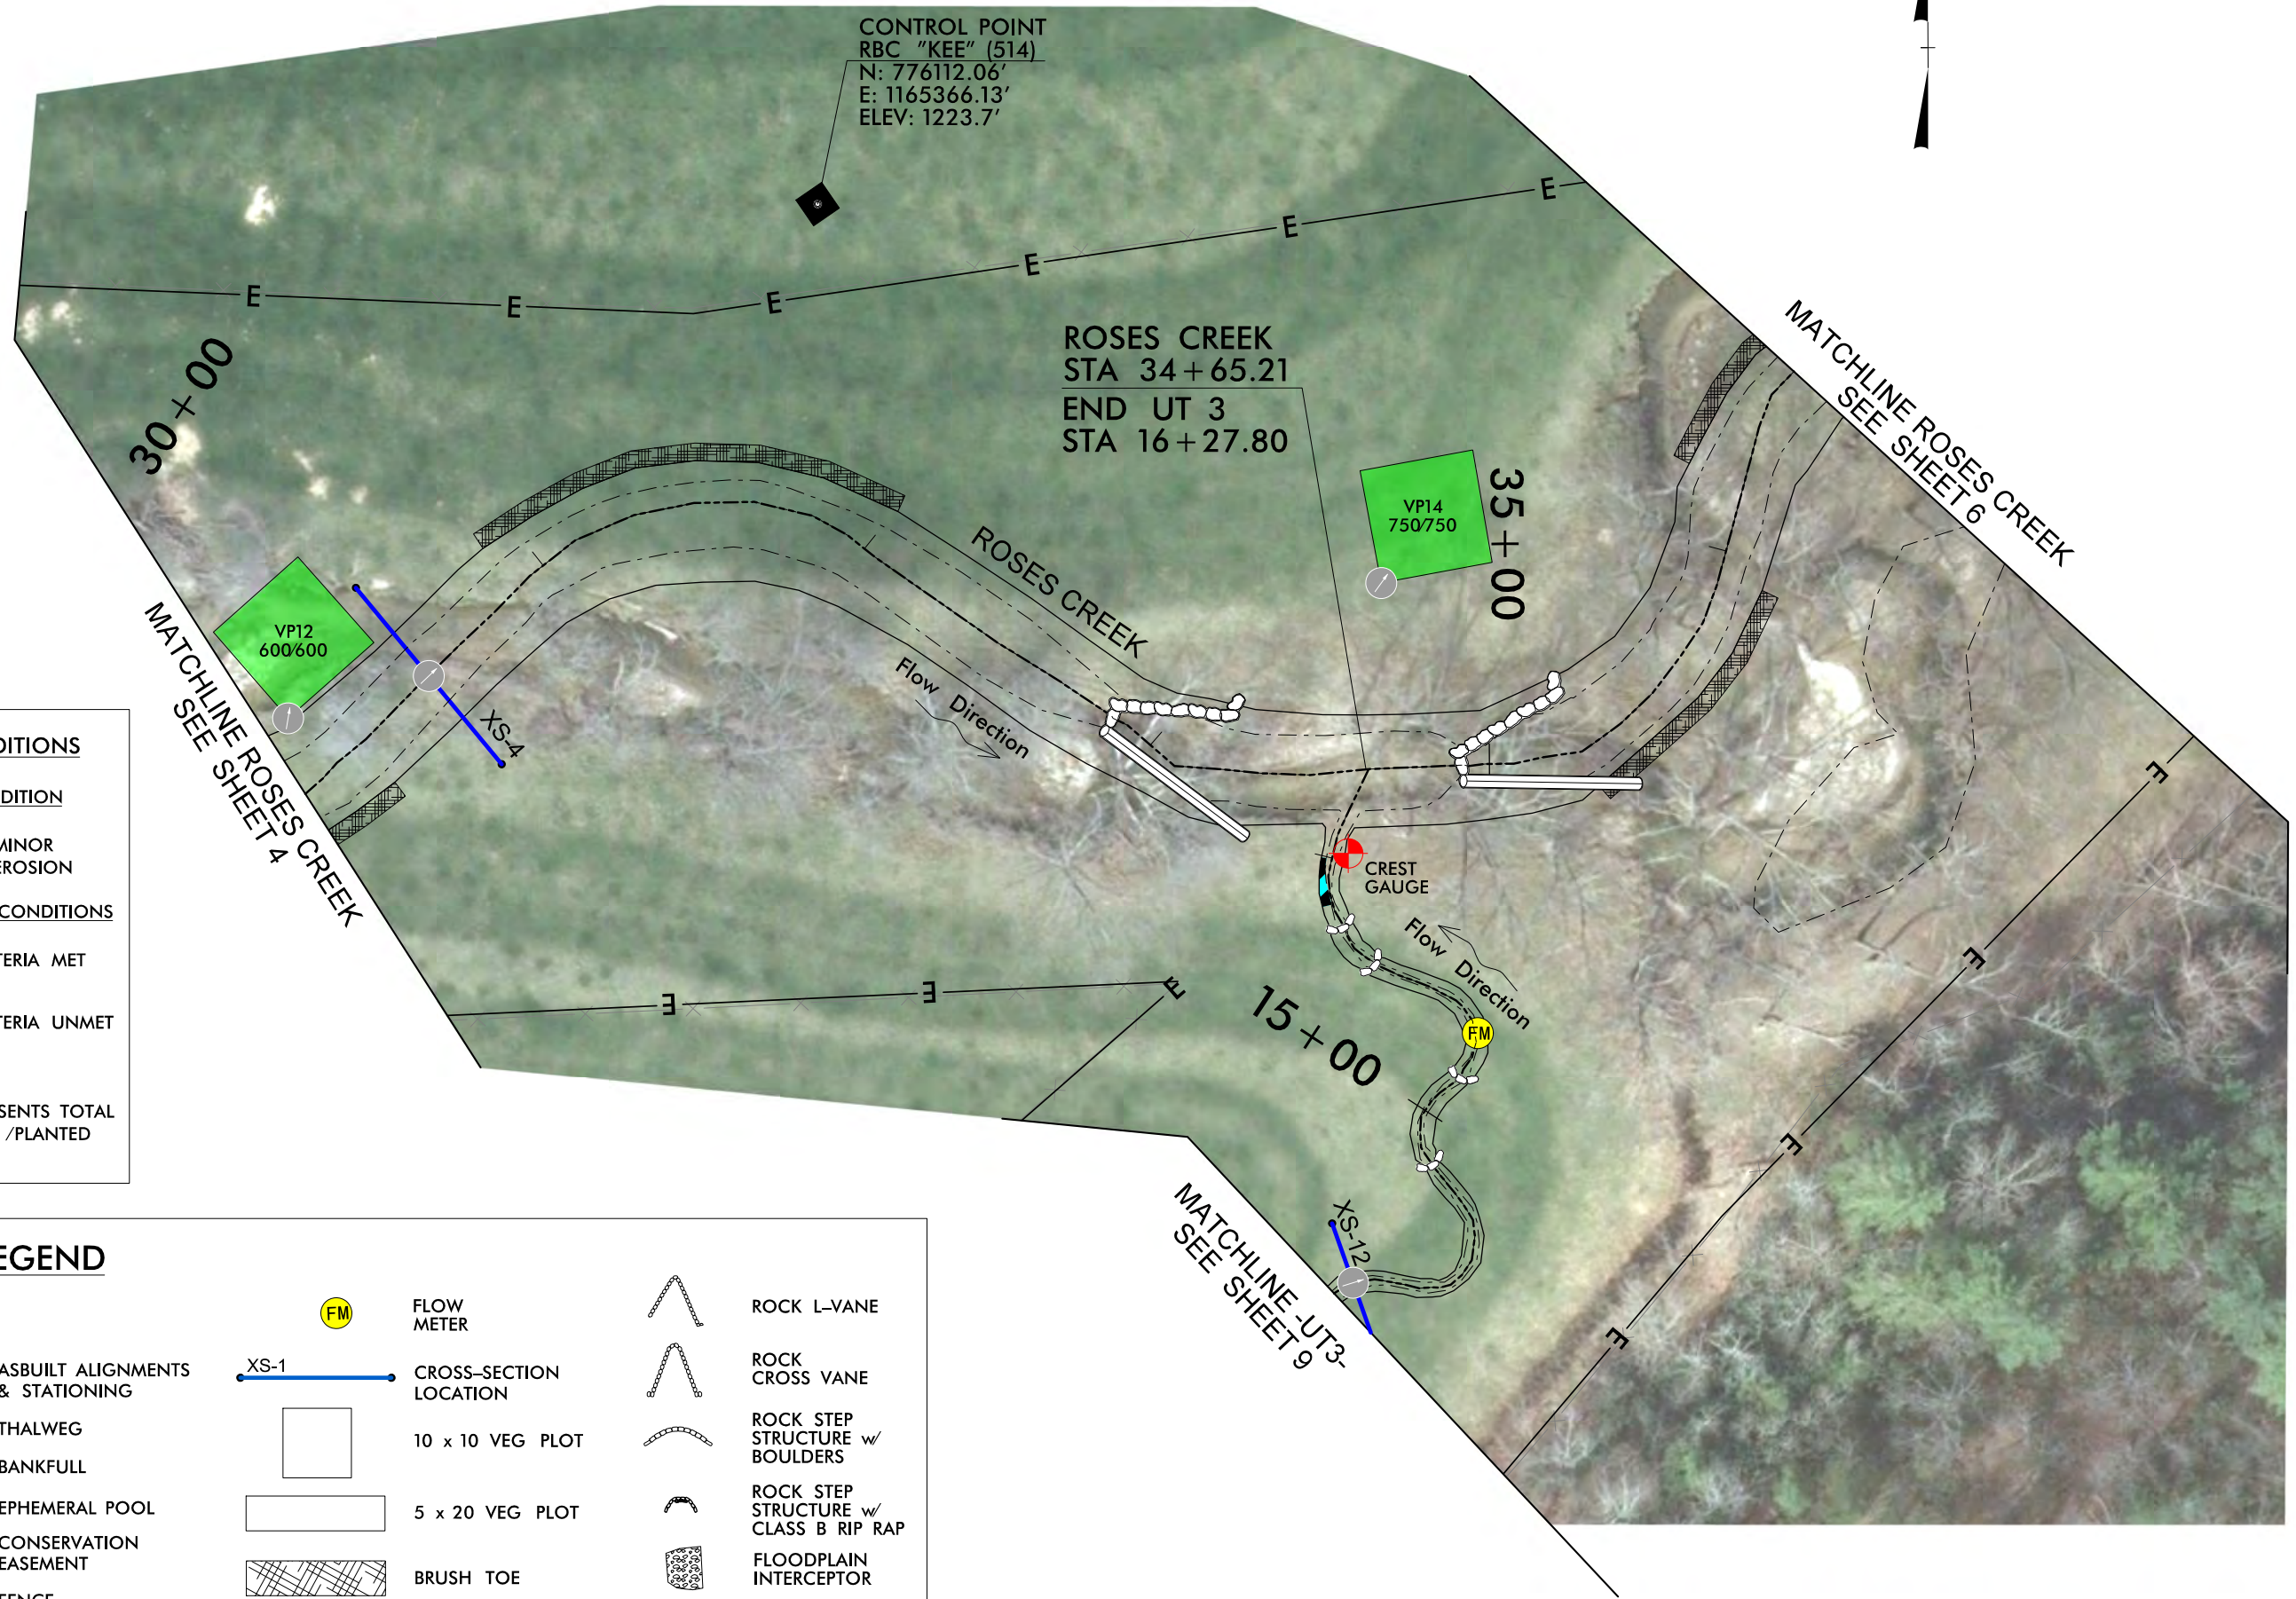
SHEET
5

Two small holes were noted on-site where backfill from construction has settled. HDR|ICA will monitor these areas to ensure that they do not increase in size.

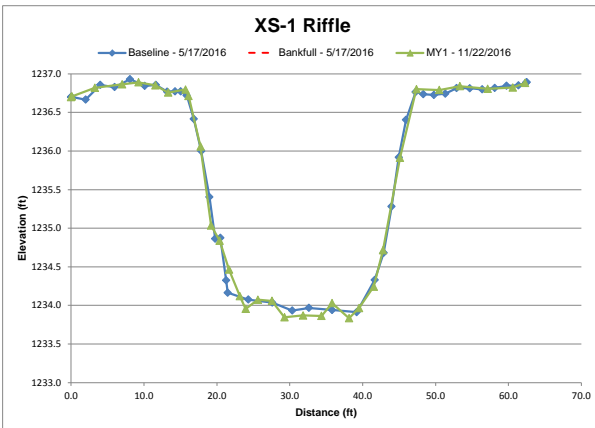
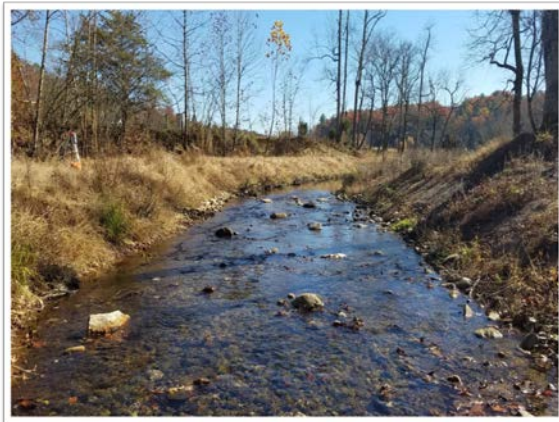
River Basin	Catawba
Watershed	03050101060030
XS ID	XS 1
Drainage Area (Acres)	3,309
Date	11/22/2016
Field Crew	Bill Wollman, Alex DeGironimo

Dimension and substrate	Cross Section 1 (Riffle)							
	Base	MY1	MY2	MY3	MY4	MY5	MY6	MY7
Based on fixed baseline bankfull elevation								
Bankfull Width (ft)	33.80	31.20						
Floodprone Width (ft)	508.32	508.32						
Bankfull Mean Depth (ft)	2.00	2.18						
Bankfull Max Depth (ft)	2.81	2.88						
Bankfull Cross Sectional Area (ft ²)	67.70	67.97						
Bankfull Width/Depth Ratio	16.90	14.31						
Bankfull Entrenchment Ratio	15.04	16.29						
Bankfull Bank Height Ratio	1.00	1.00

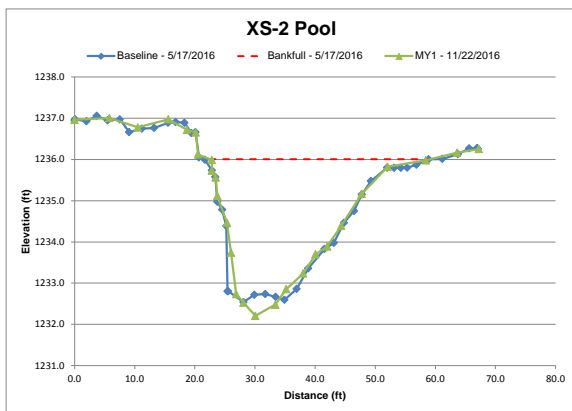
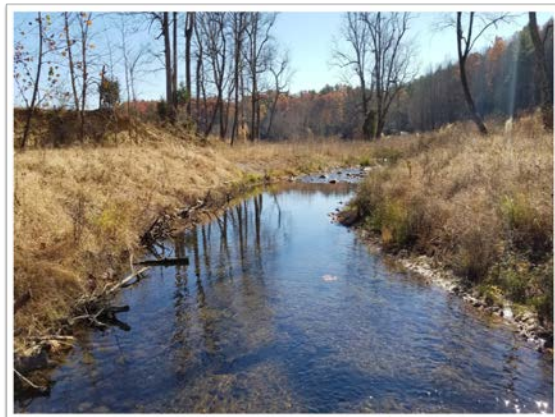
River Basin	Catawba
Watershed	03050101060030
XS ID	XS 2
Drainage Area (Acres)	3,309
Date	11/22/2016
Field Crew	Bill Wollman, Alex DeGironimo

Dimension and substrate	Cross Section 2 (Pool)							
	Base	MY1	MY2	MY3	MY4	MY5	MY6	MY7
Based on fixed baseline bankfull elevation								
Bankfull Width (ft)	38.53	35.95						
Floodprone Width (ft)								
Bankfull Mean Depth (ft)	1.73	1.79						
Bankfull Max Depth (ft)	3.47	3.78						
Bankfull Cross Sectional Area (ft ²)	66.48	64.24						
Bankfull Width/Depth Ratio								
Bankfull Entrenchment Ratio								
Bankfull Bank Height Ratio

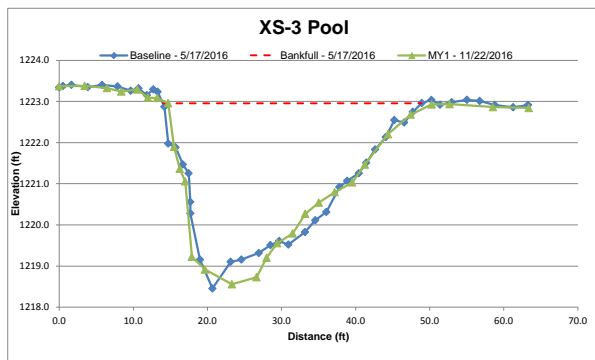
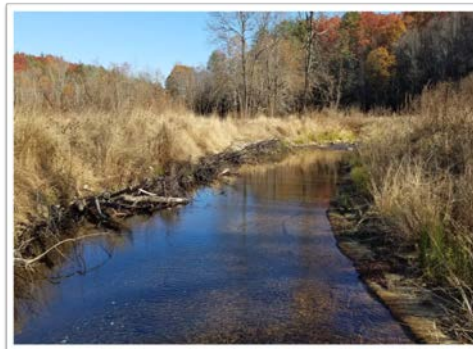
River Basin	Catawba
Watershed	03050101060030
XS ID	XS 3
Drainage Area (Acres)	3,309
Date	11/22/2016
Field Crew	Bill Wollman, Alex DeGironimo

Dimension and substrate	Cross Section 3 (Pool)							
	Base	MY1	MY2	MY3	MY4	MY5	MY6	MY7
Based on fixed baseline bankfull elevation								
Bankfull Width (ft)	32.44	35.57						
Floodprone Width (ft)								
Bankfull Mean Depth (ft)	2.19	2.45						
Bankfull Max Depth (ft)	4.10	4.40						
Bankfull Cross Sectional Area (ft ²)	71.10	87.13						
Bankfull Width/Depth Ratio								
Bankfull Entrenchment Ratio								
Bankfull Bank Height Ratio

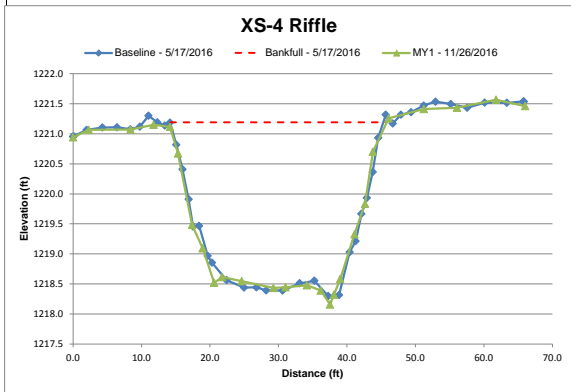
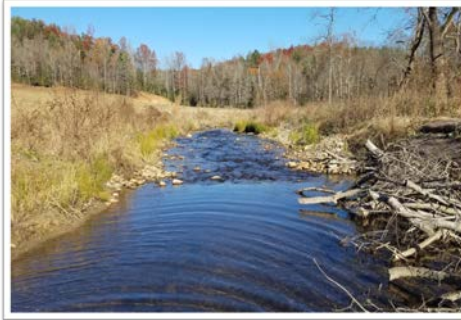
River Basin	Catawba
Watershed	03050101060030
XS ID	XS 4
Drainage Area (Acres)	3,309
Date	11/22/2016
Field Crew	Bill Wollman, Alex DeGironimo

Dimension and substrate	Cross Section 4 (Riffle)							
	Base	MY1	MY2	MY3	MY4	MY5	MY6	MY7
Based on fixed baseline bankfull elevation								
Bankfull Width (ft)	31.11	31.42						
Floodprone Width (ft)	696.00	696.00						
Bankfull Mean Depth (ft)	2.19	2.11						
Bankfull Max Depth (ft)	2.89	2.96						
Bankfull Cross Sectional Area (ft ²)	68.21	66.2						
Bankfull Width/Depth Ratio	14.21	14.89						
Bankfull Entrenchment Ratio	22.37	22.15						
Bankfull Bank Height Ratio	1.00	1.00

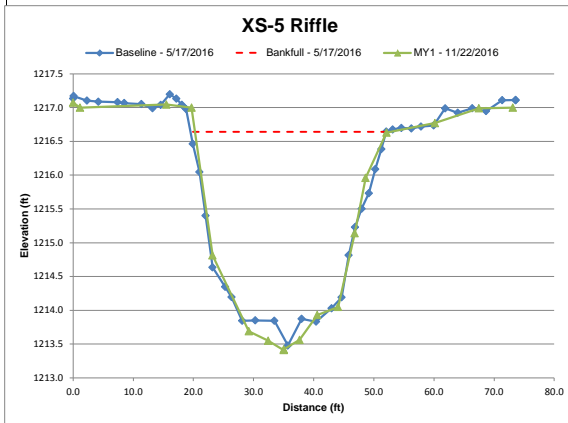
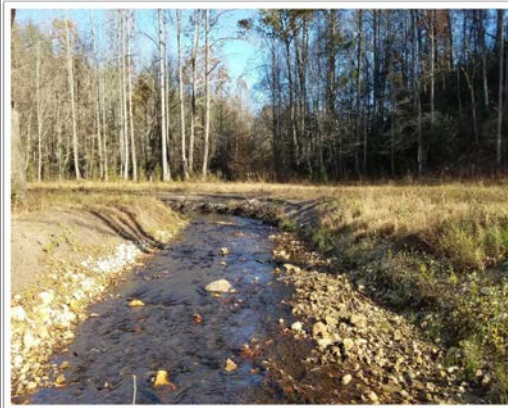
River Basin	Catawba
Watershed	03050101060030
XS ID	XS 5
Drainage Area (Acres)	3,309
Date	11/22/2016
Field Crew	Bill Wollman, Alex DeGironimo

Dimension and substrate	Cross Section 5 (Riffle)							
	Base	MY1	MY2	MY3	MY4	MY5	MY6	MY7
Based on fixed baseline bankfull elevation								
Bankfull Width (ft)	32.56	33.03						
Floodprone Width (ft)	563.60	563.60						
Bankfull Mean Depth (ft)	2.13	2.23						
Bankfull Max Depth (ft)	3.16	3.22						
Bankfull Cross Sectional Area (ft ²)	69.41	73.79						
Bankfull Width/Depth Ratio	15.29	14.81						
Bankfull Entrenchment Ratio	17.31	17.06						
Bankfull Bank Height Ratio	1.00	1.00

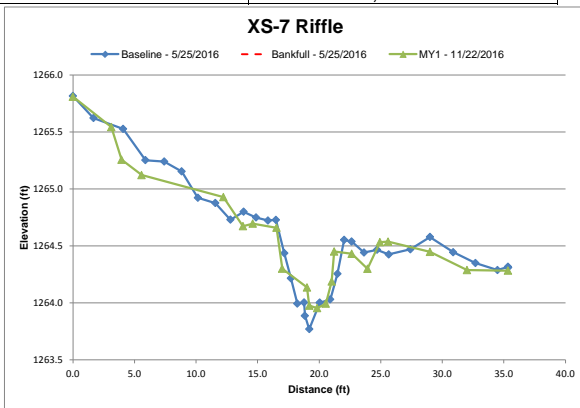
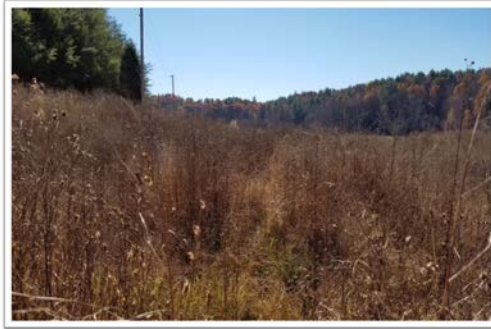
River Basin	Catawba
Watershed	03050101060030
XS ID	XS 7
Drainage Area (Acres)	38.40
Date	11/22/2016
Field Crew	Bill Wollman, Alex DeGironimo

Roses Creek and its tributaries appear to be in stable and functioning condition. Cross Section dimensions remain consistent with baseline surveys. Cross Sections 7 and 8 have decreased slightly in depth and area. Both cross sections are located on UT 1, which currently has vegetation in the channel. It is likely that in-channel vegetation has trapped sediment,

Dimension and substrate	Cross Section 7 (Riffle)							
	Base	MY1	MY2	MY3	MY4	MY5	MY6	MY7
Based on fixed baseline bankfull elevation								
Bankfull Width (ft)	5.12	4.46						
Floodprone Width (ft)	91.80	91.80						
Bankfull Mean Depth (ft)	0.45	0.41						
Bankfull Max Depth (ft)	0.78	0.59						
Bankfull Cross Sectional Area (ft ²)	2.30	1.82						
Bankfull Width/Depth Ratio	11.38	10.88						
Bankfull Entrenchment Ratio	17.93	20.58						
Bankfull Bank Height Ratio	1.00	1.00

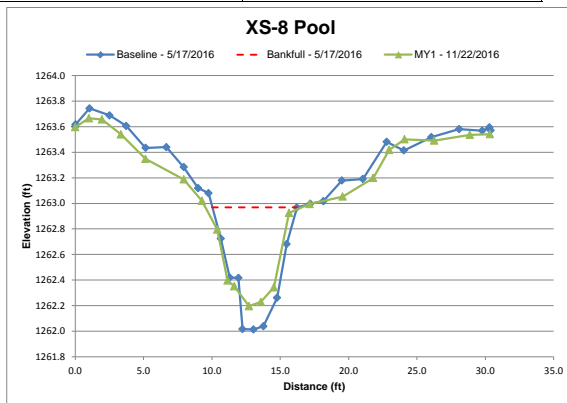
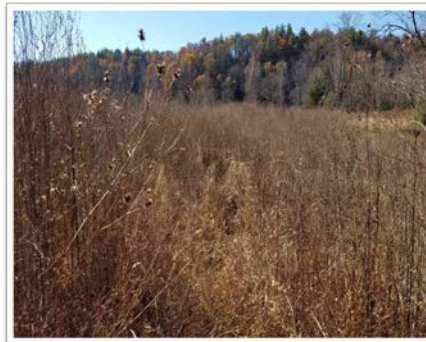
River Basin	Catawba
Watershed	03050101060030
XS ID	XS 8
Drainage Area (Acres)	38.40
Date	11/22/2016
Field Crew	Bill Wollman, Alex DeGironimo

Dimension and substrate	Cross Section 8 (Pool)							
	Base	MY1	MY2	MY3	MY4	MY5	MY6	MY7
Based on fixed baseline bankfull elevation								
Bankfull Width (ft)	6.24	6.00						
Floodprone Width (ft)								
Bankfull Mean Depth (ft)	0.58	0.47						
Bankfull Max Depth (ft)	0.96	0.73						
Bankfull Cross Sectional Area (ft ²)	3.64	2.83						
Bankfull Width/Depth Ratio								
Bankfull Entrenchment Ratio								
Bankfull Bank Height Ratio
