YEAR 2 MONITORING REPORT

ROSES CREEK STREAM MITIGATION SITE
Burke County, North Carolina
NC DMS Project No. 96309

Construction Completed: May 2016
Morphology Data Collected: June 1, 2017
Vegetation Data Collected: August 14, 2017
Submitted: December 2017

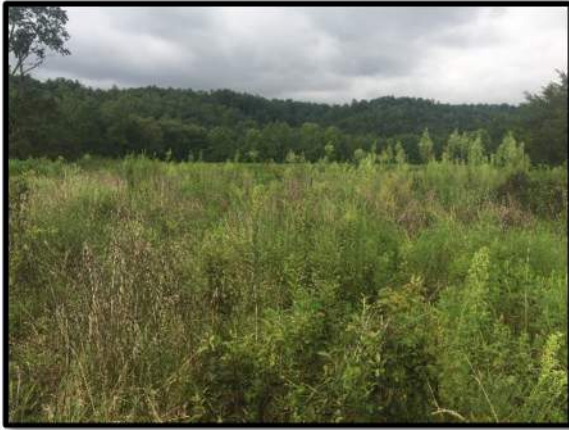
3.1 Vegetation Plot 1

Planted stems along UT 1 and UT 2 have been heavily browsed upon by deer. Deer trails were noted through Plot 1 and while all the planted stems in this plot were either dead or missing, stems in the surrounding area showed signs of browsing. A large deer bed was discovered at the center of Plot 2 and only one stem has survived after supplemental planting.

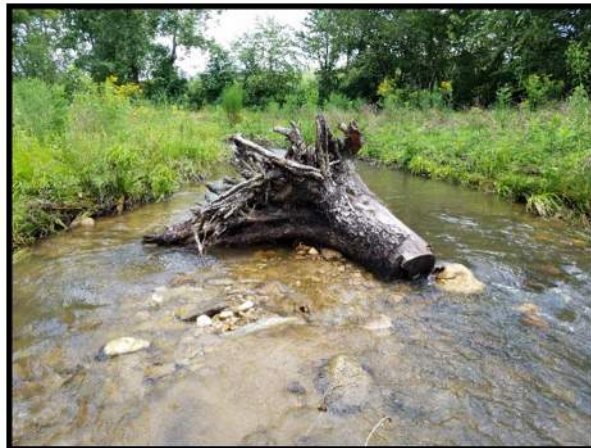
A large tree stump has washed downstream into the project area indicating that the site has experienced heavy flows over the past year. The stump has not caused any damage but its effect on the stream will continue to be monitored by HDR | ICA. Wrack lines were noted along the top of bank on the main channel. The crest gauge at the downstream end of the main channel indicates that Roses Creek overtopped its banks at least one time during the first half of the monitoring year. A second bankfull event was also documented by the landowner in October 2017. Crest gauge records are provided in Appendix E.

**3.18 Stump washed into project area
STA 13+40 (Roses Creek)**

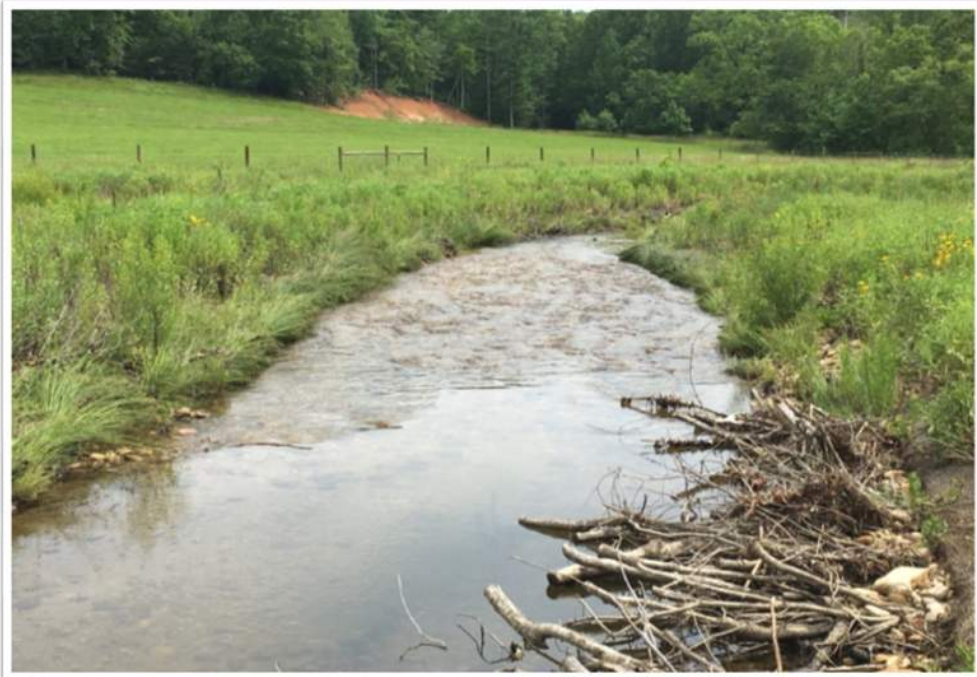
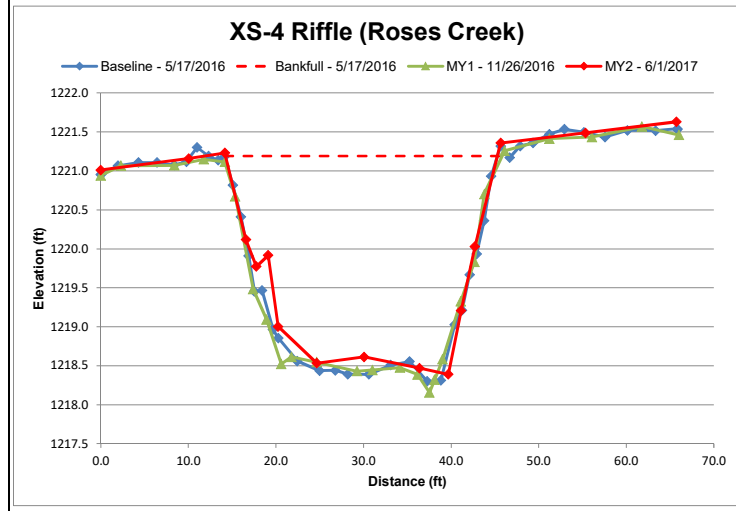
River Basin	Catawba
Watershed	03050101060030
XS ID	XS 4 (Roses Creek)
Drainage Area (Acres)	3,309
Date	6/1/2017
Field Crew	Bill Wollman, Alex DiGeronimo

Dimension and substrate	Cross Section 4 (Riffle)							
	Base	MY1	MY2	MY3	MY4	MY5	MY6	MY7
Based on fixed baseline bankfull elevation								
Bankfull Width (ft)	31.11	31.66	31.03					
Floodprone Width (ft)	696.00	696.00	696.00					
Bankfull Mean Depth (ft)	2.19	2.16	2.08					
Bankfull Max Depth (ft)	2.89	3.03	2.80					
Bankfull Cross Sectional Area (ft ²)	68.21	68.41	64.61					
Bankfull Width/Depth Ratio	14.21	14.66	14.92					
Bankfull Entrenchment Ratio	22.37	21.98	22.43					
Bankfull Bank Height Ratio	1.00	1.00	1.00

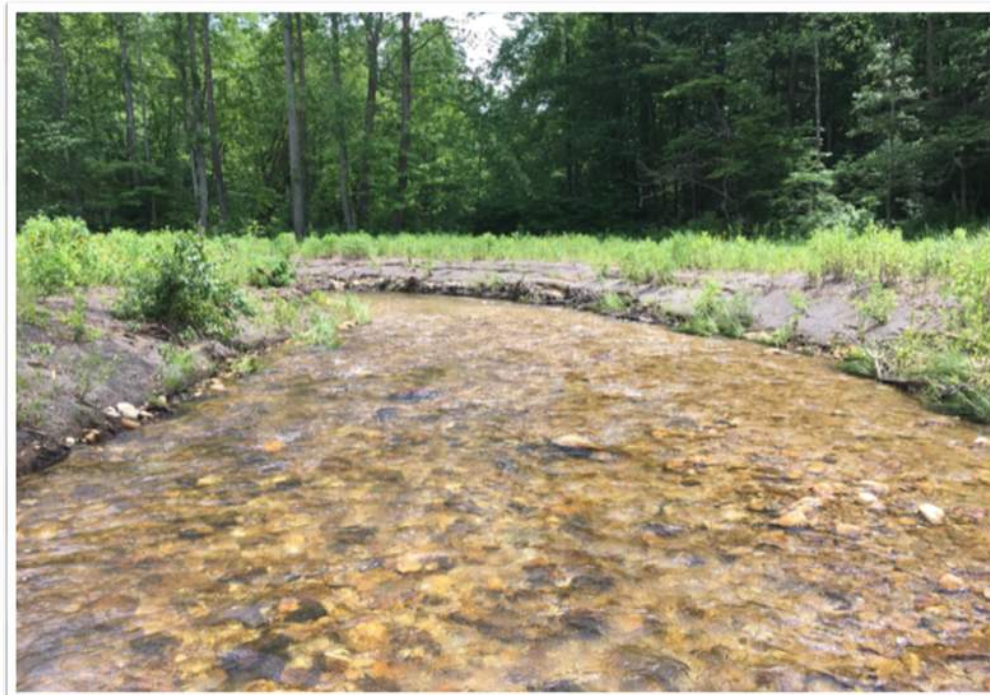
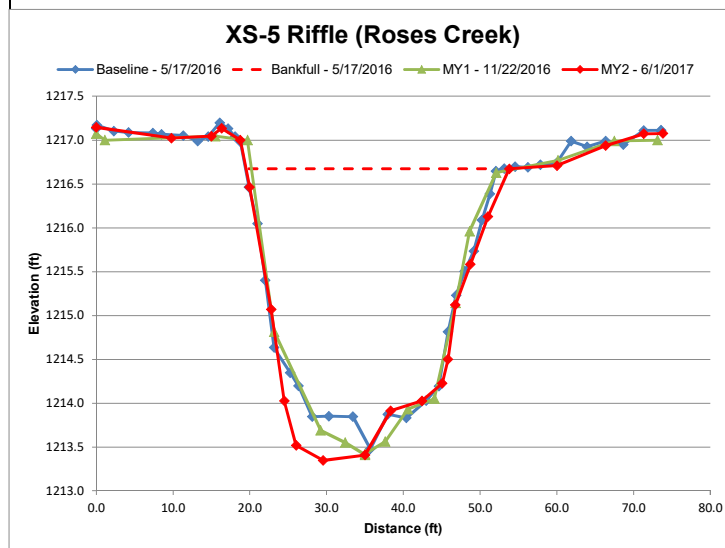
River Basin	Catawba
Watershed	03050101060030
XS ID	XS 5 (Roses Creek)
Drainage Area (Acres)	3,309
Date	6/1/2017
Field Crew	Bill Wollman, Alex DiGeronimo

Dimension and substrate	Cross Section 5 (Riffle)							
	Base	MY1	MY2	MY3	MY4	MY5	MY6	MY7
Based on fixed baseline bankfull elevation								
Bankfull Width (ft)	32.56	32.99	34.06					
Floodprone Width (ft)	563.60	563.60	563.60					
Bankfull Mean Depth (ft)	2.13	2.25	2.22					
Bankfull Max Depth (ft)	3.16	3.23	3.29					
Bankfull Cross Sectional Area (ft ²)	69.41	74.12	75.52					
Bankfull Width/Depth Ratio	15.29	14.66	15.34					
Bankfull Entrenchment Ratio	17.31	17.08	16.55					
Bankfull Bank Height Ratio	1.00	1.00	1.00

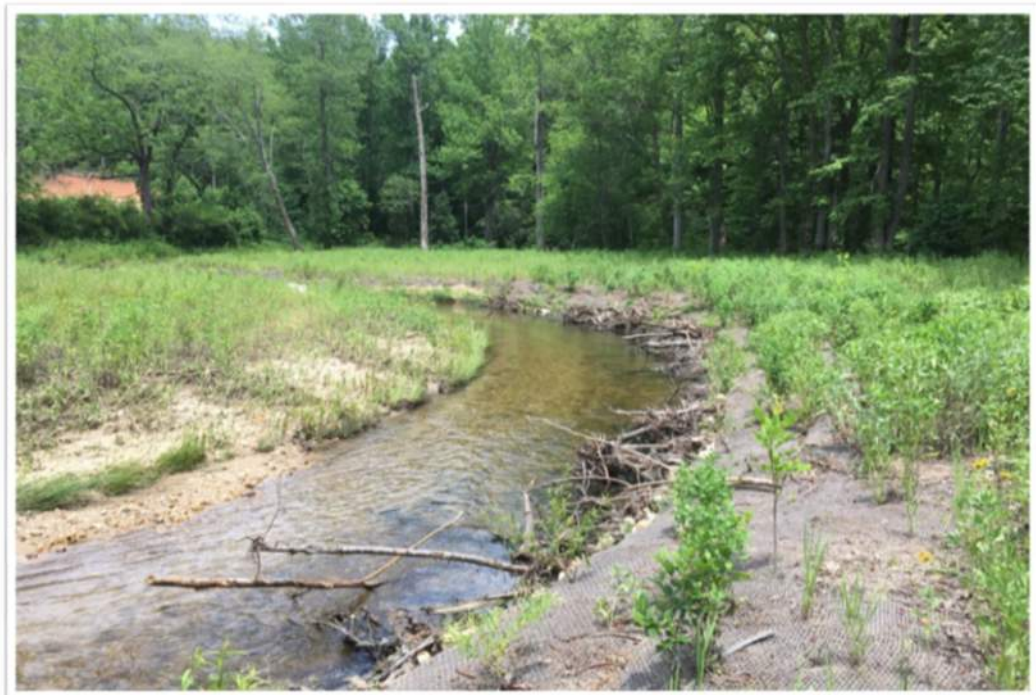
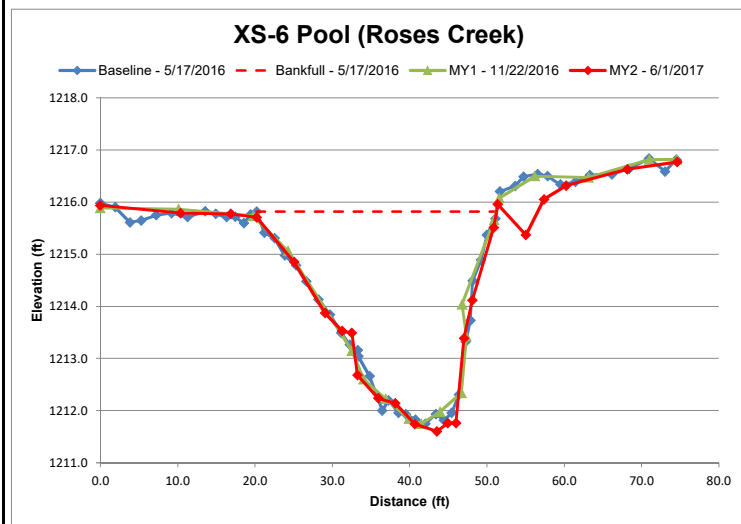
River Basin	Catawba
Watershed	03050101060030
XS ID	XS 6 (Roses Creek)
Drainage Area (Acres)	3,309
Date	6/1/2017
Field Crew	Bill Wollman, Alex DiGeronimo

Dimension and substrate	Cross Section 6 (Pool)							
	Base	MY1	MY2	MY3	MY4	MY5	MY6	MY7
Based on fixed baseline bankfull elevation								
Bankfull Width (ft)	31.02	31.30	30.99					
Floodprone Width (ft)								
Bankfull Mean Depth (ft)	2.37	2.23	2.32					
Bankfull Max Depth (ft)	4.07	3.98	4.11					
Bankfull Cross Sectional Area (ft ²)	73.63	69.77	71.83					
Bankfull Width/Depth Ratio								
Bankfull Entrenchment Ratio								
Bankfull Bank Height Ratio

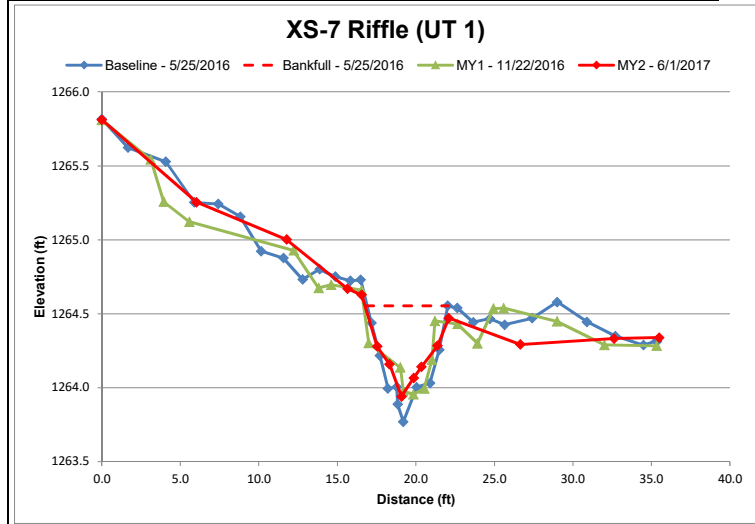
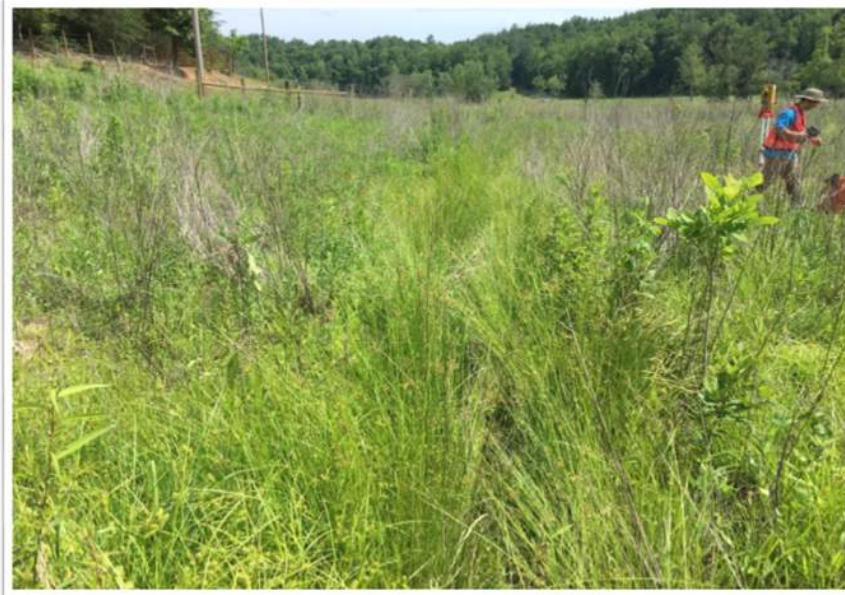
River Basin	Catawba
Watershed	03050101060030
XS ID	XS 7 (UT 1)
Drainage Area (Acres)	38.40
Date	6/1/2017
Field Crew	Bill Wollman, Alex DiGeronimo

Dimension and substrate	Cross Section 7 (Riffle)							
	Base	MY1	MY2	MY3	MY4	MY5	MY6	MY7
Based on fixed baseline bankfull elevation								
Bankfull Width (ft)	5.12	4.46	5.31					
Floodprone Width (ft)	91.80	91.80	91.80					
Bankfull Mean Depth (ft)	0.45	0.41	0.35					
Bankfull Max Depth (ft)	0.78	0.59	0.61					
Bankfull Cross Sectional Area (ft ²)	2.30	1.82	1.86					
Bankfull Width/Depth Ratio	11.38	10.88	15.17					
Bankfull Entrenchment Ratio	17.93	20.58	17.29					
Bankfull Bank Height Ratio	1.00	1.00*	1.00*

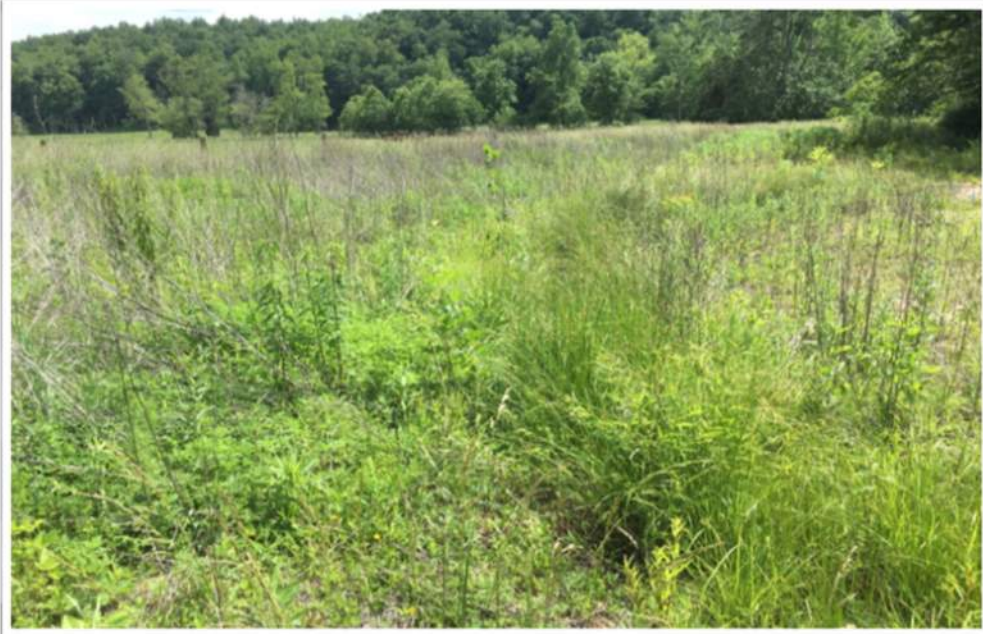
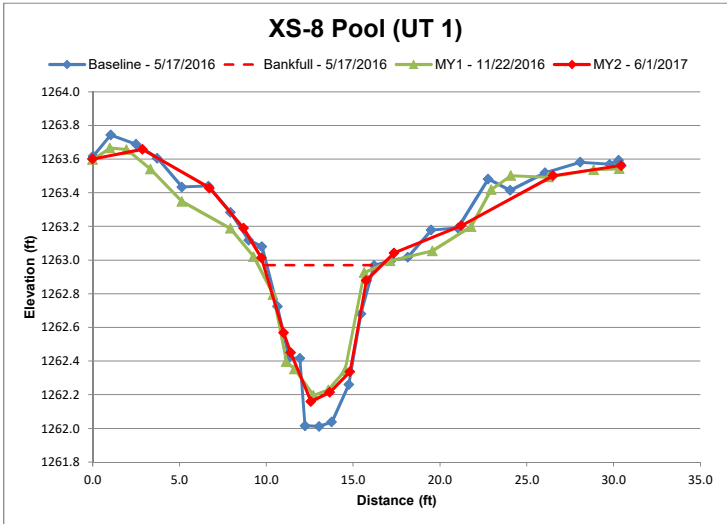
River Basin	Catawba
Watershed	03050101060030
XS ID	XS 8 (UT 1)
Drainage Area (Acres)	38.40
Date	6/1/2017
Field Crew	Bill Wollman, Alex DiGeronimo

Dimension and substrate	Cross Section 8 (Pool)							
	Base	MY1	MY2	MY3	MY4	MY5	MY6	MY7
Based on fixed baseline bankfull elevation								
Bankfull Width (ft)	6.24	7.07	6.80					
Floodprone Width (ft)								
Bankfull Mean Depth (ft)	0.58	0.44	0.47					
Bankfull Max Depth (ft)	0.96	0.77	0.81					
Bankfull Cross Sectional Area (ft ²)	3.64	3.10	3.23					
Bankfull Width/Depth Ratio								
Bankfull Entrenchment Ratio								
Bankfull Bank Height Ratio

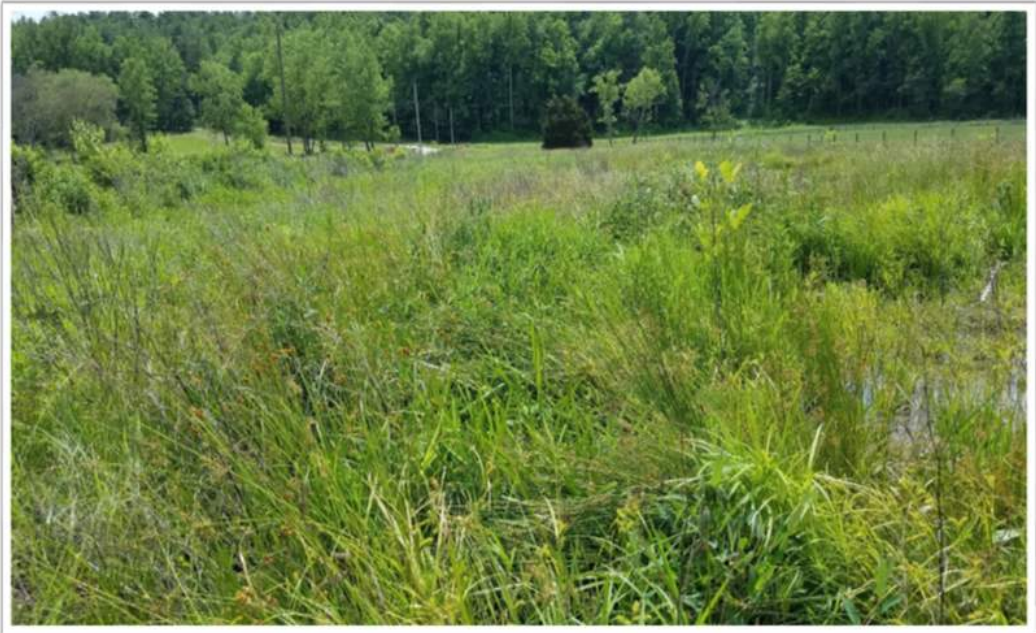
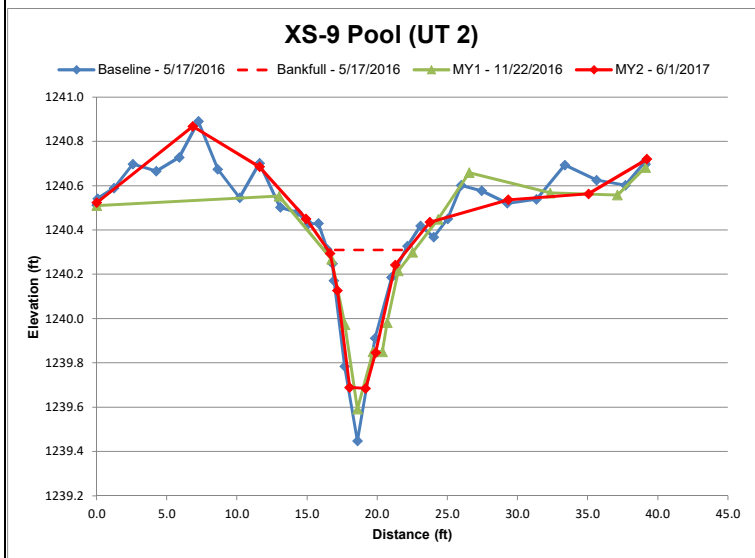
River Basin	Catawba
Watershed	03050101060030
XS ID	XS 9 (UT 2)
Drainage Area (Acres)	44.80
Date	6/1/2017
Field Crew	Bill Wollman, Alex DiGeronimo

Dimension and substrate	Cross Section 9 (Pool)							
	Base	MY1	MY2	MY3	MY4	MY5	MY6	MY7
Based on fixed baseline bankfull elevation								
Bankfull Width (ft)	5.56	6.43	5.69					
Floodprone Width (ft)								
Bankfull Mean Depth (ft)	0.37	0.31	0.33					
Bankfull Max Depth (ft)	0.86	0.72	0.63					
Bankfull Cross Sectional Area (ft ²)	2.07	1.97	1.90					
Bankfull Width/Depth Ratio								
Bankfull Entrenchment Ratio								
Bankfull Bank Height Ratio

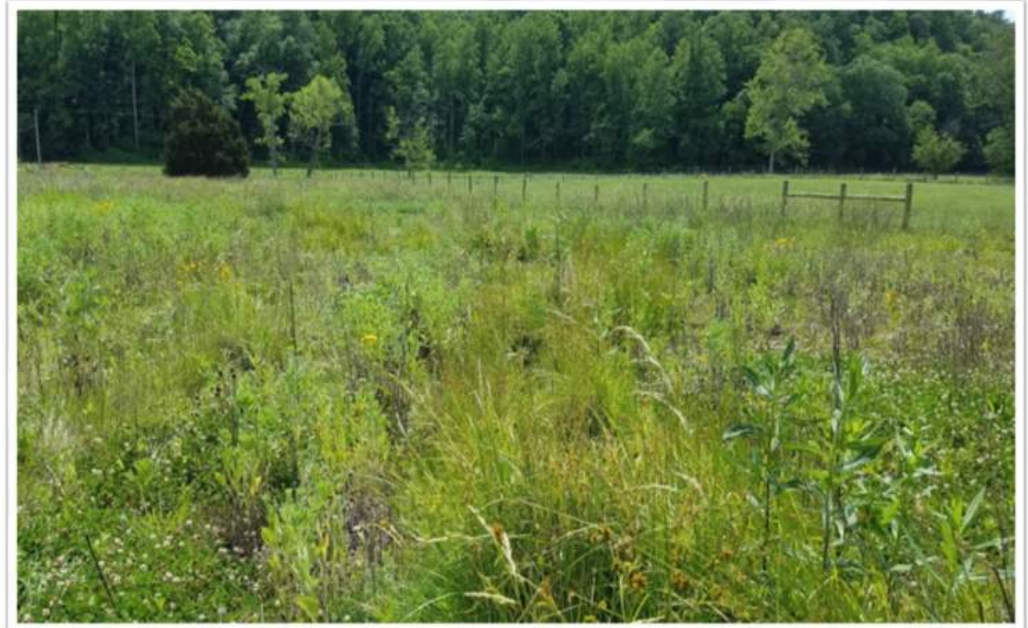
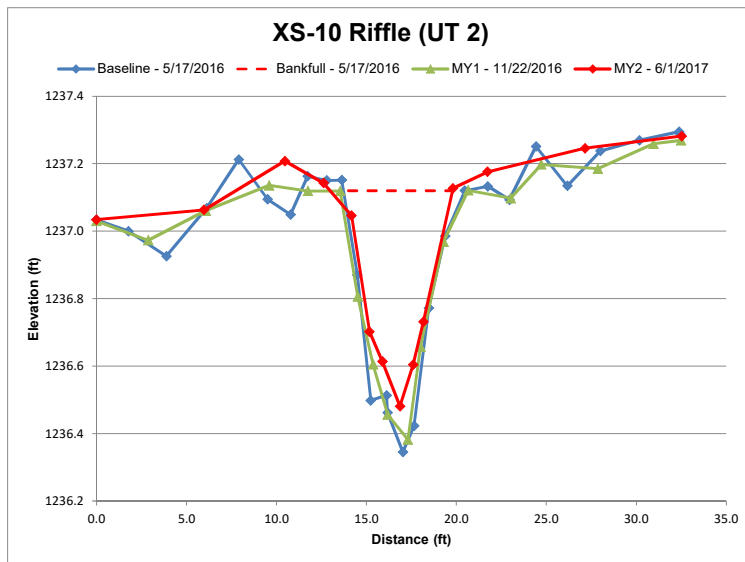
River Basin	Catawba
Watershed	03050101060030
XS ID	XS 10 (UT 2)
Drainage Area (Acres)	44.80
Date	6/1/2017
Field Crew	Bill Wollman, Alex DiGeronimo

Dimension and substrate	Cross Section 10 (Riffle)							
	Base	MY1	MY2	MY3	MY4	MY5	MY6	MY7
Based on fixed baseline bankfull elevation								
Bankfull Width (ft)	6.70	7.10	6.79					
Floodprone Width (ft)	93.36	93.36	93.36					
Bankfull Mean Depth (ft)	0.42	0.38	0.32					
Bankfull Max Depth (ft)	0.77	0.74	0.64					
Bankfull Cross Sectional Area (ft ²)	2.79	2.69	2.17					
Bankfull Width/Depth Ratio	16.75	18.68	21.22					
Bankfull Entrenchment Ratio	13.93	13.14	13.75					
Bankfull Bank Height Ratio	1.00	1.00	1.01

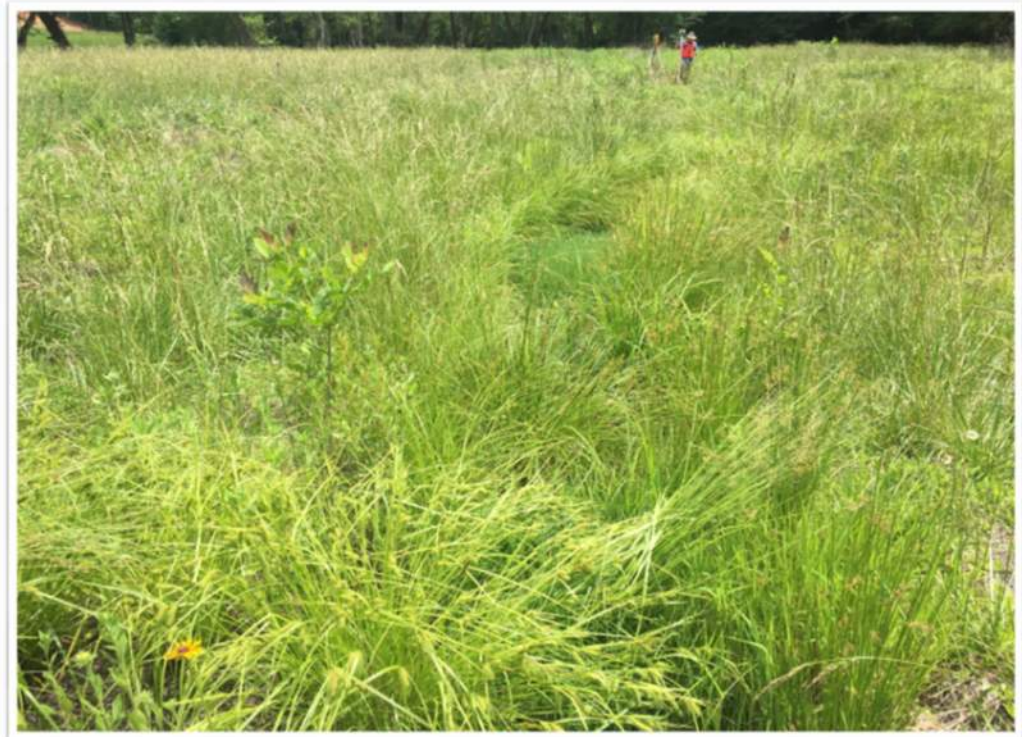
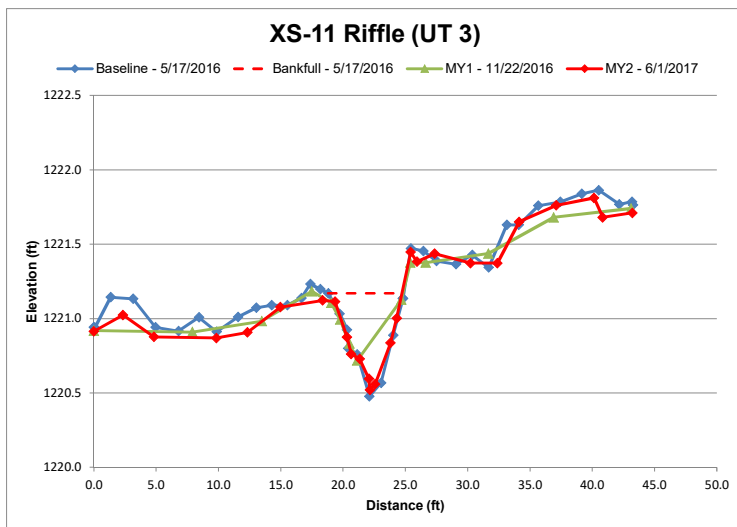
River Basin	Catawba
Watershed	03050101060030
XS ID	XS 11 (UT 3)
Drainage Area (Acres)	12.80
Date	6/1/2017
Field Crew	Bill Wollman, Alex DiGeronimo

Dimension and substrate	Cross Section 11 (Riffle)							
	Base	MY1	MY2	MY3	MY4	MY5	MY6	MY7
Based on fixed baseline bankfull elevation								
Bankfull Width (ft)	6.00	7.28	5.38					
Floodprone Width (ft)	175.41	175.41	175.41					
Bankfull Mean Depth (ft)	0.36	0.21	0.37					
Bankfull Max Depth (ft)	0.69	0.46	0.65					
Bankfull Cross Sectional Area (ft ²)	2.19	1.51	2.01					
Bankfull Width/Depth Ratio	16.67	34.67	14.54					
Bankfull Entrenchment Ratio	29.24	24.09	32.60					
Bankfull Bank Height Ratio	1.00	1.00	1.00*

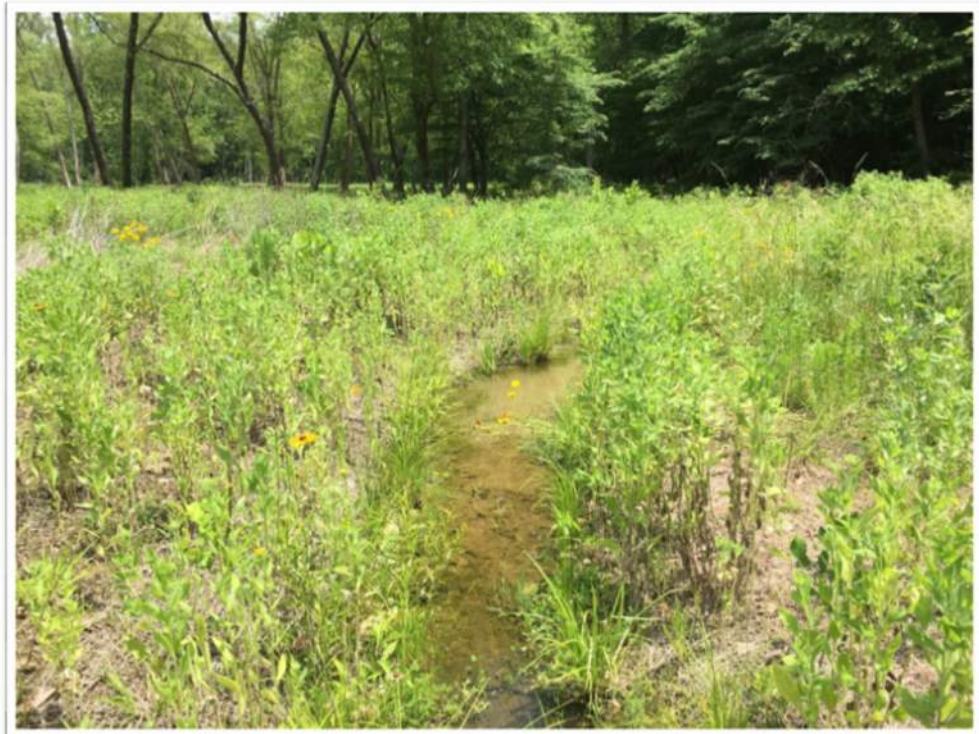
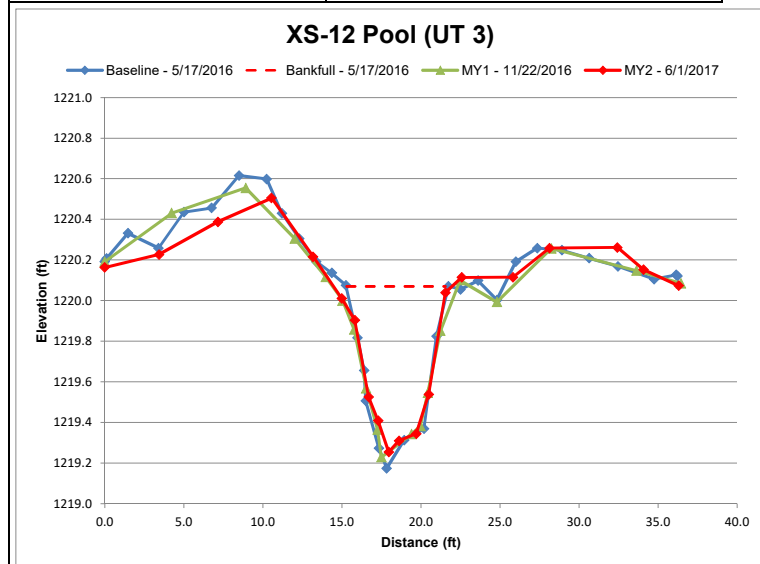
River Basin	Catawba
Watershed	03050101060030
XS ID	XS 12 (UT 3)
Drainage Area (Acres)	12.80
Date	6/1/2017
Field Crew	Bill Wollman, Alex DiGeronimo

Cross Section 12 (Pool)							
Dimension and substrate	Base	MY1	MY2	MY3	MY4	MY5	MY6	MY7
Based on fixed baseline bankfull elevation								
Bankfull Width (ft)	6.39	7.93	7.52					
Floodprone Width (ft)								
Bankfull Mean Depth (ft)	0.56	0.46	0.45					
Bankfull Max Depth (ft)	0.90	0.84	0.82					
Bankfull Cross Sectional Area (ft ²)	3.55	3.61	3.40					
Bankfull Width/Depth Ratio								
Bankfull Entrenchment Ratio								
Bankfull Bank Height Ratio
