YEAR 3 MONITORING REPORT

ROSES CREEK STREAM MITIGATION SITE

Burke County, North Carolina
NC DMS Project # 96309

Construction Completed: May 2016
Morphology Data Collected: March 28, 2018
Vegetation Data Collected: August 6, 2018
Submitted: December 18, 2018

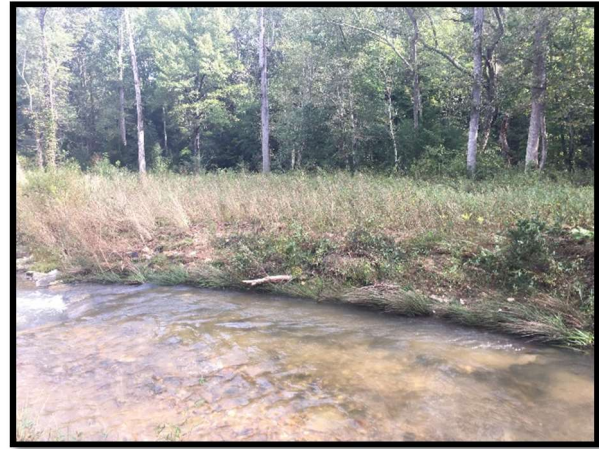
3.27 Repair at station 39+26-39+44

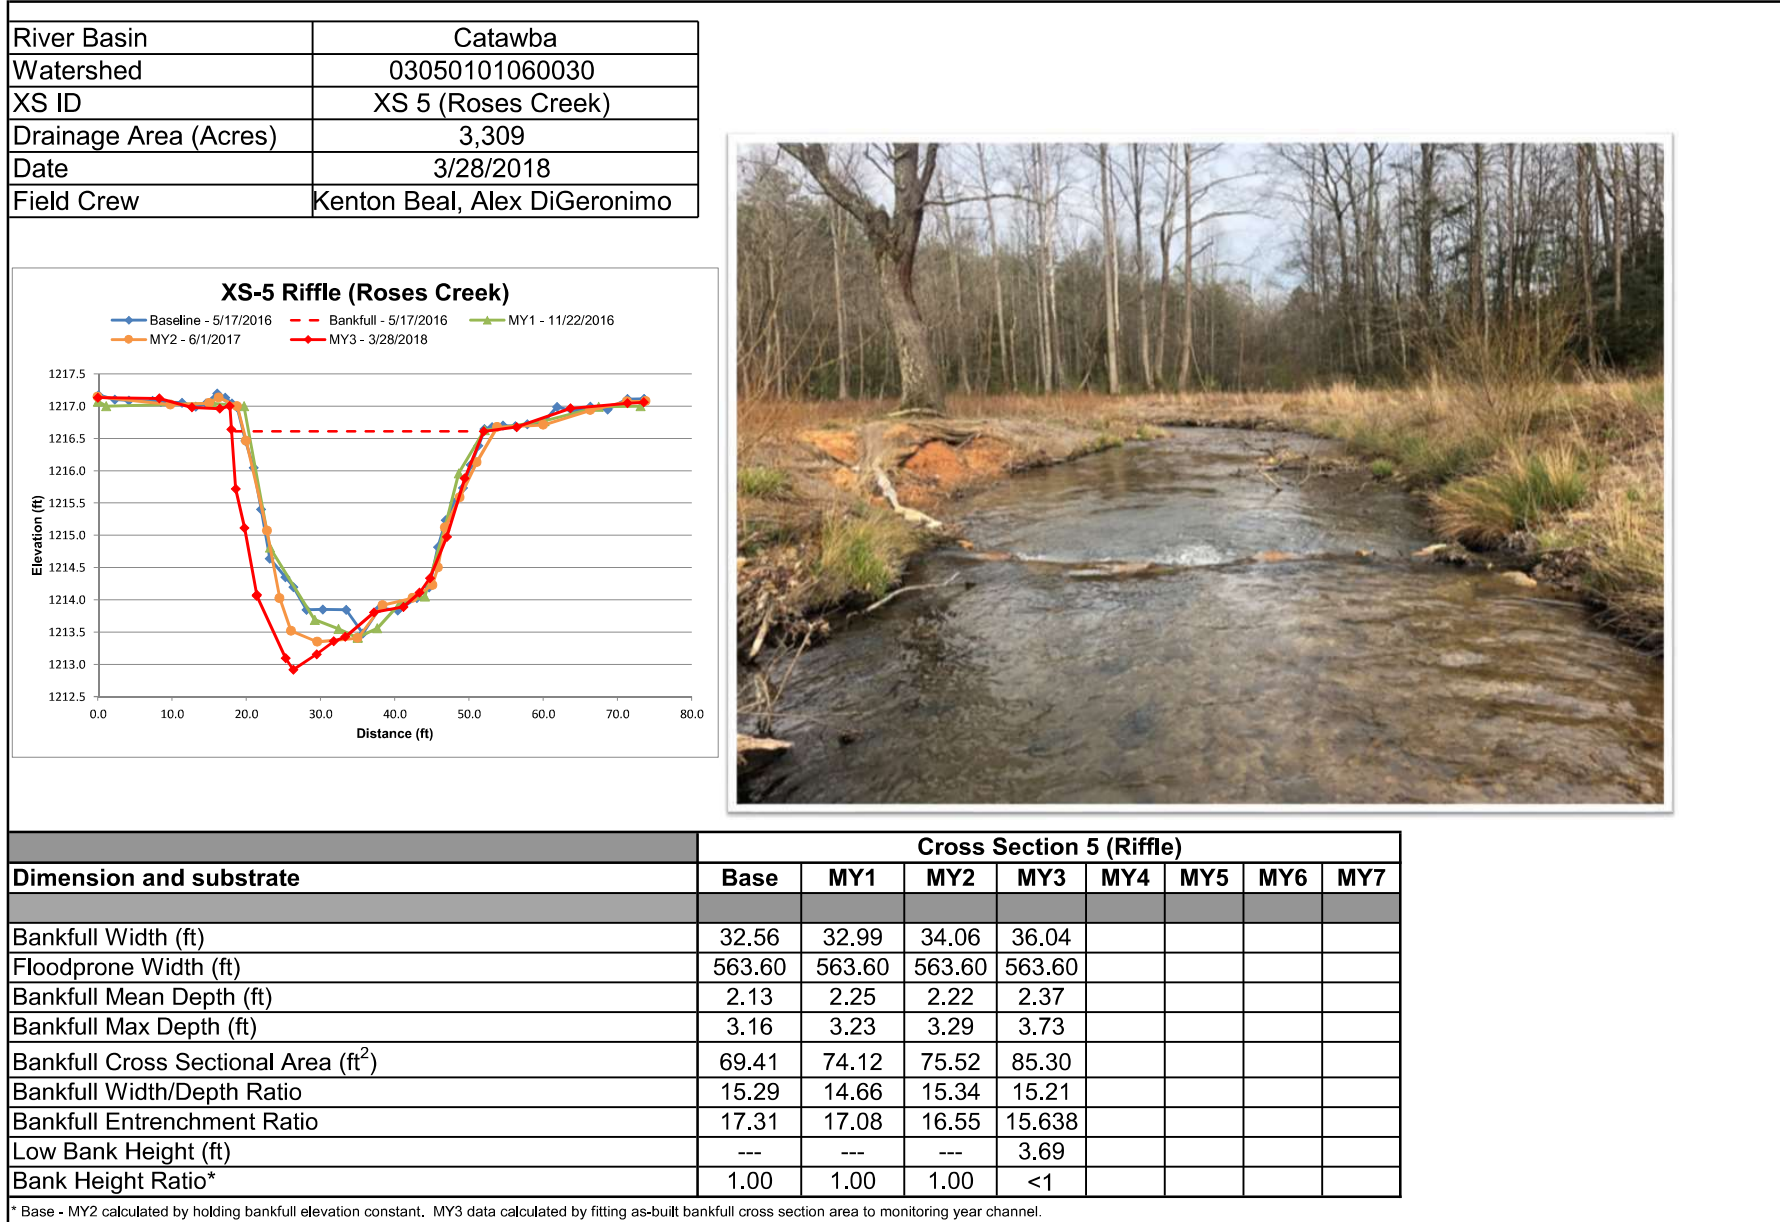
Figure 4.5

Cross Section geometry along Roses Creek has experienced minor fluctuations from previous monitoring years. Cross Sections 5 and 6 have increased in depth and bankfull area due to severe erosion along the left bank. Following the recent repair of the severe bank erosion, it is expected that the cross section will exhibit stability within acceptable parameters. Cross Sections 9 and 10 have increased in depth and bankfull area from last year. This is likely the result of sediment that was deposited in previous years moving downstream. As sediment continues to be transported through UT 2 it is expected that the trend towards baseline conditions will continue. UT 3 is exhibiting minor aggradation in the upstream half of the tributary. This can be seen in Cross Section 11 which has decreased in area and doubled in width to depth ratio. This is most likely the result of thick vegetation along the banks retarding flow and causing sediment deposition.
