**YEAR 4 MONITORING REPORT**

**ROSES CREEK STREAM MITIGATION SITE**  
Burke County, North Carolina  
NC DMS Project # 96309

Construction Completed: May 2016  
Visual Assessment Data Collected: Jan 2019, May 2019, Aug 2019, Sept 2019, Nov 2019  
Submitted: February, 2020

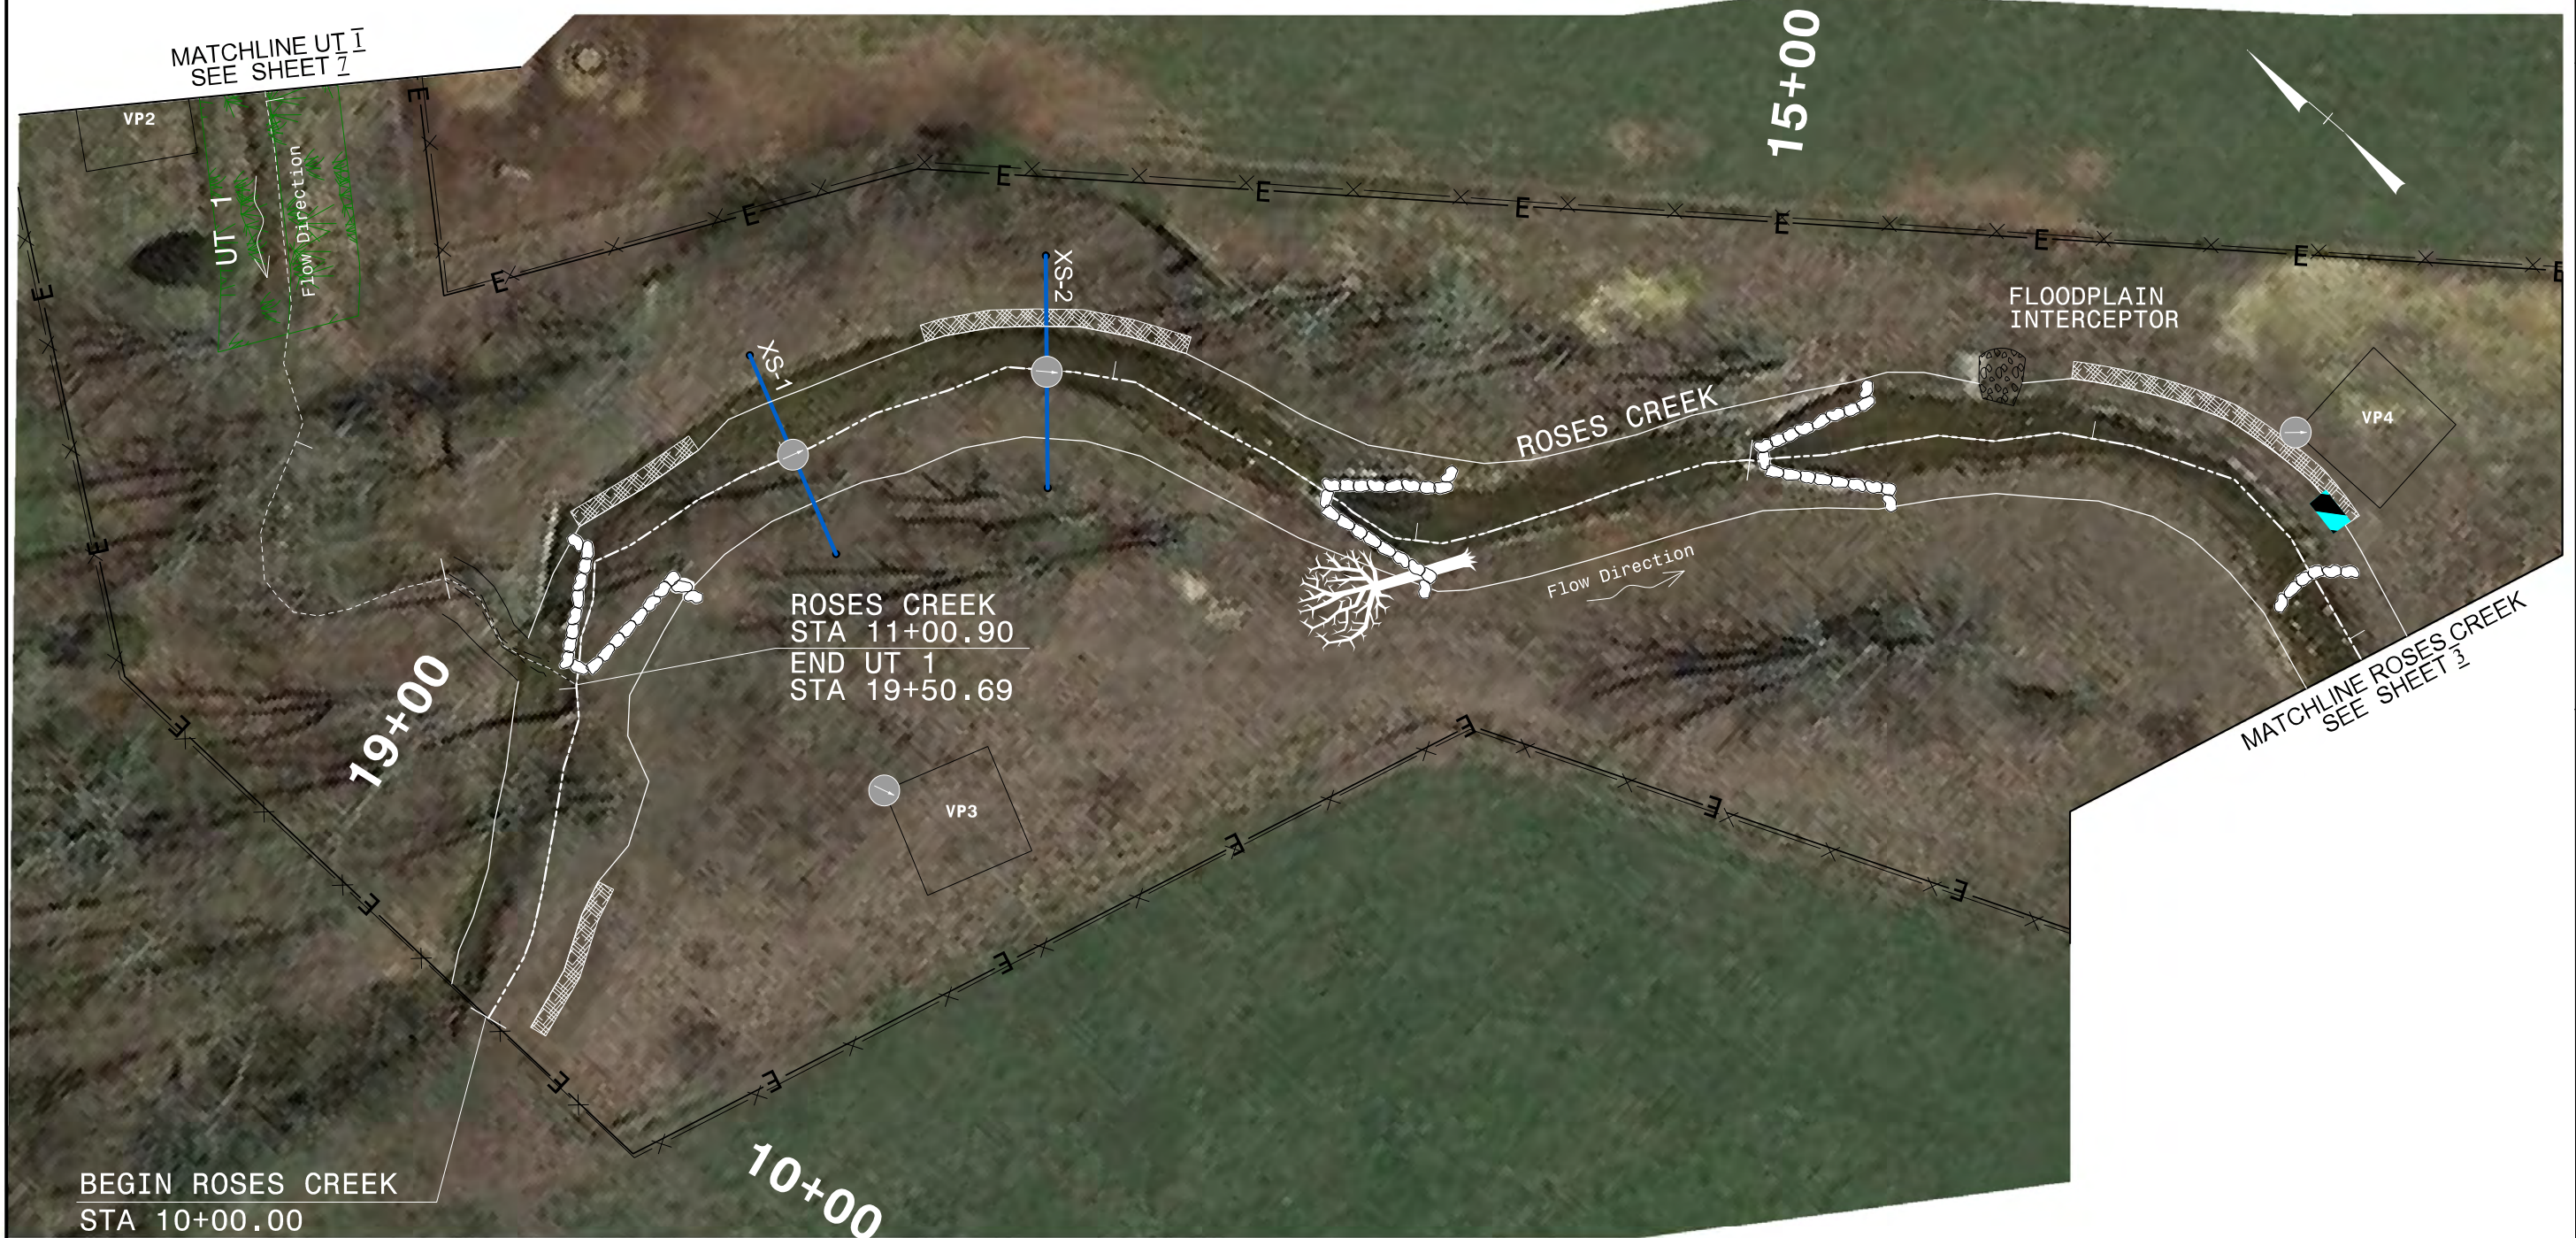
# CURRENT CONDITIONS PLAN VIEW (CCPV) YEAR 4

Roses Creek remains stable and functioning as designed. Bank erosion areas repaired in 2018 continue to benefit from the establishment of vegetation along the channel toes and bank. During Year 4, eight small areas of minor to moderate erosion were noted on Roses Creek as depicted in the Current Conditions Plan View (CCPV). Maturing vegetation along the stream banks should

YEAR 4 CONDITIONS	
	FALLEN TREE
<b>BANK/BED CONDITION</b>	
	MINOR EROSION
<b>VEGETATION PROBLEM AREAS</b>	
	INVASIVE POPULATION

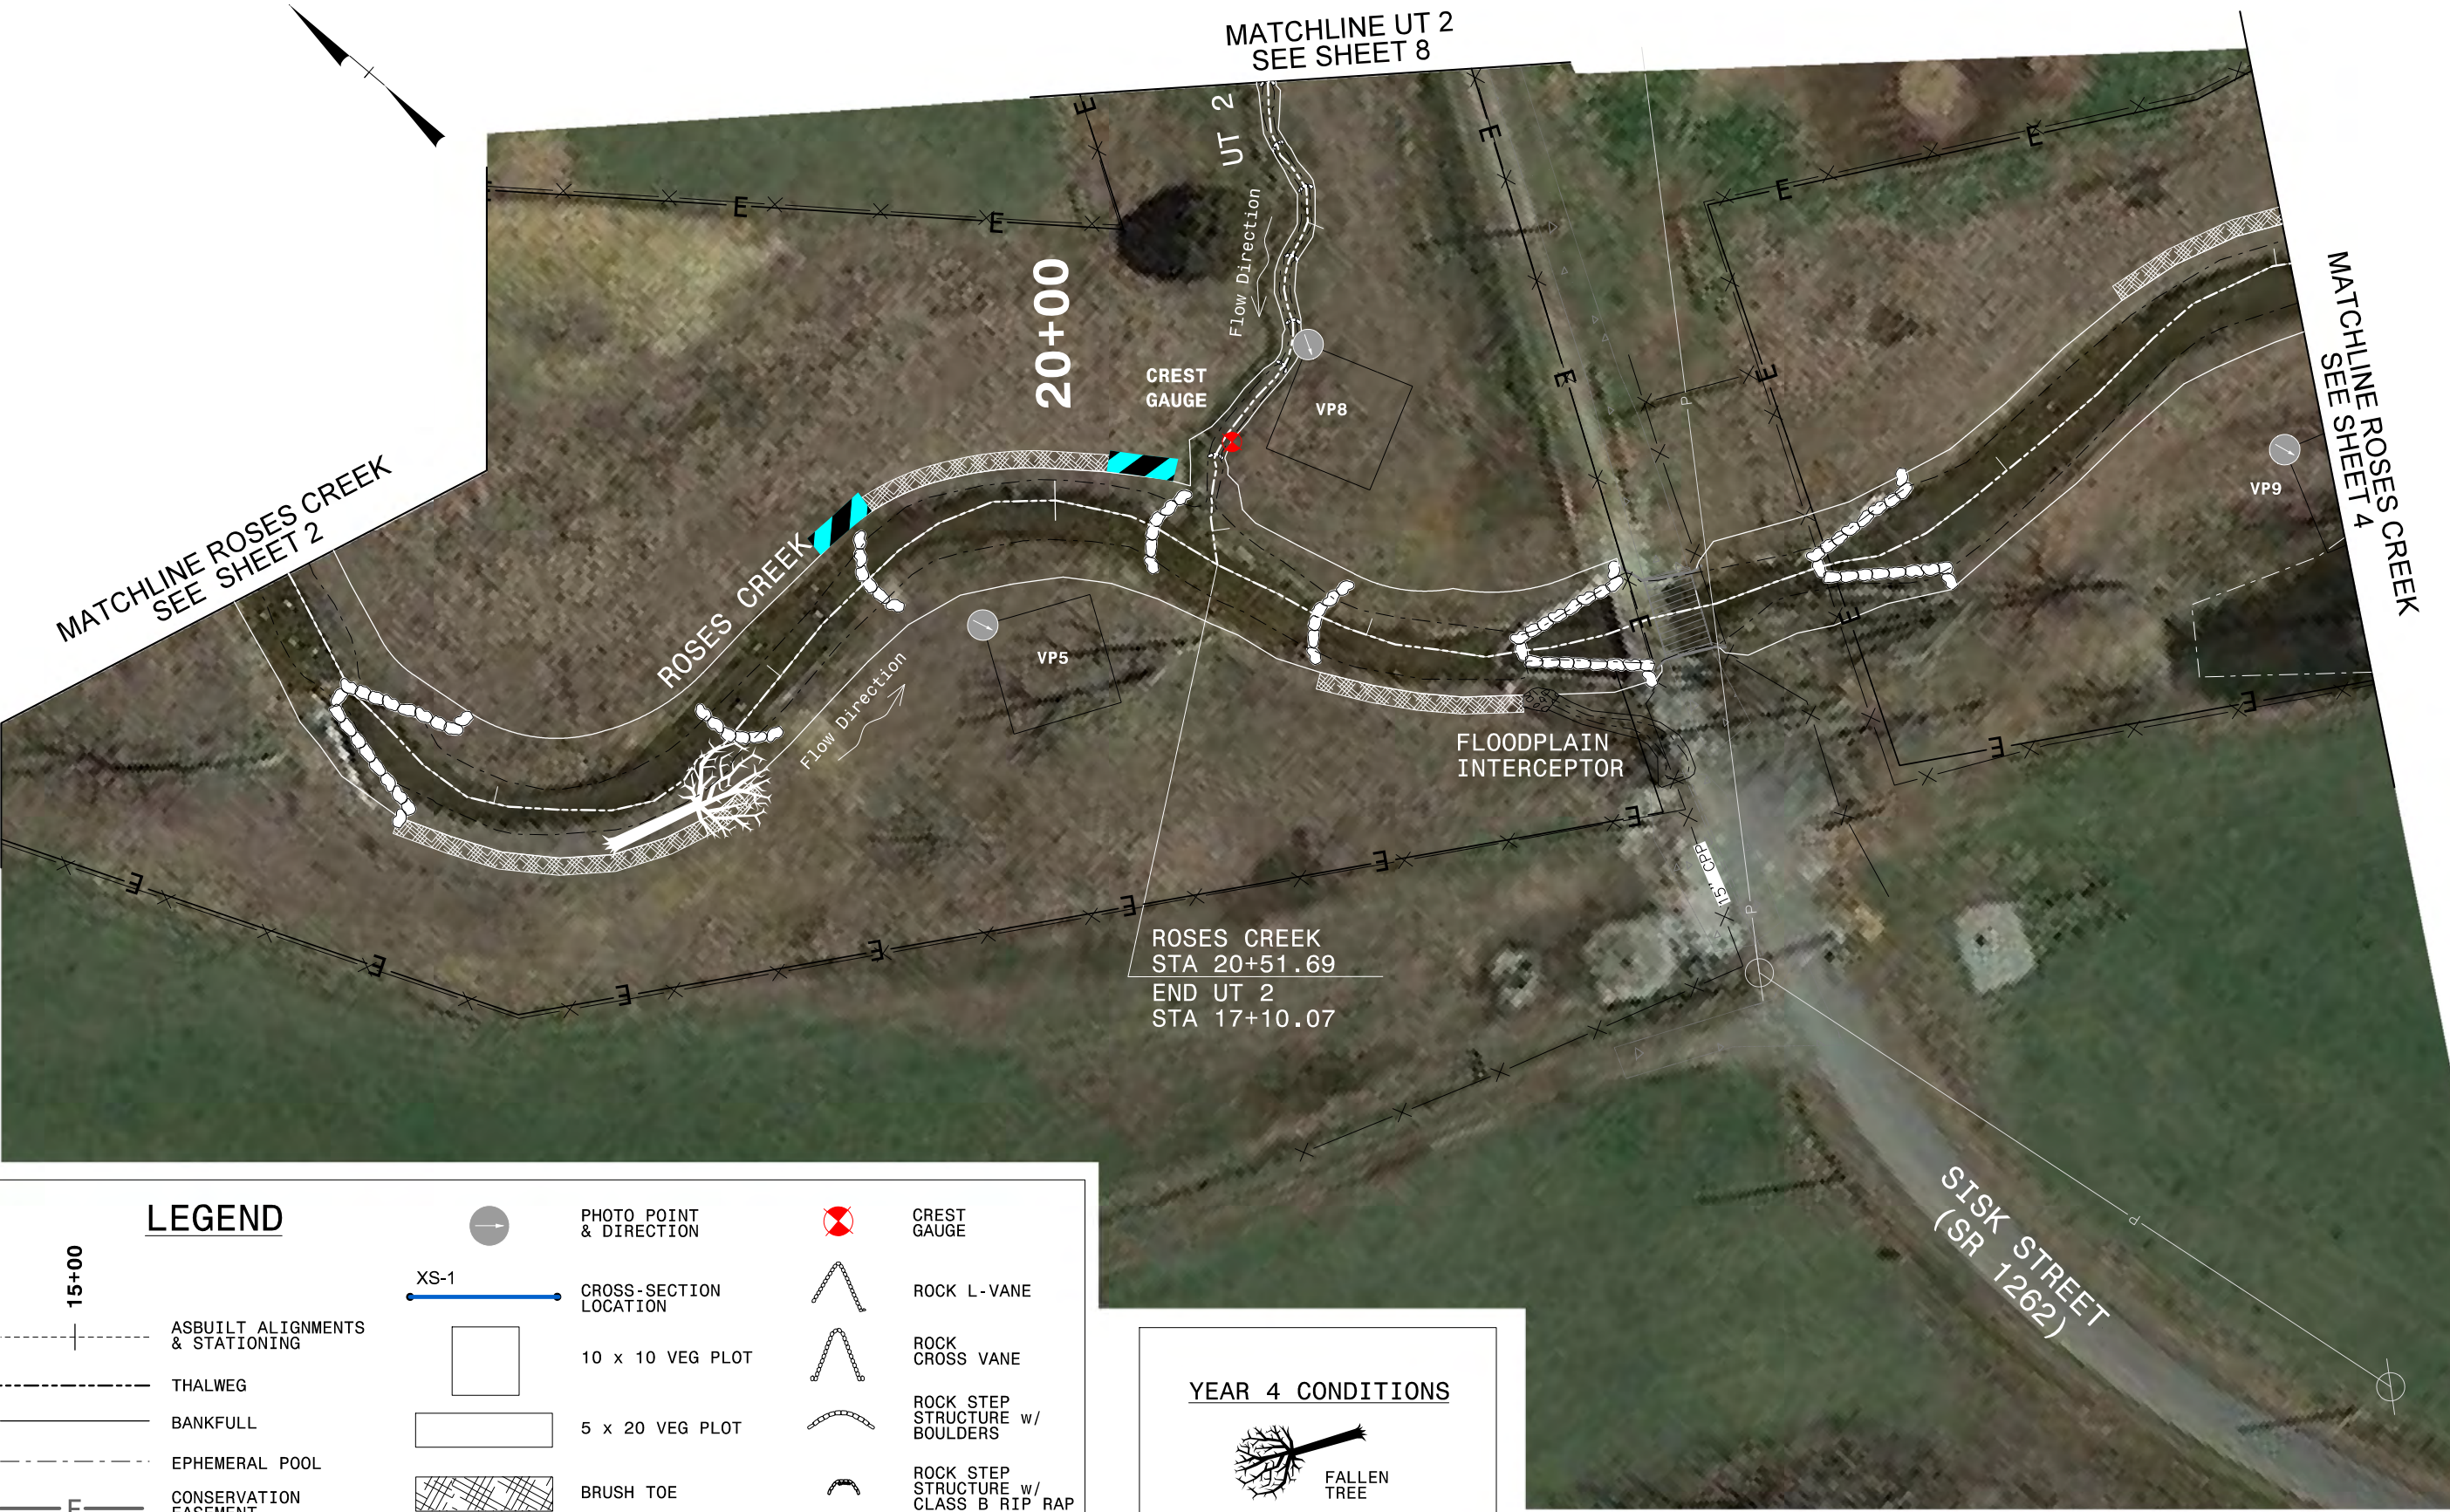
**CURRENT CONDITIONS PLAN VIEW (CCPV)**  
**YEAR 4**

- FALLEN TREE
- BANK/BED CONDITION
- MINOR EROSION

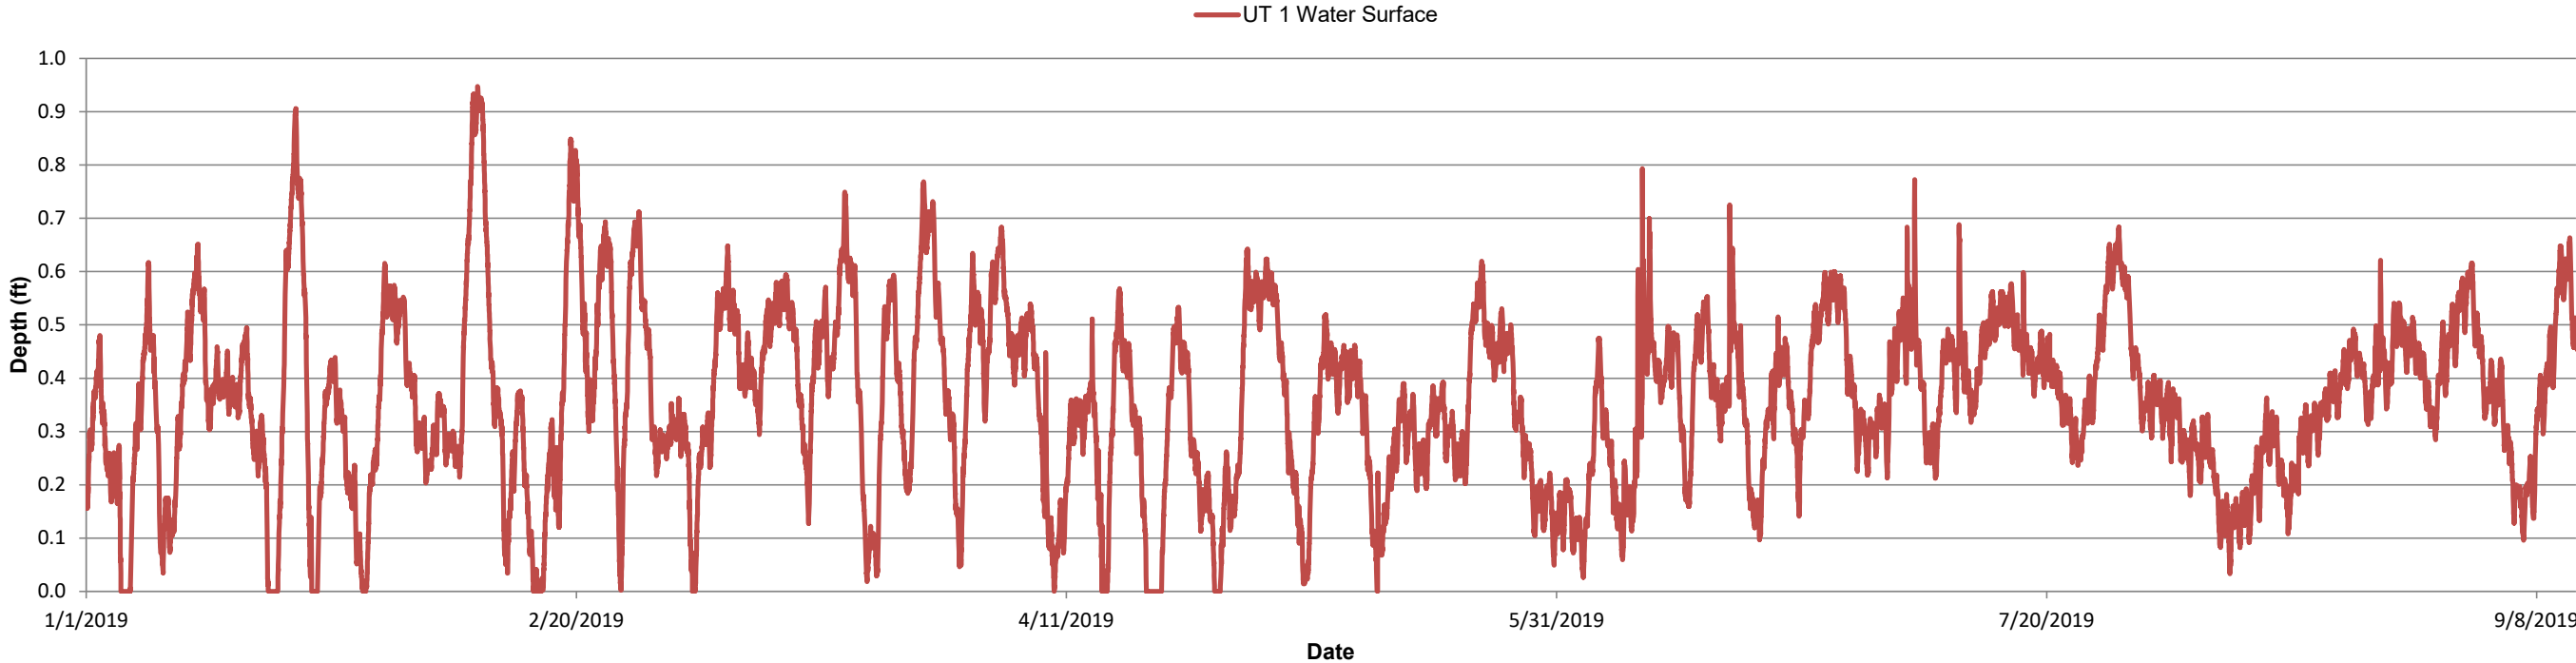
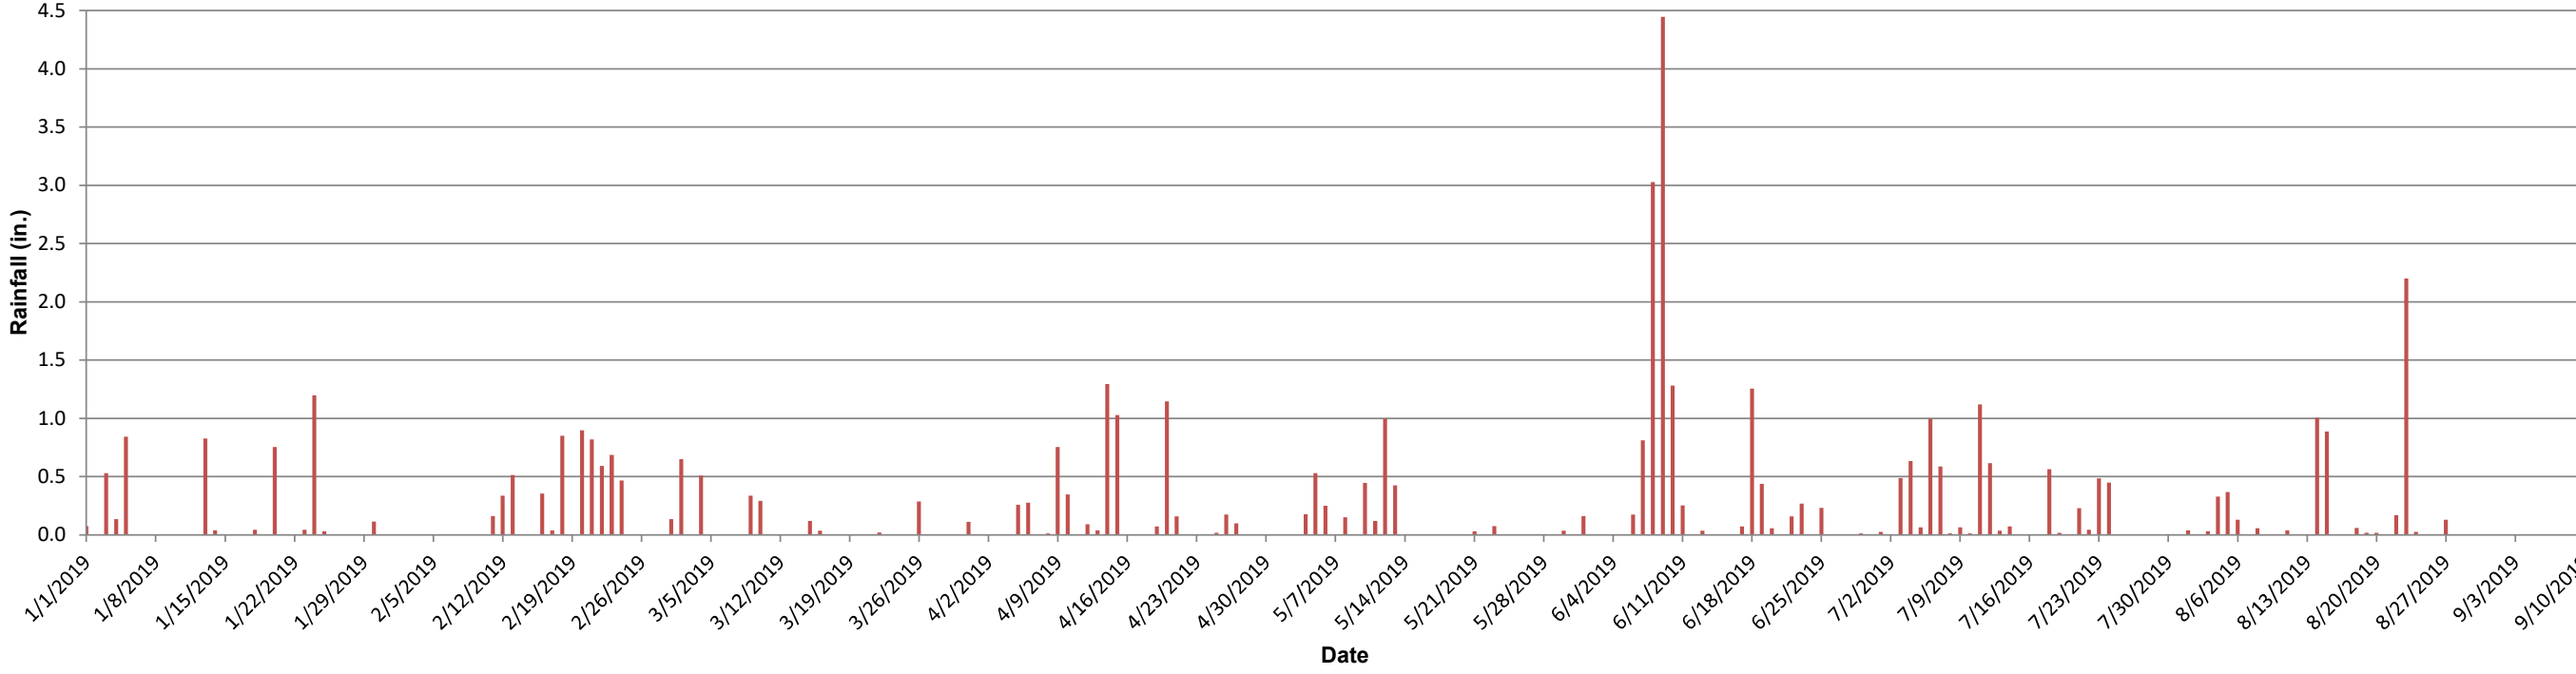
Figure 4.1 UT 1 Water Level

UT 1 and UT 3 have remained stable over the past monitoring year. Thick herbaceous vegetation along the stream banks makes it difficult to see the channels during the growing season in some areas but single channel flow is obvious during winter months (see Figures 3.11 – 3.16). During a site visit in August 2019 it was noted that sediment from the soil farm road had deposited in the bed of UT 2 just downstream of the culvert and partially diverted base flow through the floodplain over the upstream most 100 feet of UT 2. Diverted flow re-entered the channel just downstream of the constructed berm near cross section 9. Single channel flow was evident throughout UT 2 downstream of cross section 9 and the stream was functioning as intended through this reach. Based on aerial photos taken in January 2020 (Figures 3.13 and 3.14), single channel flow was evident throughout the entirety of UT 2. Based on water level data obtained using the Hobo U20 pressure transducers installed in the bottom of each tributary, all three tributaries have indicated constant flow for a span of 30+ consecutive days at least once this past year. Water level data is provided in Appendix C.
