YEAR 5 MONITORING REPORT

**ROSES CREEK STREAM MITIGATION SITE
Burke County, North Carolina
NC DMS Project # 96309**

Construction Completed: May 2016
Morphology Data Collected: February 17, 2020
Vegetation Data Collected: August 10, 2020
Submitted: January 2021

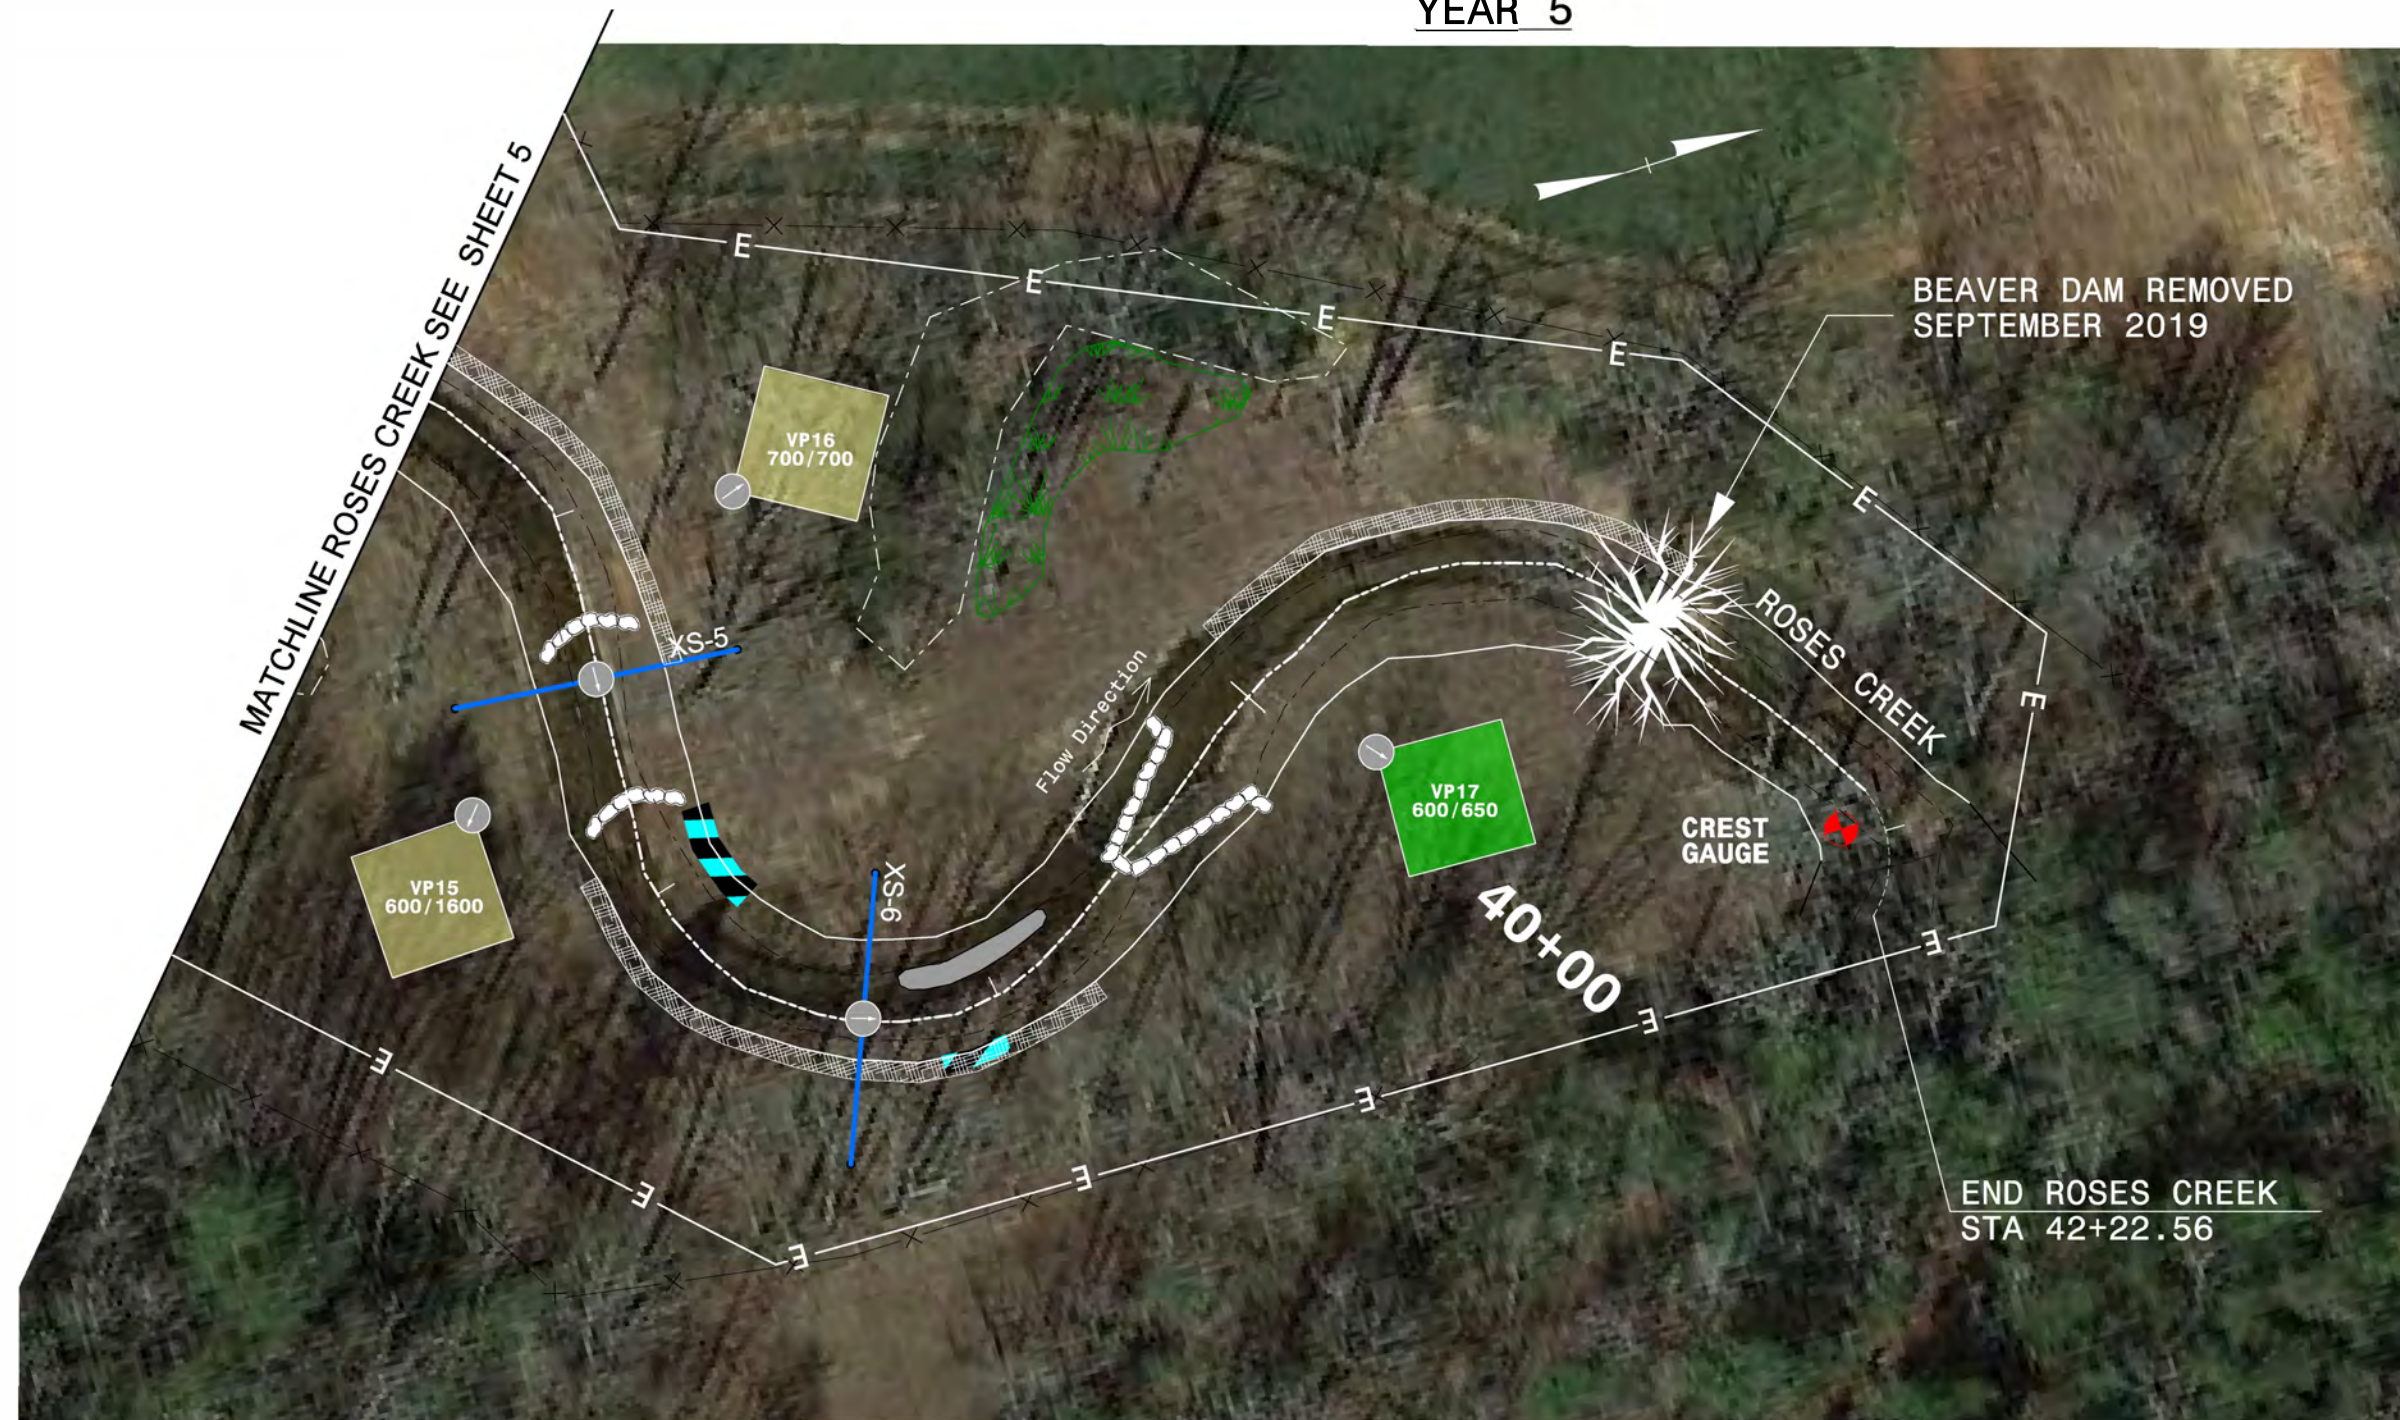
BEAVER DAM REMOVED
SEPTEMBER 2019

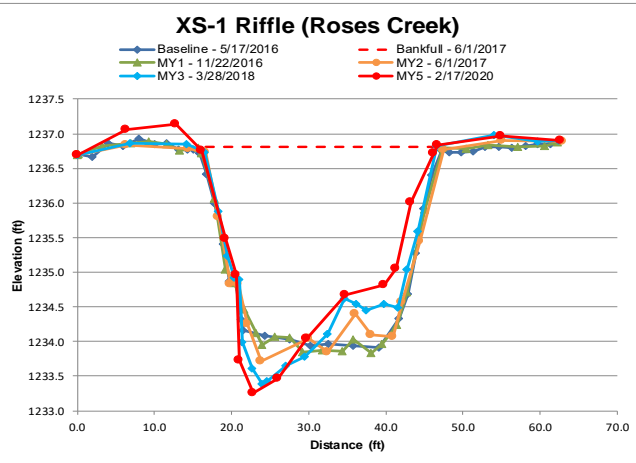
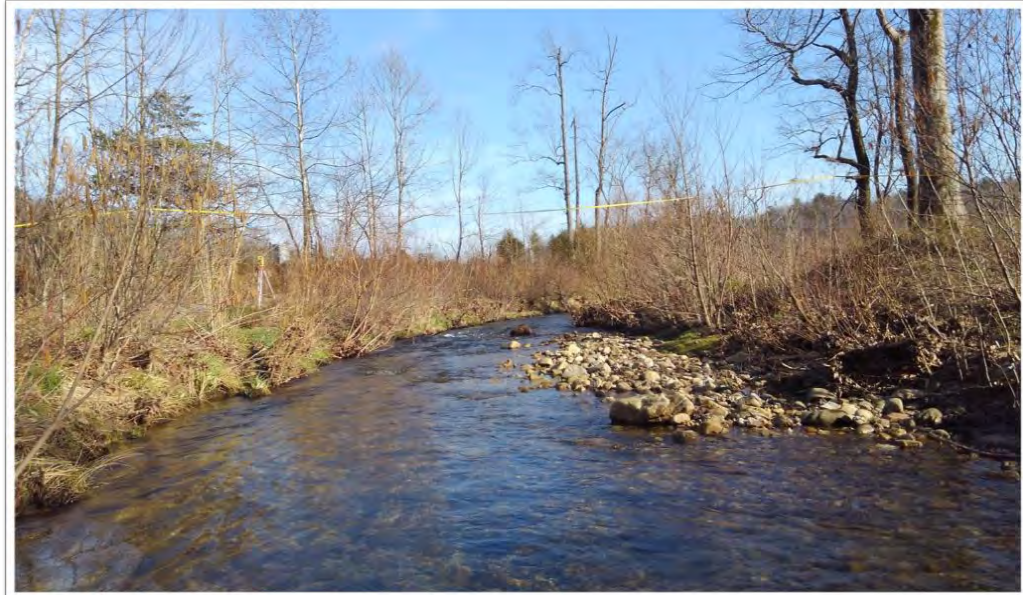
Figure 4.1

Dimension and substrate	Cross Section 1 (Riffle)					
	Base	MY1	MY2	MY3	MY5	MY7
Bankfull Width (ft)	33.80	31.10	30.73	29.98	29.94	
Floodprone Width (ft)	508.32	508.32	508.32	508.32	508.32	
Bankfull Mean Depth (ft)	2.00	2.20	2.19	2.18	2.02	
Bankfull Max Depth (ft)	2.81	2.89	3.01	3.35	3.47	
Bankfull Cross Sectional Area (ft ²)	67.70	68.28	67.22	65.27	60.43	
Bankfull Width/Depth Ratio	16.90	14.14	14.03	13.75	14.82	
Bankfull Entrenchment Ratio	15.04	16.35	16.54	16.96	16.98	
Low Bank Height (ft)	---	---	---	3.44	3.60	
Bank Height Ratio*	1.00	1.00	1.00	1.00	1.00

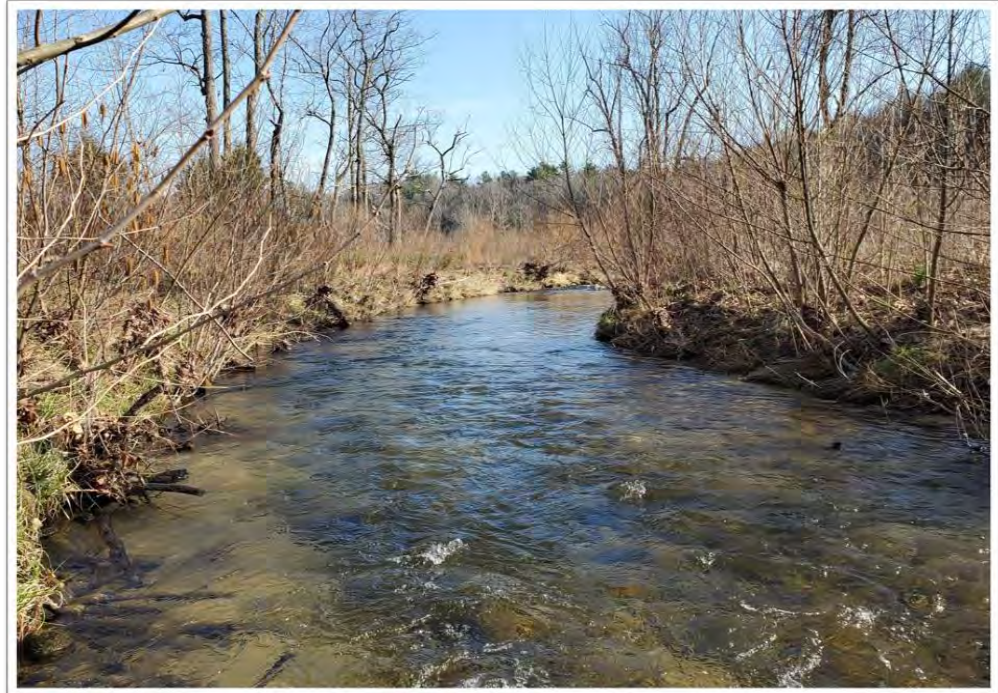
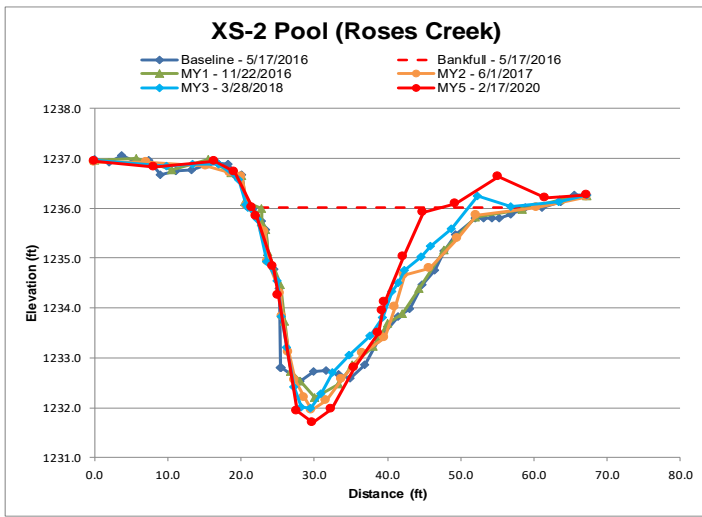
Figure 4.2

Dimension and substrate	Cross Section 2 (Pool)					
	Base	MY1	MY2	MY3	MY5	MY7
Bankfull Width (ft)	38.53	37.04	39.49	30.03	25.64	
Floodprone Width (ft)						
Bankfull Mean Depth (ft)	1.73	1.75	1.65	1.96	2.24	
Bankfull Max Depth (ft)	3.47	3.80	4.05	4.02	4.32	
Bankfull Cross Sectional Area (ft ²)	66.48	64.97	65.02	58.79	57.56	
Bankfull Width/Depth Ratio						
Bankfull Entrenchment Ratio						
Low Bank Height (ft)						
Bank Height Ratio

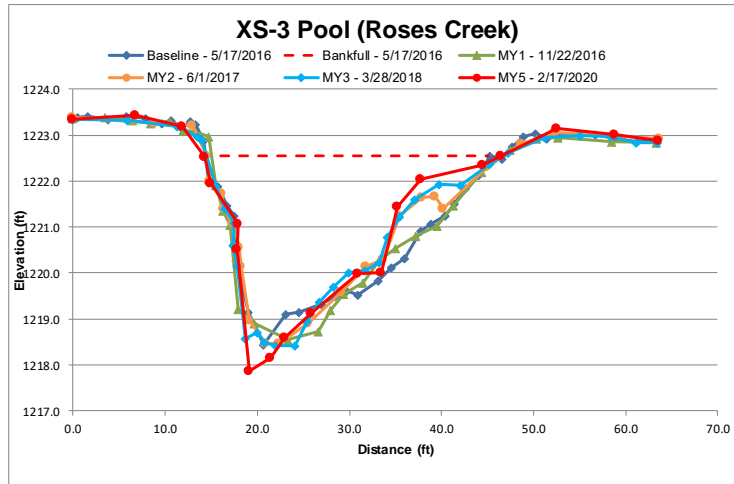
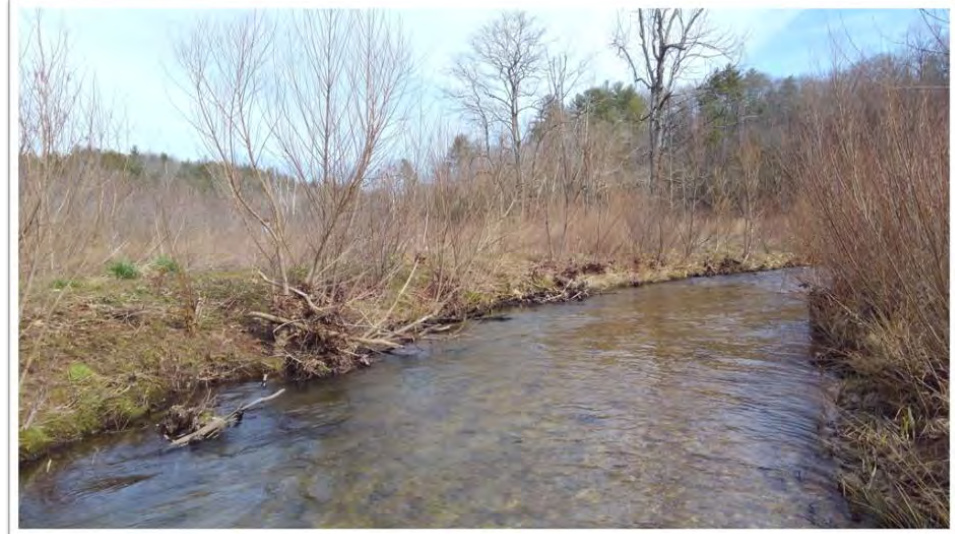
Figure 4.3

Dimension and substrate	Cross Section 3 (Pool)					
	Base	MY1	MY2	MY3	MY5	MY7
Bankfull Width (ft)	32.44	31.58	32.26	32.20	32.28	
Floodprone Width (ft)						
Bankfull Mean Depth (ft)	2.19	2.32	2.07	2.03	2.00	
Bankfull Max Depth (ft)	4.10	3.99	4.09	4.13	4.68	
Bankfull Cross Sectional Area (ft ²)	71.10	73.39	66.76	65.48	64.54	
Bankfull Width/Depth Ratio						
Bankfull Entrenchment Ratio						
Low Bank Height (ft)						
Bank Height Ratio

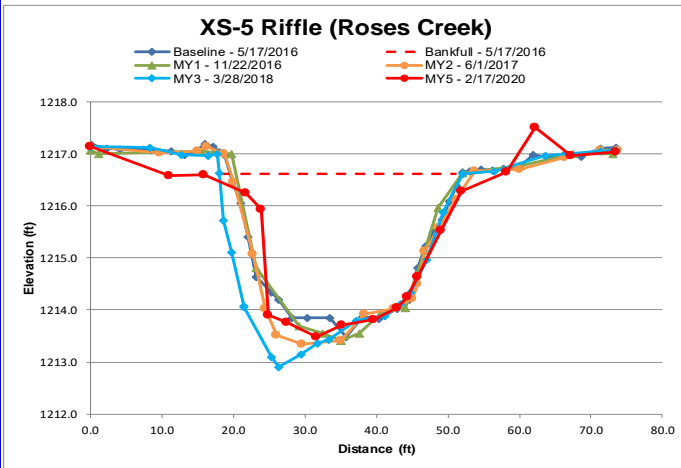
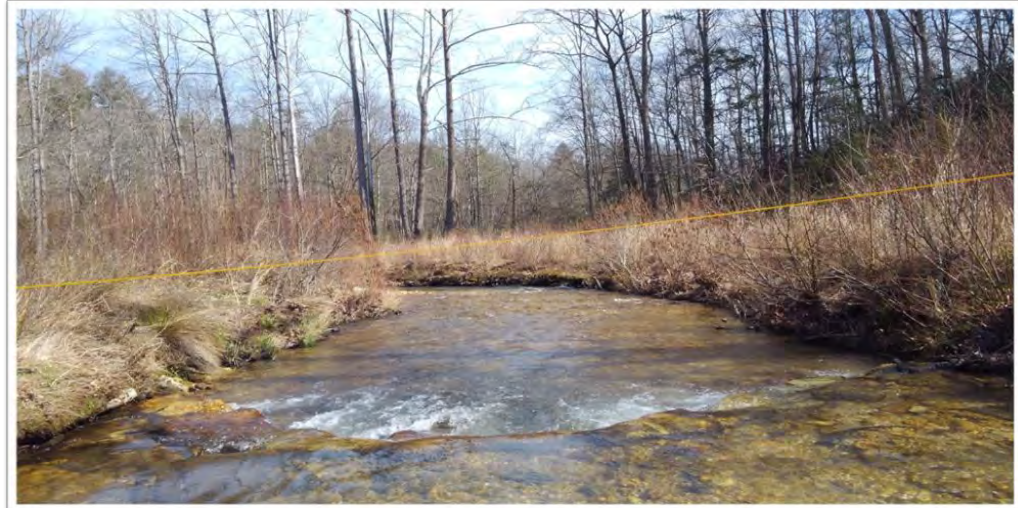
Figure 4.5

Dimension and substrate	Cross Section 5 (Riffle)					
	Base	MY1	MY2	MY3	MY5	MY7
Bankfull Width (ft)	32.56	32.99	34.06	36.04	30.66	
Floodprone Width (ft)	563.60	563.60	563.60	563.60	563.60	
Bankfull Mean Depth (ft)	2.13	2.25	2.22	2.37	1.90	
Bankfull Max Depth (ft)	3.16	3.23	3.29	3.73	2.80	
Bankfull Cross Sectional Area (ft ²)	69.41	74.12	75.52	85.30	58.11	
Bankfull Width/Depth Ratio	15.29	14.66	15.34	15.21	16.14	
Bankfull Entrenchment Ratio	17.31	17.08	16.55	15.64	18.38	
Low Bank Height (ft)	---	---	---	3.69	2.80	
Bank Height Ratio*	1.00	1.00	1.00	<1	<1

* Base - MY2 calculated by holding bankfull elevation constant. MY5 data calculated by fitting as-built bankfull cross section area to monitoring year channel.

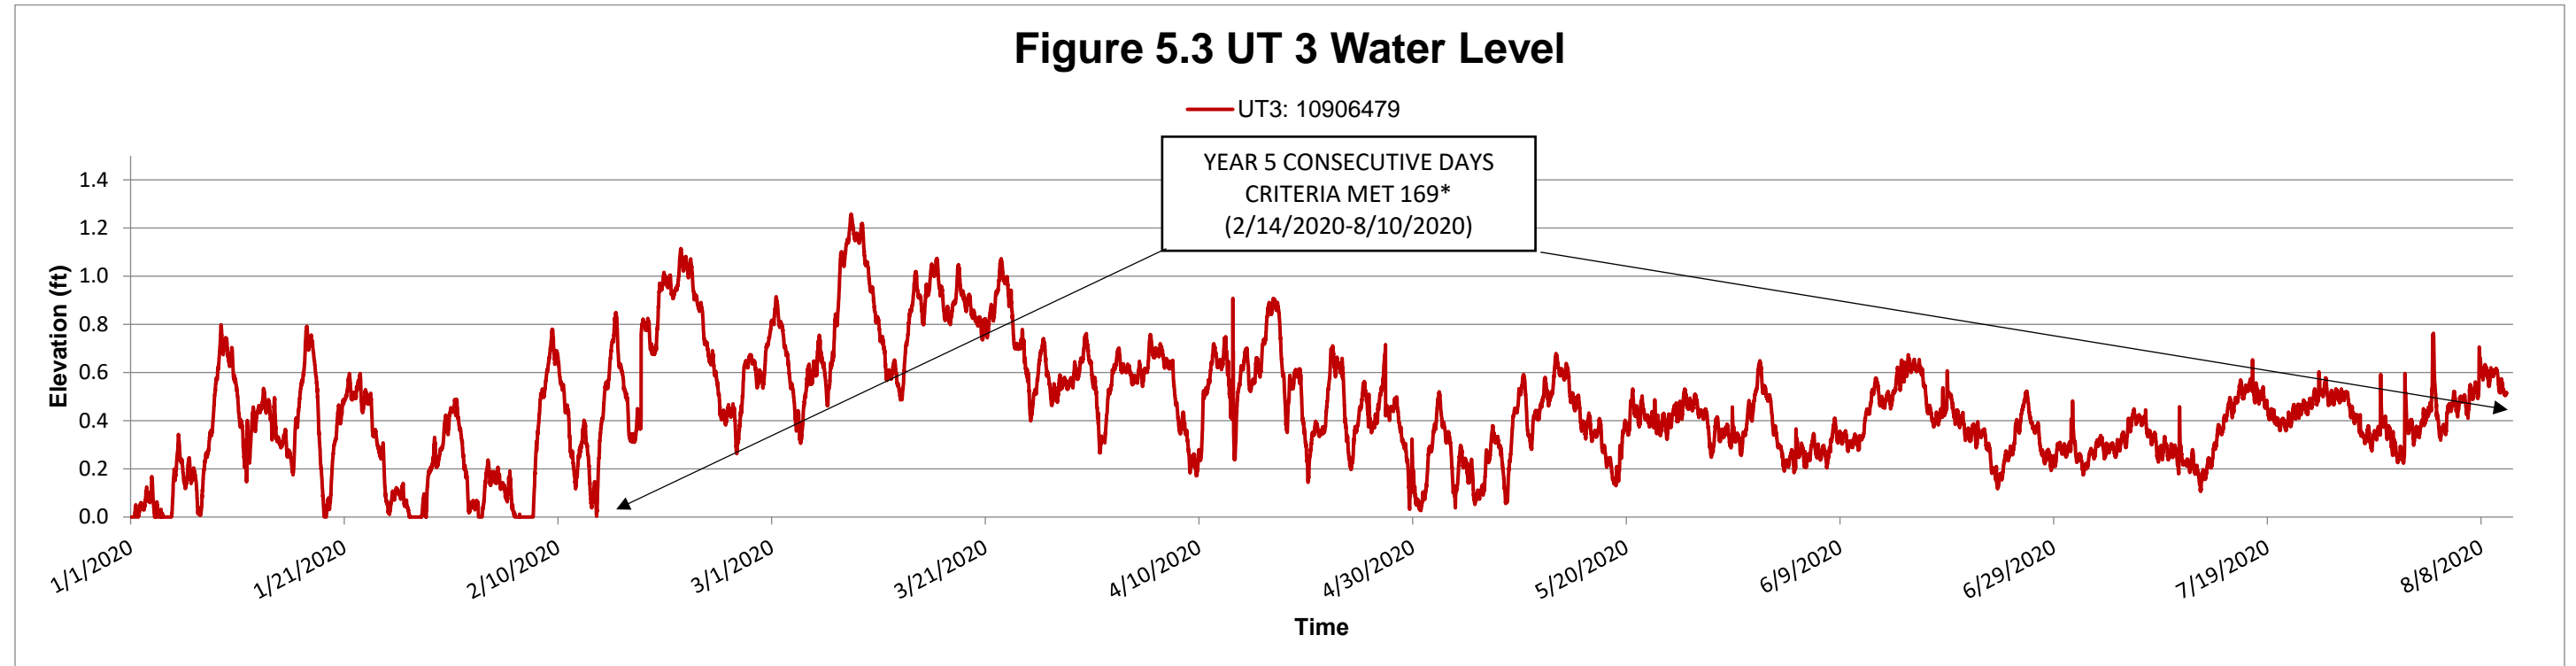
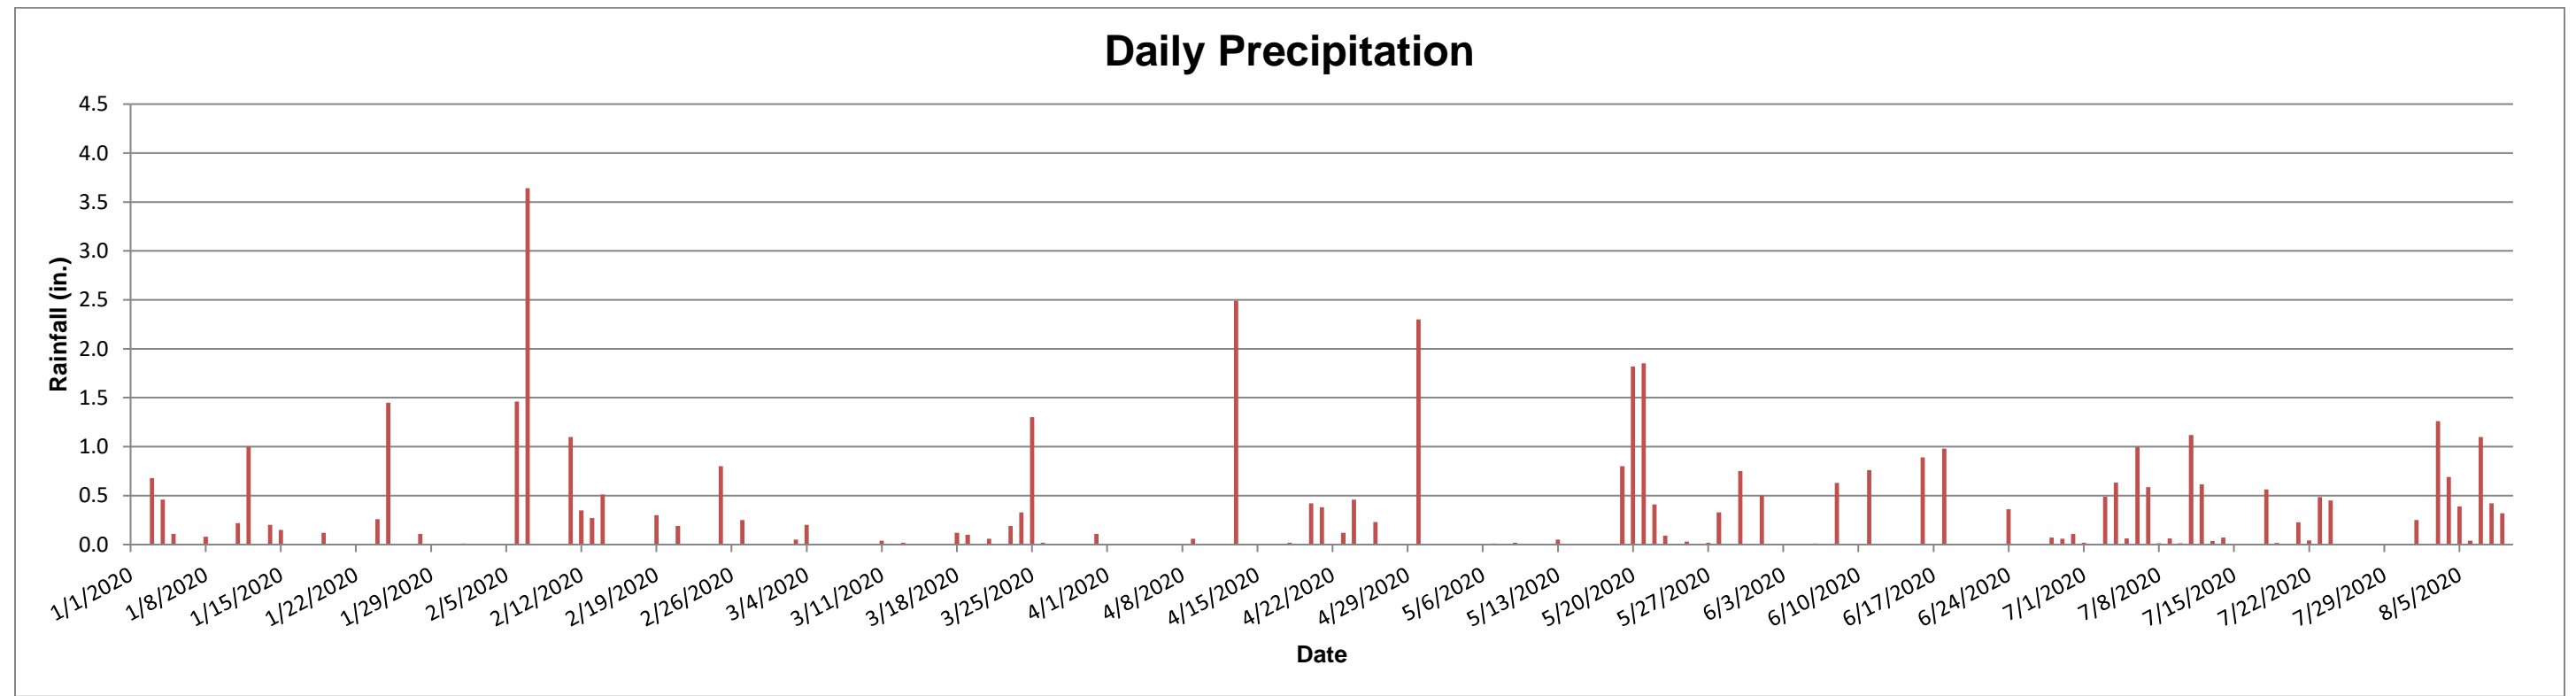
Figure 5.3 UT 3 Water Level

3. Fig 5.3 x-axis label has distance rather than time as a label. This was also an issue in the prior (MY4) annual report.
RE: Comply. Figure 5.3 x-axis has been revised to show time.
