Year 7 Monitoring and Closeout Report

Roses Creek
Burke County, NC

DMS Project ID No. 96309

Submitted: February 2023

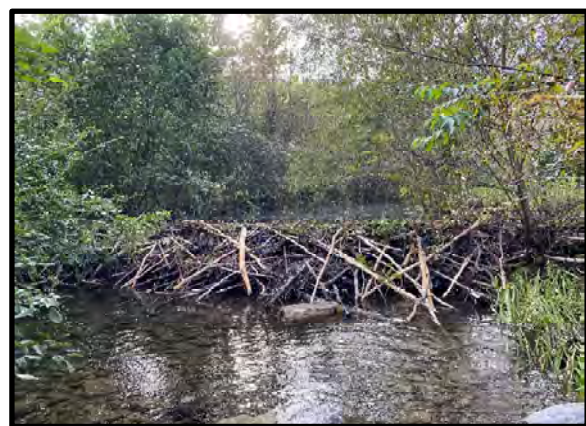
Beaver activity was noted in late summer of 2022 in the downstream portions of Roses Creek. Two beaver dams were located at stations 29+25 and 32+50 along Roses Creek and created some backwater effects upstream of these locations. In late fall of 2022, four beavers were trapped by APHIS and the dams were removed by hand raking and minimal chainsaw work. HDR will visually assess and photo document these areas for stability in late 2022/early 2023 ahead of the agency meeting.

3.18 Upper beaver dam station 29+25

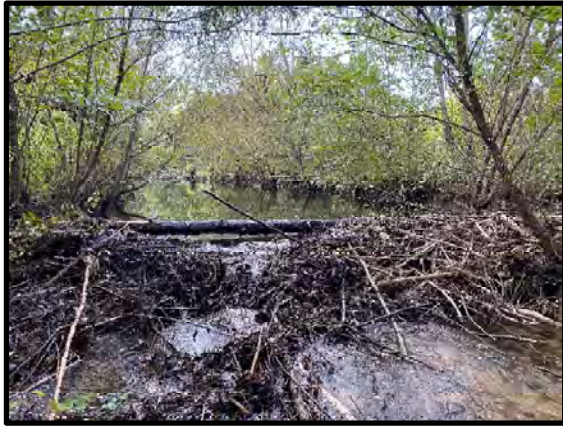
3.19 Lower beaver dam station 32+50

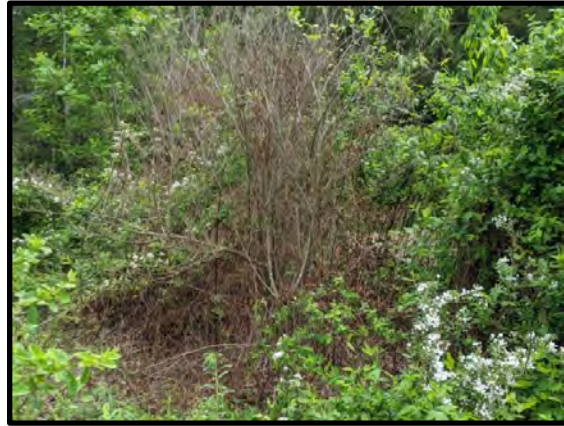
Chinese privet (*Ligustrum sinense*), Japanese honeysuckle (*Lonicera japonica*), multiflora rose (*Rosa multiflora*), and mimosa (*Albizia julibrissin*) have been observed in the past years and recently downstream of station 14+75 along the UT 1 floodplain. As part of the invasives management plan for 2022, invasive species were chemically treated on both sides of UT 1 floodplain, at the confluence at UT1 with Roses Creek, Roses Creek a few hundred feet downstream on both banks and along the fence line of Sisk Farm Road adjacent to UT 2 on April 5, and 29, 2022. On April 5, a combination of basal bark application (20% Garlon 4 in Bark Oil Blue) and foliar spray with 3% glyphosate was applied in the invasive areas along UT 1, Roses Creek and the roadside adjacent to UT 2. On April 29 the foliar spray and cut stem application to privet and a large mimosa along UT 1 was performed. A final treatment for these identified invasives areas is scheduled for UT 2 in the spring of 2023 for the Japanese honeysuckle. The Current Conditions Plan View depicts this invasive populations of honeysuckle between Sisk Farm Road and UT 2.

3.20 Invasive treatment results at UT1

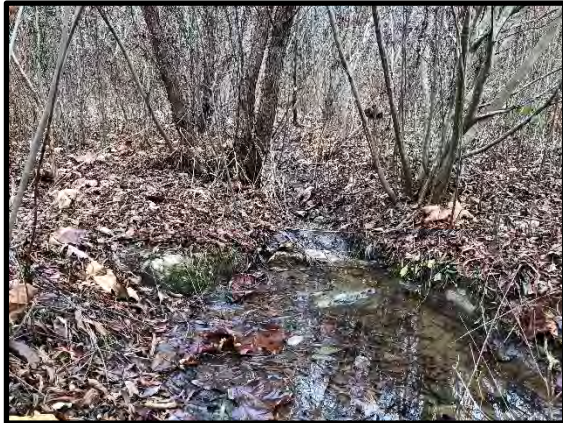
In Year 5 monitoring, deposition was seen in UT 1, 2, and 3. These conditions have improved for UT 1 and 2 based on Year 7 cross section values. UT 3 however continues a depositional trend. As noted in previous year monitoring, the likely cause is increased vegetation establishment and narrowing of the bankfull area. Each tributary maintains a single thread channel throughout the Site as seen from the aerial drone photography.

**3.25 UT 3, view upstream
December 2022**

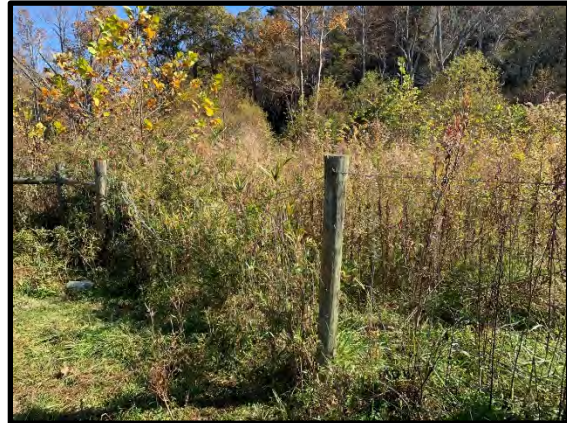
The cattle waste encroachment area outside the conservation easement at approximately station 41+50 of Roses Creek is running into the forested and herbaceous riparian buffer between the pasture area and the stream since it is the low spot in the landscape. The landowner is not willing to remove his cattle from this area of the pasture as it provides a shady spot for cattle and the landowner noted he has limited pasture. HDR believes the wide forested and herbaceous buffer (over 50 feet) inside the easement is processing the excess cattle waste. Another area has been called out on the CCPV as “Fence undermining area” and is located at approximately station 40+00 adjacent to an ephemeral pool. The landowner has added wood and concrete blocks to shore up the bottom fence openings to prevent cattle from passing under or breaching the easement fence. There is no evidence of livestock entering into the easement in 2022.

**3.26 Fence opening nearby by Roses Creek
Station 36+50**

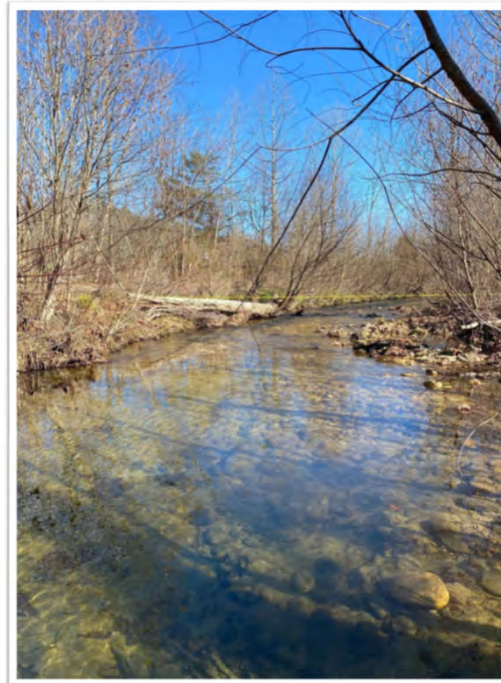
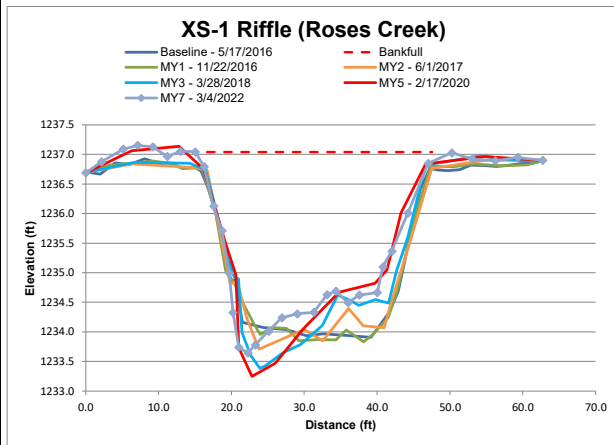
River Basin	Catawba
Watershed	03050101060030
XS ID	XS 1 (Roses Creek)
Drainage Area (Acres)	3,309
Date	3/3/2022
Field Crew	TC, WY

Dimension and substrate	Cross Section 1 (Riffle)					
	Base	MY1	MY2	MY3	MY5	MY7**
Bankfull Width (ft)	33.80	31.10	30.73	29.98	29.94	30.76
Floodprone Width (ft)	508.32	508.32	508.32	508.32	508.32	508.32
Bankfull Mean Depth (ft)	2.00	2.20	2.19	2.18	2.02	2.21
Bankfull Max Depth (ft)	2.81	2.89	3.01	3.35	3.47	3.40
Bankfull Cross Sectional Area (ft ²)	67.70	68.28	67.22	65.27	60.43	68.06
Bankfull Width/Depth Ratio	16.90	14.14	14.03	13.75	14.82	13.90
Bankfull Entrenchment Ratio	15.04	16.35	16.54	16.96	16.98	16.53
Low Bank Height (ft)	---	---	---	3.44	3.6	3.15
Bank Height Ratio*	1.00	1.00	1.00	1.00	>1	0.93

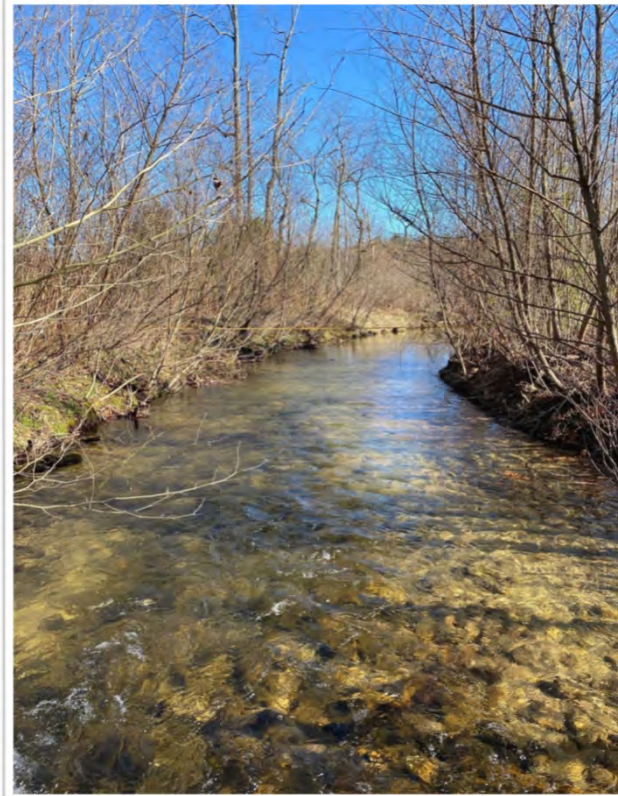
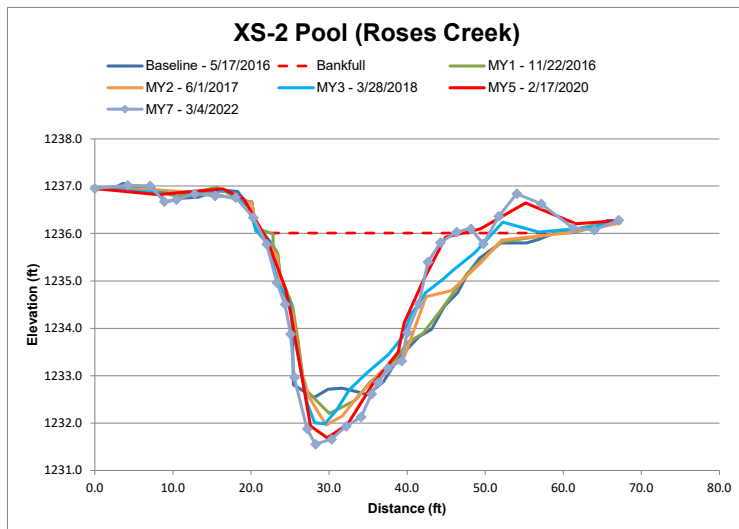
River Basin	Catawba
Watershed	03050101060030
XS ID	XS 2 (Roses Creek)
Drainage Area (Acres)	3,309
Date	3/3/2022
Field Crew	TC, WY

Dimension and substrate	Cross Section 2 (Pool)					
	Base	MY1	MY2	MY3	MY5	MY7
Bankfull Width (ft)	38.53	37.04	39.49	30.03	25.64	24.84
Floodprone Width (ft)						
Bankfull Mean Depth (ft)	1.73	1.75	1.65	1.96	2.24	2.52
Bankfull Max Depth (ft)	3.47	3.80	4.05	4.02	4.32	4.45
Bankfull Cross Sectional Area (ft ²)	66.48	64.97	65.02	58.79	57.56	62.53
Bankfull Width/Depth Ratio						
Bankfull Entrenchment Ratio						
Low Bank Height (ft)						
Bank Height Ratio

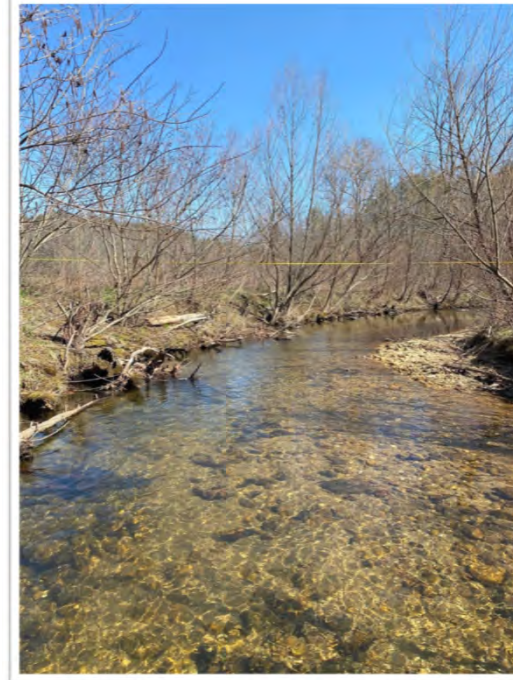
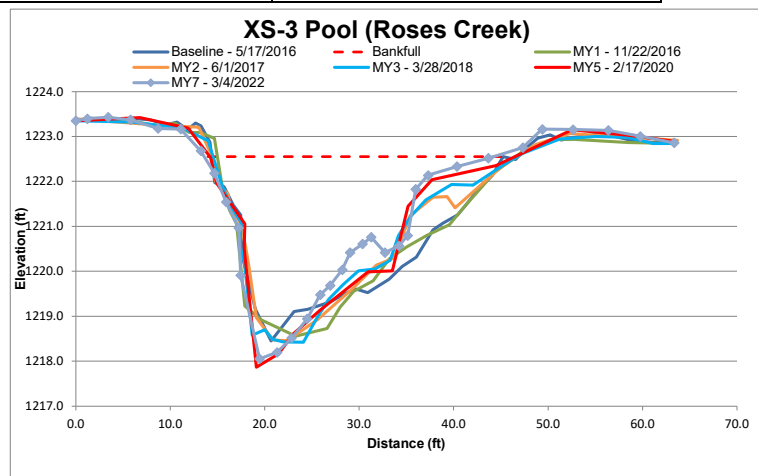
River Basin	Catawba
Watershed	03050101060030
XS ID	XS 3 (Roses Creek)
Drainage Area (Acres)	3,309
Date	3/3/2022
Field Crew	TC, WY

Dimension and substrate	Cross Section 3 (Pool)					
	Base	MY1	MY2	MY3	MY5	MY7
Bankfull Width (ft)	32.44	31.58	32.26	32.20	32.28	30.61
Floodprone Width (ft)						
Bankfull Mean Depth (ft)	2.19	2.32	2.07	2.03	2.00	1.95
Bankfull Max Depth (ft)	4.10	3.99	4.09	4.13	4.68	4.49
Bankfull Cross Sectional Area (ft ²)	71.10	73.39	66.76	65.48	64.54	59.61
Bankfull Width/Depth Ratio						
Bankfull Entrenchment Ratio						
Low Bank Height (ft)						
Bank Height Ratio

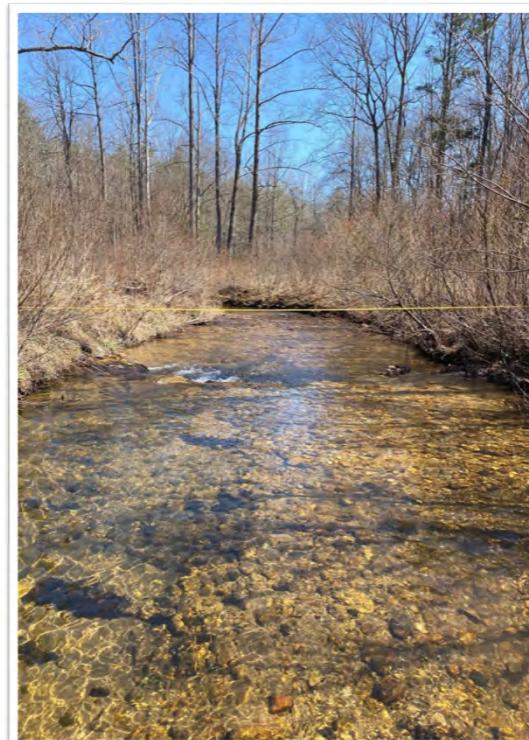
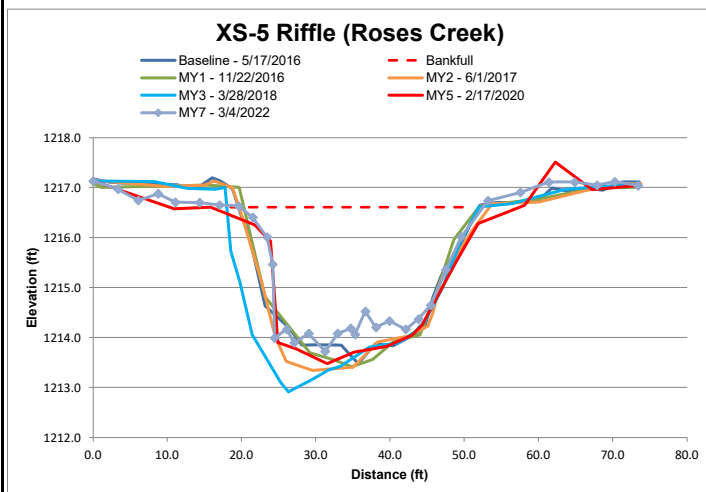
River Basin	Catawba
Watershed	03050101060030
XS ID	XS 5 (Roses Creek)
Drainage Area (Acres)	3,309
Date	3/3/2022
Field Crew	TC, WY

Dimension and substrate	Cross Section 5 (Riffle)					
	Base	MY1	MY2	MY3	MY5	MY7**
Bankfull Width (ft)	32.56	32.99	34.06	36.04	30.66	32.81
Floodprone Width (ft)	563.60	563.60	563.60	563.60	563.60	563.60
Bankfull Mean Depth (ft)	2.13	2.25	2.22	2.37	1.90	1.82
Bankfull Max Depth (ft)	3.16	3.23	3.29	3.73	2.80	2.89
Bankfull Cross Sectional Area (ft ²)	69.41	74.12	75.52	85.30	58.11	59.80
Bankfull Width/Depth Ratio	15.29	14.66	15.34	15.21	16.14	18.00
Bankfull Entrenchment Ratio	17.31	17.08	16.55	15.64	18.38	17.18
Low Bank Height (ft)	---	---	---	3.69	2.80	2.89
Bank Height Ratio*	1.00	1.00	1.00	<1	<1	1.00

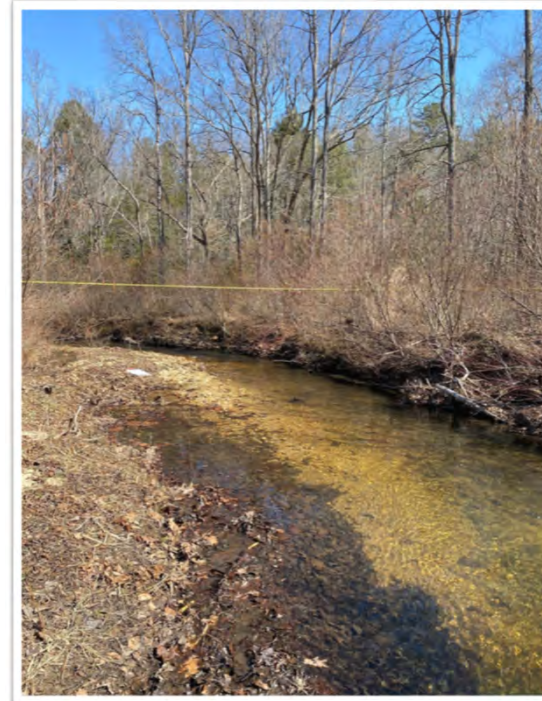
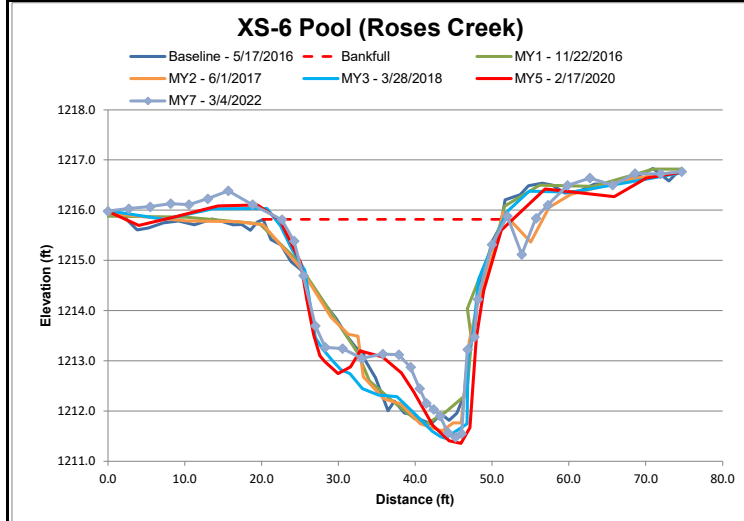
River Basin	Catawba
Watershed	03050101060030
XS ID	XS 6 (Roses Creek)
Drainage Area (Acres)	3,309
Date	3/3/2022
Field Crew	TC, WY

Dimension and substrate	Cross Section 6 (Pool)					
	Base	MY1	MY2	MY3	MY5	MY7
Bankfull Width (ft)	31.02	31.30	30.99	29.70	29.46	32.76
Floodprone Width (ft)						
Bankfull Mean Depth (ft)	2.37	2.23	2.32	2.69	2.56	2.18
Bankfull Max Depth (ft)	4.07	3.98	4.11	4.36	4.37	4.34
Bankfull Cross Sectional Area (ft ²)	73.63	69.77	71.83	80.01	75.54	71.40
Bankfull Width/Depth Ratio						
Bankfull Entrenchment Ratio						
Low Bank Height (ft)						
Bank Height Ratio

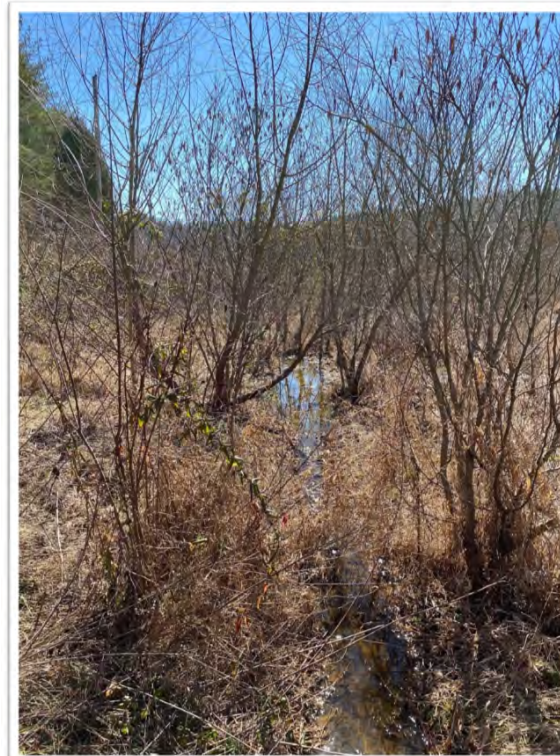
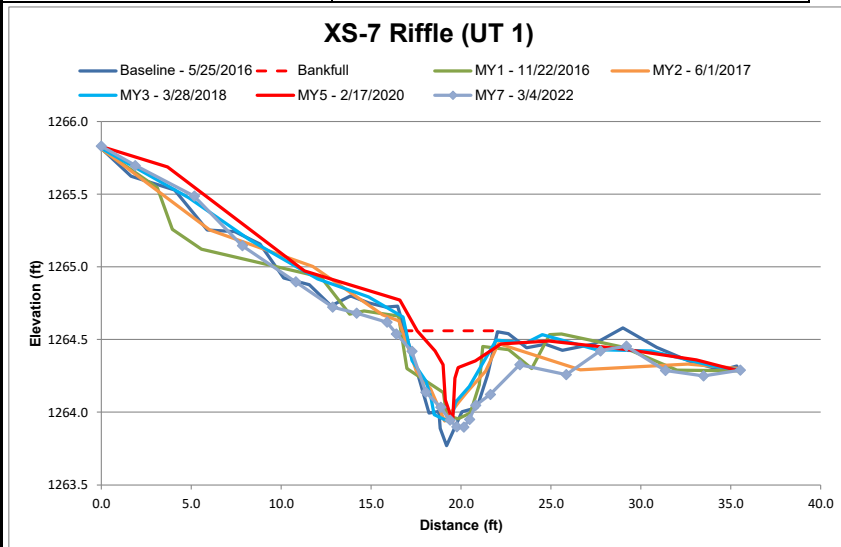
River Basin	Catawba
Watershed	03050101060030
XS ID	XS 7 (UT 1)
Drainage Area (Acres)	38.40
Date	3/3/2022
Field Crew	TC, WY

Dimension and substrate	Cross Section 7 (Riffle)					
	Base	MY1	MY2	MY3	MY5	MY7**
Bankfull Width (ft)	5.12	4.46	5.31	5.01	4.66	5.23
Floodprone Width (ft)	91.80	91.80	91.80	91.80	91.80	91.80
Bankfull Mean Depth (ft)	0.45	0.41	0.35	0.36	0.21	0.48
Bankfull Max Depth (ft)	0.78	0.59	0.61	0.62	0.62	0.66
Bankfull Cross Sectional Area (ft ²)	2.30	1.82	1.86	1.78	0.96	2.52
Bankfull Width/Depth Ratio	11.38	10.88	15.17	13.92	22.19	10.86
Bankfull Entrenchment Ratio	17.93	20.58	17.29	18.32	19.70	17.55
Low Bank Height (ft)	---	---	---	0.57	0.53	0.43
Bank Height Ratio*	1.00	1.00	1.00	<1	<1	0.65

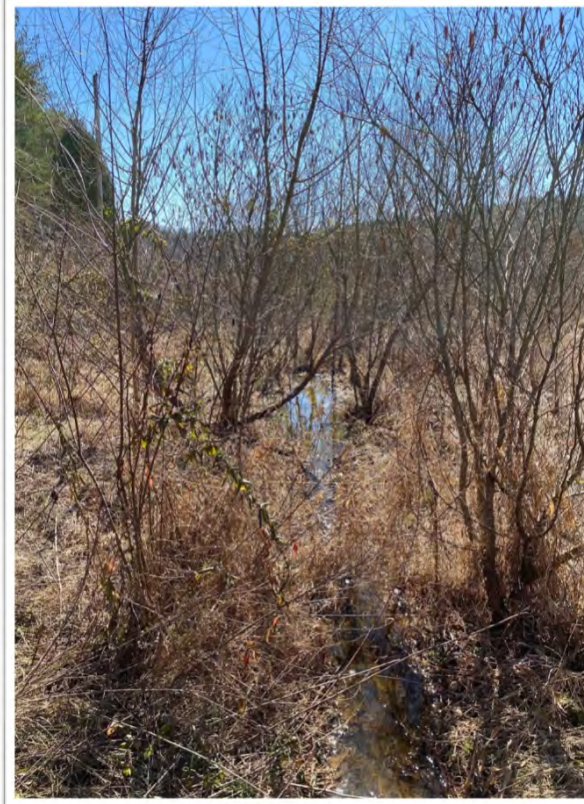
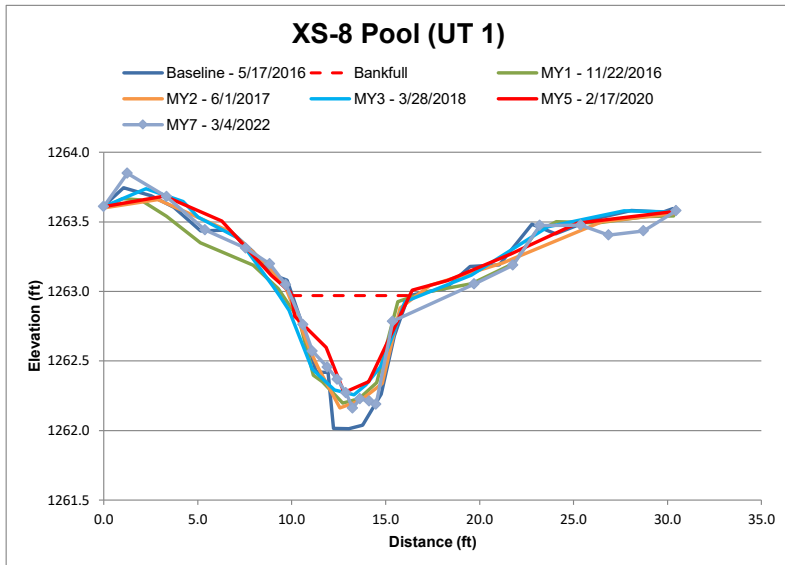
River Basin	Catawba
Watershed	03050101060030
XS ID	XS 8 (UT 1)
Drainage Area (Acres)	38.40
Date	3/3/2022
Field Crew	TC, WY

Dimension and substrate	Cross Section 8 (Pool)					
	Base	MY1	MY2	MY3	MY5	MY7
Bankfull Width (ft)	6.24	7.07	6.80	7.49	6.30	8.45
Floodprone Width (ft)						
Bankfull Mean Depth (ft)	0.58	0.44	0.47	0.42	0.40	0.37
Bankfull Max Depth (ft)	0.96	0.77	0.81	0.71	0.70	0.81
Bankfull Cross Sectional Area (ft ²)	3.64	3.10	3.23	3.12	2.50	3.11
Bankfull Width/Depth Ratio						
Bankfull Entrenchment Ratio						
Low Bank Height (ft)						
Bank Height Ratio

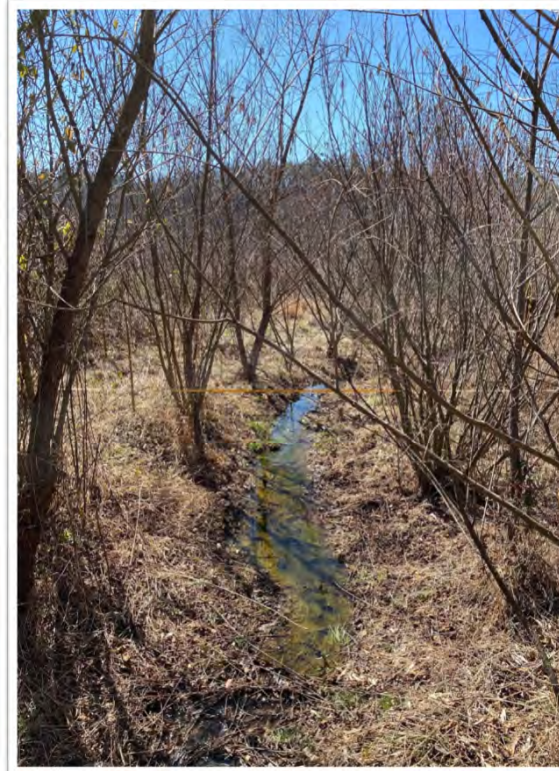
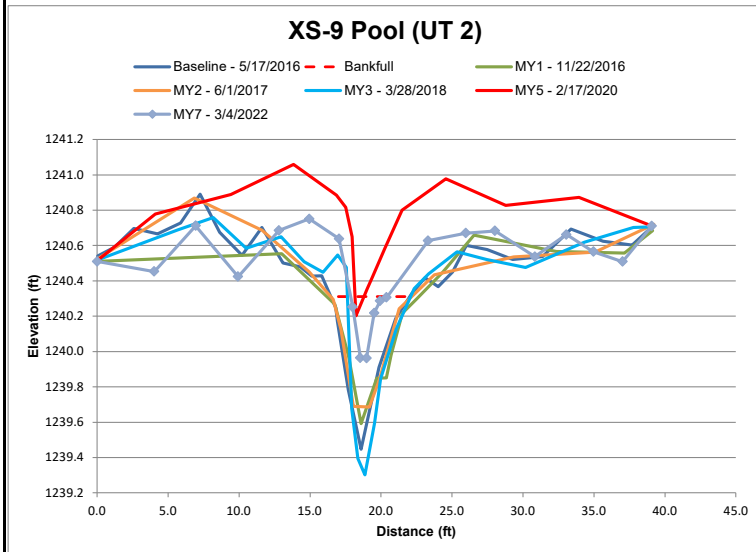
River Basin	Catawba
Watershed	03050101060030
XS ID	XS 9 (UT 2)
Drainage Area (Acres)	44.80
Date	3/3/2022
Field Crew	TC, WY

Dimension and substrate	Cross Section 9 (Pool)					
	Base	MY1	MY2	MY3	MY5	MY7
Bankfull Width (ft)	5.56	6.43	5.69	5.53	2.37	2.57
Floodprone Width (ft)						
Bankfull Mean Depth (ft)	0.37	0.31	0.33	0.49	0.53	0.16
Bankfull Max Depth (ft)	0.86	0.72	0.63	1.12	0.73	0.35
Bankfull Cross Sectional Area (ft ²)	2.07	1.97	1.90	2.73	1.26	0.41
Bankfull Width/Depth Ratio						
Bankfull Entrenchment Ratio						
Low Bank Height (ft)						
Bank Height Ratio

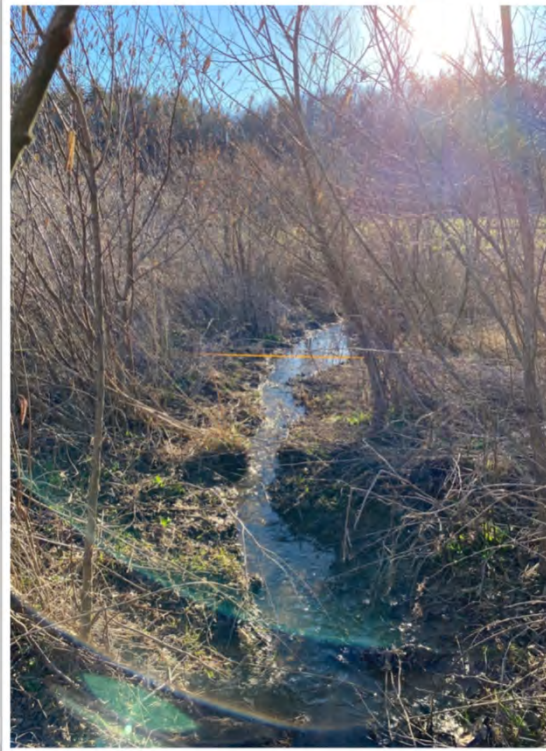
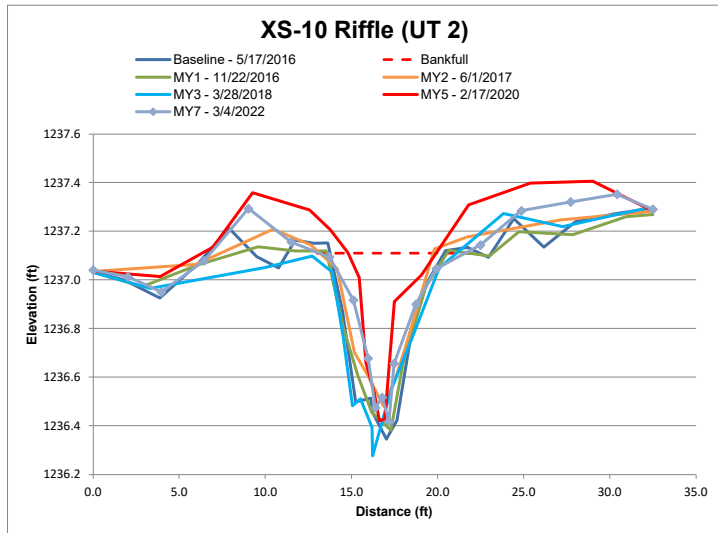
River Basin	Catawba
Watershed	03050101060030
XS ID	XS 10 (UT 2)
Drainage Area (Acres)	44.80
Date	3/3/2022
Field Crew	TC, WY

Dimension and substrate*	Cross Section 10 (Riffle)					
	Base	MY1	MY2	MY3	MY5	MY7**
Bankfull Width (ft)	6.70	7.10	6.79	7.38	5.32	4.81
Floodprone Width (ft)	93.36	93.36	93.36	93.36	93.36	93.36
Bankfull Mean Depth (ft)	0.42	0.38	0.32	0.39	0.25	0.36
Bankfull Max Depth (ft)	0.77	0.74	0.64	0.84	0.70	0.69
Bankfull Cross Sectional Area (ft ²)	2.79	2.69	2.17	2.88	1.35	1.74
Bankfull Width/Depth Ratio	16.75	18.68	21.22	18.92	21.28	13.28
Bankfull Entrenchment Ratio	13.93	13.14	13.75	12.65	17.55	19.41
Low Bank Height (ft)	---	---	---	0.83	0.87	0.63
Bank Height Ratio*	1.00	1.00	1.01	1.00	>1	0.91

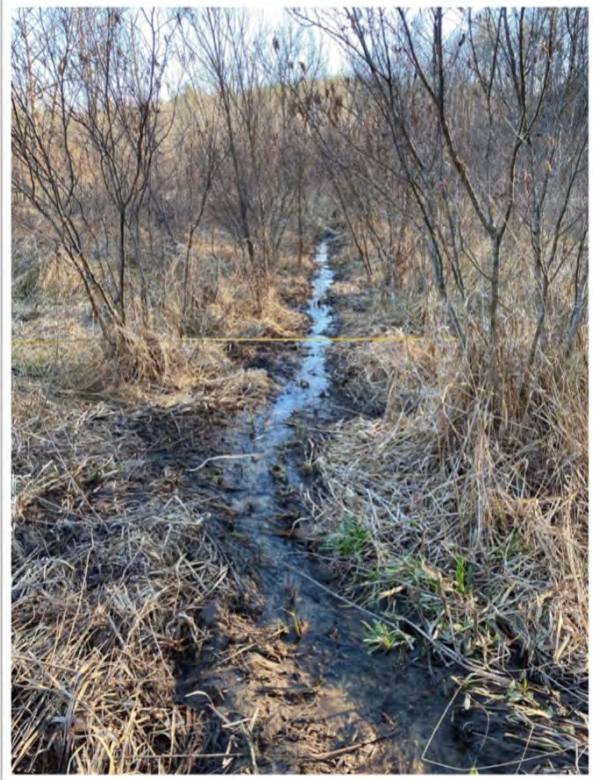
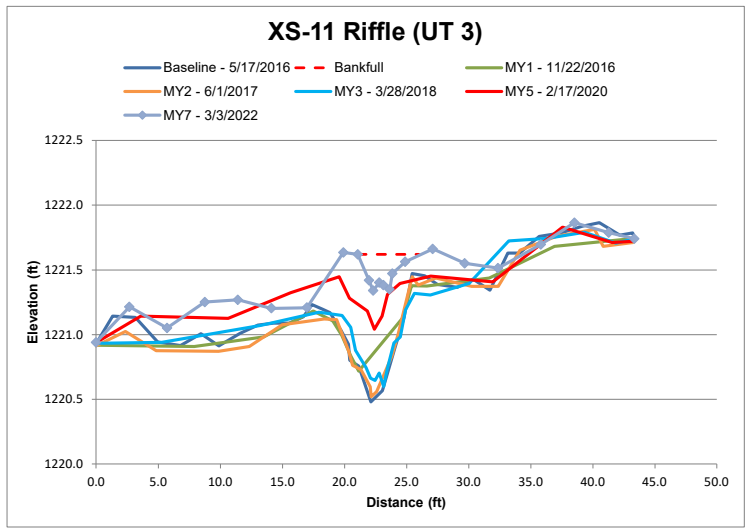
River Basin	Catawba
Watershed	03050101060030
XS ID	XS 11 (UT 3)
Drainage Area (Acres)	12.80
Date	3/3/2022
Field Crew	TC, WY

Dimension and substrate	Cross Section 11 (Riffle)					
	Base	MY1	MY2	MY3	MY5	MY7**
Bankfull Width (ft)	6.00	7.28	5.38	6.73	7.22	5.11
Floodprone Width (ft)	175.41	175.41	175.41	175.41	175.41	175.4
Bankfull Mean Depth (ft)	0.36	0.21	0.37	0.24	0.3	0.13
Bankfull Max Depth (ft)	0.69	0.46	0.65	0.57	0.76	0.57
Bankfull Cross Sectional Area (ft ²)	2.19	1.51	2.01	1.62	2.18	0.69
Bankfull Width/Depth Ratio	16.67	34.67	14.54	28.04	24.07	106.7
Bankfull Entrenchment Ratio	29.24	24.09	32.60	26.06	24.3	34.34
Low Bank Height (ft)	---	---	---	0.50	0.85	0.58
Bank Height Ratio*	1.00	1.00	1.00	<1	1.12	1.03

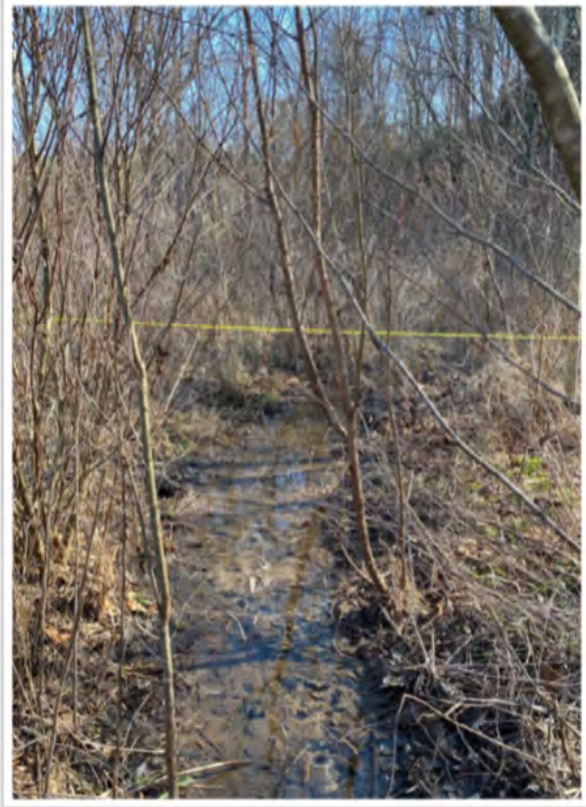
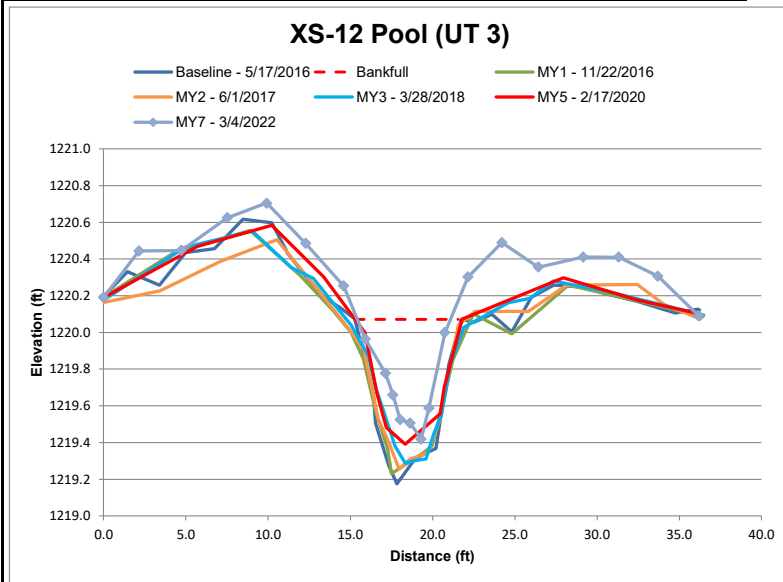
River Basin	Catawba
Watershed	03050101060030
XS ID	XS 12 (UT 3)
Drainage Area (Acres)	12.80
Date	3/3/2022
Field Crew	TC, WY

Dimension and substrate	Cross Section 12 (Pool)					
	Base	MY1	MY2	MY3	MY5	MY7
Bankfull Width (ft)	6.39	7.93	7.52	7.99	6.50	5.65
Floodprone Width (ft)						
Bankfull Mean Depth (ft)	0.56	0.46	0.45	0.40	0.43	0.34
Bankfull Max Depth (ft)	0.90	0.84	0.82	0.78	0.68	0.65
Bankfull Cross Sectional Area (ft ²)	3.55	3.61	3.40	3.23	2.78	1.93
Bankfull Width/Depth Ratio						
Bankfull Entrenchment Ratio						
Low Bank Height (ft)						
Bank Height Ratio

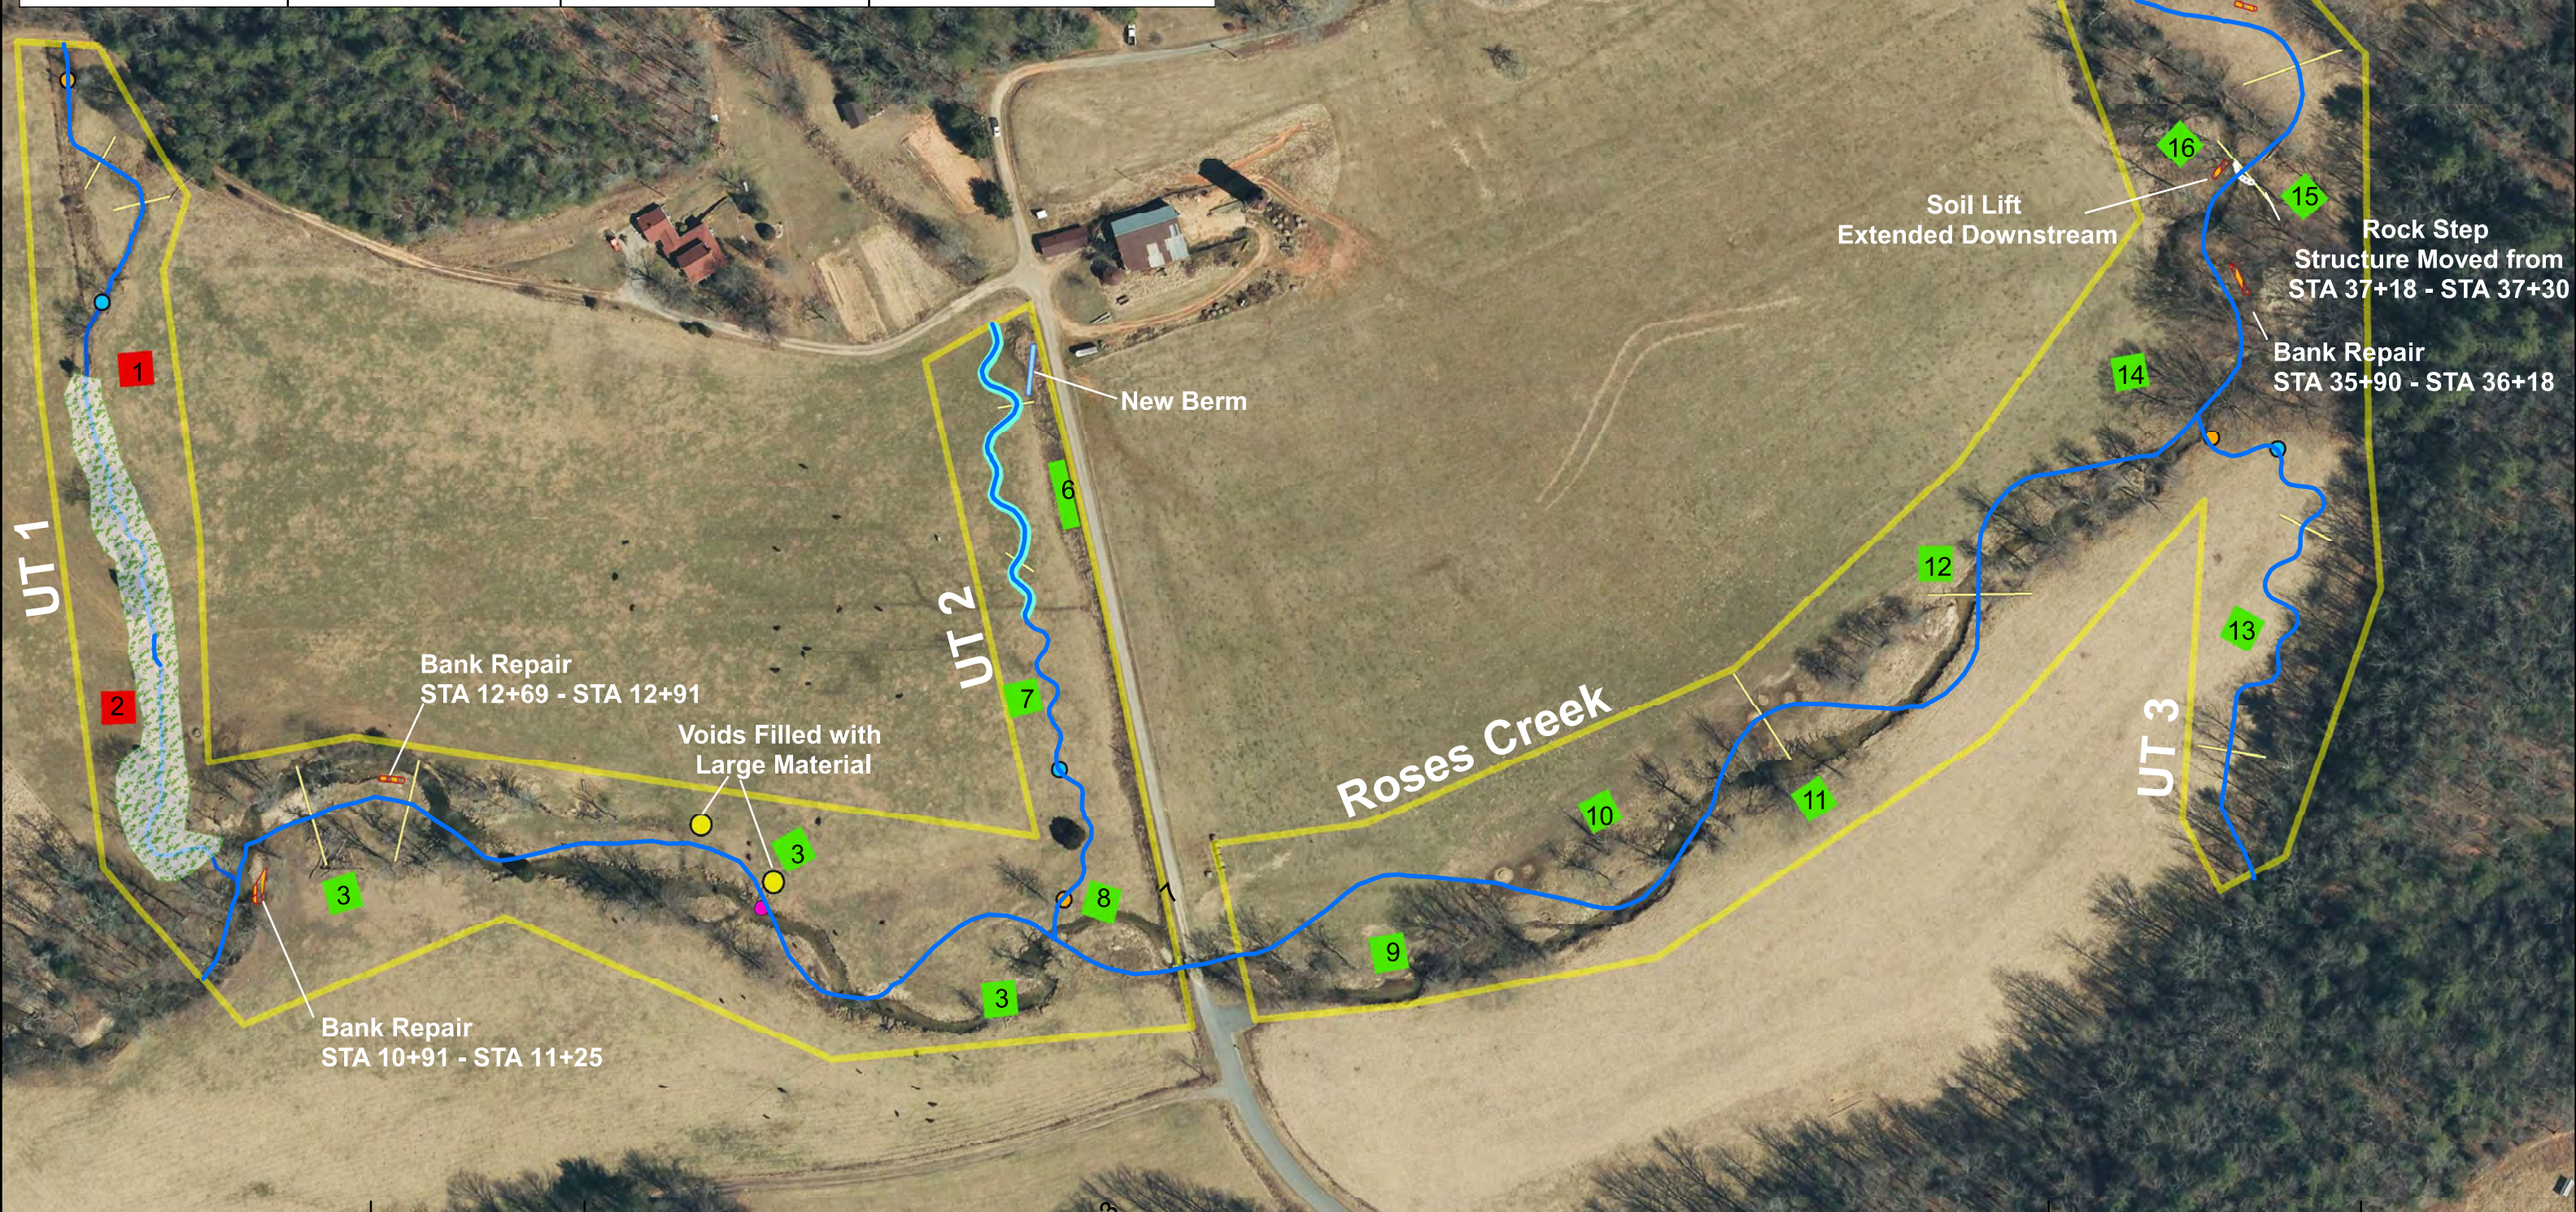
Figure 7. Roses Creek Adaptive Management Map- MY3

Adaptive management in the form of supplemental tree planting in 2016/2017 and stream channel repairs in 2018/2019 assisted to increase tree density and stabilize stream banks and channels. Appendix H has been added to the report to show the locations and tree species that were planted in 2017. Appendix I shows the location of repairs along the UTs and the mainstem of Roses Creek that were completed in October 2018 and early 2019.
