# MY01 MONITORING REPORT

Round Hill Branch Restoration Site  
Buncombe County, North Carolina  
French Broad River Basin - 06010105

DMS Project #100066

Monitoring Data Collected: 2022

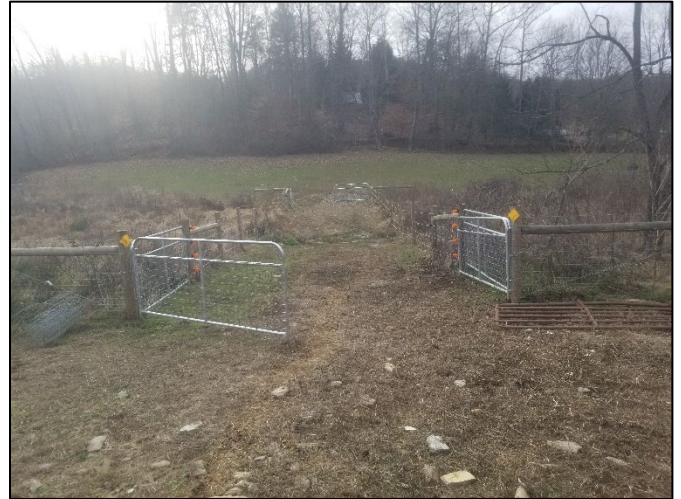
PP1 – MY-01 – 12/20/22

4. Please provide an additional photo for the crossing where photo point 1 is located, from the perspective of looking upstream at the crossing (position yourself near STA 14+00). Both photos of this crossing show the gates open, so livestock access to the ford crossing is a concern.  
*KCI Response: This photo has been provided in the MY01 report. During the first monitoring year there have been no signs of damage or instability in and around this crossing.*

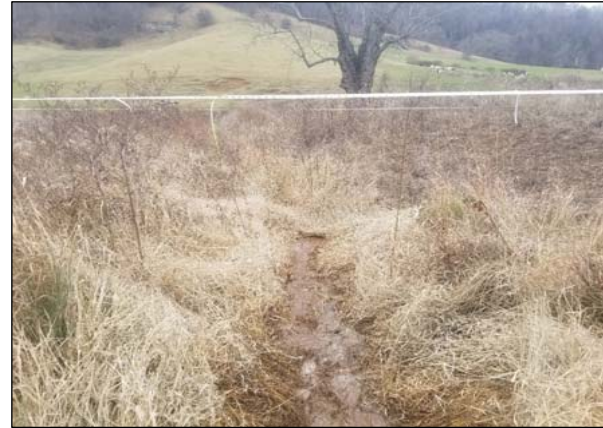
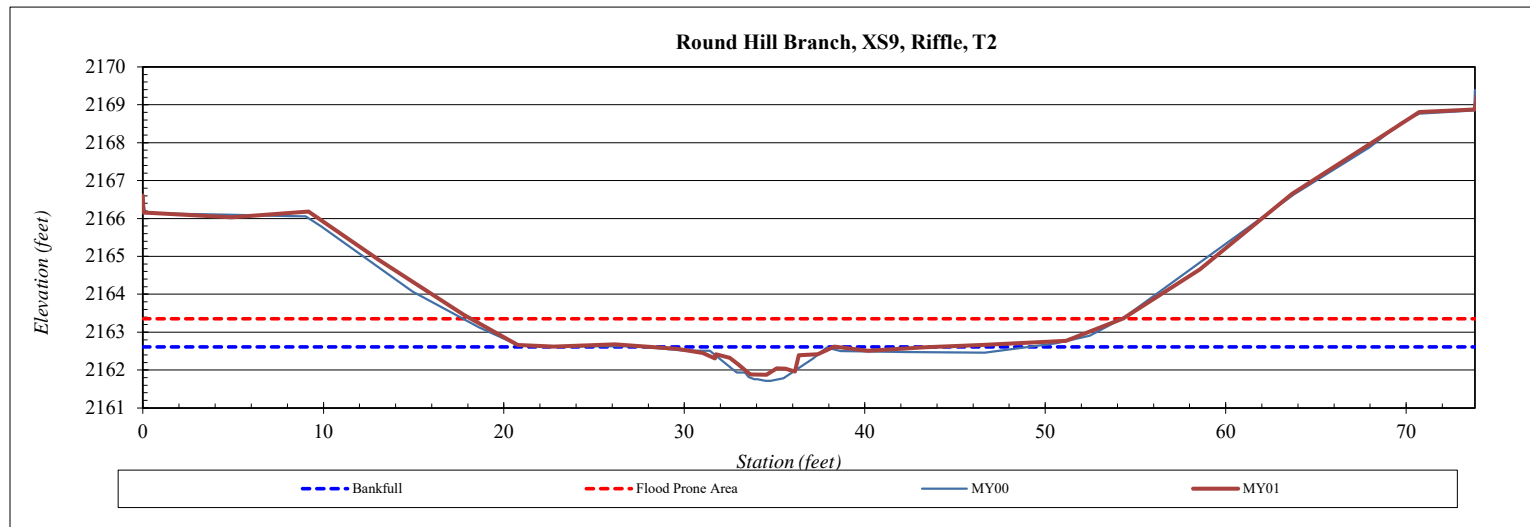
<b>River Basin:</b>	French Broad
<b>Site:</b>	Round Hill Branch
<b>XS ID</b>	XS9
<b>Drainage Area (sq mi):</b>	0.11
<b>Date:</b>	1/19/2022
<b>Field Crew:</b>	TS, KB

SUMMARY DATA	
<b>Bankfull Elevation (ft) - Based on AB-Bankfull Area</b>	2162.61
<b>Bankfull Cross-Sectional Area:</b>	3.1
<b>LTOB Cross-Sectional Area:</b>	3.2
<b>Bankfull Width:</b>	10.0
<b>Flood Prone Area Elevation:</b>	2163.35
<b>Flood Prone Width:</b>	36.1
<b>LTOB Max Depth</b>	0.7
<b>LTOB Mean Depth</b>	0.3
<b>W / D Ratio:</b>	31.2
<b>Entrenchment Ratio:</b>	3.6
<b>Bank Height Ratio:</b>	1.0
<b>Thalweg Elevation:</b>	2161.87

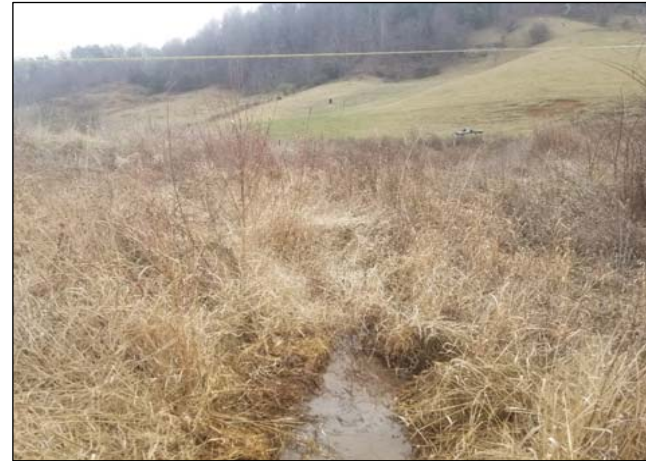
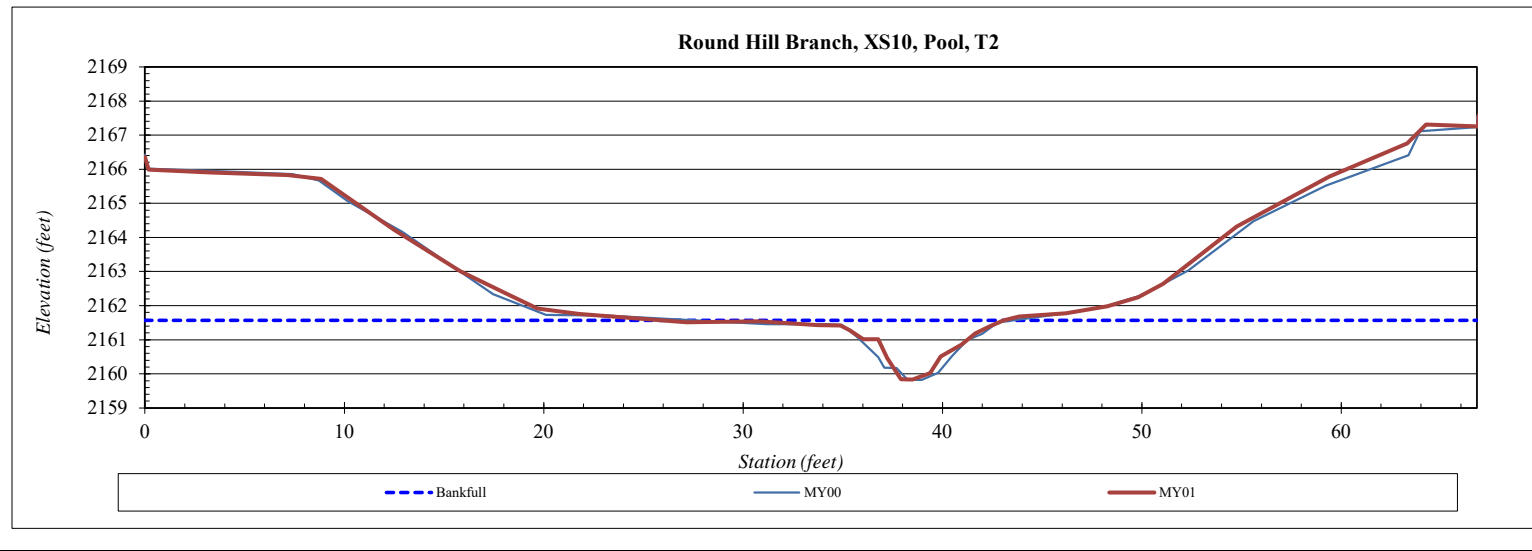
<b>River Basin:</b>	French Broad
<b>Site:</b>	Round Hill Branch
<b>XS ID</b>	XS10
<b>Drainage Area (sq mi):</b>	0.11
<b>Date:</b>	1/19/2022
<b>Field Crew:</b>	TS, KB

SUMMARY DATA	
<b>Bankfull Elevation (ft) - Based on AB-Bankfull Area</b>	2161.56
<b>Bankfull Cross-Sectional Area:</b>	6.8
<b>LTOB Cross-Sectional Area:</b>	5.8
<b>Bankfull Width:</b>	8.1
<b>Flood Prone Area Elevation:</b>	---
<b>Flood Prone Width:</b>	---
<b>LTOB Max Depth</b>	1.6
<b>LTOB Mean Depth</b>	0.7
<b>W / D Ratio:</b>	---
<b>Entrenchment Ratio:</b>	---
<b>Bank Height Ratio:</b>	---
<b>Thalweg Elevation:</b>	2159.84
