# MY02 MONITORING REPORT

Round Hill Branch Restoration Site  
Buncombe County, North Carolina  
French Broad River Basin - 06010105

DMS Project #100066

Monitoring Data Collected: 2023

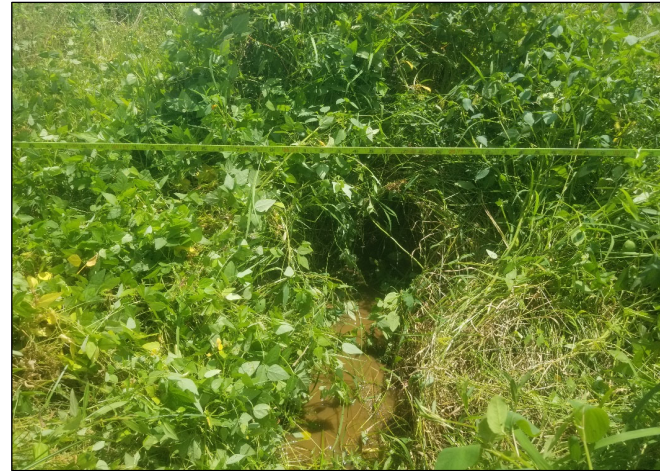
<b>River Basin:</b>	French Broad
<b>Site:</b>	Round Hill Branch
<b>XS ID</b>	XS7
<b>Drainage Area (sq mi):</b>	0.11
<b>Date:</b>	8/1/2023
<b>Field Crew:</b>	TS, CK

SUMMARY DATA	
<b>Bankfull Elevation (ft) - Based on AB-Bankfull Area</b>	2167.85
<b>Bankfull Cross-Sectional Area:</b>	3.5
<b>LTOB Cross-Sectional Area:</b>	3.6
<b>Bankfull Width:</b>	7.9
<b>Flood Prone Area Elevation:</b>	2168.93
<b>Flood Prone Width:</b>	51.6
<b>LTOB Max Depth</b>	1.1
<b>LTOB Mean Depth</b>	0.5
<b>W / D Ratio:</b>	17.5
<b>Entrenchment Ratio:</b>	6.5
<b>Bank Height Ratio:</b>	1.0
<b>Thalweg Elevation:</b>	2166.77

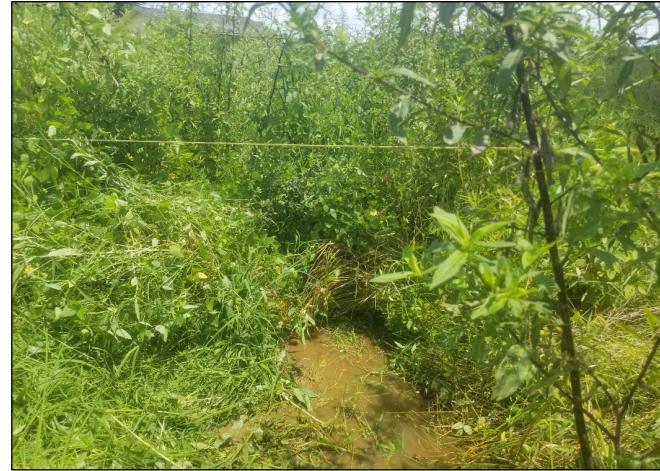
<b>River Basin:</b>	French Broad
<b>Site:</b>	Round Hill Branch
<b>XS ID</b>	XS8
<b>Drainage Area (sq mi):</b>	0.11
<b>Date:</b>	8/1/2023
<b>Field Crew:</b>	TS, CK

SUMMARY DATA	
<b>Bankfull Elevation (ft) - Based on AB-Bankfull Area</b>	2167.82
<b>Bankfull Cross-Sectional Area:</b>	10.2
<b>LTOB Cross-Sectional Area:</b>	6.1
<b>Bankfull Width:</b>	9.2
<b>Flood Prone Area Elevation:</b>	---
<b>Flood Prone Width:</b>	---
<b>LTOB Max Depth</b>	1.3
<b>LTOB Mean Depth</b>	0.7
<b>W / D Ratio:</b>	---
<b>Entrenchment Ratio:</b>	---
<b>Bank Height Ratio:</b>	---
<b>Thalweg Elevation:</b>	2166.09

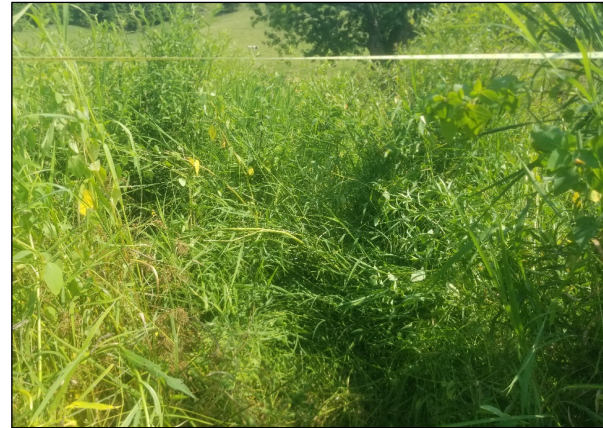
<b>River Basin:</b>	French Broad
<b>Site:</b>	Round Hill Branch
<b>XS ID</b>	XS9
<b>Drainage Area (sq mi):</b>	0.11
<b>Date:</b>	8/1/2023
<b>Field Crew:</b>	TS, CK

SUMMARY DATA	
<b>Bankfull Elevation (ft) - Based on AB-Bankfull Area</b>	2162.85
<b>Bankfull Cross-Sectional Area:</b>	3.1
<b>LTOB Cross-Sectional Area:</b>	1.1
<b>Bankfull Width:</b>	6.0
<b>Flood Prone Area Elevation:</b>	2163.36
<b>Flood Prone Width:</b>	35.7
<b>LTOB Max Depth</b>	0.5
<b>LTOB Mean Depth</b>	0.2
<b>W / D Ratio:</b>	32.2
<b>Entrenchment Ratio:</b>	5.9
<b>Bank Height Ratio:</b>	0.3
<b>Thalweg Elevation:</b>	2162.01

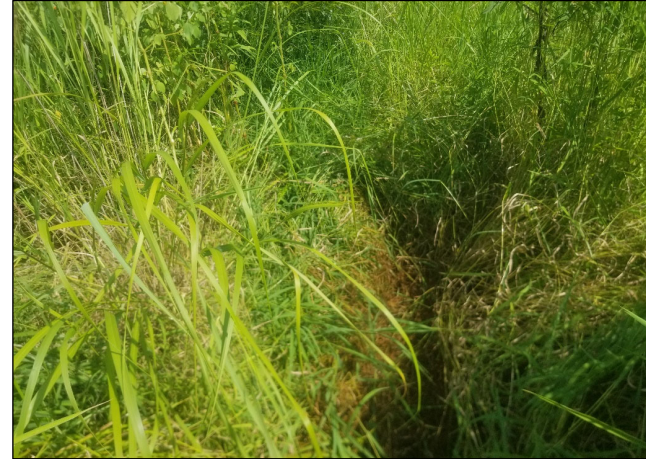
<b>River Basin:</b>	French Broad
<b>Site:</b>	Round Hill Branch
<b>XS ID</b>	XS10
<b>Drainage Area (sq mi):</b>	0.11
<b>Date:</b>	8/1/2023
<b>Field Crew:</b>	TS, CK

SUMMARY DATA	
<b>Bankfull Elevation (ft) - Based on AB-Bankfull Area</b>	2161.92
<b>Bankfull Cross-Sectional Area:</b>	6.8
<b>LTOB Cross-Sectional Area:</b>	3.9
<b>Bankfull Width:</b>	6.3
<b>Flood Prone Area Elevation:</b>	---
<b>Flood Prone Width:</b>	---
<b>LTOB Max Depth</b>	1.3
<b>LTOB Mean Depth</b>	0.6
<b>W / D Ratio:</b>	---
<b>Entrenchment Ratio:</b>	---
<b>Bank Height Ratio:</b>	---
<b>Thalweg Elevation:</b>	2160.21
